MADRID-BOSTON PROJECT
FINAL ENVIRONMENTAL IMPACT STATEMENT

Appendix V5-6Q

Proposed Access Road Fisheries Assessments,
Doris North Project 2015

Subject: Proposed Access Road Fisheries Assessments, Doris North Project, 2015

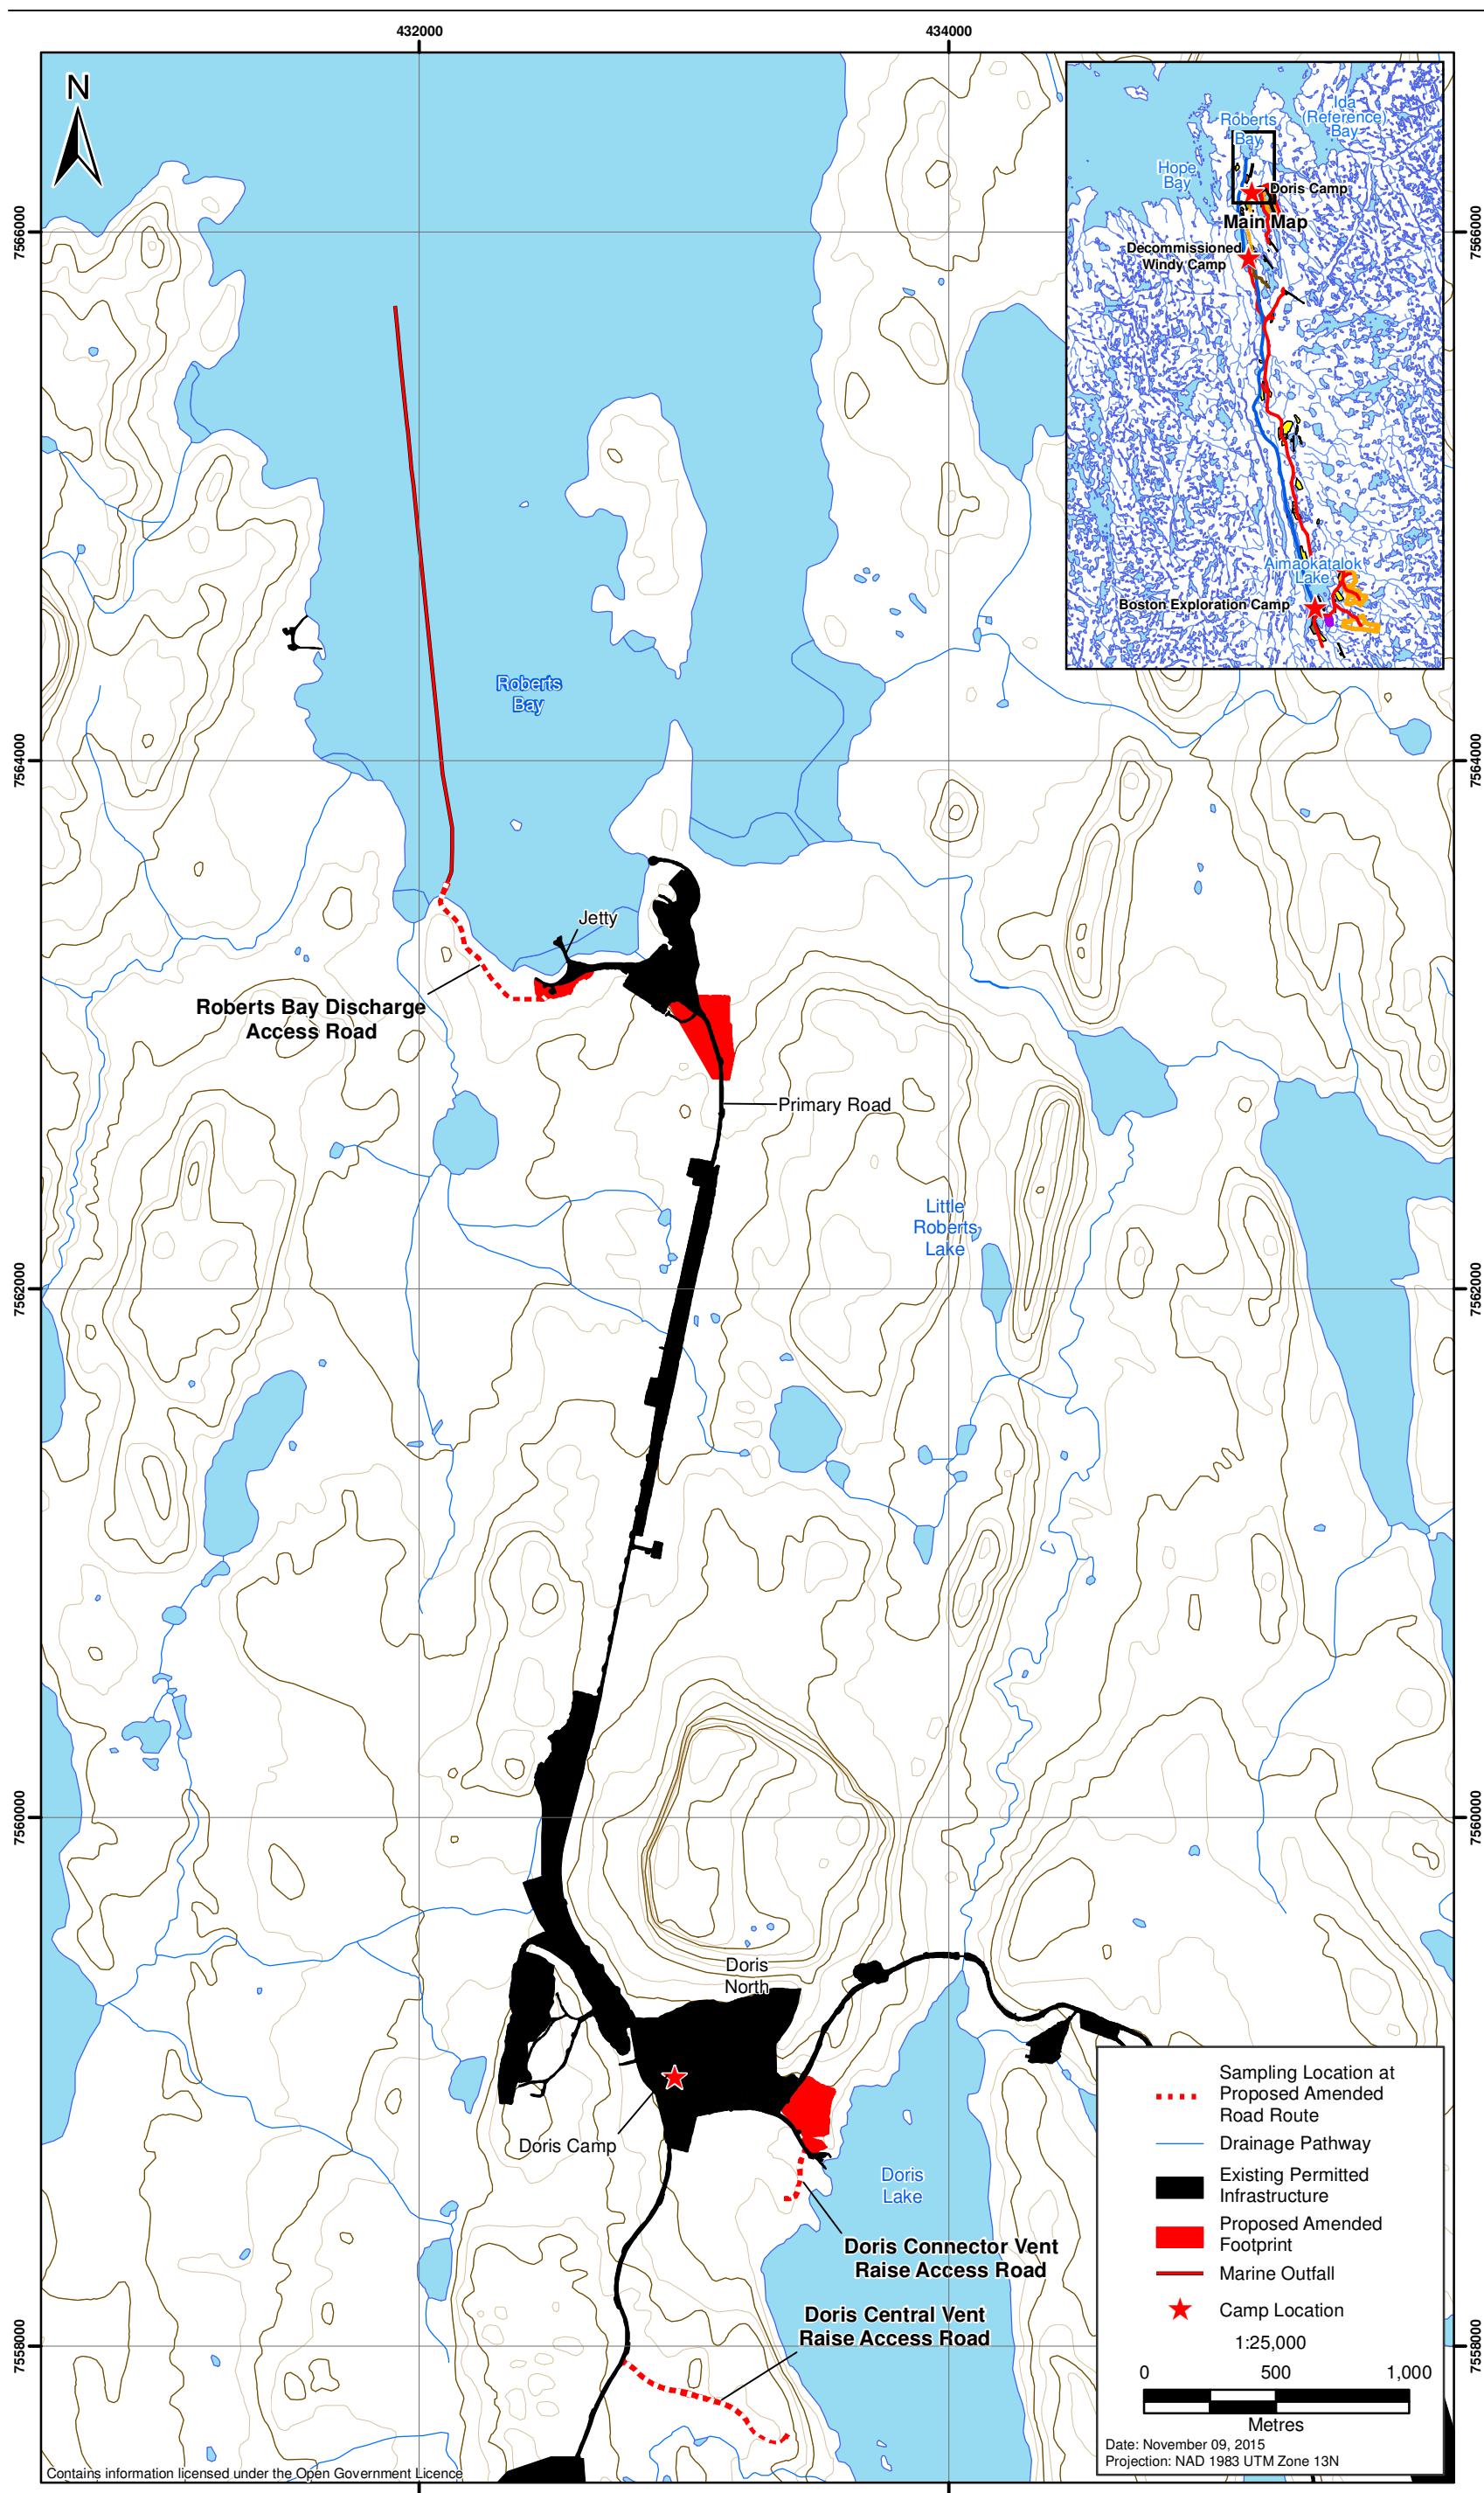
Figure 1-1
Proposed Access Road Sampling Locations, Doris North Project, 2015

- Doris Connector Vent Raise Access Road;
- Doris Central Vent Raise Access Road; and
- Roberts Bay Discharge Access Road (Figure 1-1).

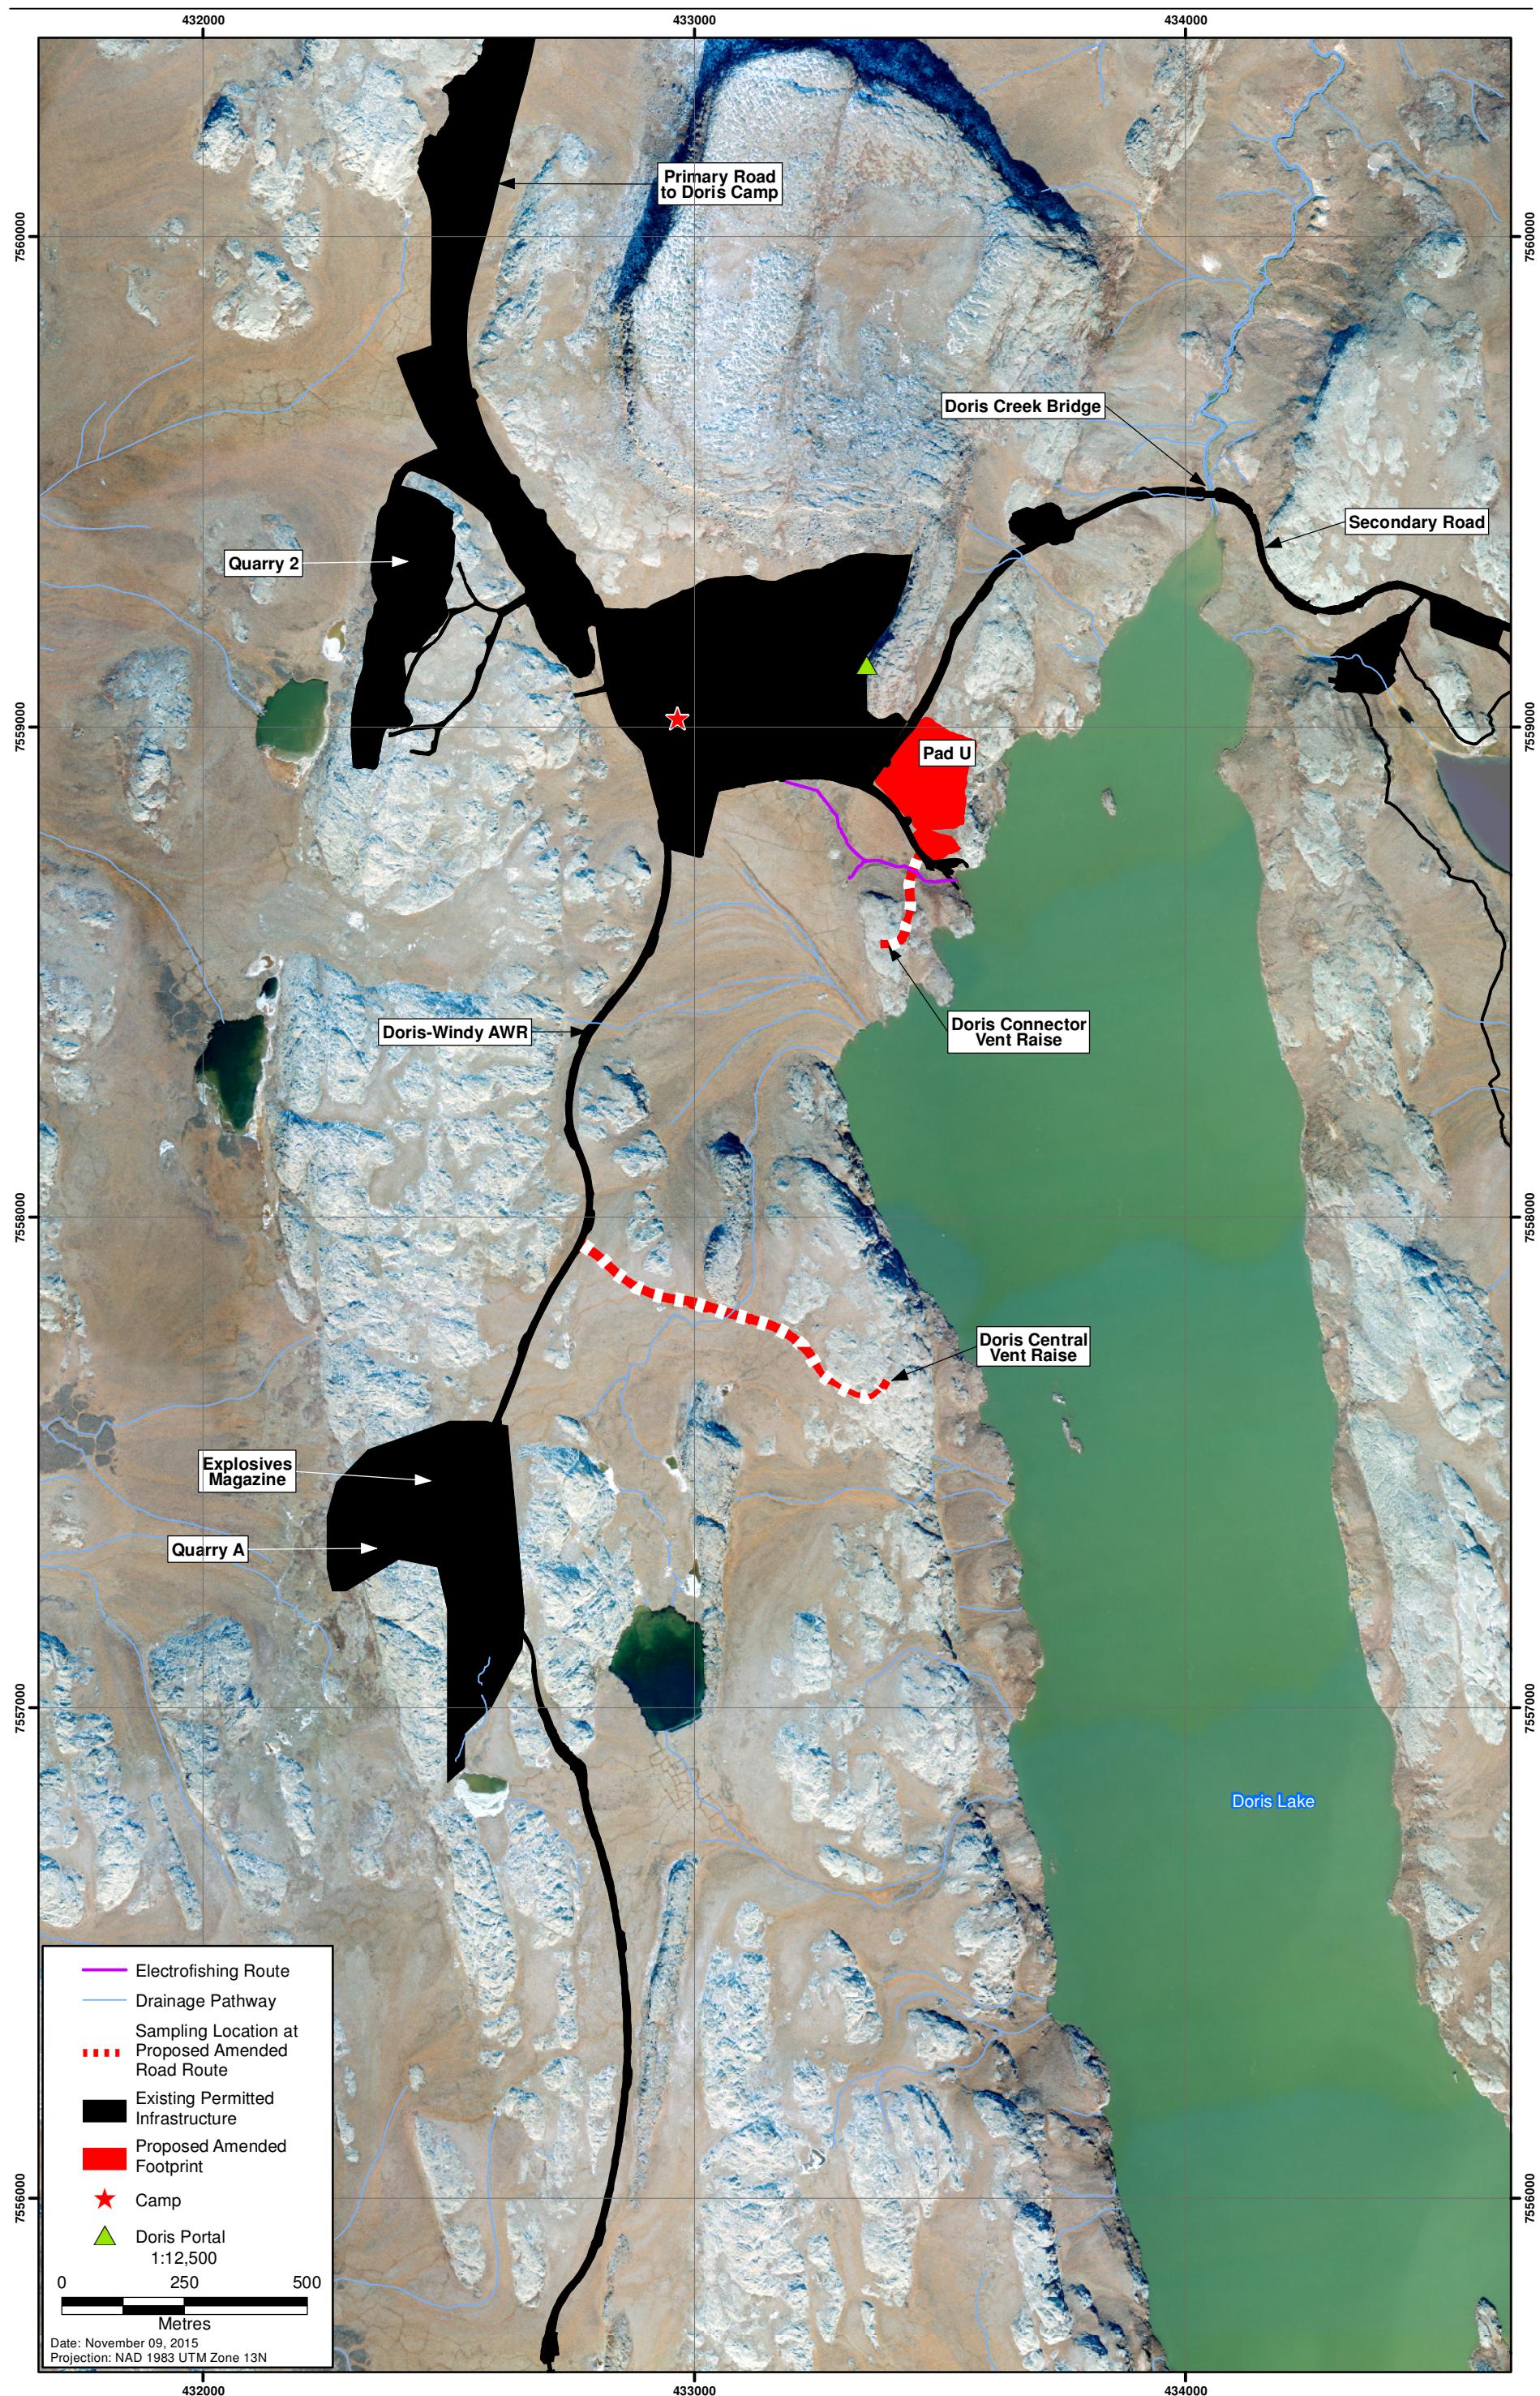
Figure 2.3-1

Electrofishing Sample Route along Unnamed Tributary to Doris Lake, Doris North Project, 2015

Backpack electrofishing was the primary method used to sample stream fish communities on August 13 and 14, 2015. Figures 2.3-1 and 2.3-2 show the stream sections sampled by electrofishing in an unnamed tributary to Doris Lake and an unnamed tributary to Roberts Bay respectively. A crew leader operated a Smith-Root LR-24 and was accompanied by one dip netter. Anode ring diameter was 28 cm and dip net diameter was 21 cm with 3.2 mm mesh.

The review of topographic maps identified locations where both the proposed Doris Connector Vent Raise Access Road and the Roberts Bay Discharge Access Road bisect drainages. Conflicting data exists for a third drainage under the proposed Doris Central Vent Raise Access Road; 1:50,000 map data indicates that the drainage turns south and away from the road route before they cross (e.g. Figure 1-1), whereas more recent, site plan map data indicates that this road would cross a drainage (e.g. Figure 2.3-1). Given this uncertainty, the drainage routes would later be assessed in the field.

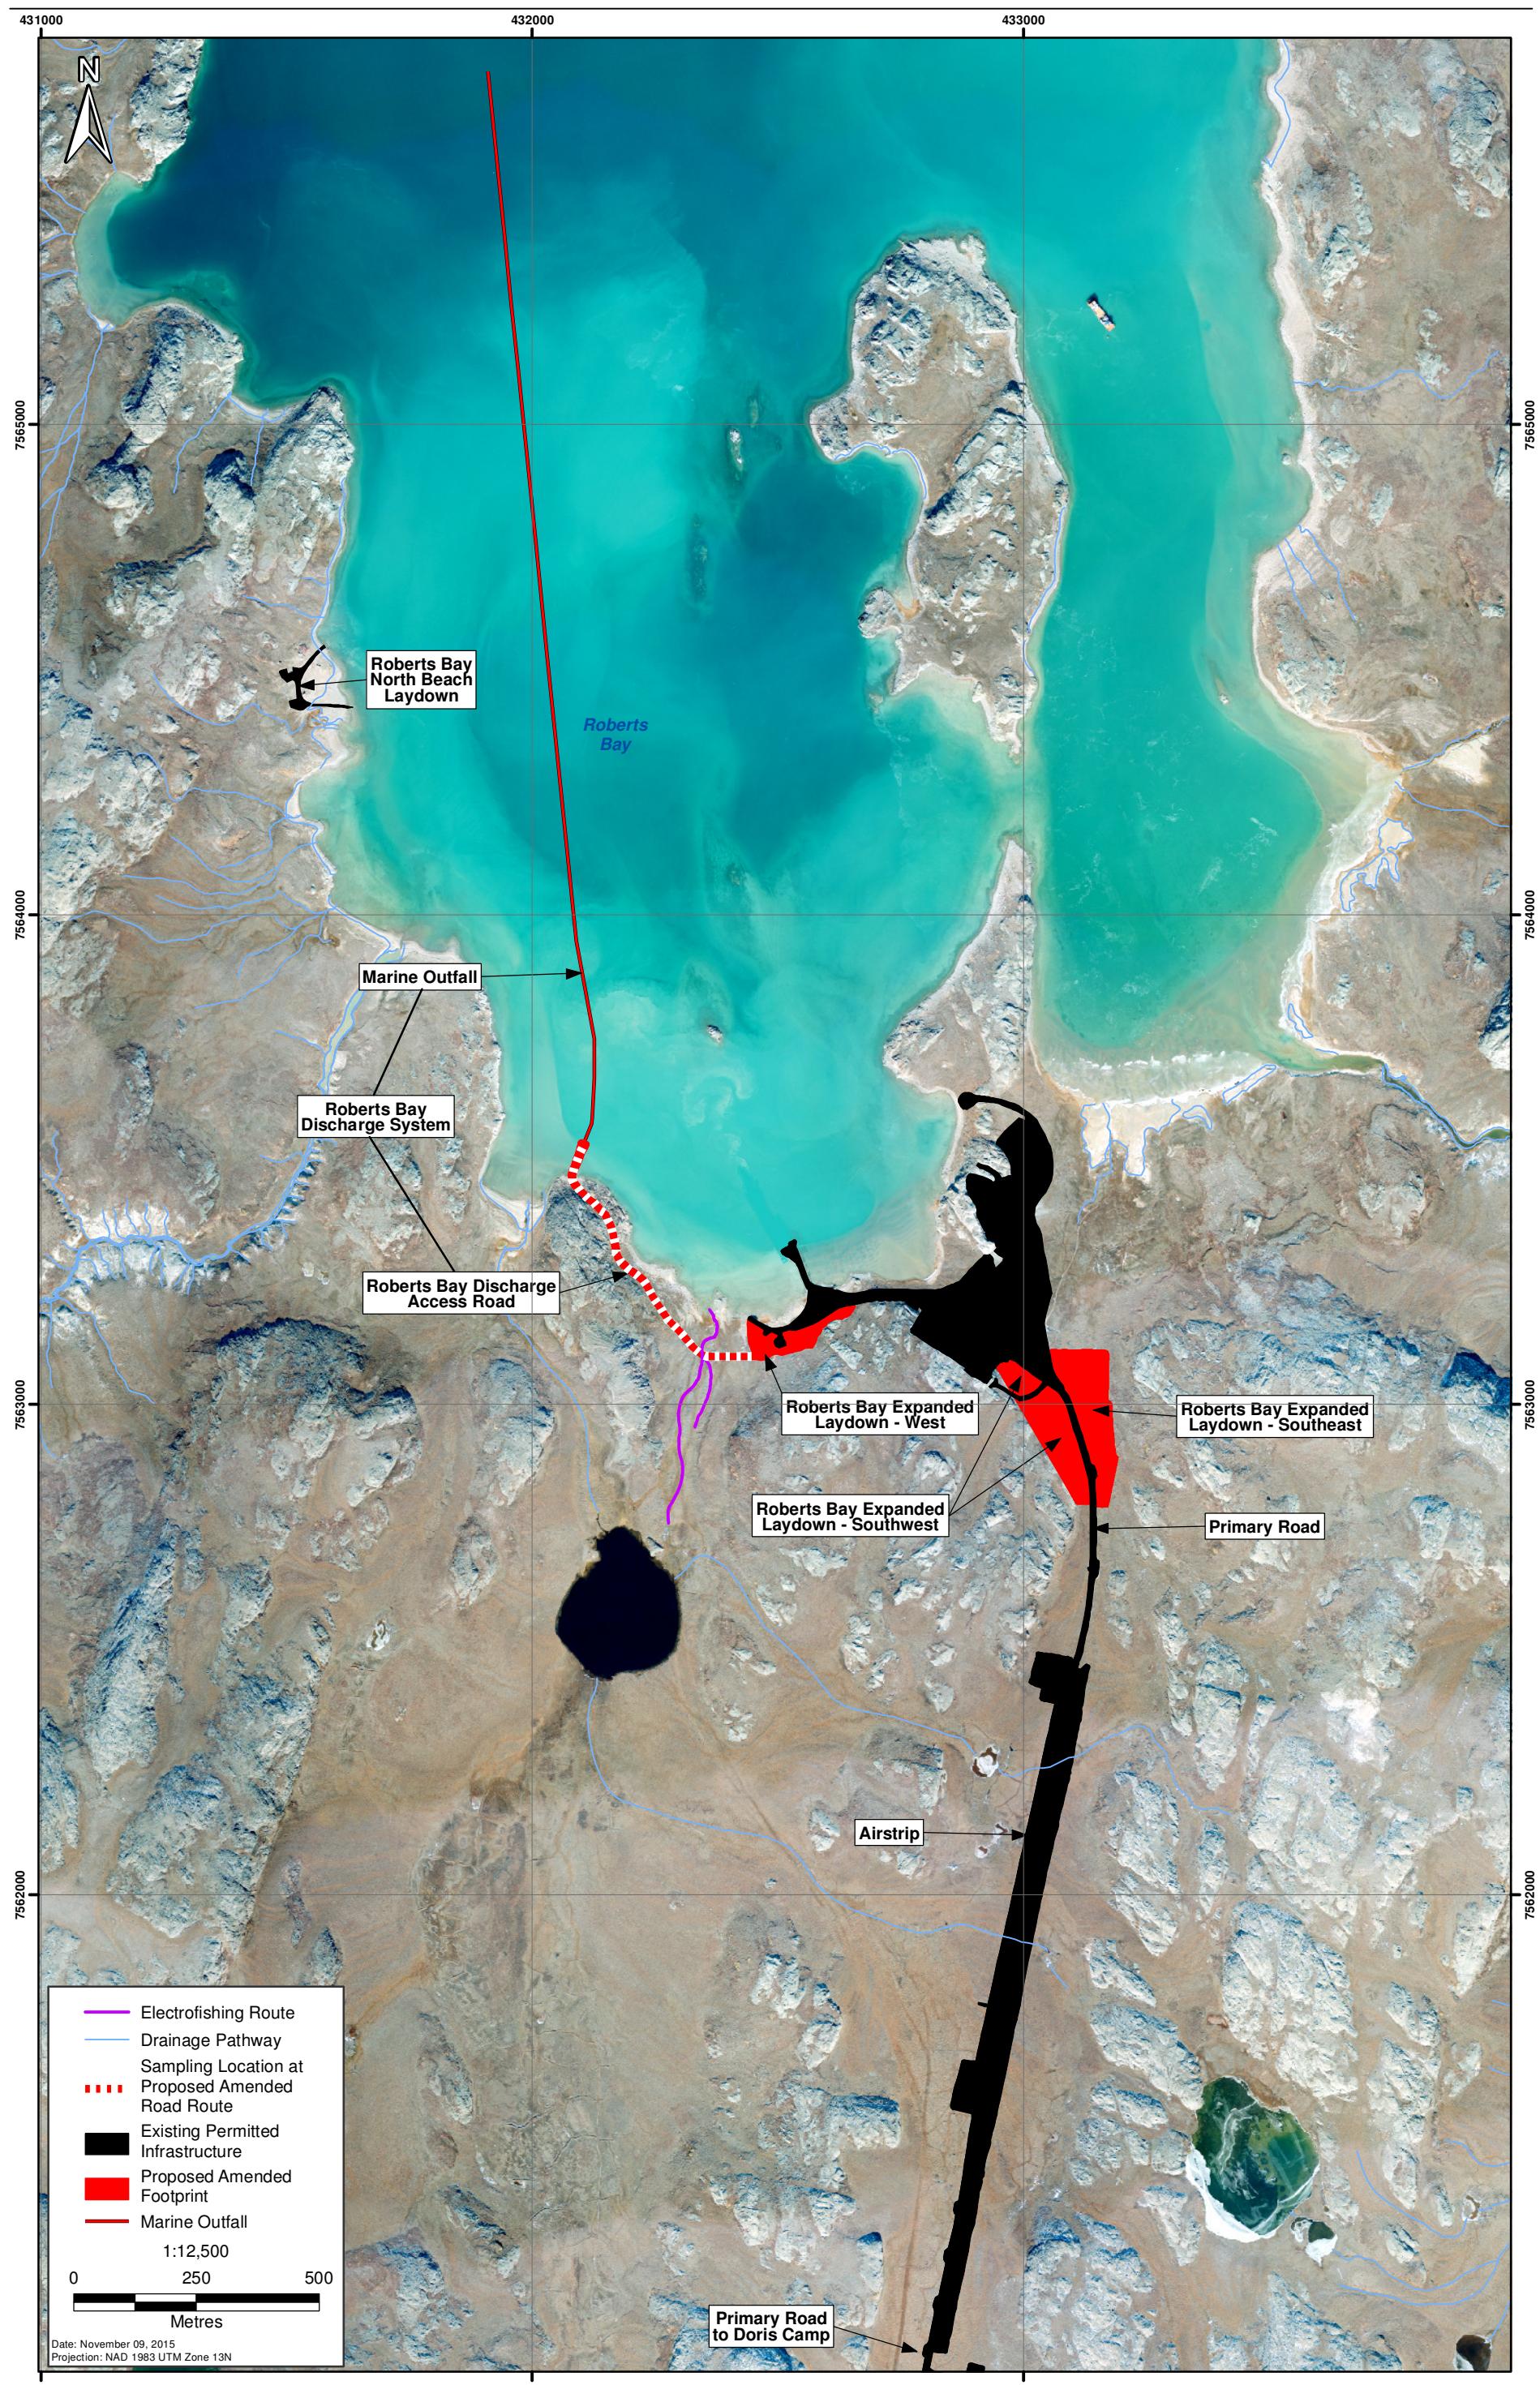
Figure 2.3-2

Electrofishing Sample Route along Unnamed Tributary to Roberts Bay, Doris North Project, 2015

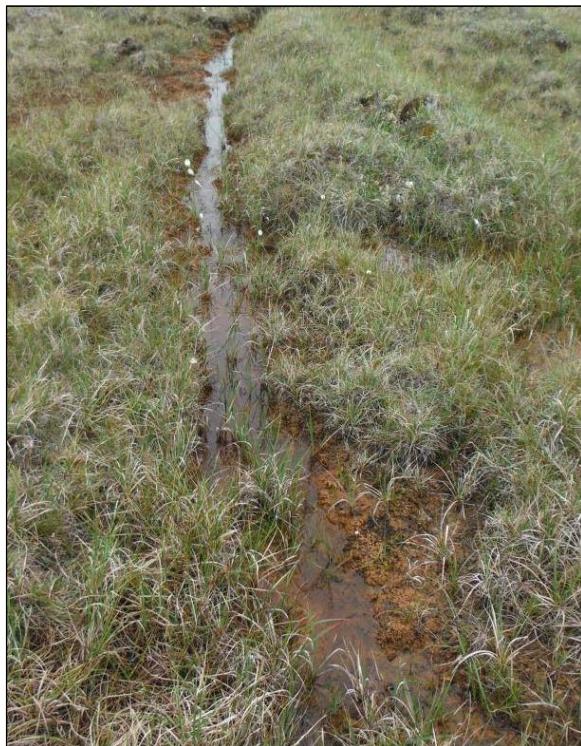
The upper section of the watershed provides poor quality fish habitat. The braided channels are poorly defined, narrow (mean width 0.28 m), shallow (mean depth 0.11 m), and have poor connectivity with each other and with the lower section of the creek (Plate 3.2-1). Dense in-channel terrestrial vegetation and low discharge even during peak periods limit fish

Plate 3.2-1. The upper stream section consists of small, braided channels with poor connectivity to the lower section of the stream, August 13, 2015.

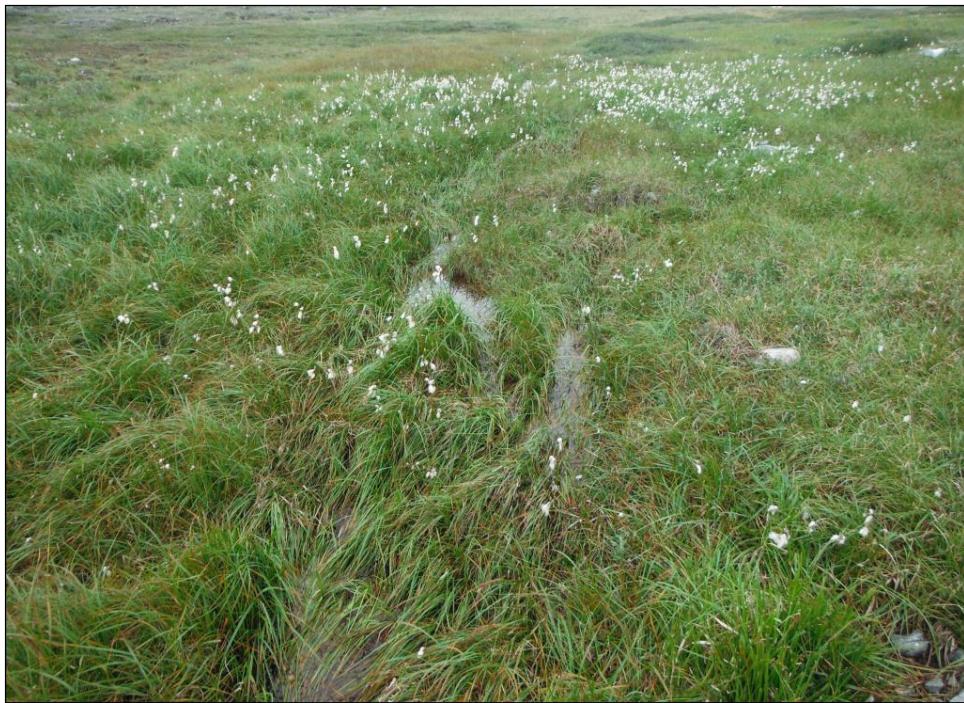
movement and the habitat value in this section. Where the proposed road route crosses the stream, the stream channel is poorly defined and is dominated by terrestrial vegetation, suggesting that it contains flow for a short period during most years (Plate 3.2-2). This area did contain a small amount of flow during August 2015 due to anomalous weather conditions; however, it is expected that this area would cease flowing soon after freshet in most years. Habitat throughout this section is of poor quality.

Plate 3.2-2. The stream section upstream of the culvert is poorly defined due to heavy in-channel vegetation, August 13, 2015.

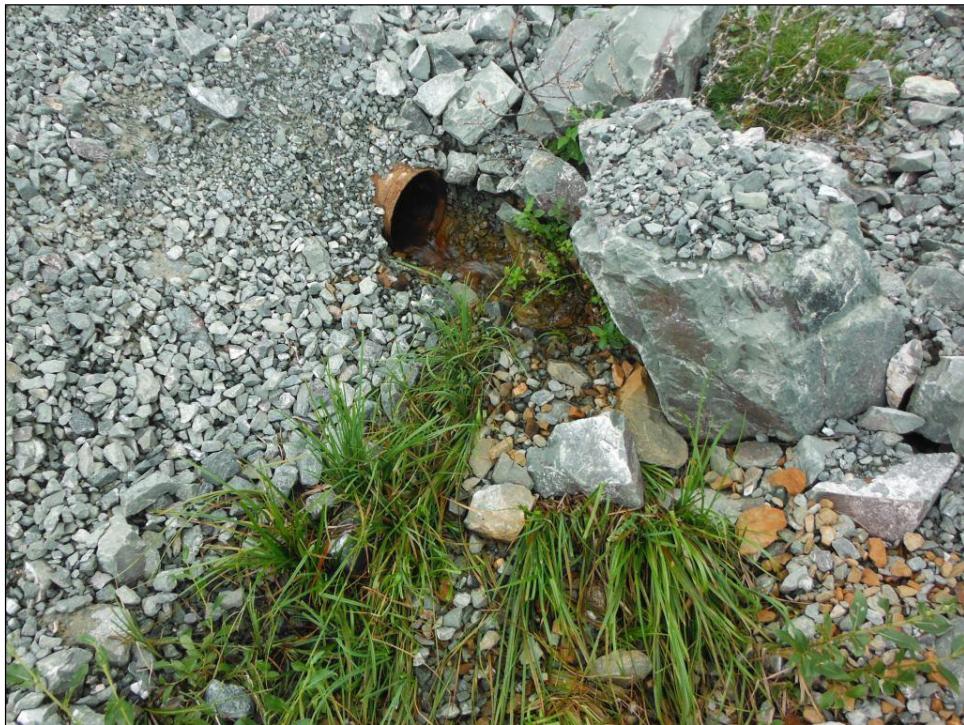
Just upstream of Doris Lake the stream flows through a single 6" diameter culvert under the Doris Lake boat launch ramp. Just upstream of the culvert there is a 3 m section of creek that has a defined channel that could provide some rearing habitat to coarse fish. During the site visit, the channel downstream of the culvert was poorly defined and contained little flow; the majority of water discharging from the culvert percolated subsurface through loose gravels before entering Doris Lake (Plate 3.2-3).

Plate 3.2-3. Discharge from the Doris Lake boat launch culvert percolates into loose gravels, August 13, 2015.

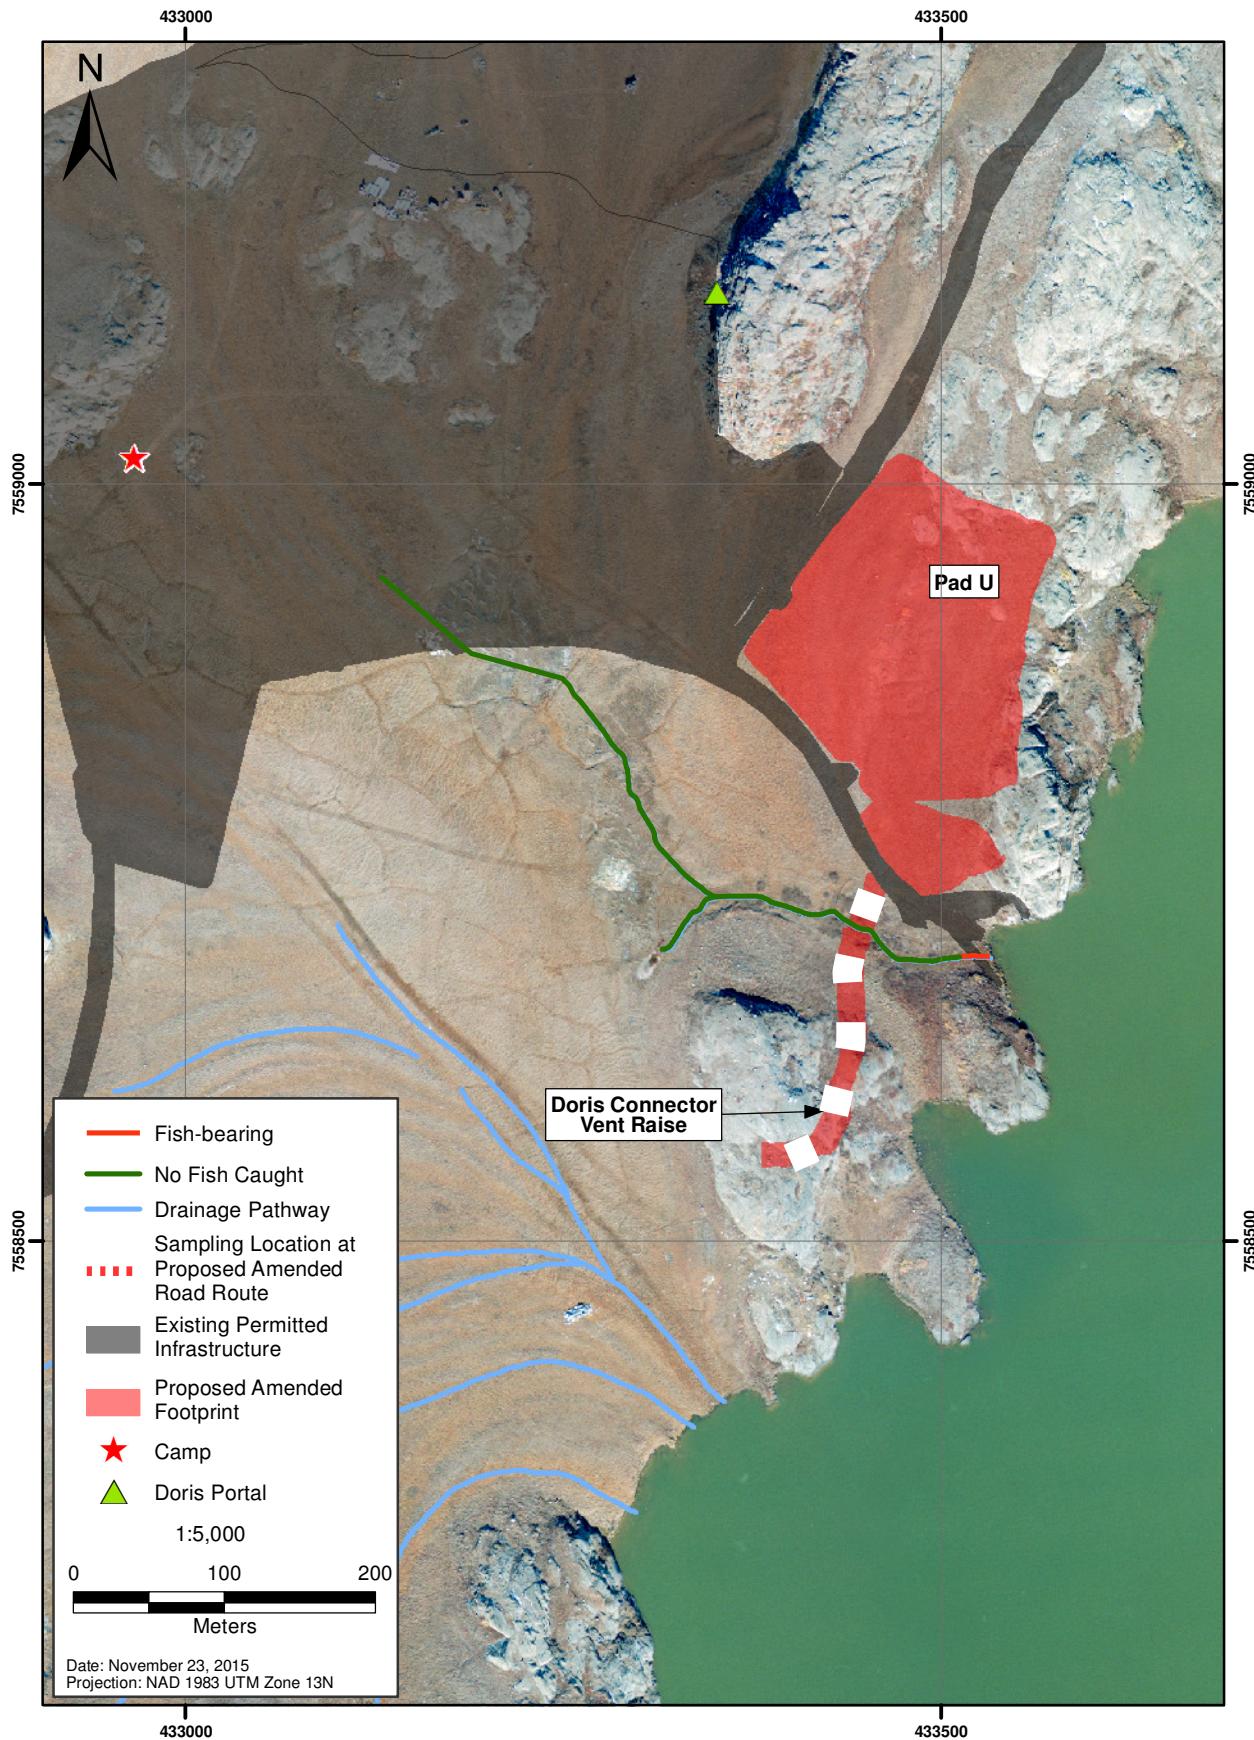
Figure 3.4-1

Fish-bearing Reach of an Unnamed Stream that Intersects the Doris

Connector Vent Raise Access Road on August 13 2015, Doris North Project

Fish do inhabit the stream that intersects with the Doris Connector Vent Raise Access Road, but fish density and diversity are both low. In 1962 seconds of electrofishing, four Ninespine Sticklebacks were captured (CPUE = 0.20) and two additional fish were observed but not captured. All of these fish were caught or observed in a 3 m section of stream just upstream of the existing culvert, confirming that fish are able to pass from the lake upstream through the culvert during freshet (Figure 3.4-1). Fish use appears to be restricted to this small section of the stream; no fish were captured or observed in the remainder of the stream, including where the stream and the road intersect, despite a high level of effort. Upstream of this small fish-bearing section of the creek, the channel is poorly defined and is dominated by dense terrestrial vegetation that limits fish passage. The fish-bearing section of stream is approximately 50 m downstream of the intersection of the stream and the proposed road route.

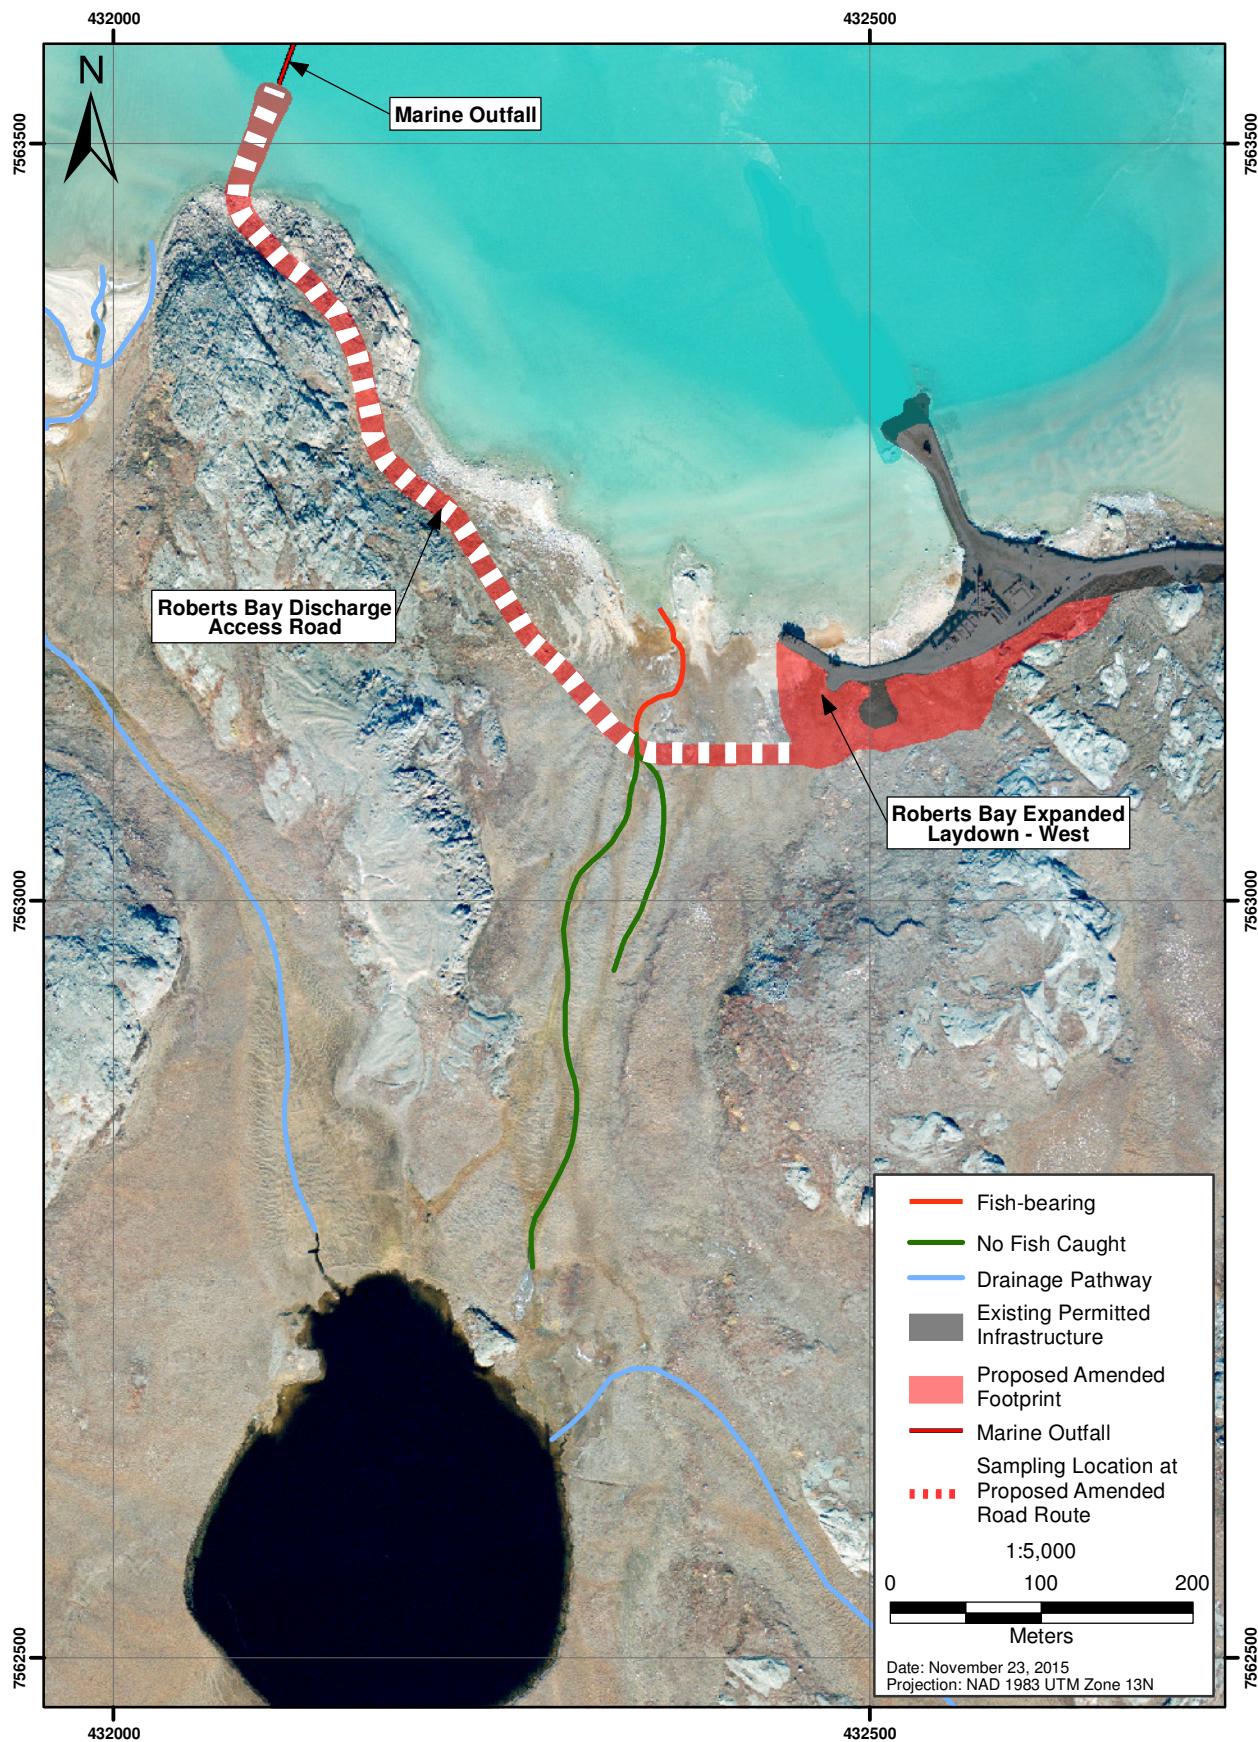
Figure 3.4-2

Fish-bearing Reach of an Unnamed Stream that intersects the Roberts Bay Discharge Access Road on August 13 2015, Doris North Project

A total of four Ninespine Sticklebacks were captured in the stream that flows under the proposed Roberts Bay Discharge Access Road in 4,284 seconds of electrofishing (CPUE = 0.01). This finding is similar to 2009, where only Ninespine Sticklebacks were captured. All fish were captured in the lower section of the stream downstream of the location where the proposed road intersects (Figure 3.4-2). This indicates that poor habitat conditions and dense vegetation prelimit upstream movement of fish from Roberts Bay beyond the lower 100 m section of the stream.
