Hope Bay Project:  
2017 Freshwater Fish and Fish Habitat Baseline Report

## 2017 Freshwater Fish and Fish Habitat Baseline Report

**TMAC Resources Inc.**

Project #0394395-0113-0002

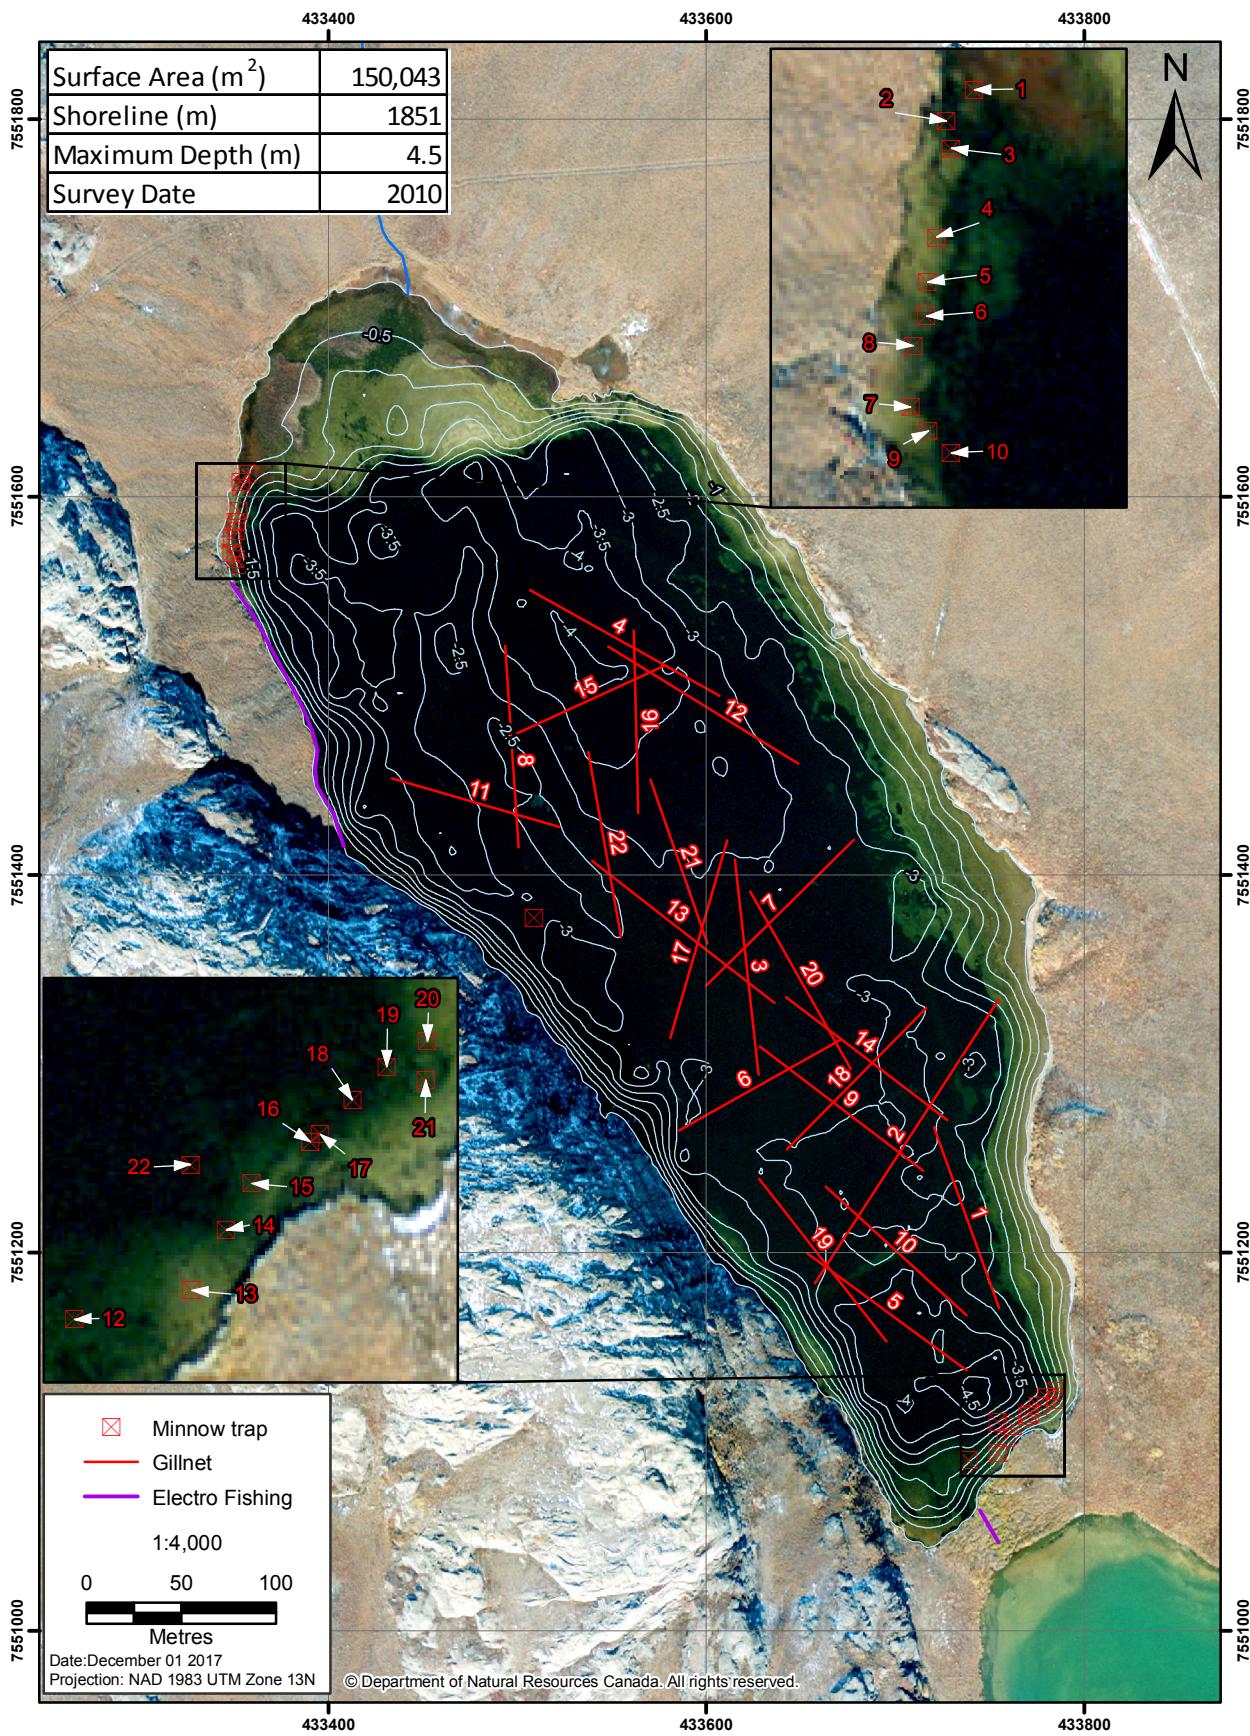
Figure 2.3-2

Fisheries Sampling Locations in Imniagut Lake, 2017

Minnow traps, gillnets, and an electrofisher were used to sample the fish community of Imniagut Lake in July 2017 (Figure 2.3-2). All captured fish were identified to species and enumerated. Fork length was measured to the nearest 1 mm with a measuring board and wet weight was measured to the nearest 0.1 g using an electronic scale for a subsample of fish. Where parasites or DELTs were observed, this information was recorded.

A total of 22 gillnets were set on July 23 and 24, 2017; eleven sinking gangs and eleven floating gangs were deployed (Figure 2.3-2). Each gillnet consisted of a standard gang of six panels of different mesh sizes recommended by the Resources Information Standards Committee (25 mm, 76 mm, 51 mm, 89 mm, 38 mm and 64 mm; RISC 2001). Each panel was 15.2 m long, and the panels were sewn together to make a net that is 91.2 m long and 2.4 m deep. Nets were deployed by boat and set for up to two hours. Gill netting data were standardised as CPUE, which was calculated as the number of fish captured per 100 m<sup>2</sup> of net per hour (Table 2.3-1).

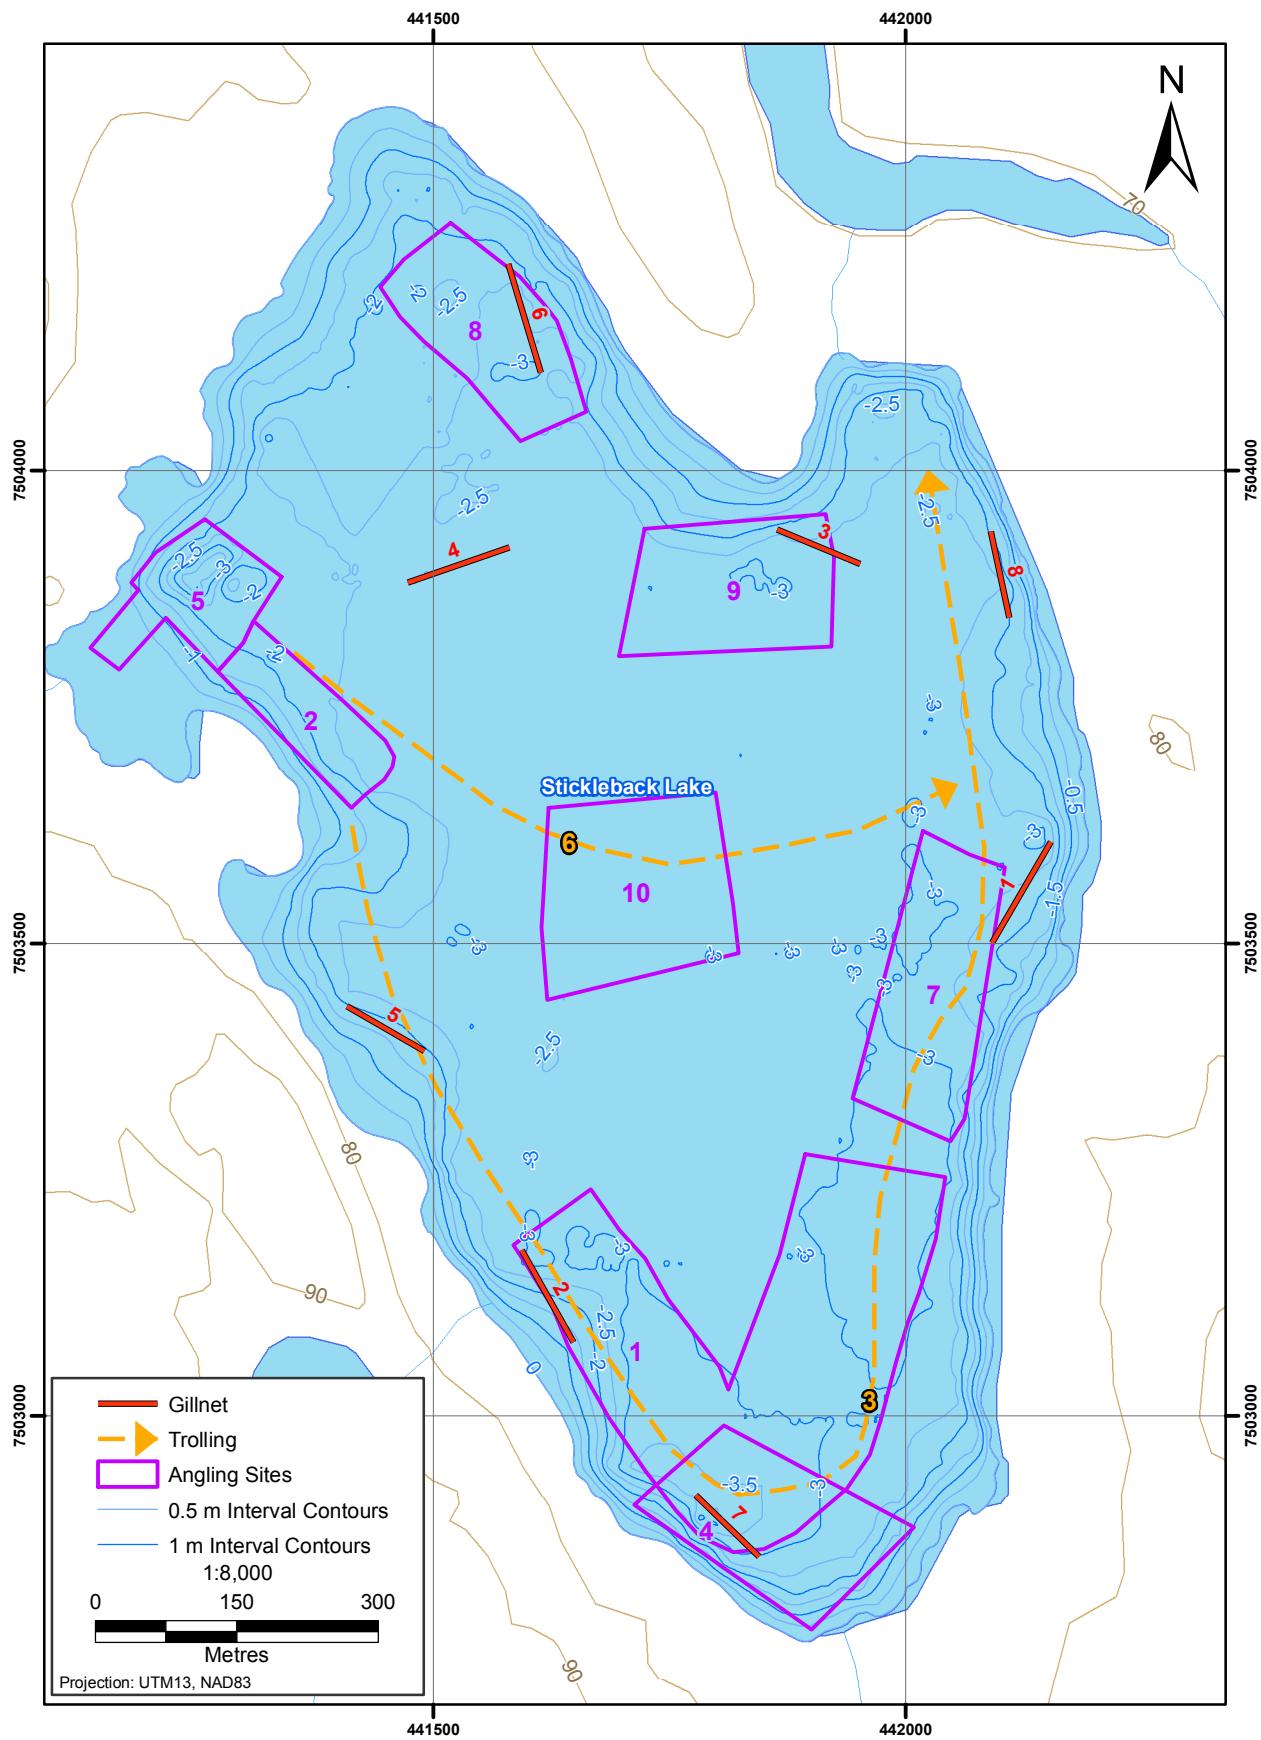
Figure 2.4-2

Fisheries Sampling Locations in Stickleback Lake, 2017

In an attempt to capture Arctic Grayling, angling methods were varied to target fish under different conditions. Angling efforts were conducted using two spinning rods simultaneously or one spinning rod and one fly fishing rod. Spinning rods were fished by spin casting or trolling with 1/16 oz. Panther Martin Spinners in various colours with barbless treble hooks. Fly rods were fished by streaming or trolling with various sinking fly patterns with size 10 - 14 barbless hooks. Fishing locations were marked on a bathymetric map (Figure 2.4-2) and duration of fishing effort at each location was recorded in the field.

A total of eight gillnets were set on August 1 and 2, 2017 (Figure 2.4-2); only sinking gangs were deployed (mesh size, panel order and panel size were as described in Section 2.3.2). Nets were deployed by boat and set for up to three hours.

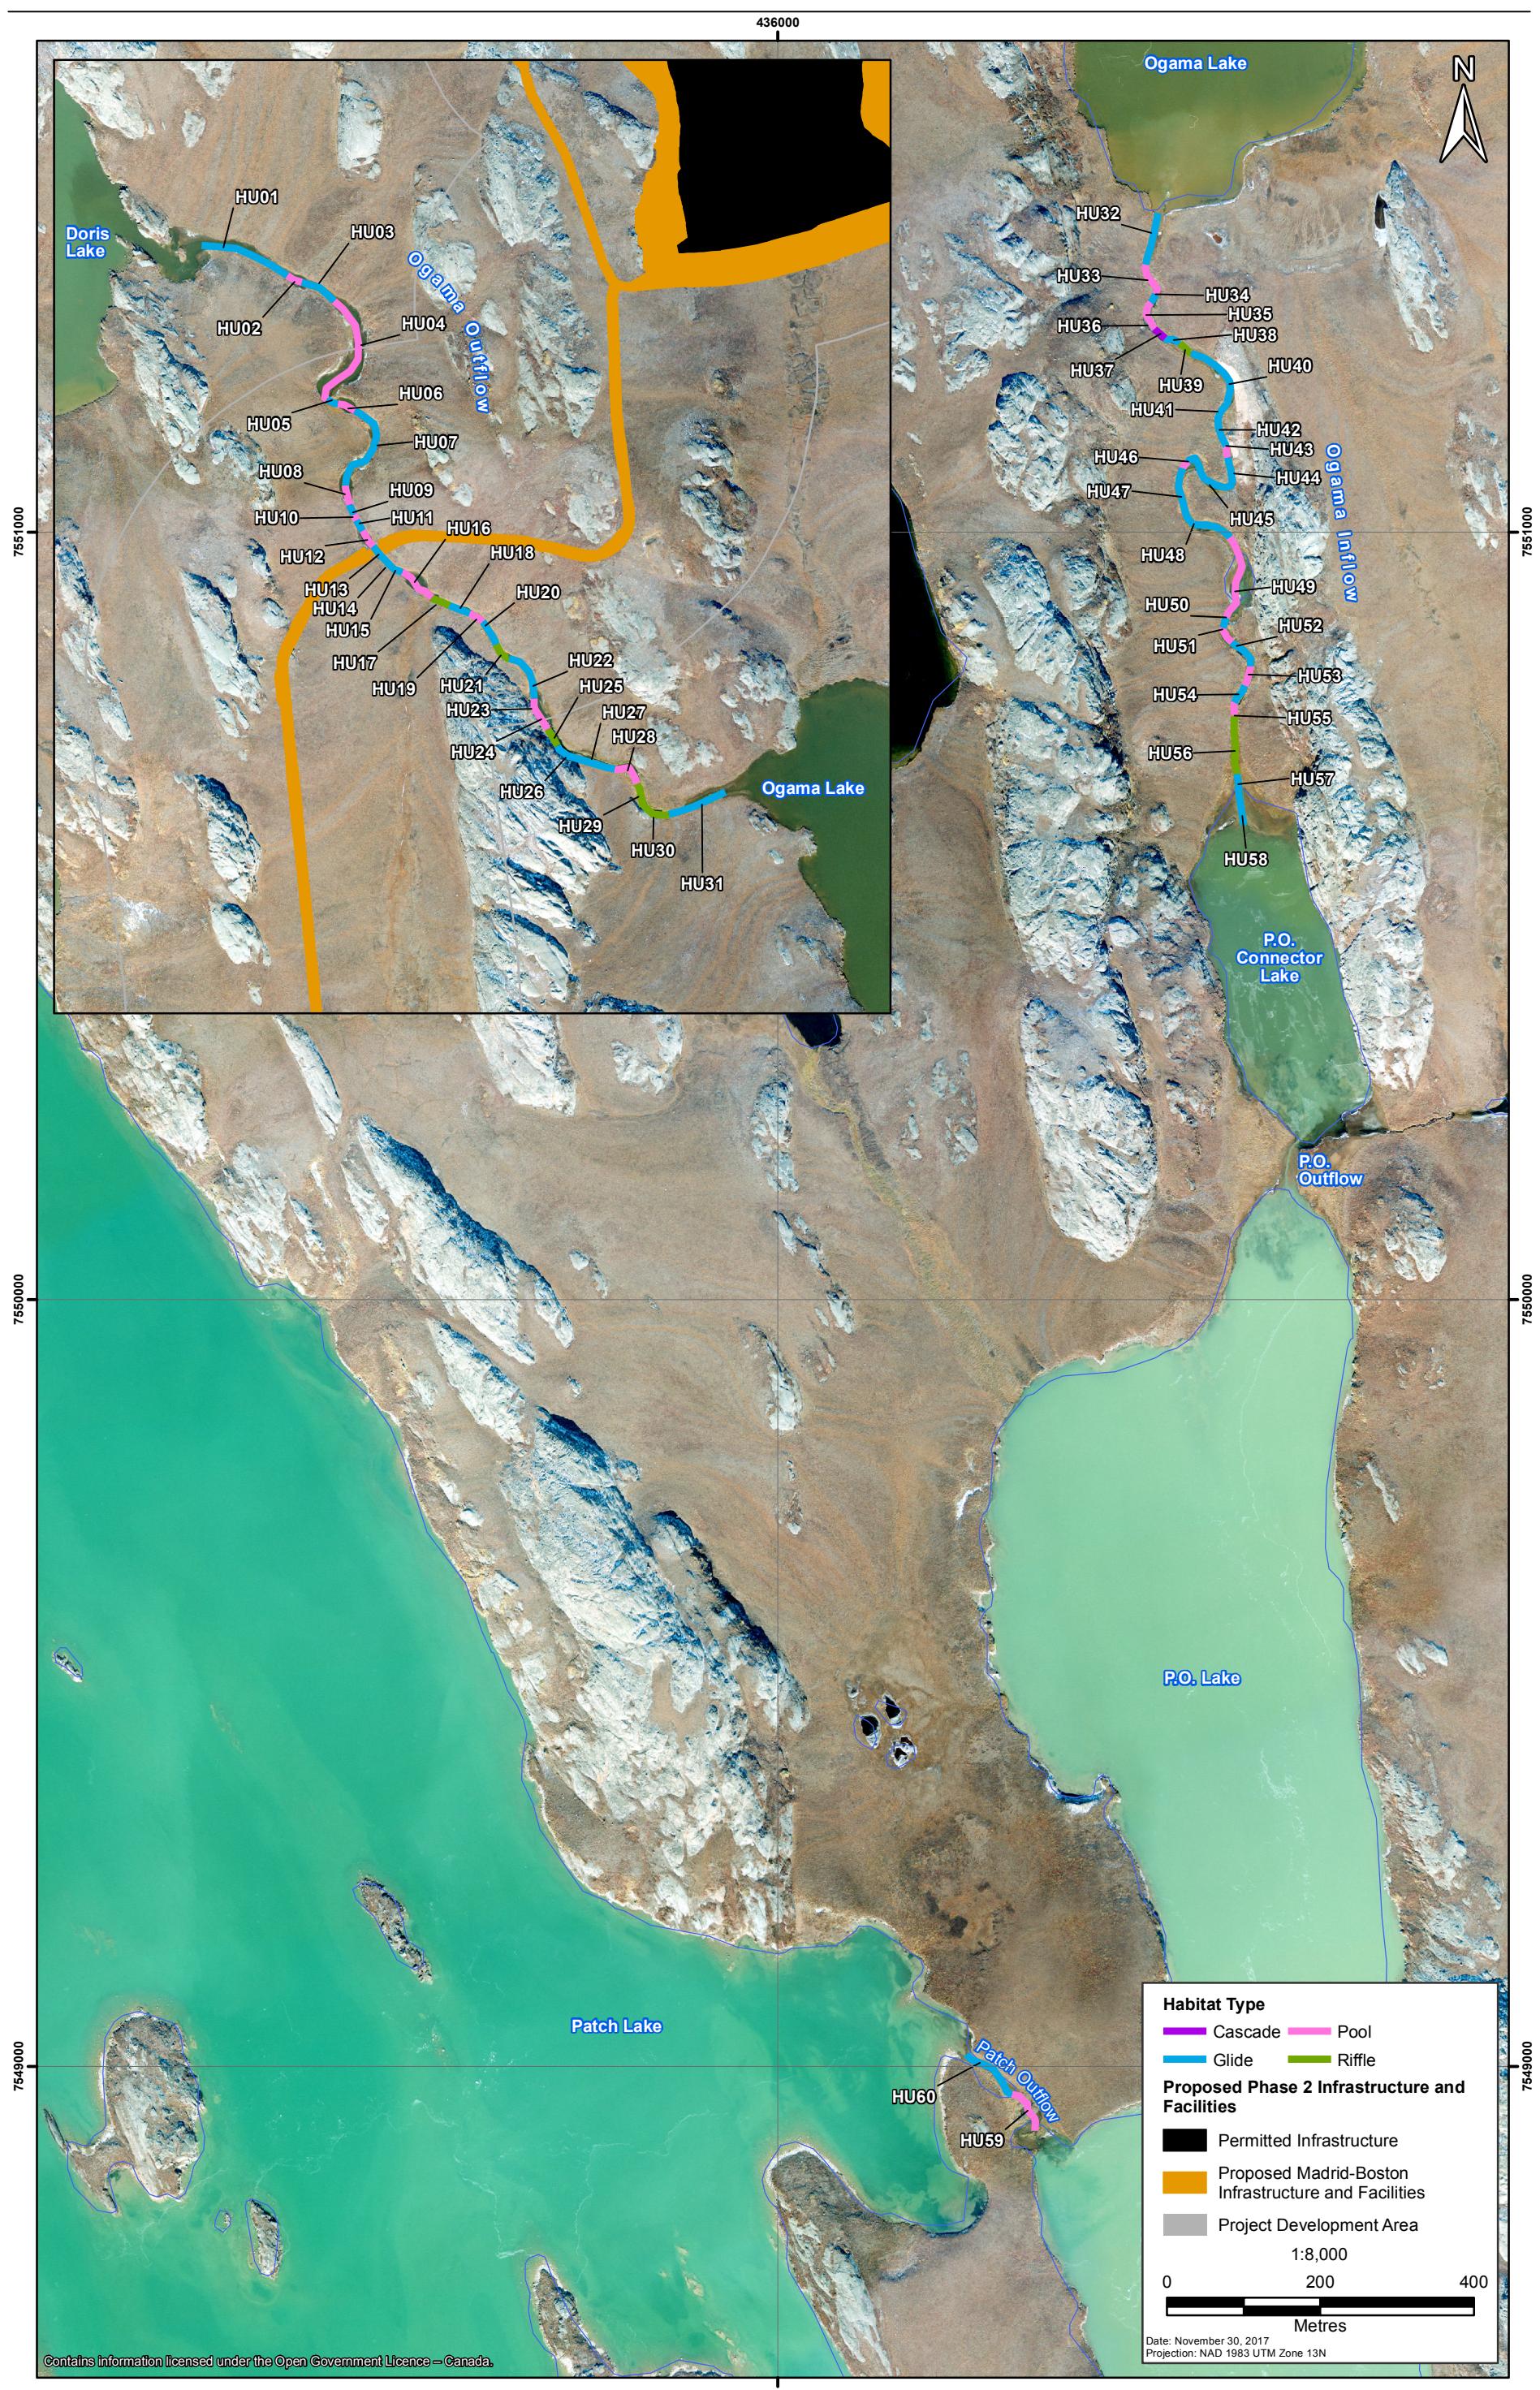
Figure 3.2-1  
Habitat Units in Ogama Outflow, Ogama Inflow, and Patch Outflow, July 2017

Streams that have the potential to interact with water withdrawal and use for the Madrid-Boston were surveyed at both high and low flows. Complete survey data are presented in Appendix 3.2-1. Habitat types recorded during the low flow survey which represent stable stream conditions are summarized in Table 3.2-1 and mapped on Figure 3.2-1 (Ogama Outflow, Ogama Inflow, and Patch Outflow only).

A total of 77 habitat units were identified (Table 3.2-1). Glides were the most common habitat type both in number of units and by stream length. In streams where pools were present they were the most common habitat type based on relative areal contributions, except in Stickleback Outflow where glides contributed a greater area. In all of the surveyed streams, glides accounted for over half of the total stream length. Pools were the next most common habitat type and were present in all streams where more than one habitat type was observed.

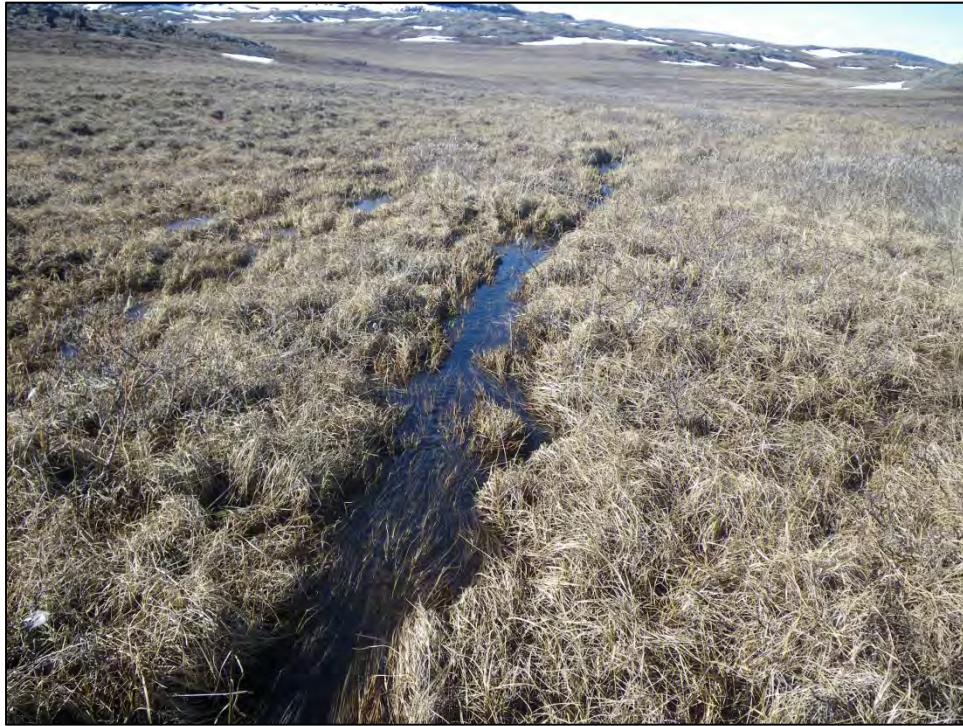
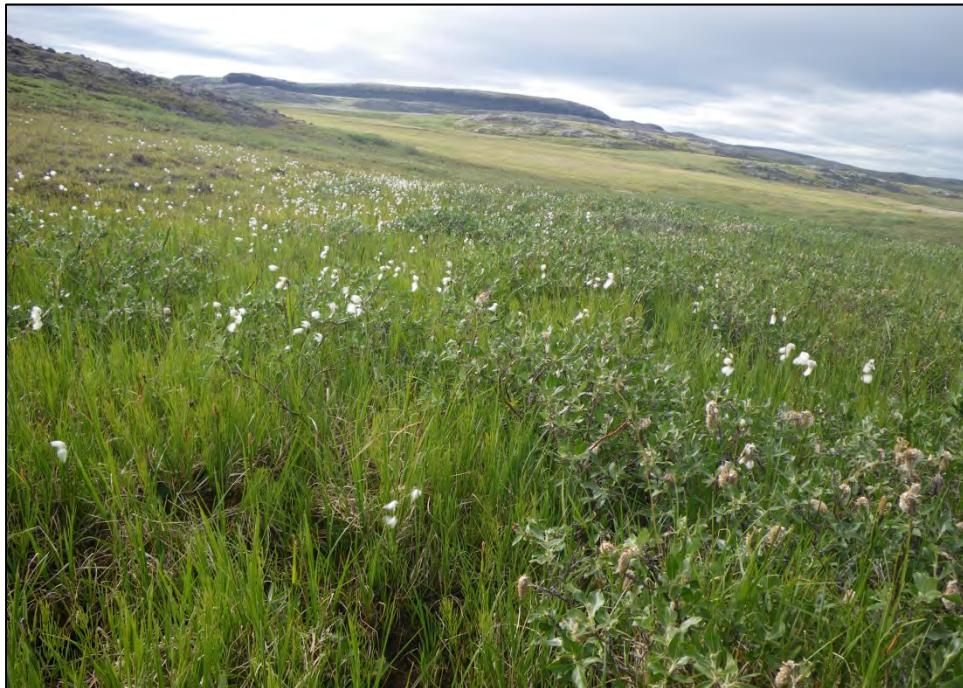
### C-CDR-01 – Roberts Bay Inflow; Roberts Bay Watershed

*High Flow 7-Jun-17; Habitat Value – Low*

*Low Flow 18-Jul-17; Habitat Value – None*

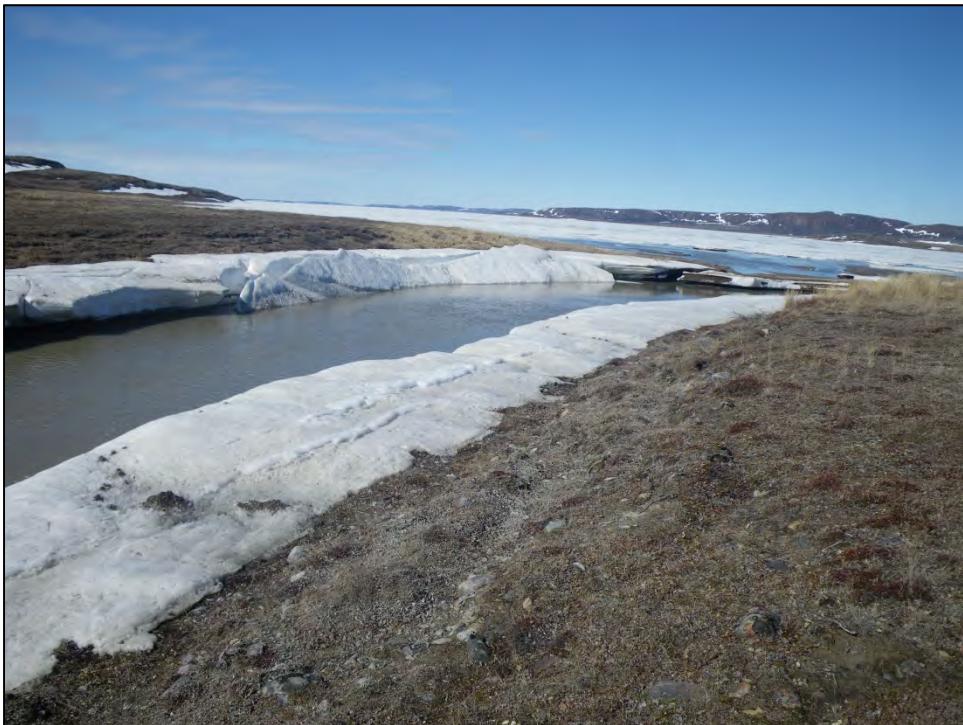
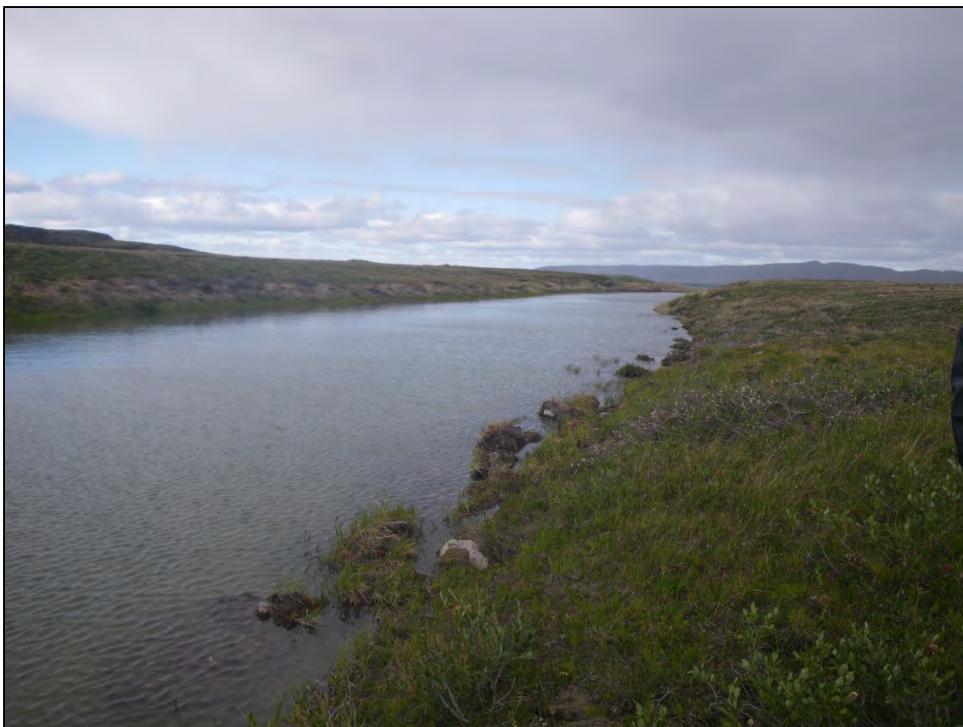
**C-CDR-02 - Glenn Outflow; Windy Watershed**

*High Flow 7-Jun-17; Habitat Value - High*

*Low Flow 26-Jul-17; Habitat Value - High*

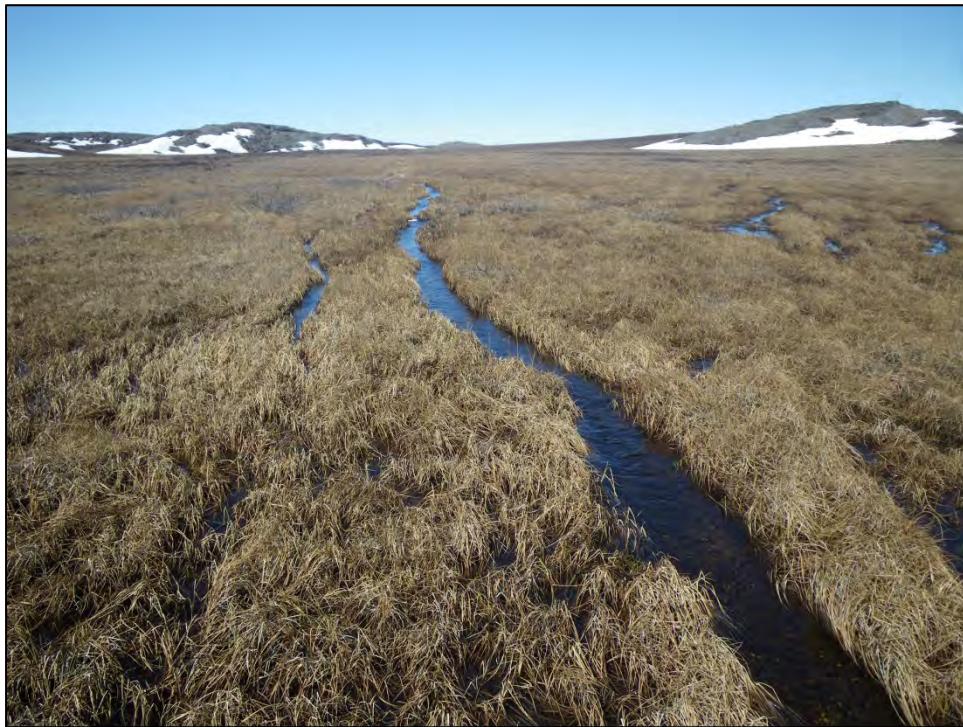
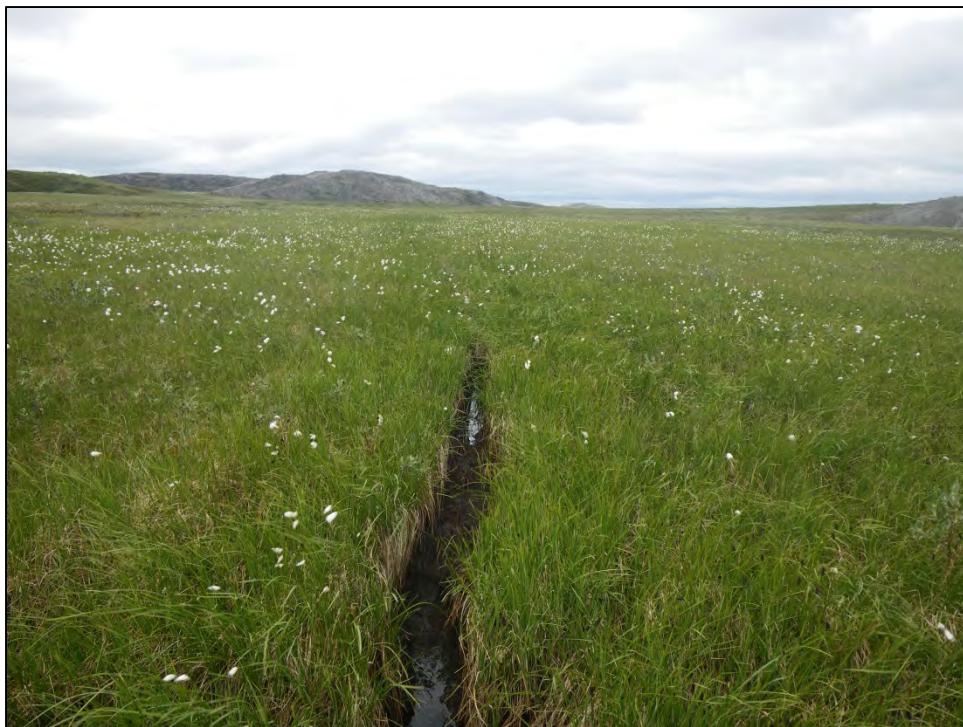
**C-TIA-01 - Patch Inflow; Doris Watershed**

*High Flow 7-Jun-17; Habitat Value – Low*

*Low Flow 18-Jul-17; Habitat Value – None*

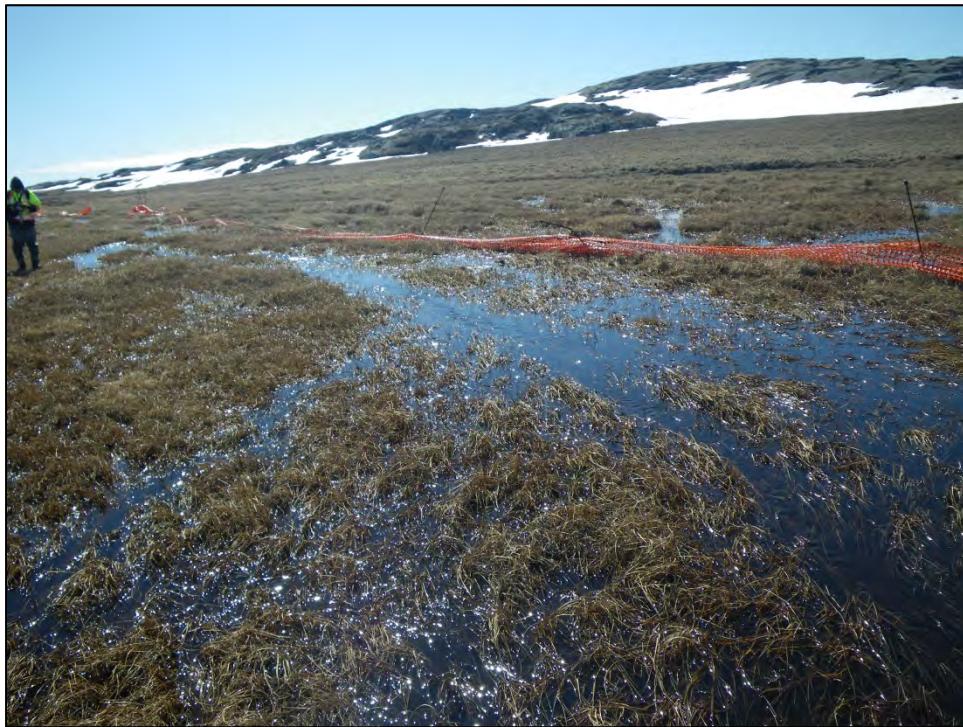
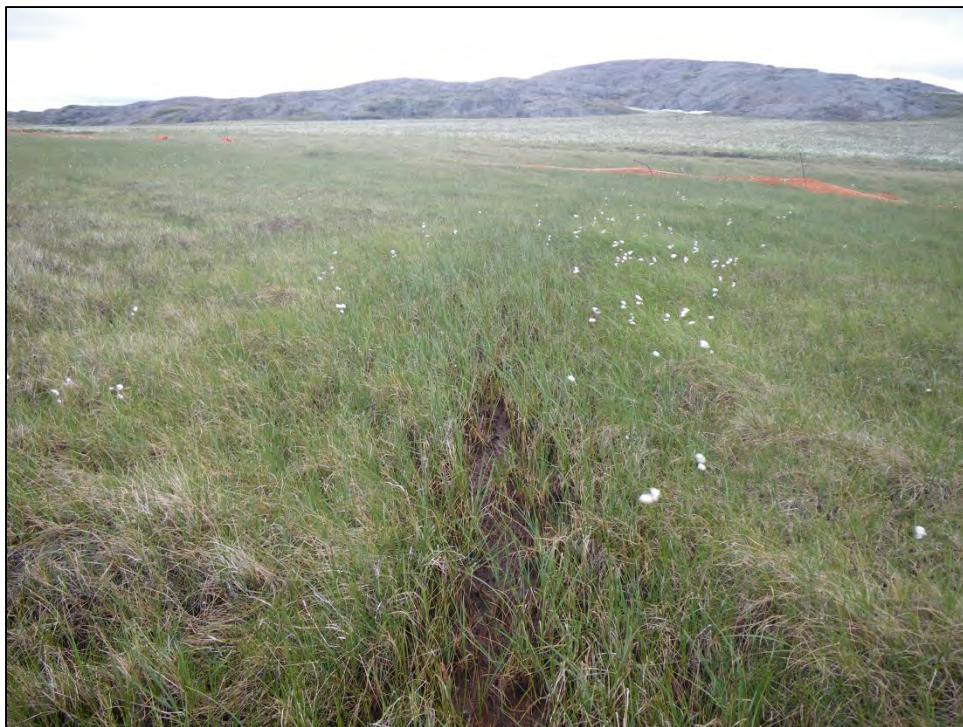
**C-TIA-02 - Doris Inflow; Doris Watershed**

*High Flow 7-Jun-17; Habitat Value – Low*

*Low Flow 18-Jul-17; Habitat Value – None*

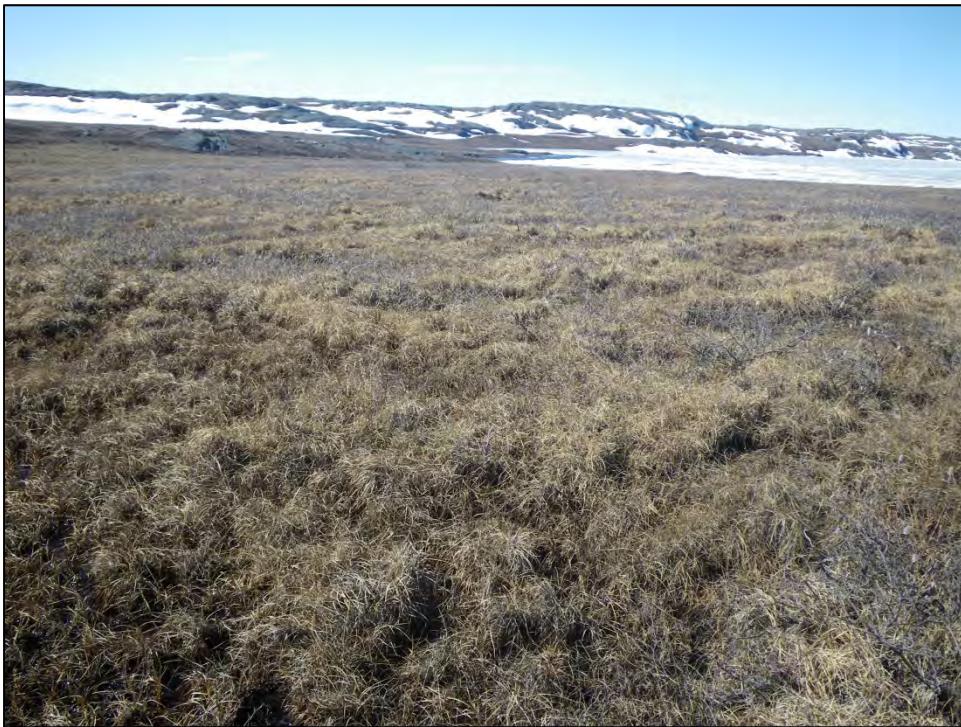
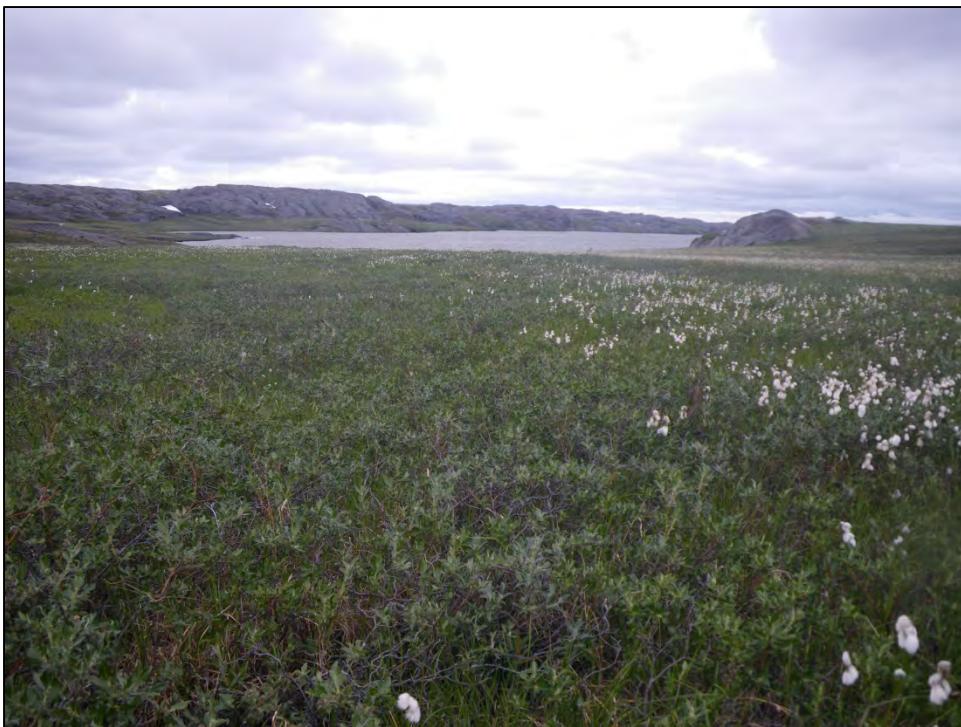
**C-TIA-03 - Doris Inflow; Doris Watershed**

*High Flow 7-Jun-17; Habitat Value – Low*

*Low Flow 18-Jul-17; Habitat Value – None*

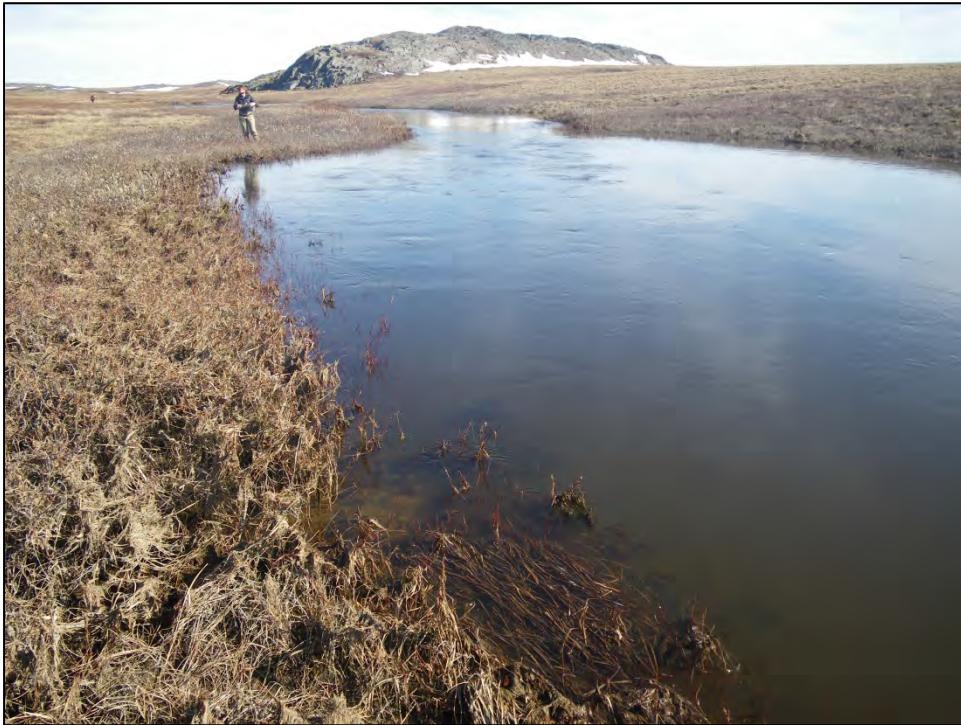
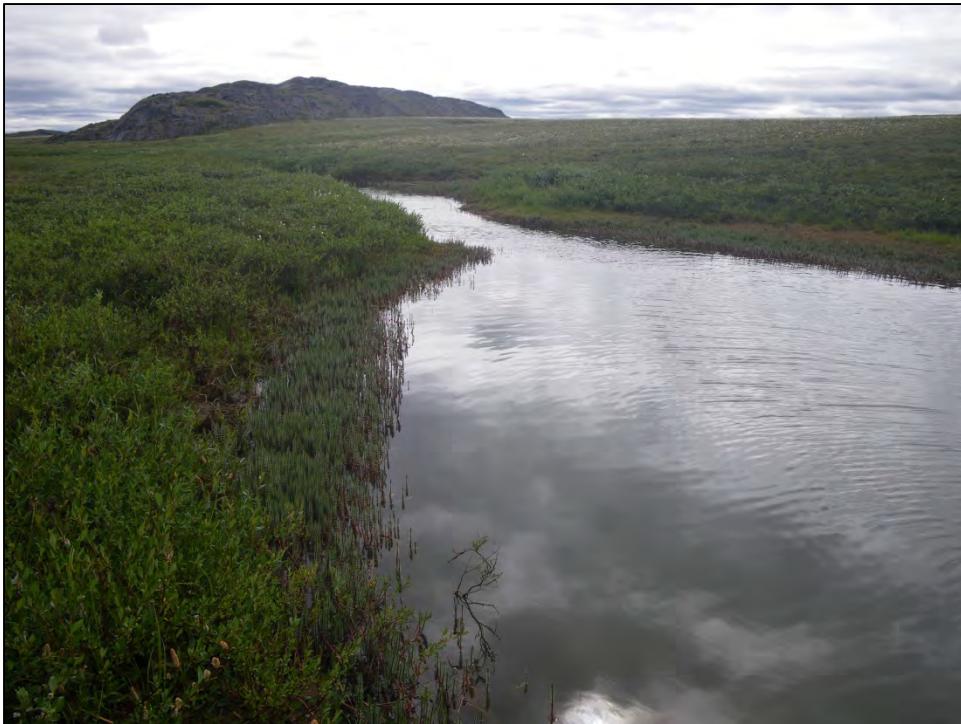
**C-TIA-04 - Ogama Outflow; Doris Watershed**

*High Flow 9-Jun-17; Habitat Value – High*

*Low Flow 25-Jul-17; Habitat Value – High*

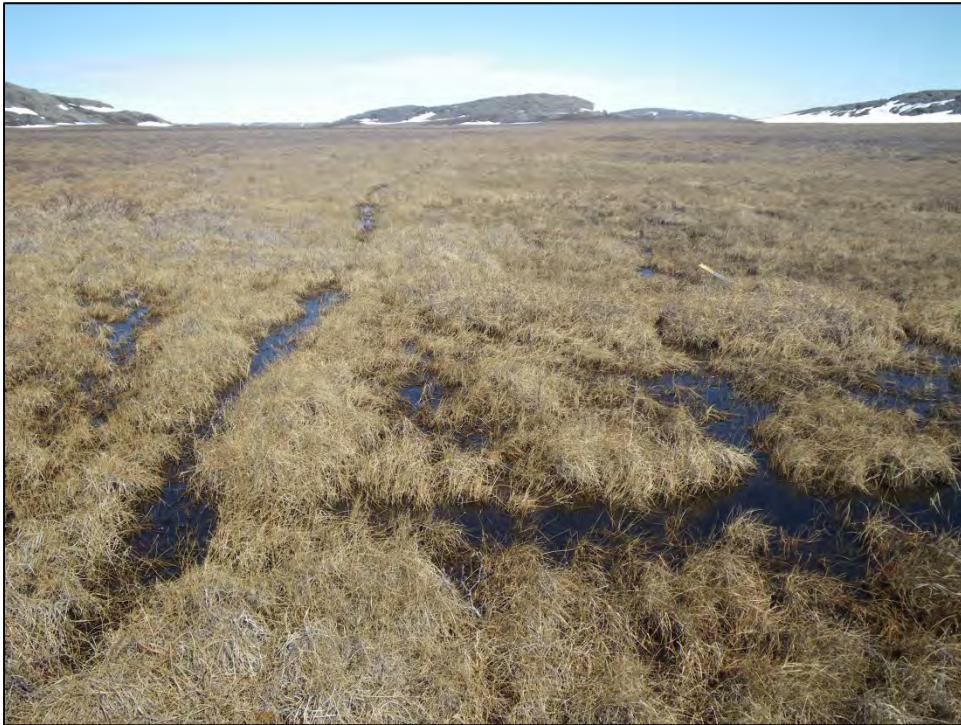
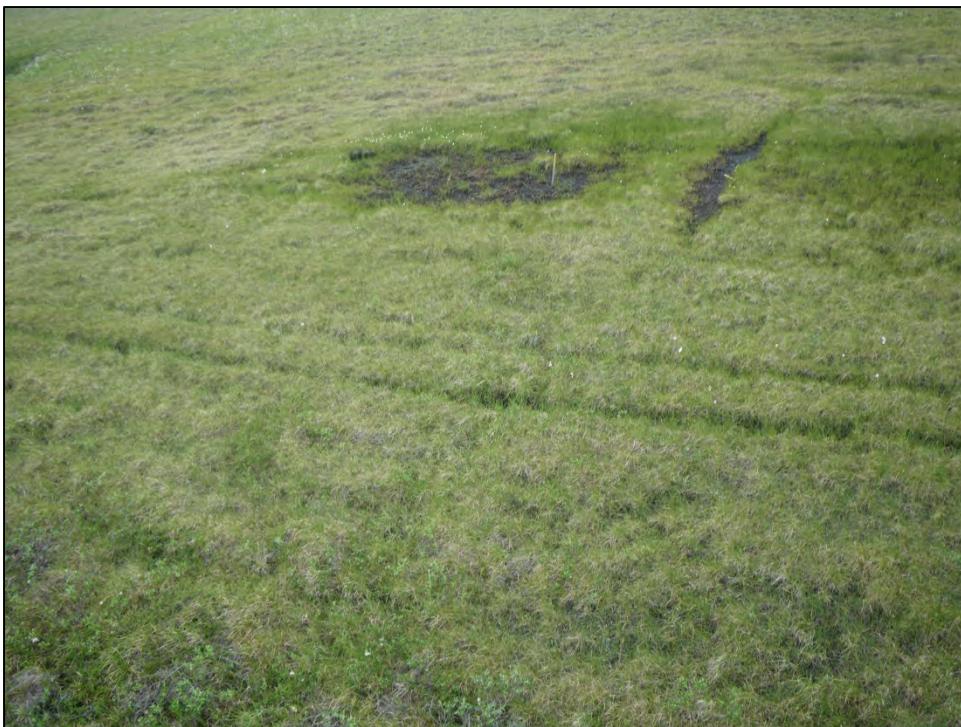
**C-MS-01 - Wolverine Outflow; Doris Watershed**

*High Flow 9-Jun-17; Habitat Value – Low*

*Low Flow 25-Jul-17; Habitat Value – None*

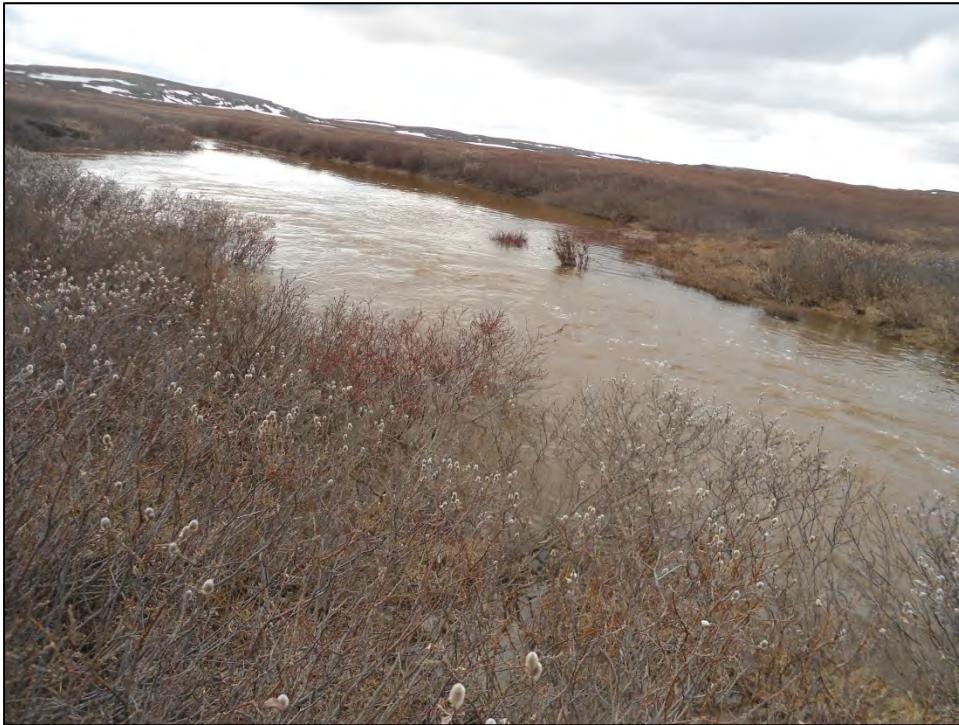
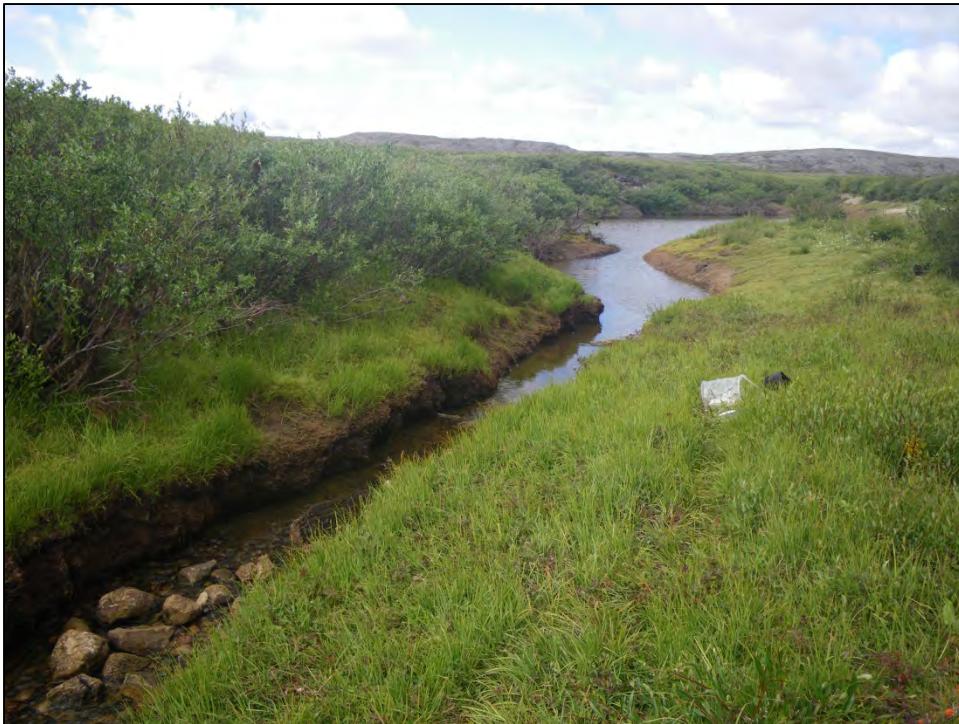
**C-MBR-7 - Boulder Creek; Aimaokatalok/Koignuk Watershed**

*High Flow 11-Jun-17; Habitat Value - High*

*Low Flow 27-Jul-17; Habitat Value - High*

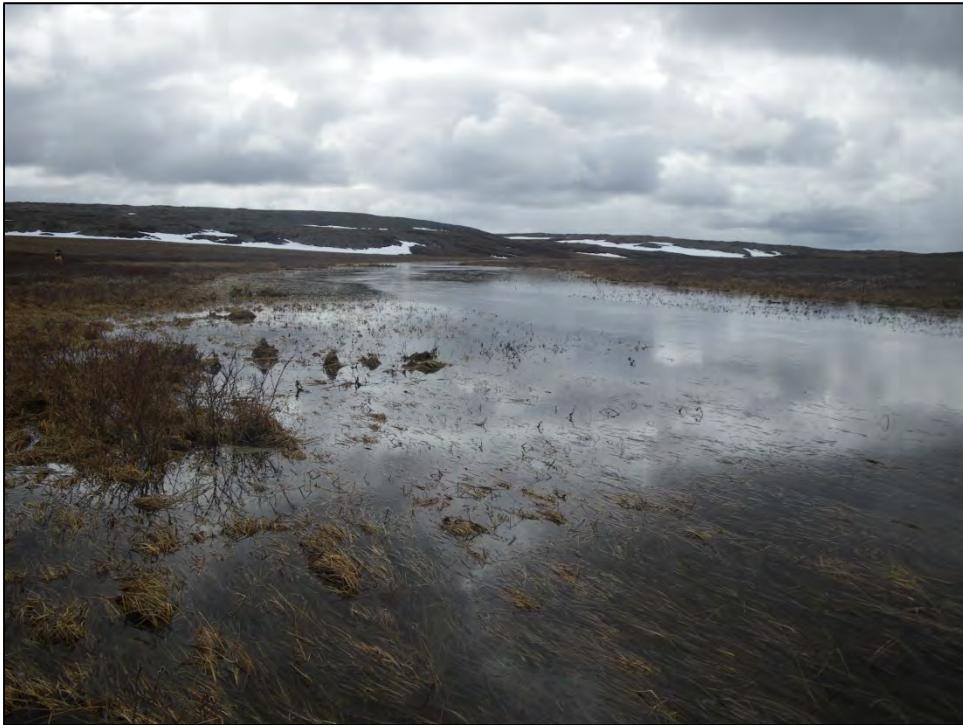
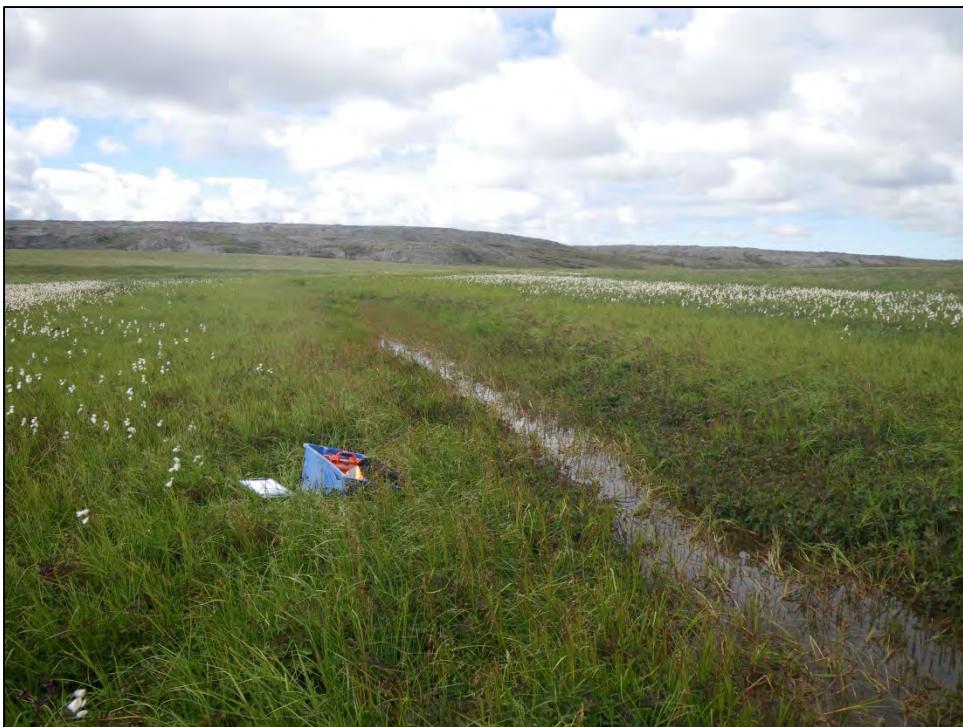
**C-MBR-8 - Boulder Creek Trib; Aimaokatalok/Koignuk Watershed**

*High Flow 11-Jun-17; Habitat Value – High*

*Low Flow 27-Jul-17; Habitat Value – High*

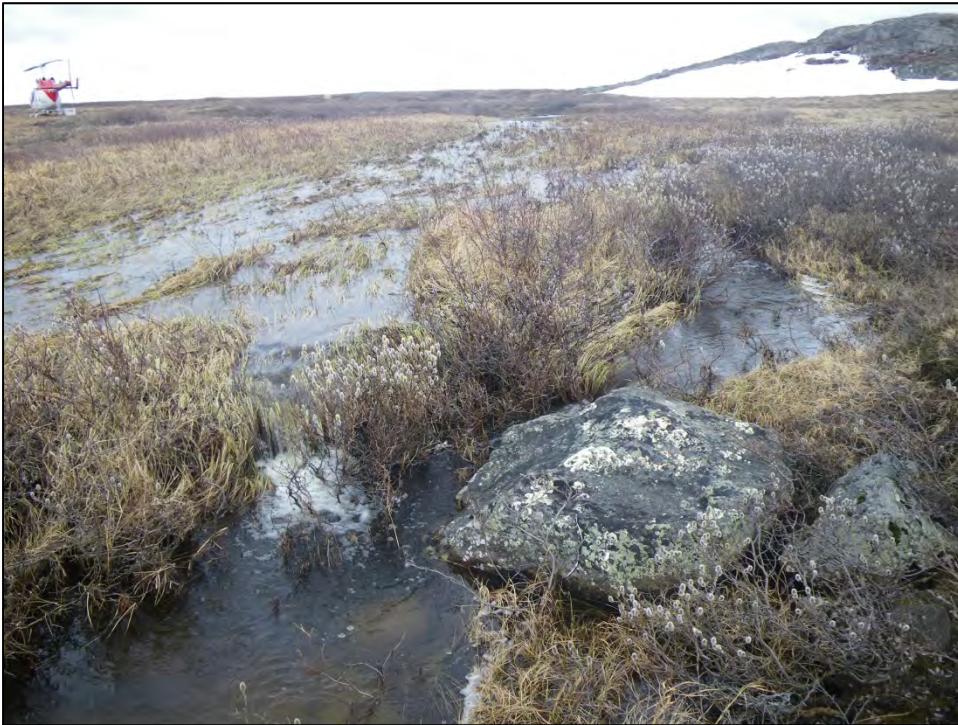
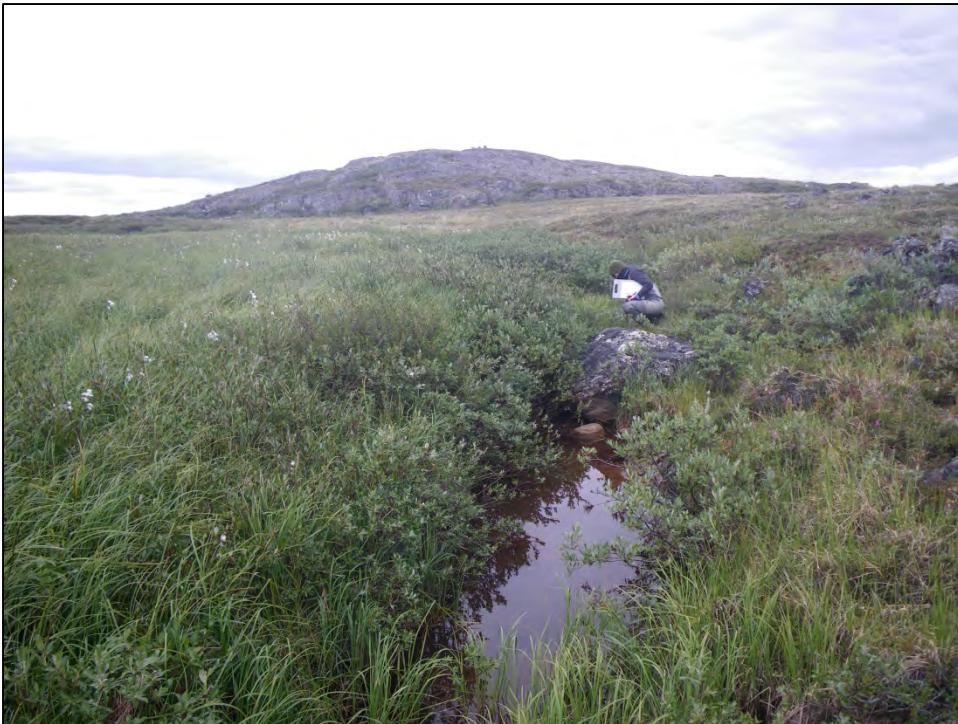
**C-MBR-9 – Aimaokatalok Inflow; Aimaokatalok Watershed**

*High Flow 11-Jun-17; Habitat Value – Moderate*

*Low Flow 29-Jul-17; Habitat Value – Moderate*
