Hope Bay Project:  
2017 Freshwater Fish and Fish Habitat Baseline Report

## 2017 Freshwater Fish and Fish Habitat Baseline Report

**TMAC Resources Inc.**

Project #0394395-0113-0002

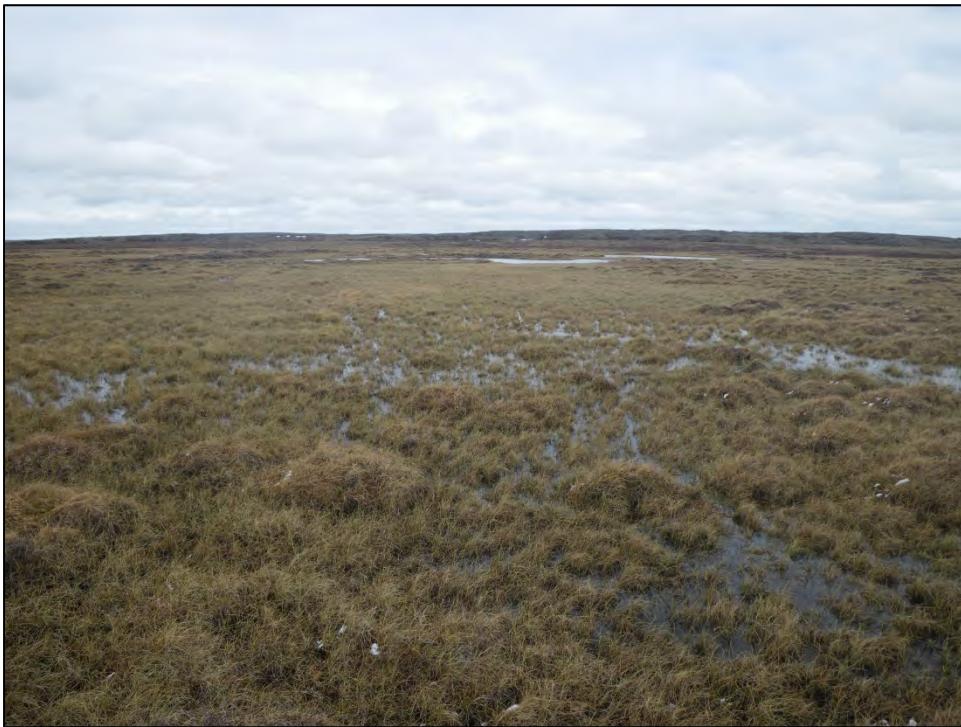
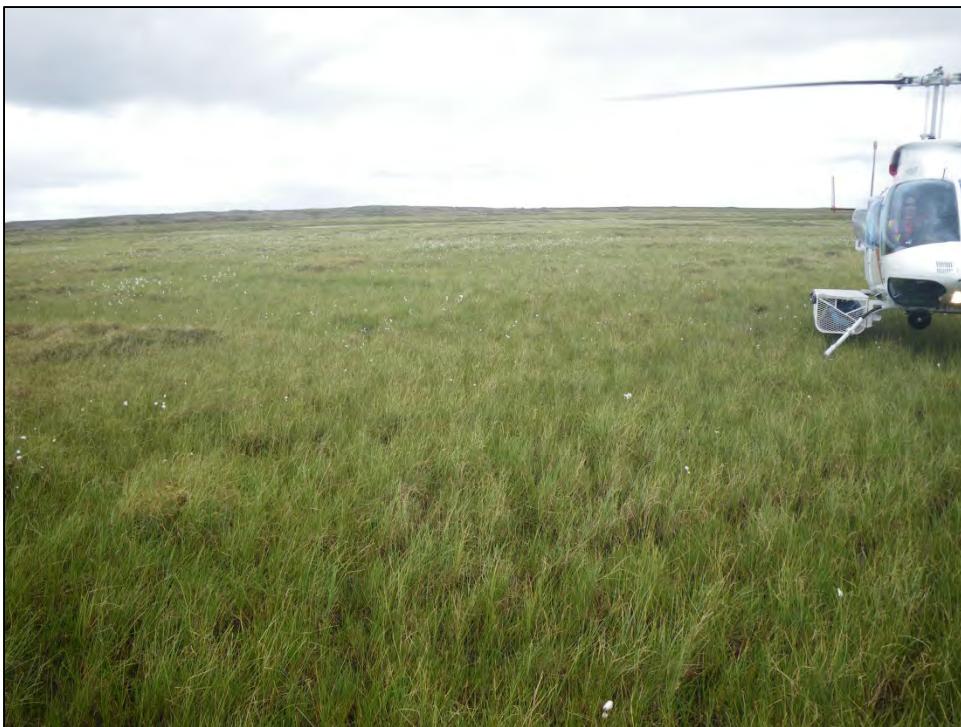
**C-MBR-10 – Aimaokatalok Inflow; Aimaokatalok Watershed**

*High Flow 11-Jun-17; Habitat Value – None*

*Low Flow 26-Jul-17; Habitat Value – None*

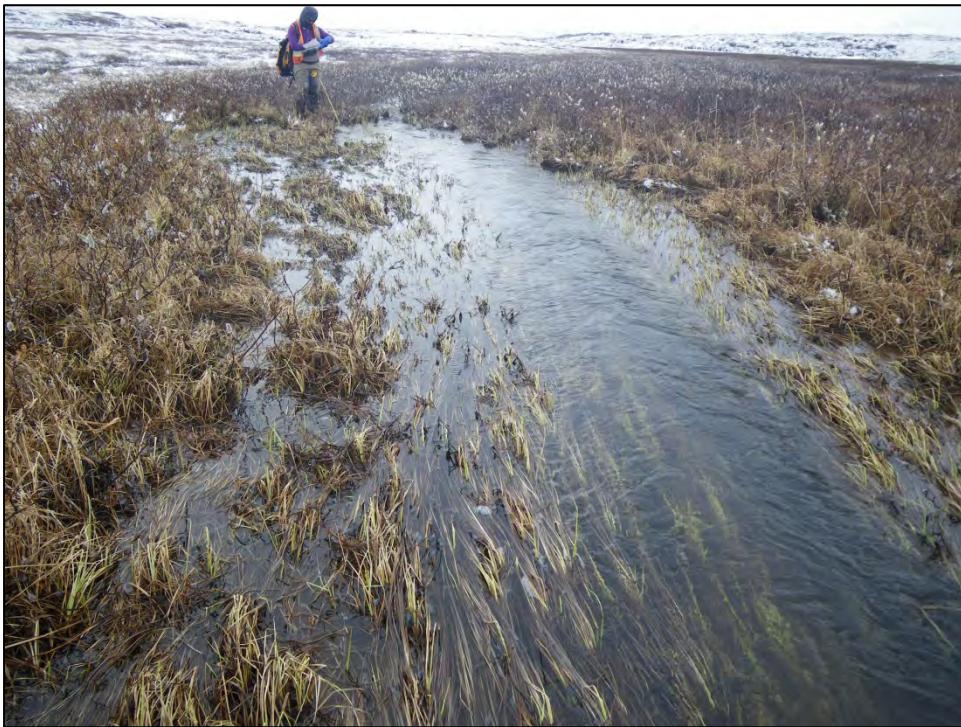
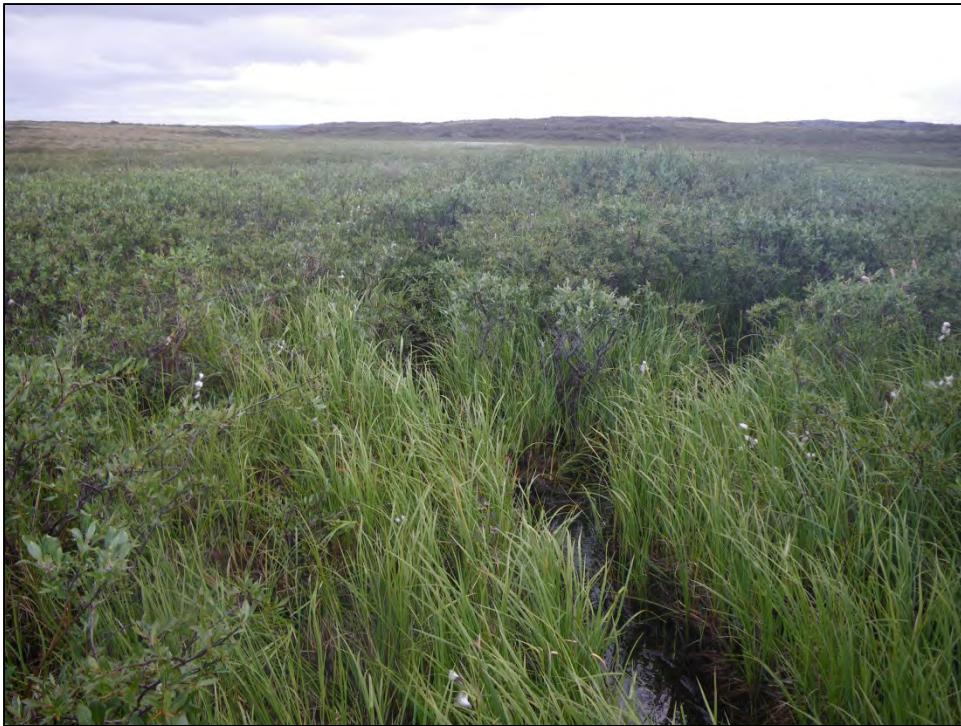
**C-MBR-11 – Aimaokatalok Inflow; Aimaokatalok Watershed**

*High Flow 11-Jun-17; Habitat Value – Moderate*

*Low Flow 27-Jul-17; Habitat Value – Moderate*

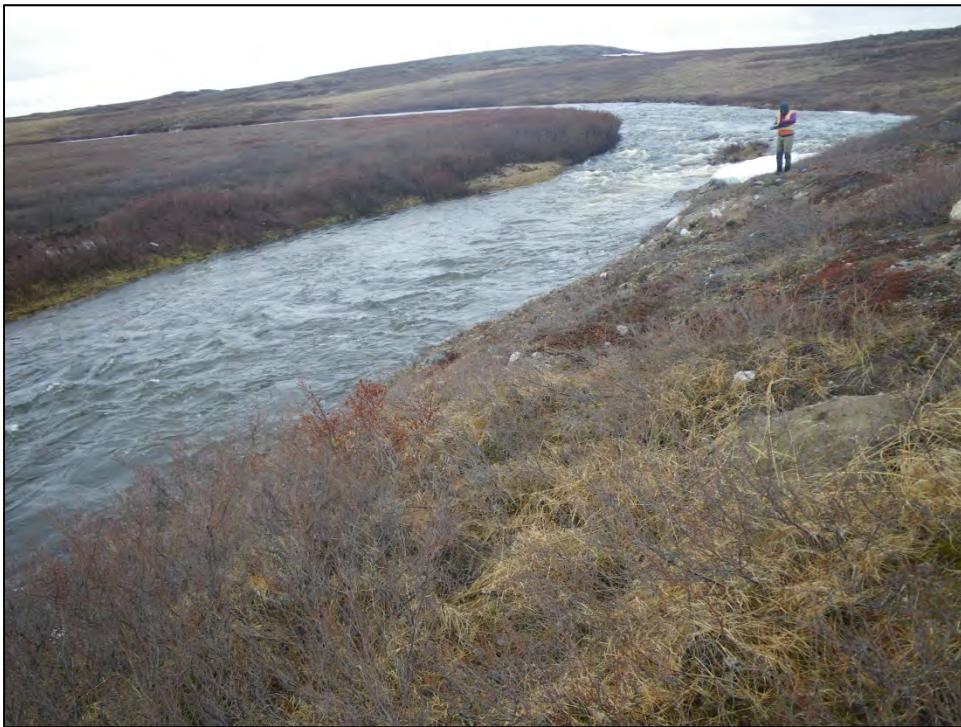
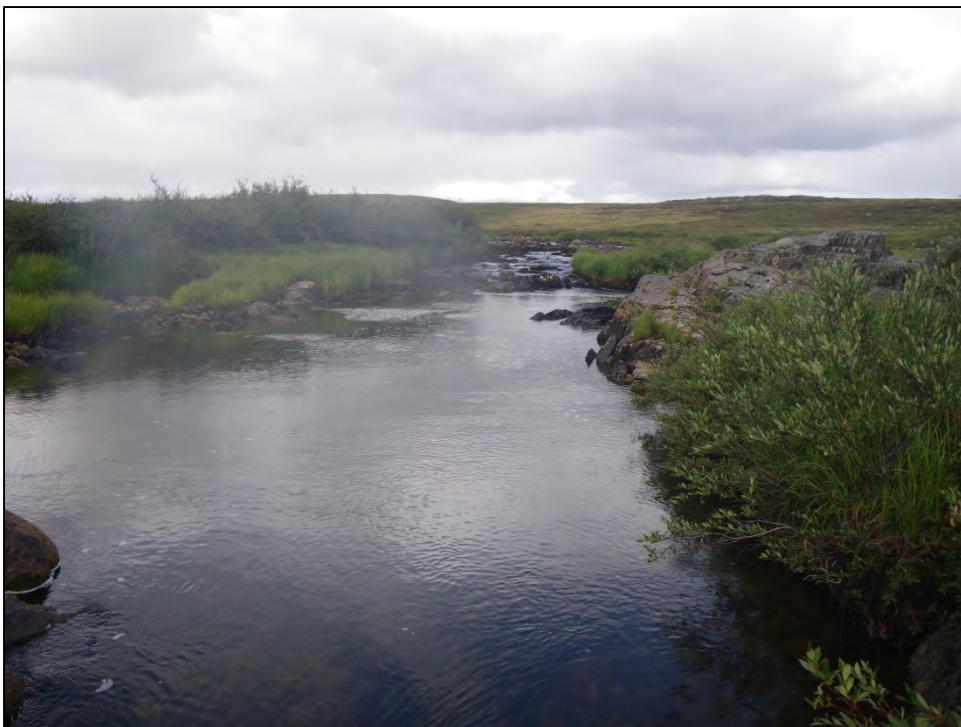
**C-MBR-12 - Aimaokatalok Inflow; Aimaokatalok Watershed**

*High Flow 11-Jun-17; Habitat Value - High*

*Low Flow 27-Jul-17; Habitat Value - High*

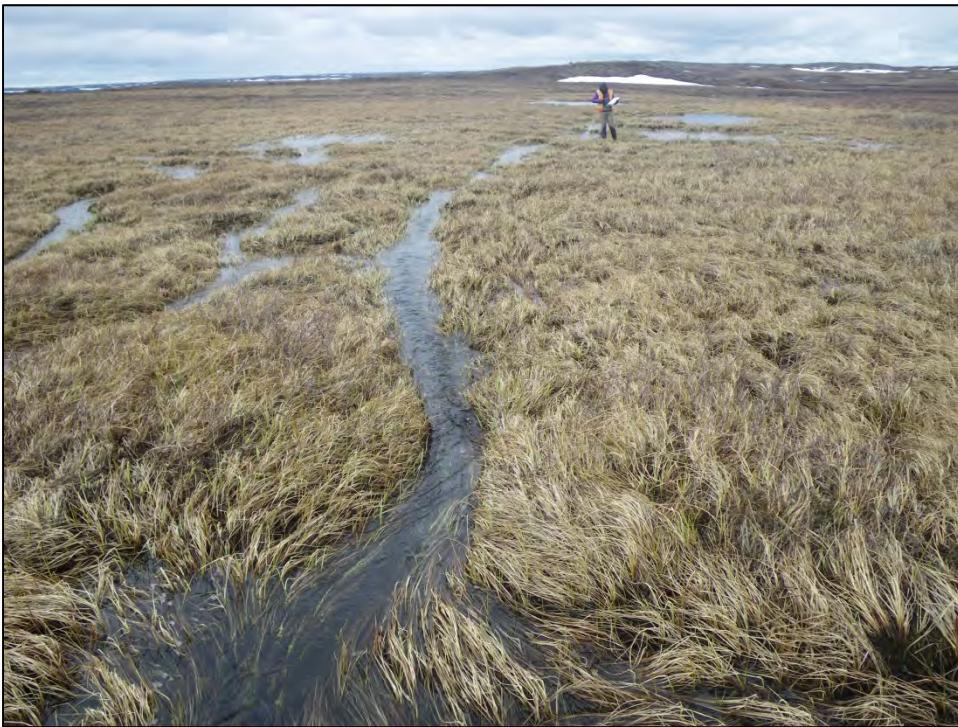
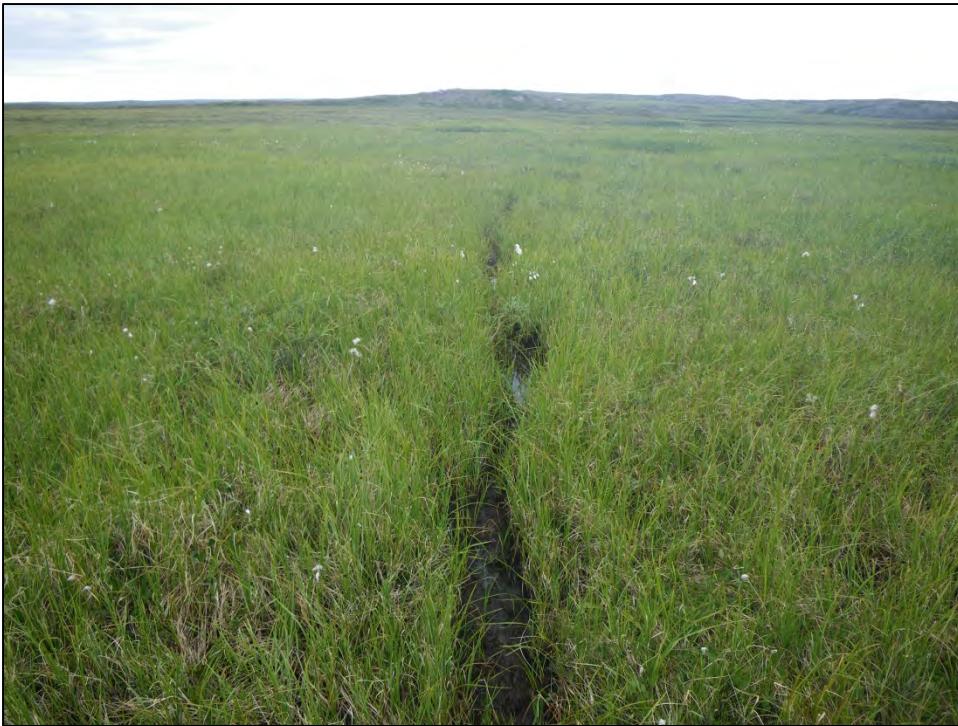
**C-MBR-13 – Aimaokatalok Inflow; Aimaokatalok Watershed**

*High Flow 11-Jun-17; Habitat Value – Low*

*Low Flow 27-Jul-17; Habitat Value – None*

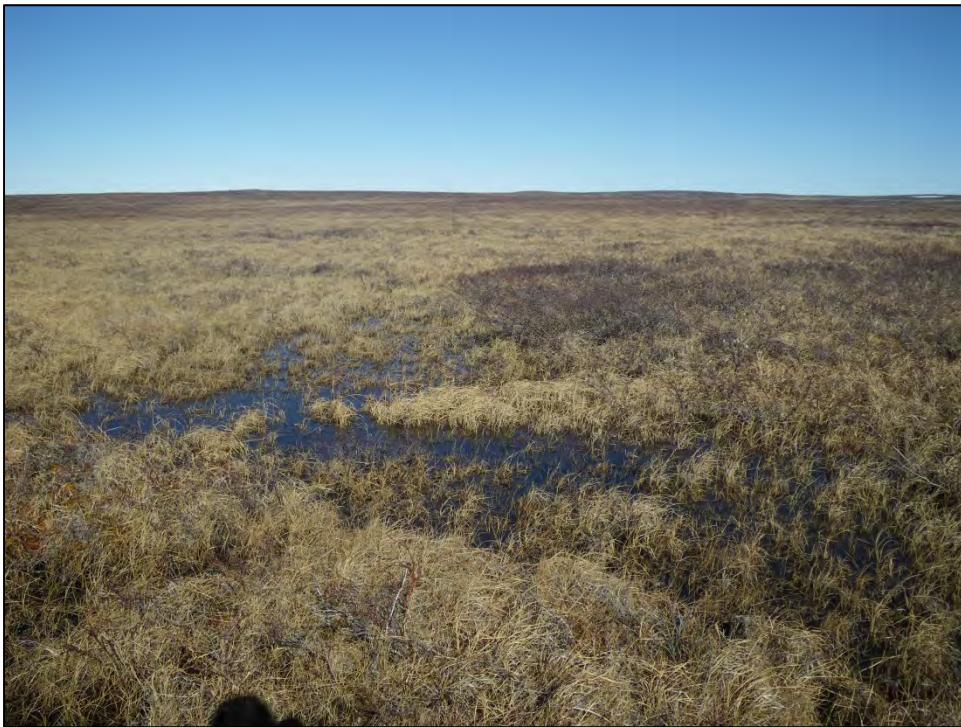
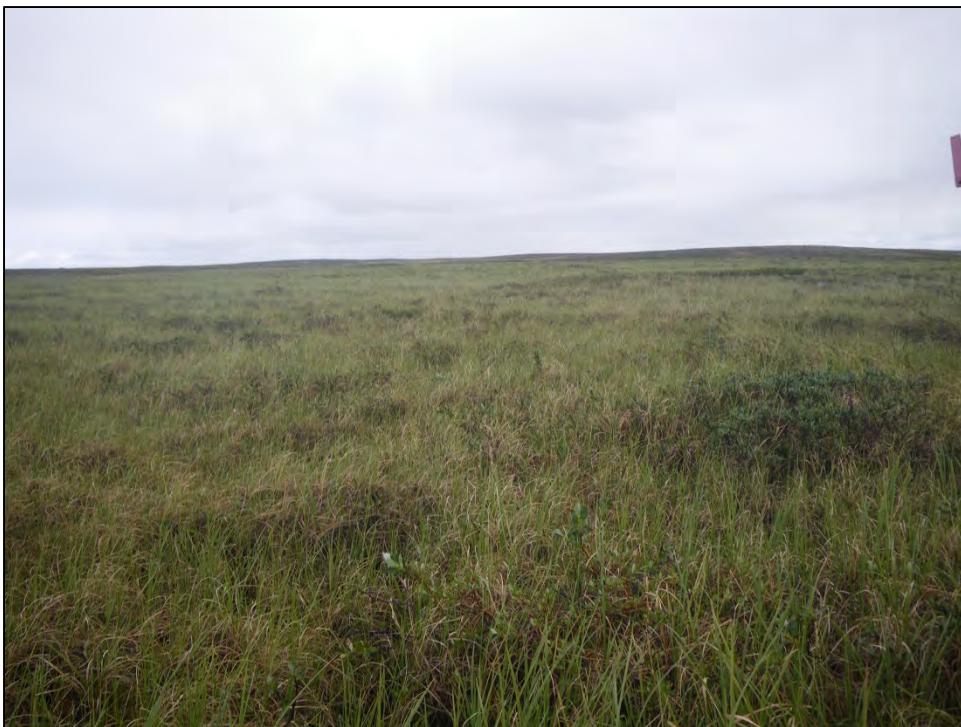
**C-MBR-14 – Aimaokatalok Inflow; Aimaokatalok Watershed**

*High Flow 8-Jun-17; Habitat Value – None*

*Low Flow 26-Jul-17; Habitat Value – None*

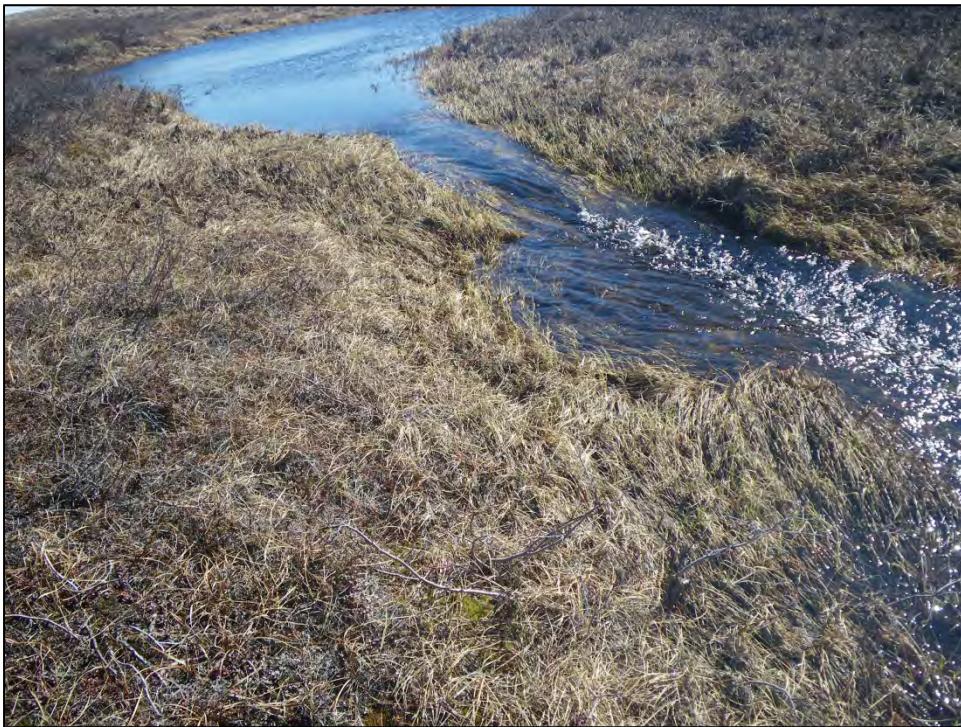
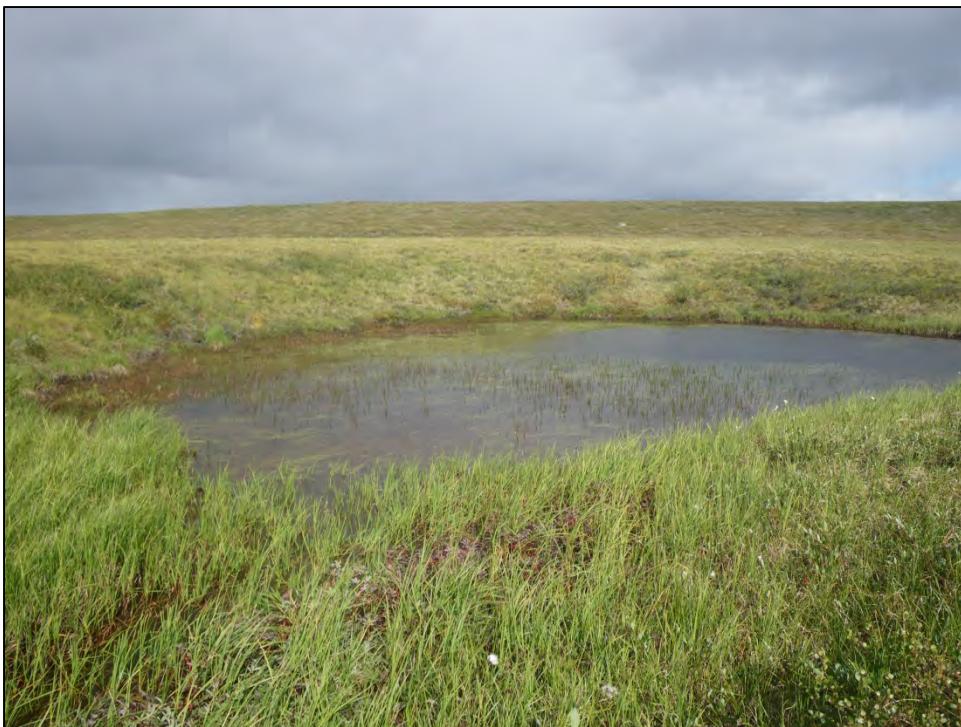
**C-MBR-15 – Aimaokatalok Inflow; Aimaokatalok Watershed**

*High Flow 8-Jun-17; Habitat Value – Moderate*

*Low Flow 26-Jul-17; Habitat Value – Moderate*

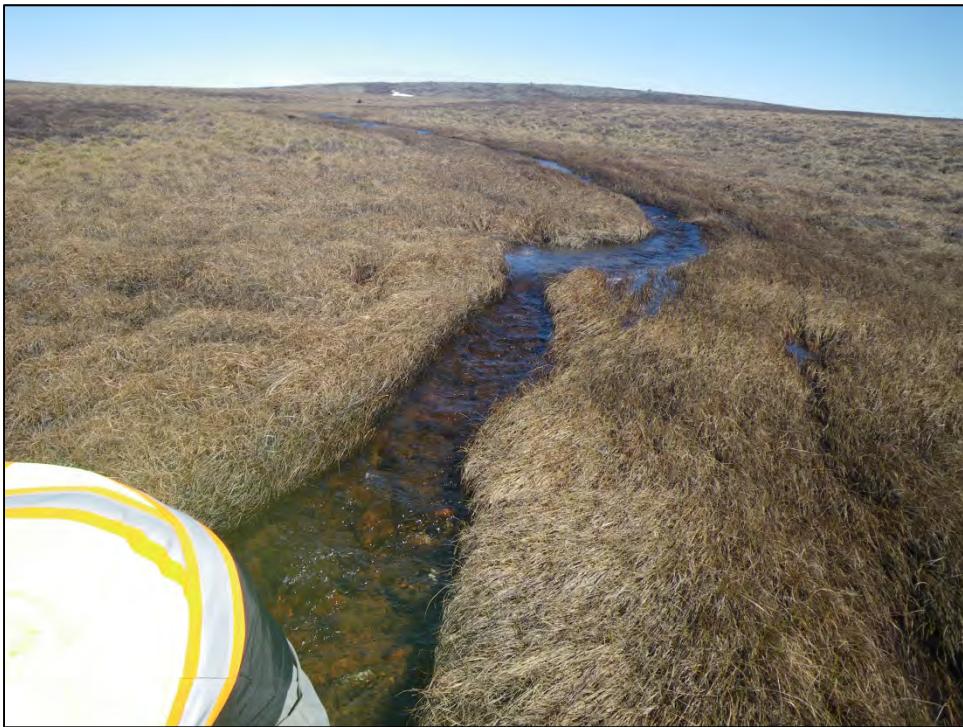
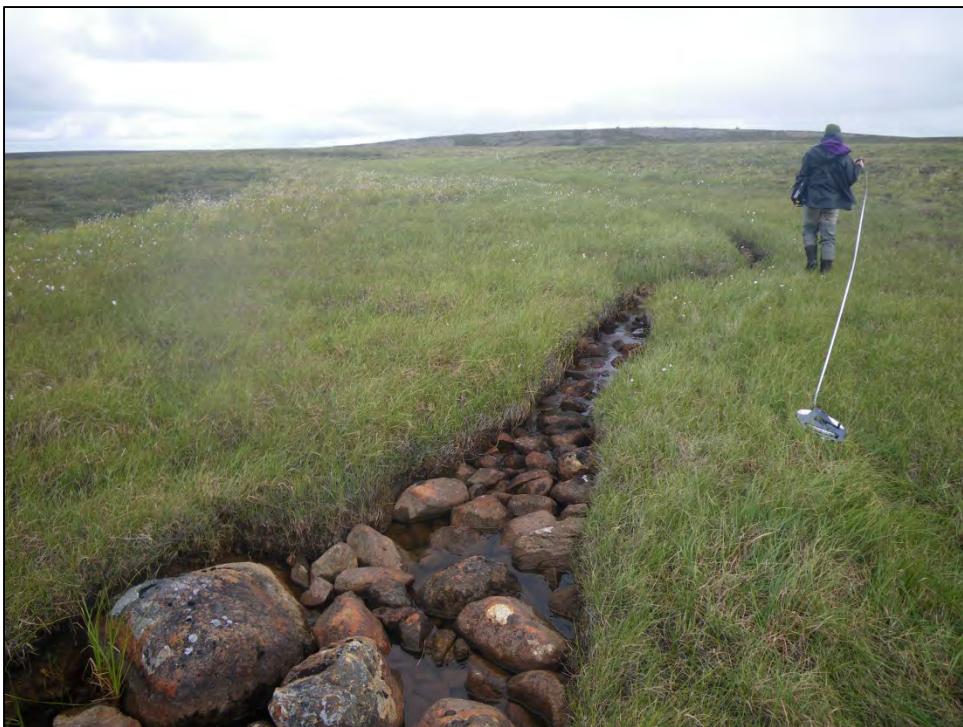
**C-MBR-16 – Aimaokatalok Inflow; Aimaokatalok Watershed**

*High Flow 8-Jun-17; Habitat Value – High*

*Low Flow 26-Jul-17; Habitat Value – High*

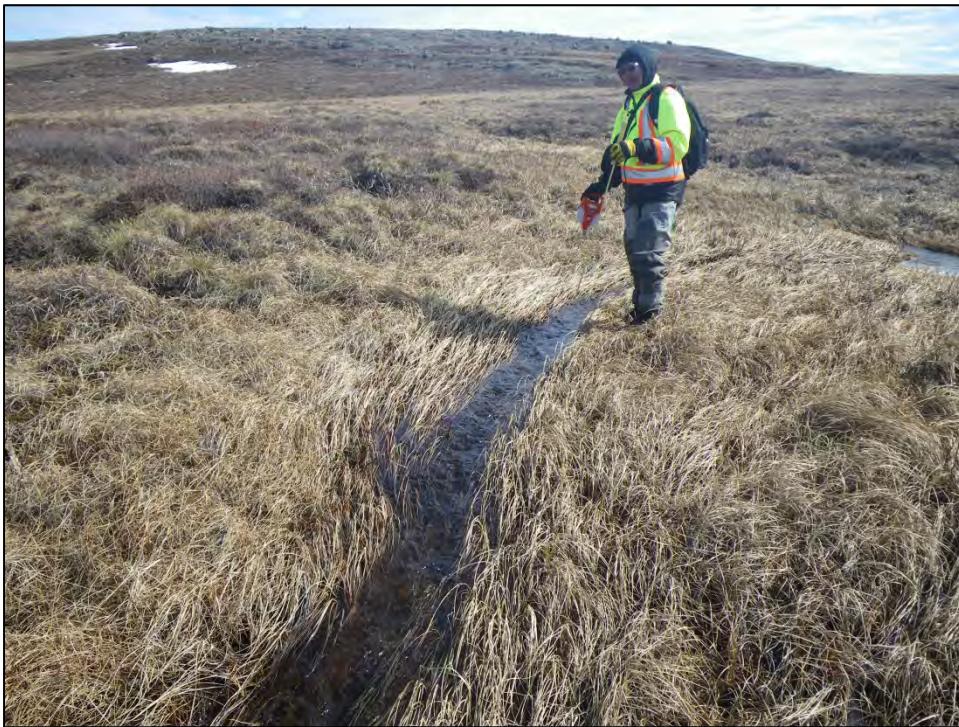
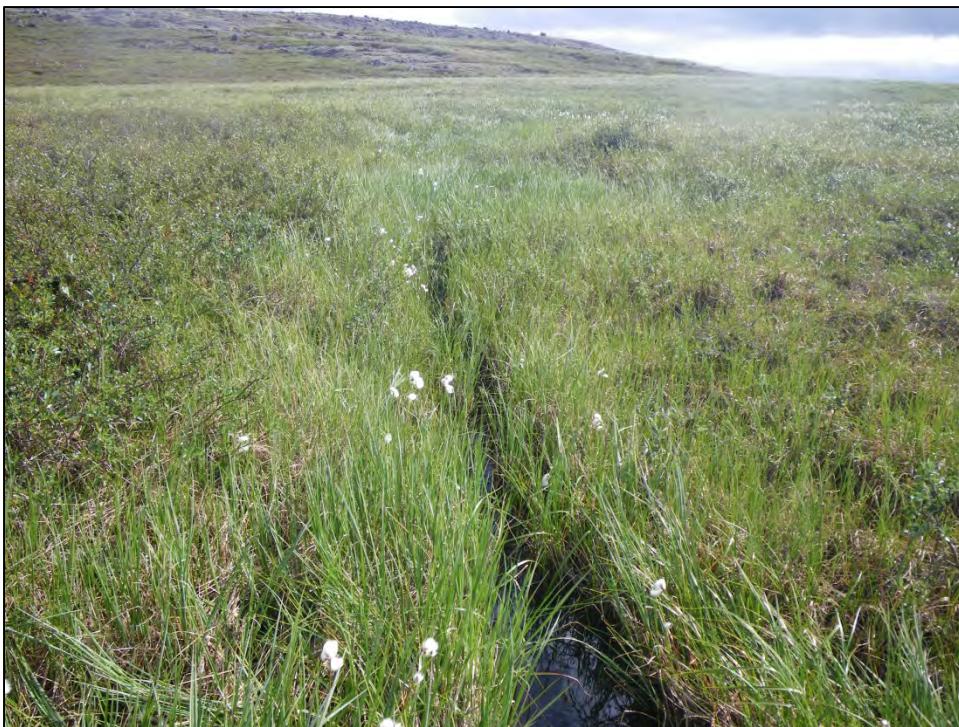
**C-MBR-17 – Aimaokatalok Inflow; Aimaokatalok Watershed**

*High Flow 8-Jun-17; Habitat Value – Low*

*Low Flow 26-Jul-17; Habitat Value – Low*

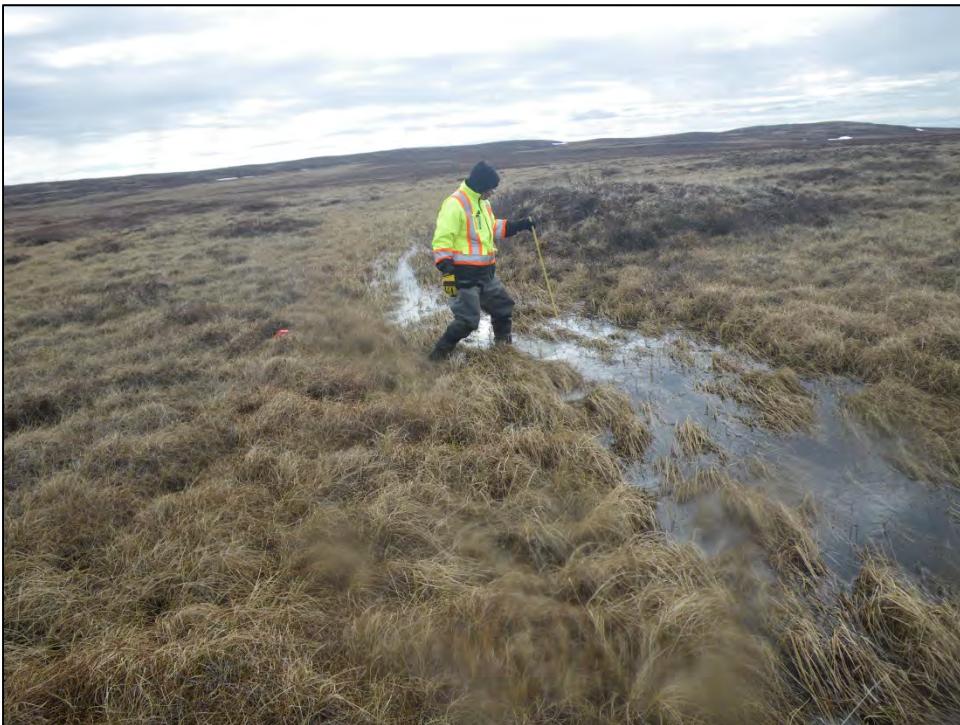
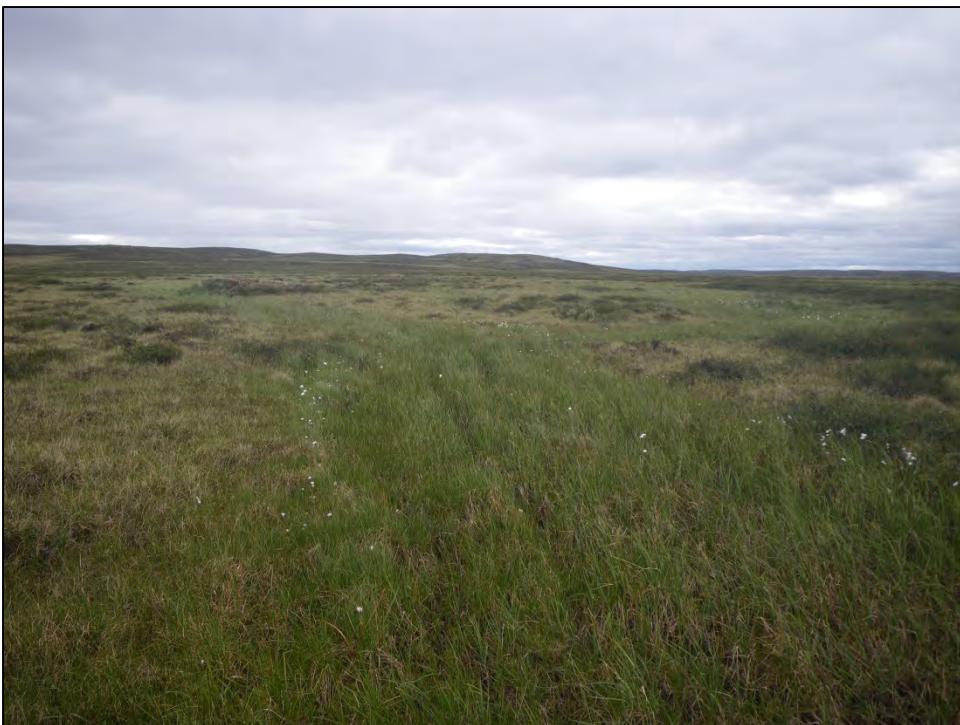
**C-MBR-18 – Aimaokatalok Inflow; Aimaokatalok Watershed**

*High Flow 8-Jun-17; Habitat Value – Low*

*Low Flow 26-Jul-17; Habitat Value – None*

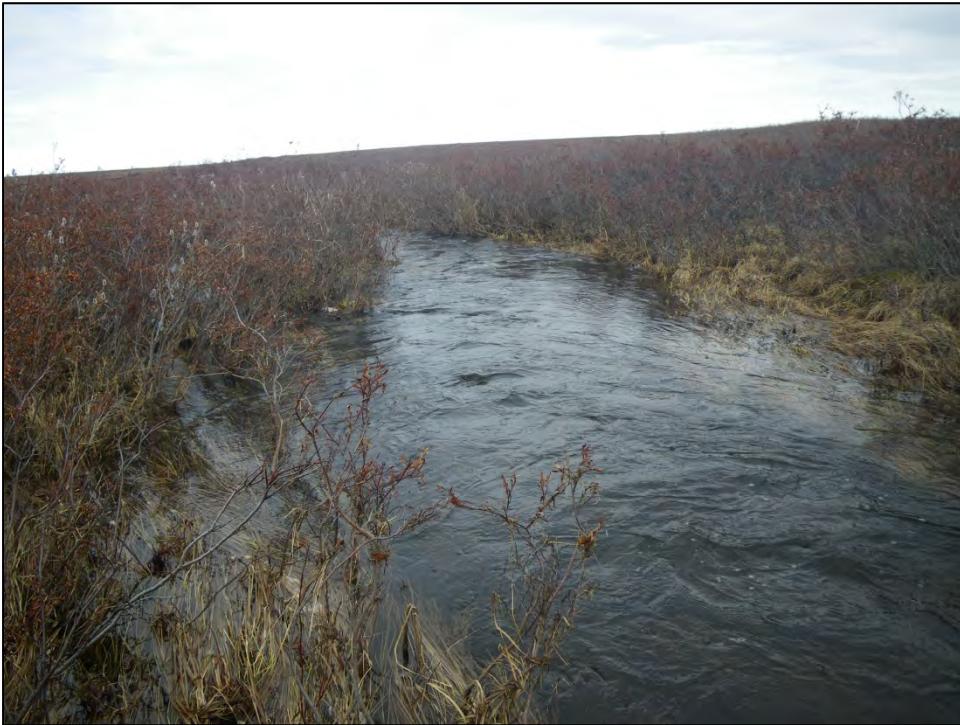
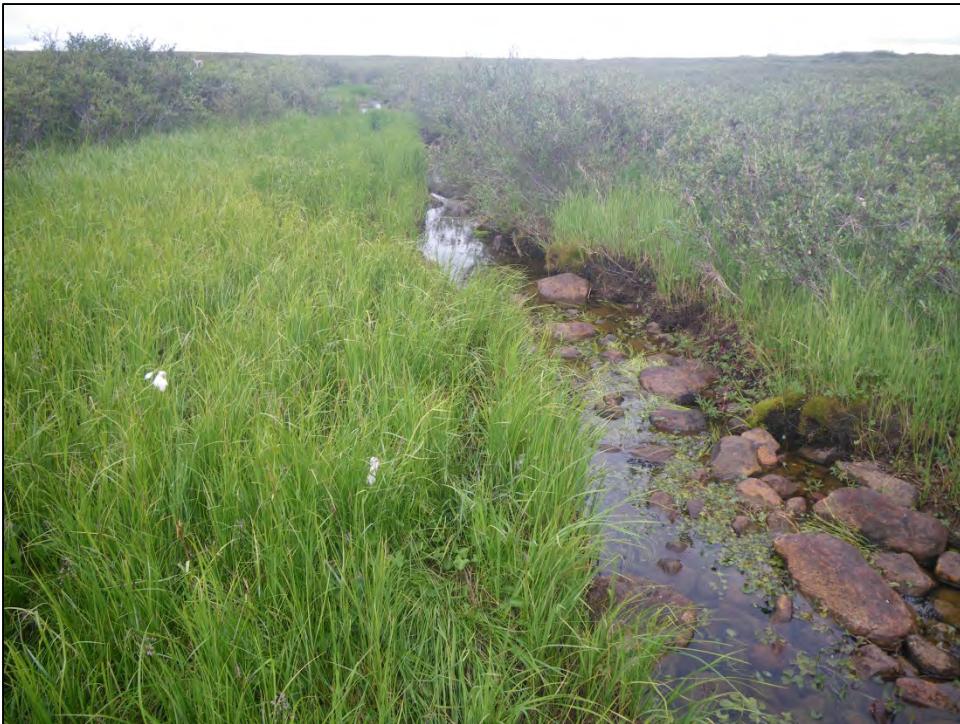
**C-MBR-19 – Trout Outflow; Aimaokatalok Watershed**

*High Flow 8-Jun-17; Habitat Value – High*

*Low Flow 30-Jul-17; Habitat Value – Moderate*

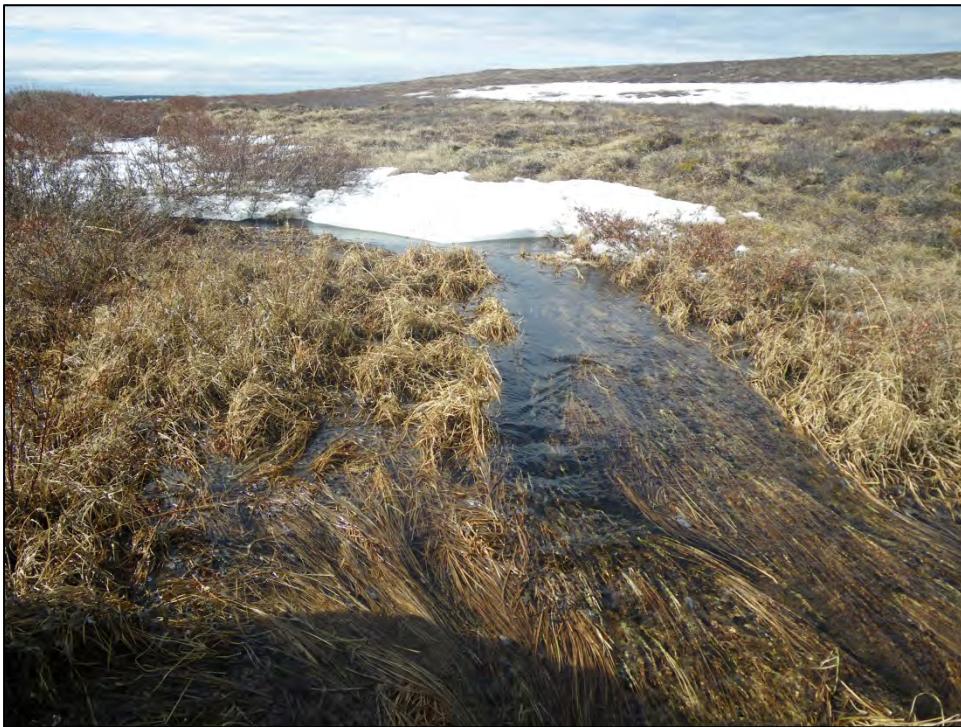
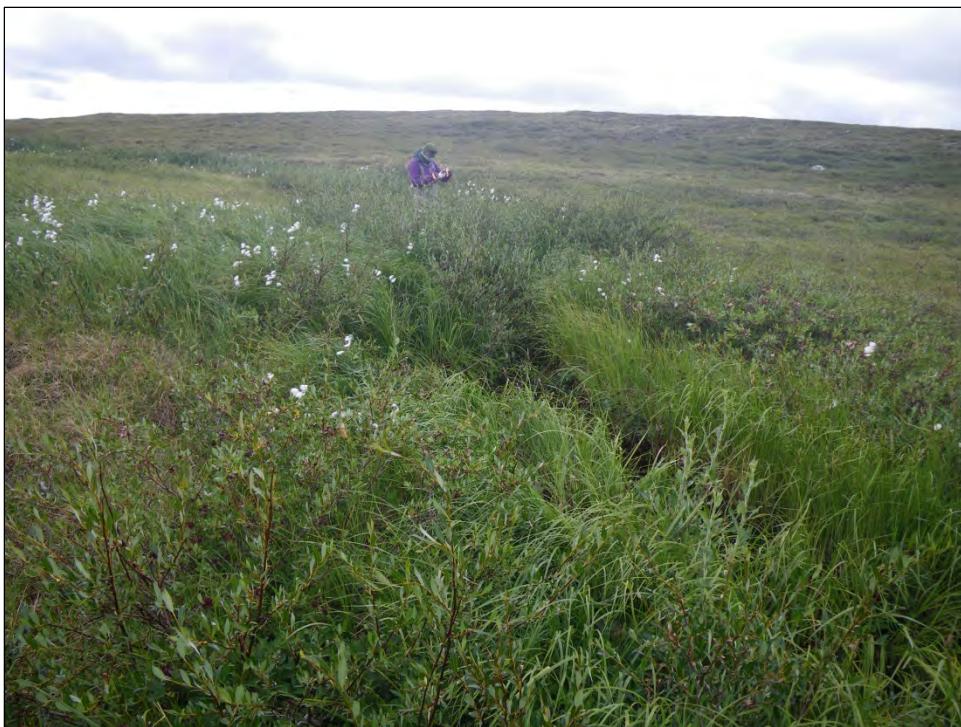
**C-MBR-20 – Stickleback Outflow; Aimaokatalok Watershed**

*High Flow 8-Jun-17; Habitat Value – High*

*Low Flow 30-Jul-17; Habitat Value – Moderate*
