Fish Bearing Status of Four Ponds in Proximity to Boston,
2017

Memorandum

Date: November 20, 2017

Subject: Fish-bearing Status of Four Ponds in Proximity to Boston, 2017

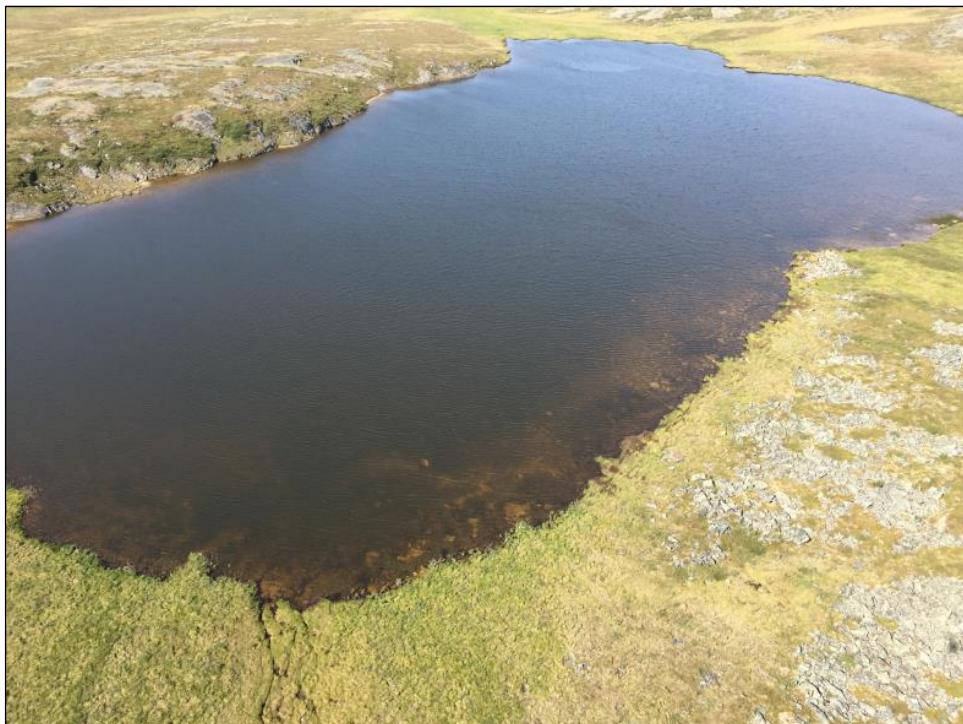
Plate 1. Aerial photo of Boston Pond 1, August 2, 2017.

Fish-bearing: Minnow traps (4 traps for 3h20) and electrofishing (514 seconds). Boston Pond 1 (Figure 1; Plate 1) has a surface area of 68,980 m² and has a maximum depth of approximately 3 m. Its outflow towards Aimaokatalok Lake was assessed for fish-bearing status at road crossing C-MBR-17 on July 26, 2017 and stickleback were captured. Downstream of the road crossing location the connectivity to Aimaokatalok Lake for fish passage was poor in June and July 2017 (data not included).

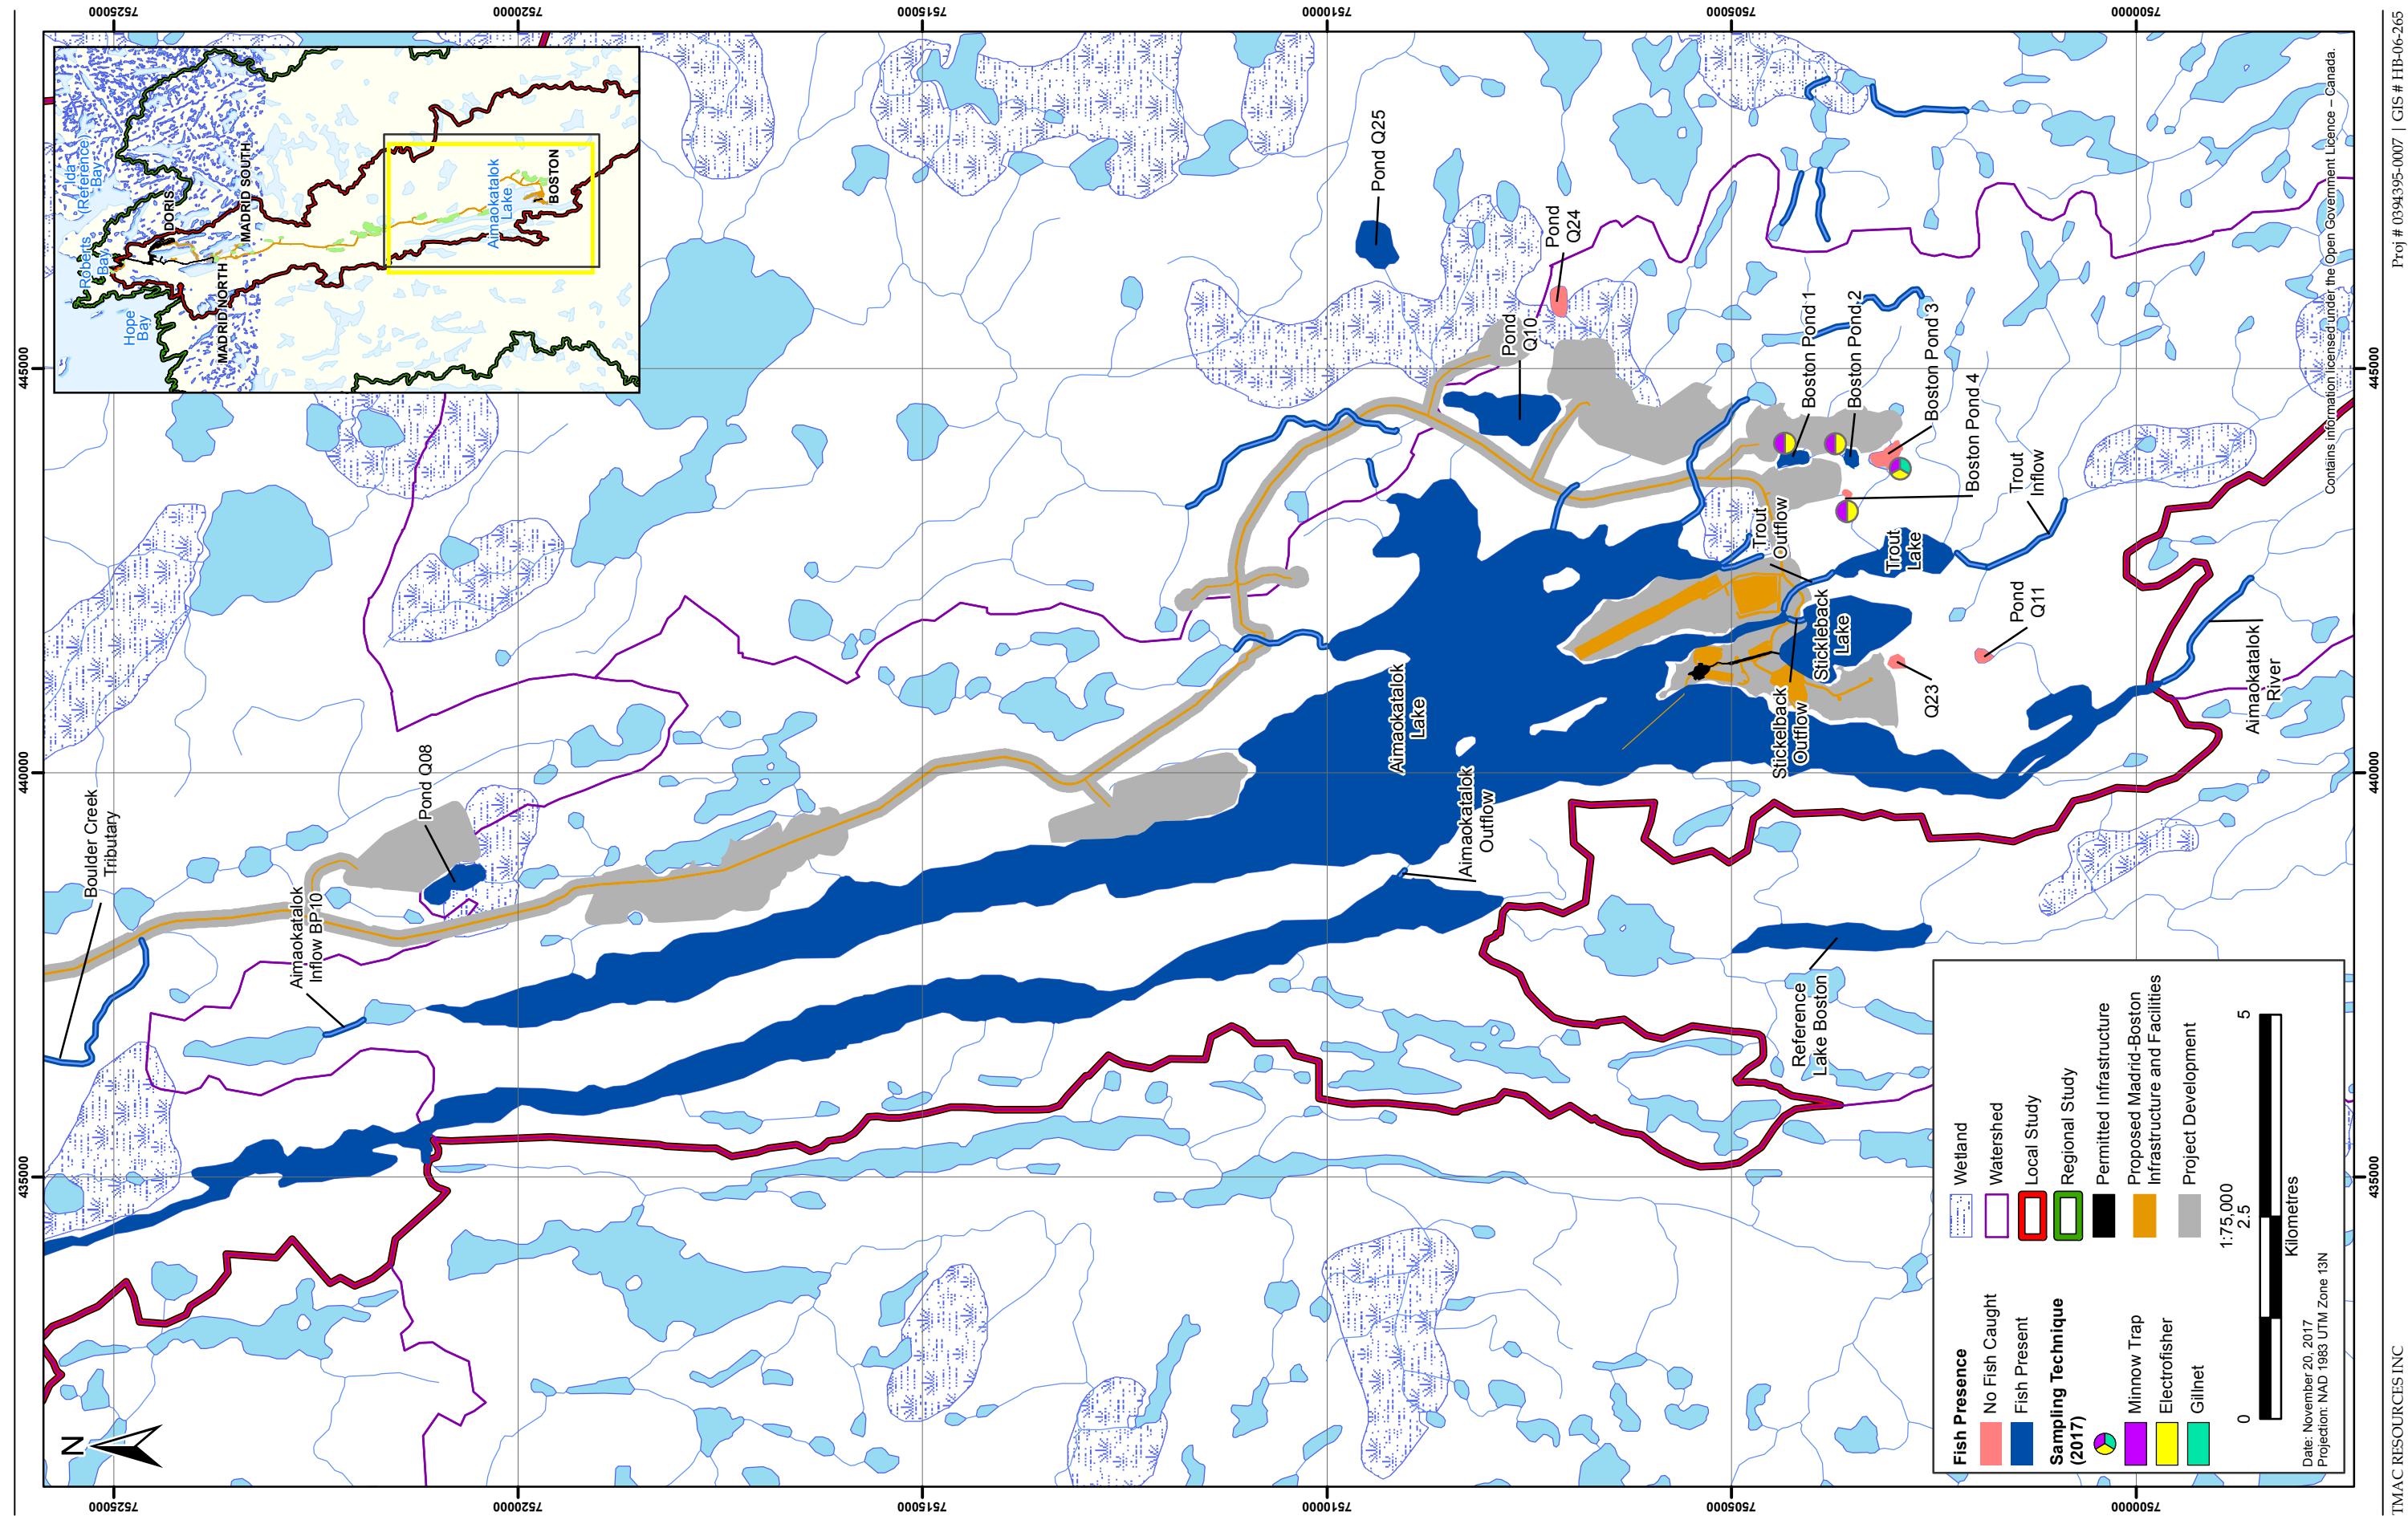
Figure 1
2017 Fish Presence in Sampled Freshwater Habitats, 1993-2017

Four ponds (Figure 1) were visited and assessed for fish-bearing status and fish habitat littoral characteristics between August 2 and August 10, 2017 to determine if the ponds were fish-bearing (Table 1). A total of three fishing techniques were used: minnow trap, electrofishing and gillnetting. Ninespine sticklebacks were observed and caught at Boston Pond 1 and Boston Pond 2 by minnow trapping and electrofishing. No fish were observed or captured in Boston Pond 3 and Boston Pond 4.

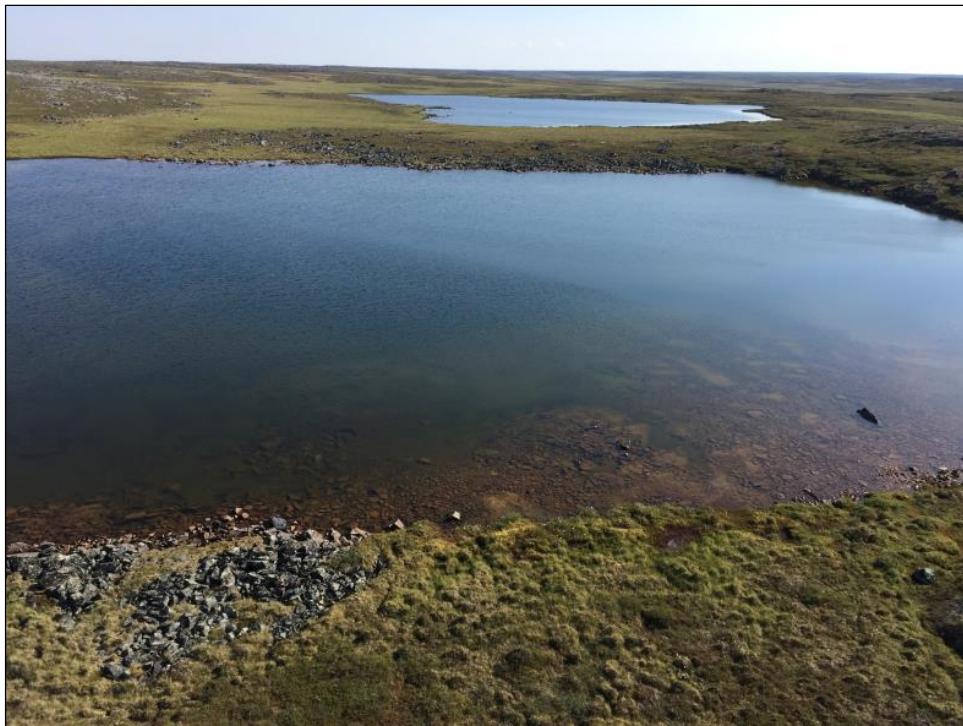
Plate 2. Aerial photo of Boston Pond 2. Boston Pond 1 is in the background, August 2, 2017.

Fish-bearing: Minnow traps (3 traps for 5h22) and electrofishing (500 seconds). Boston Pond 2 (Figure 1; Plate 2) has a surface area of 36,625 m² and a maximum depth of approximately 2 m. Its outflow towards Pond 1 was dry during August 2017 survey dates.

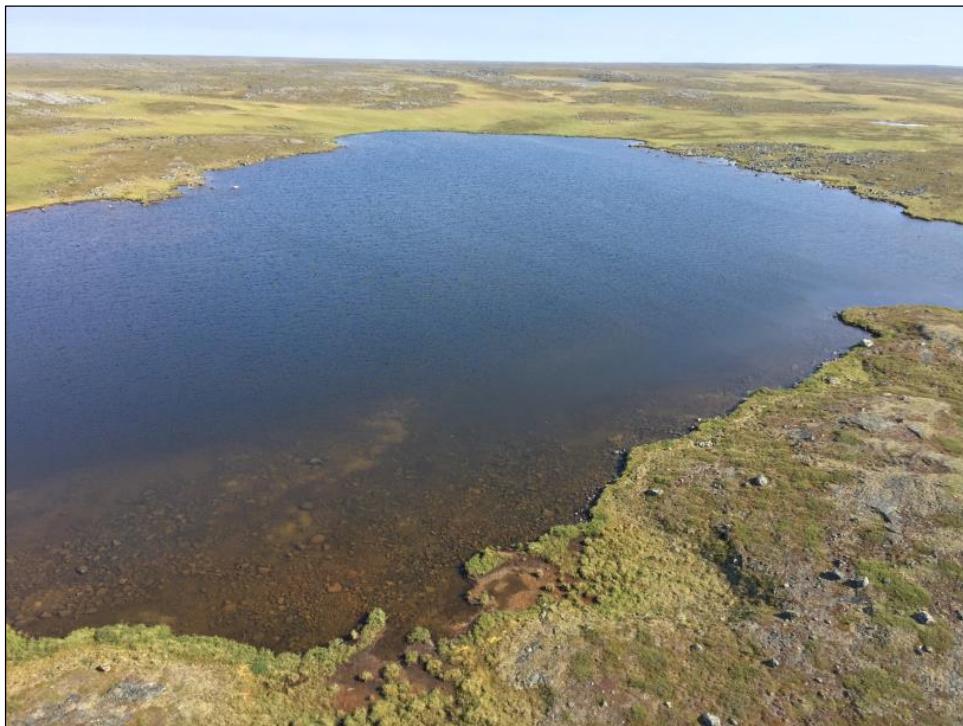
Plate 3. Aerial photo of Boston Pond 3, August 2, 2017.

Non-fish-bearing: Minnow traps (9 traps for 3h40 to 5h30 for a total of 39.9 h), electrofishing (1,005 seconds) and gillnetting (5 h). Boston Pond 3 (Figure 1; Plate 3) has a surface area of 80,365 m² and a maximum depth of approximately 3 m. The outflow towards Trout Lake was dry coming out of the pond but merged with some flow from a surface drainage to the west. The channel was wetted over a section but did not appear to be connected to Trout Lake at 2017 August flow levels. No flowing inflows were observed along the pond's perimeter during surveys.

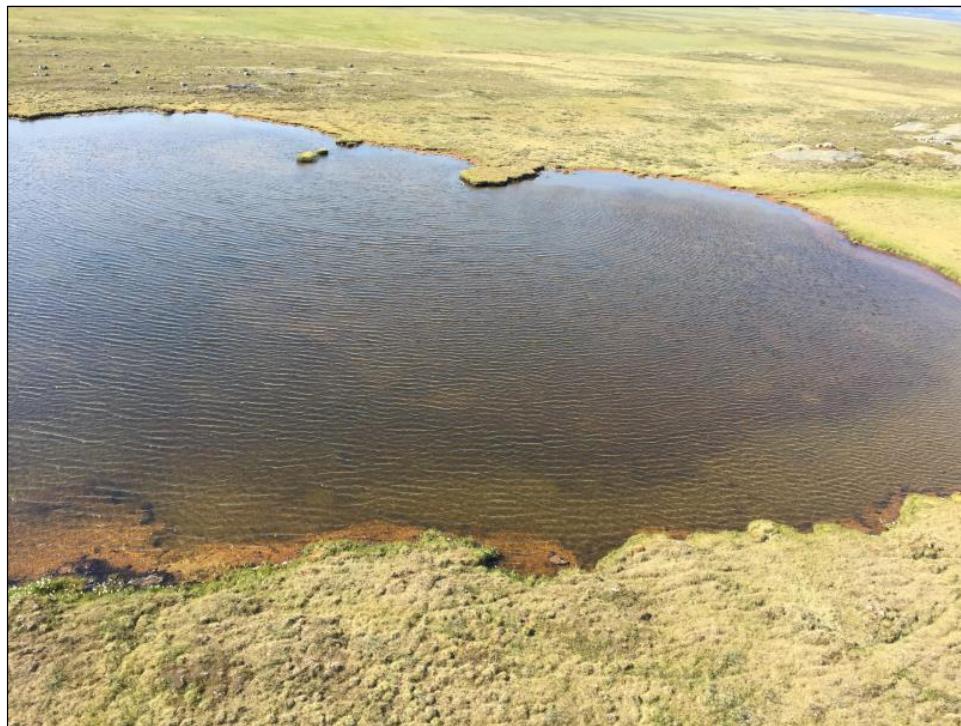
Plate 4. Aerial photo of Boston Pond 4, August 2, 2017.

Non-fish-bearing: Minnow traps (20 traps for 1h to 5h for a total of 74 h), electrofishing (1,008 seconds). Boston Pond 4 (Figure 1; Plate 4) has a surface area of 10,520 m² and a maximum depth of approximately 1 m. The outflow towards Aimaokatalok Lake was dry on survey dates. This outflow was assessed downstream at road crossing C-MBR-18 in June and July; during both visits the outflow was assessed as a Non-Classified Drainage (NCD). The area was wetted but the connectivity for fish passage was very poor (data not included).
