BACK RIVER PROJECT

SITE WIDE WATER MANAGEMENT REPORT

PHASE 4  
Post-Closure  
Year 18+

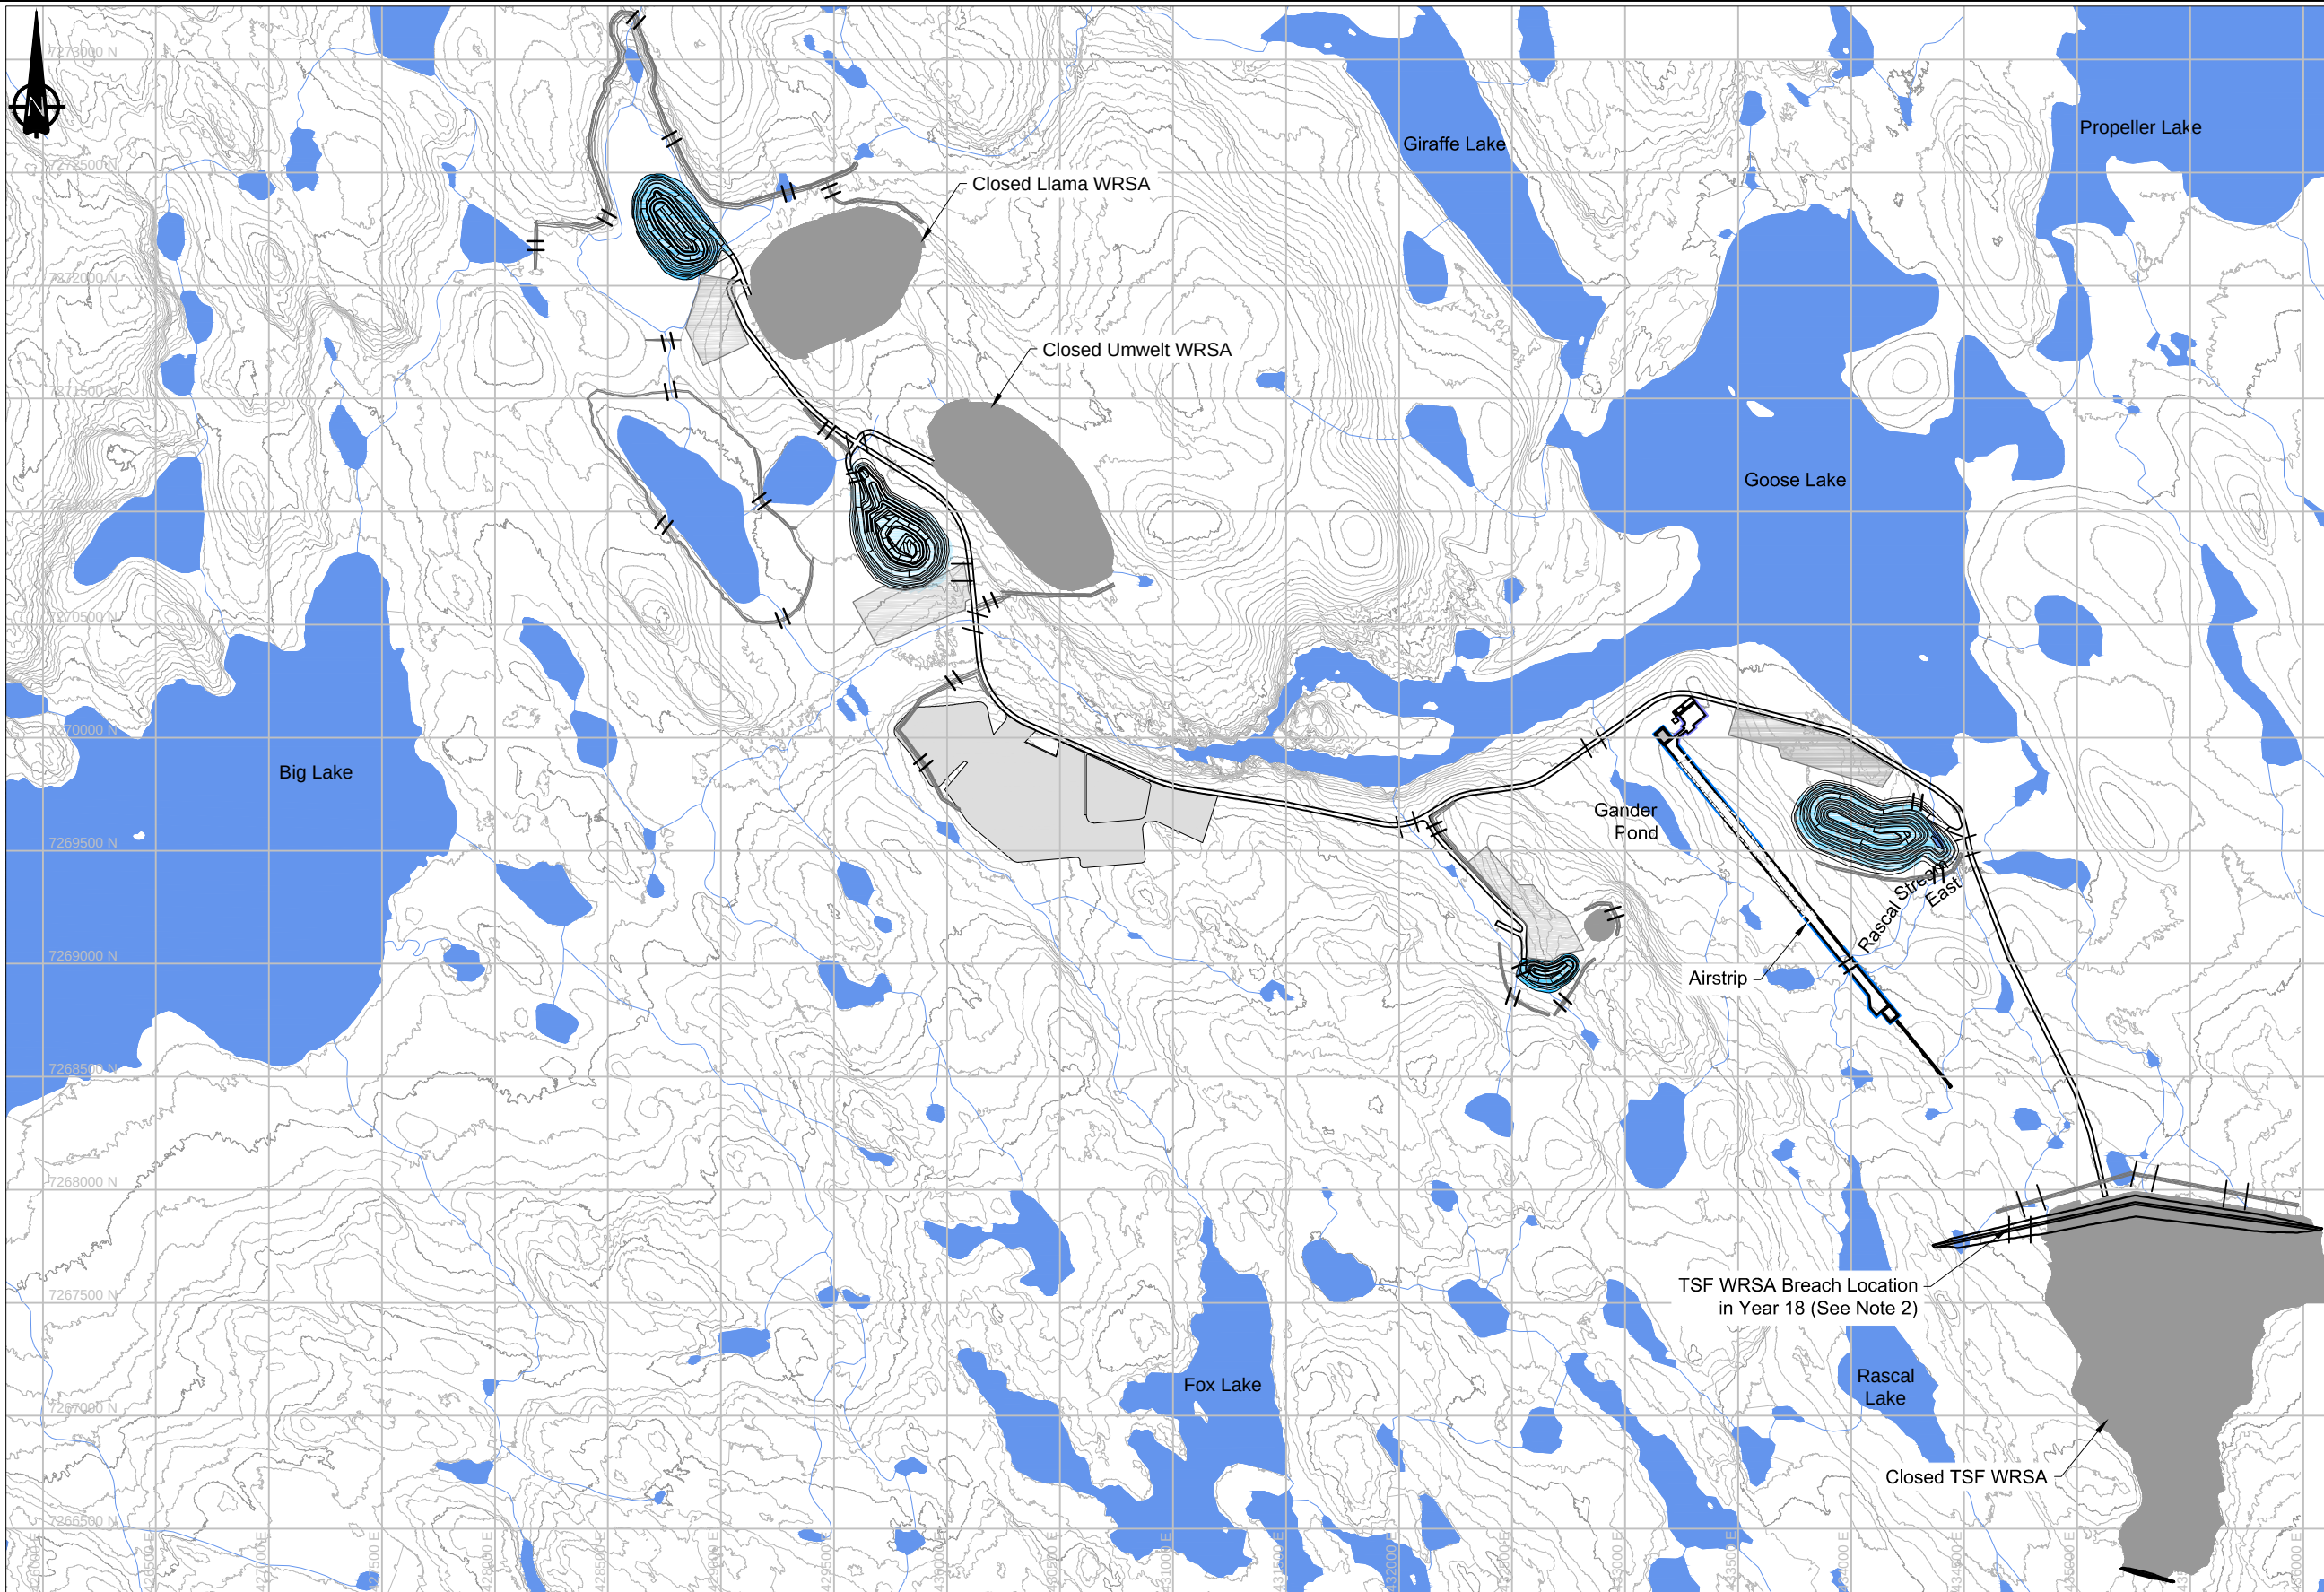
FIGURE:  
11

- Contours shown at 2m intervals.
- TSF WRSA pond breached to Goose TF.

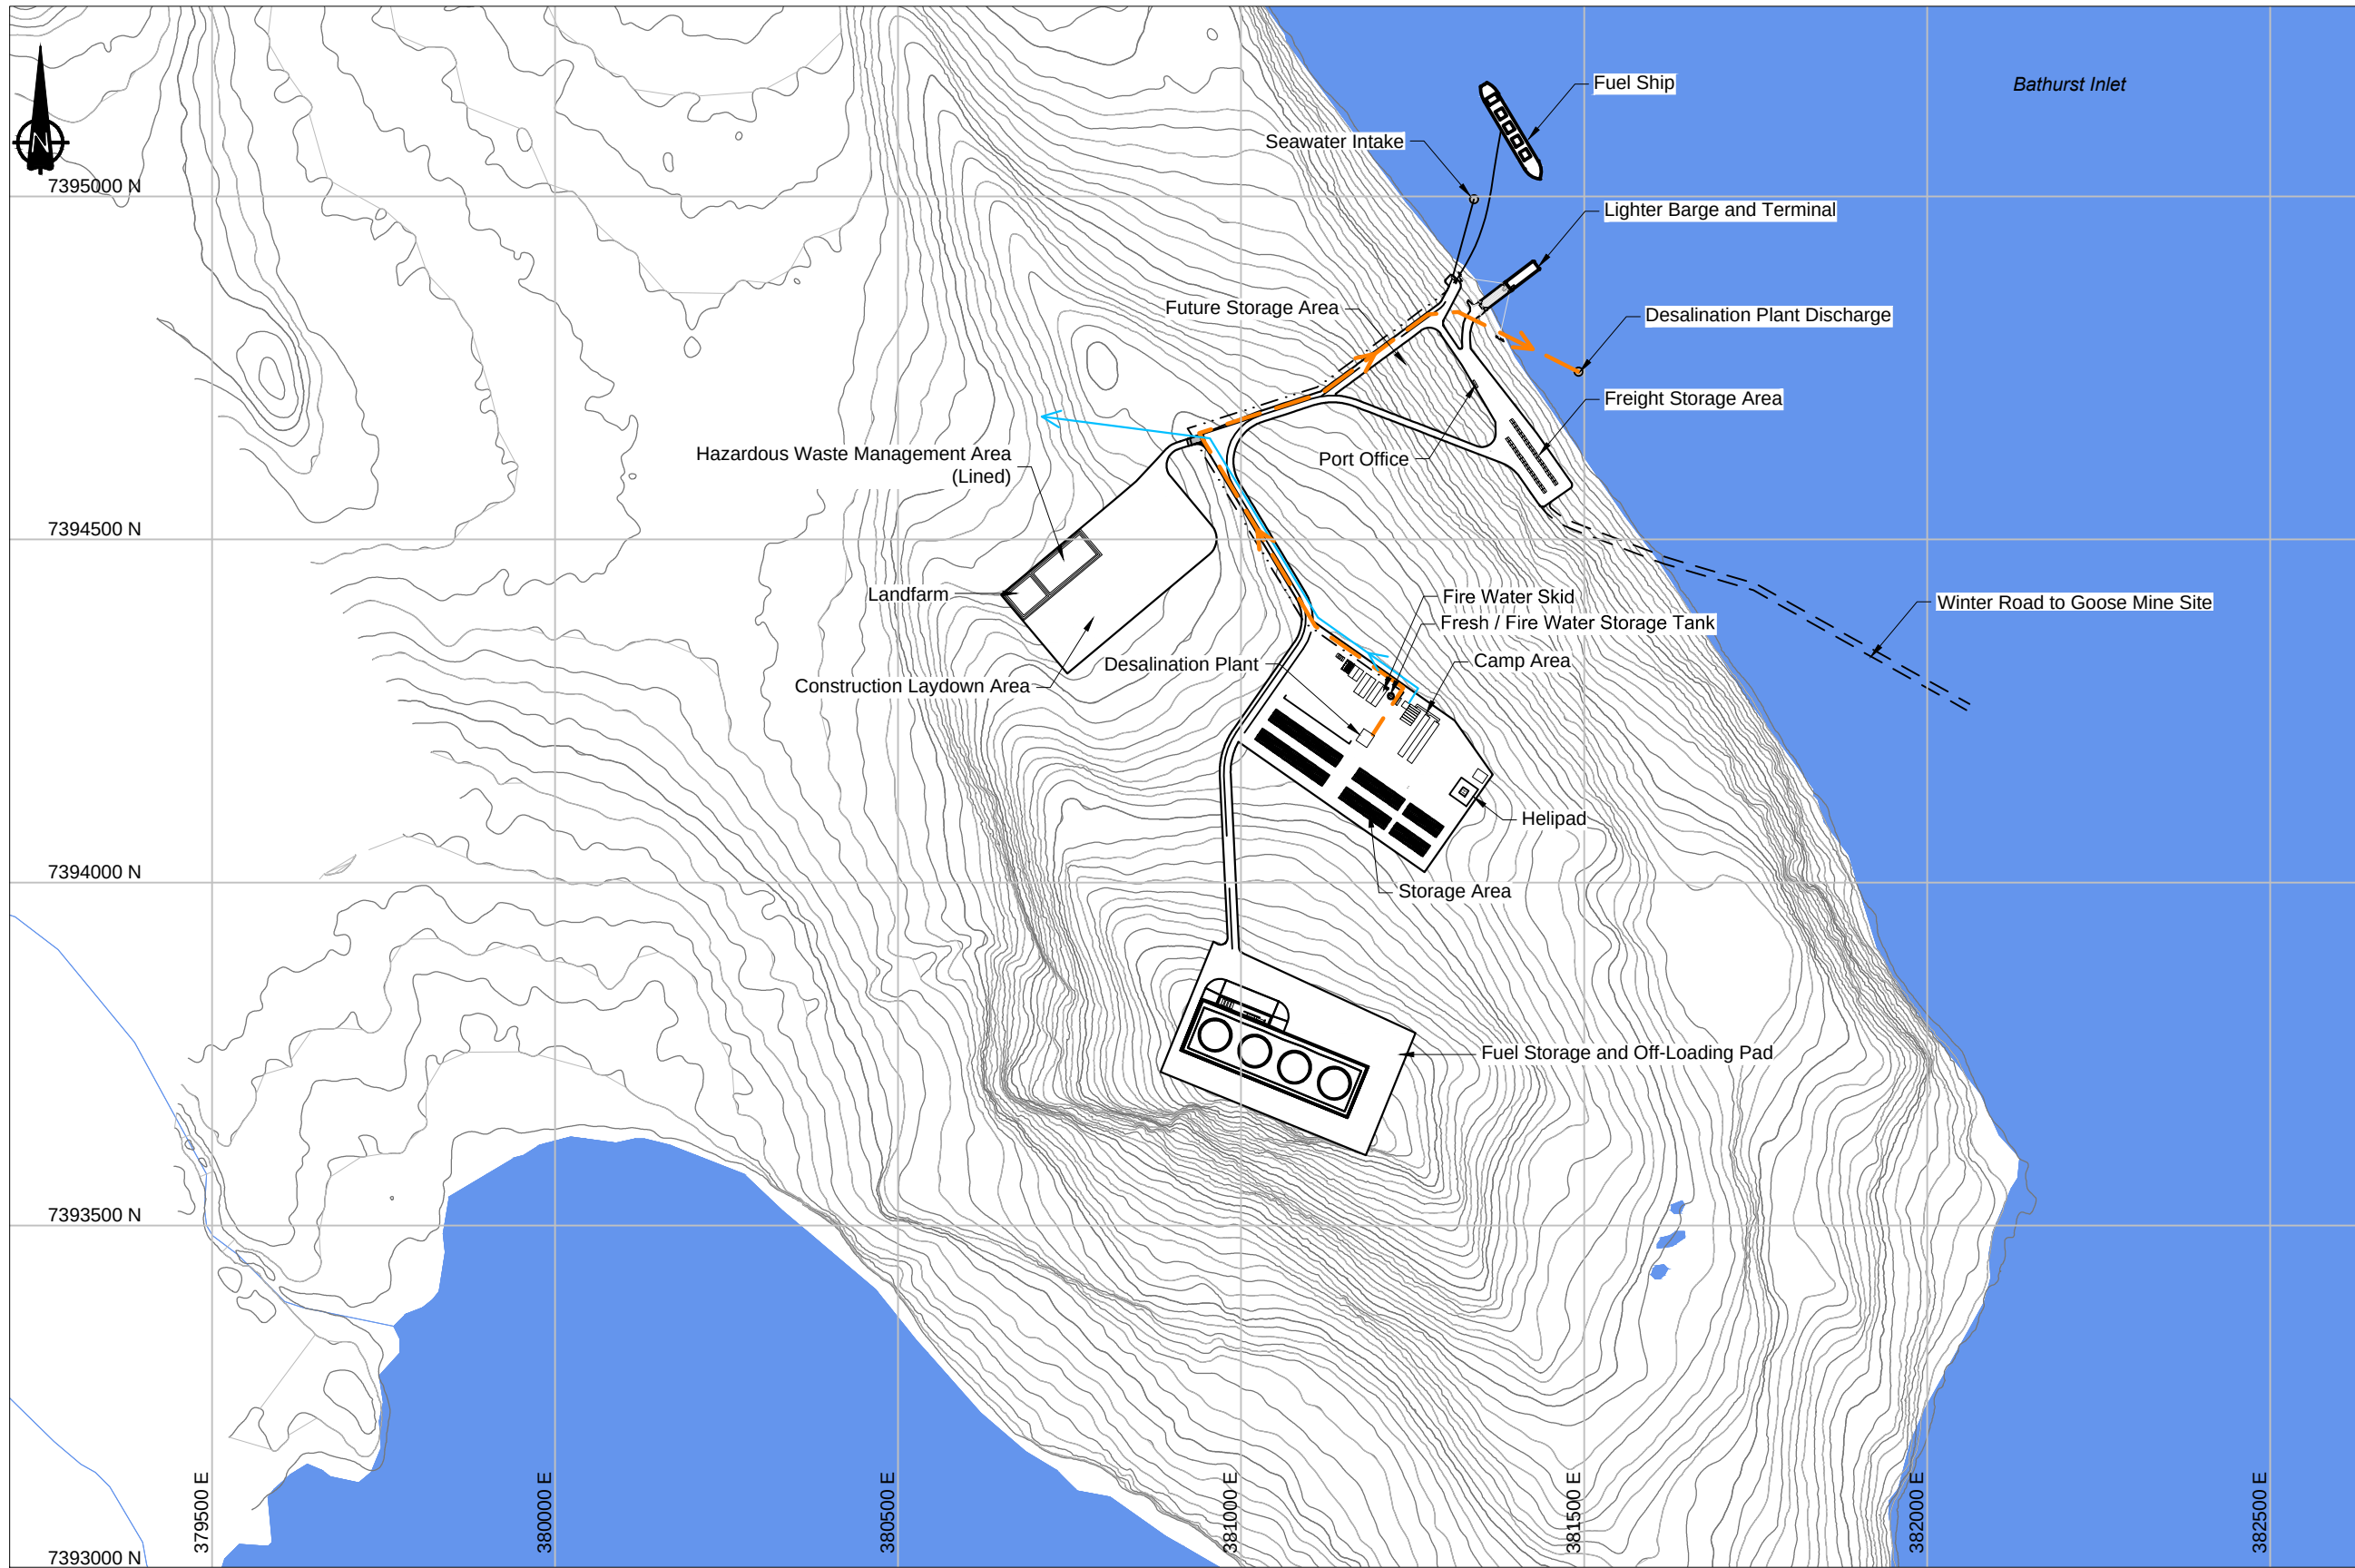
| | | | | FIGURE:<br>12 | |

| SRK JOB NO.: 1CS020.008 | | BACK RIVER PROJECT | | PHASE 1 & 2<br>Construction and Operations<br>(Year -2 to Year 10) | |
