# 2017-2018 Annual Monitoring Report

Nunavut Impact Review Board  
File No. 12MN036  
October 2018

**Report Title:** The Nunavut Impact Review Board's 2017-2018 Annual Monitoring Report for the Back River Gold Mine Project (NIRB File No. 12MN036)

# 2018 Site Visit Report

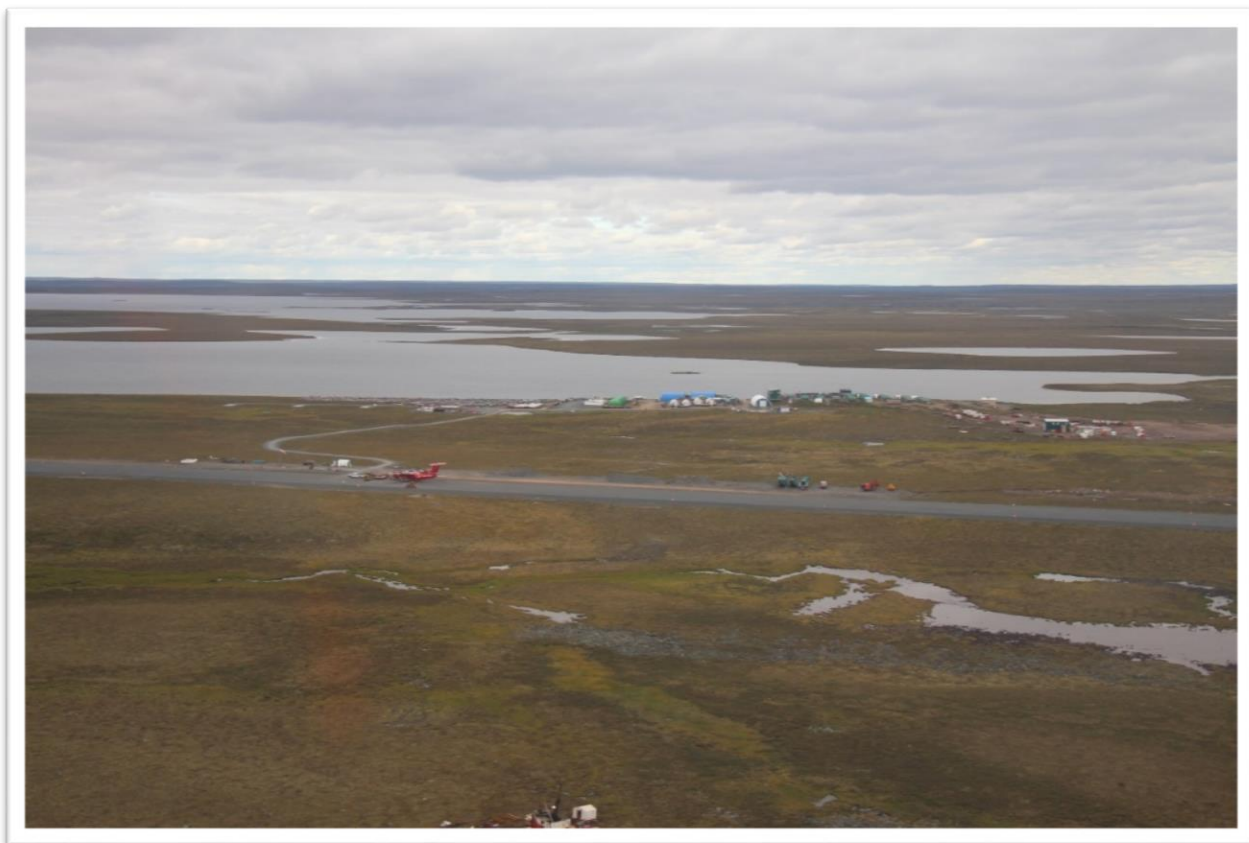
**Photo 1: Goose Lake Camp**

The Goose Lake camp can accommodate up to 158 people; however, during the site visit there were around 45 people employed by Sabina and other contractors.

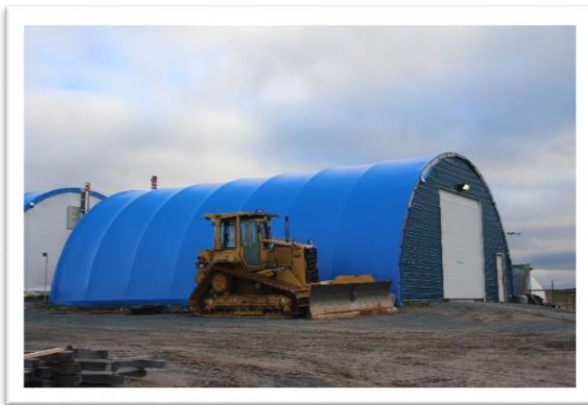
**Photo 4: Truck Shop - Goose Lake**

A small truck shop is housed in tent and was heated by a waste oil burner. Several other buildings on site also use waste oil burners to heat them.

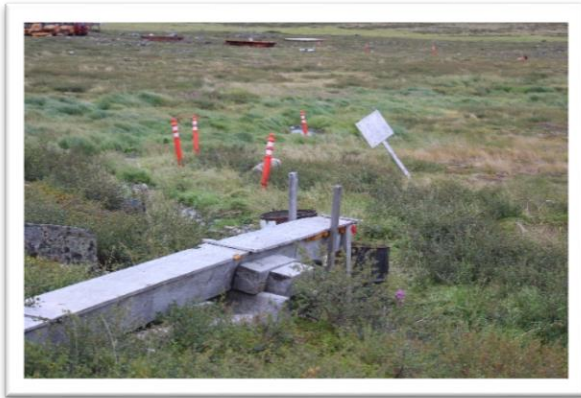
**Photo 8: Grey Water Disposal**

At the Goose Lake Camp, sewage is collected in PACTO toilets and the bags are collected and incinerated. The greywater generated from washing is collected and re-directed onto the tundra ([Photo 8](#), [Photo 9](#)).

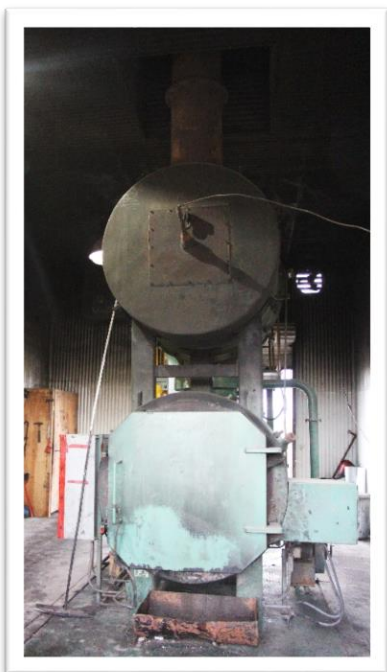
**Photo 10: Incinerator**

The Monitoring Officer noted that the incinerator in use at the Back River Project was well maintained and that there appeared to be no “back log” of waste. No stack testing had been done, but it will be once the new incinerator is online at the new camp.

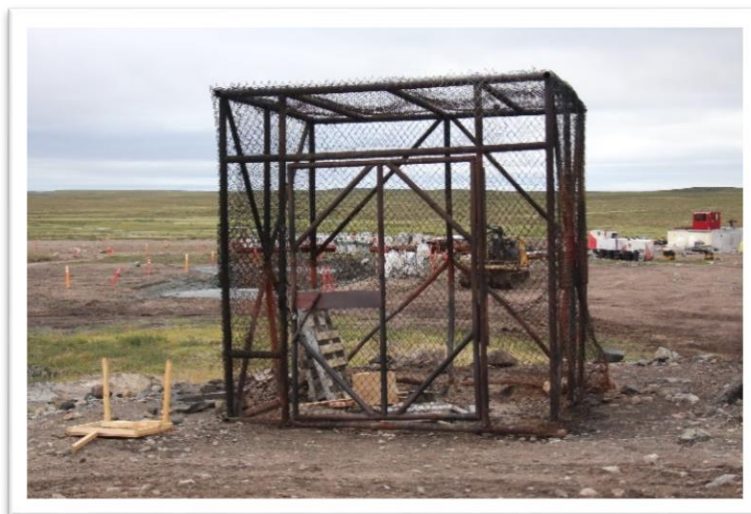
**Photo 11: Burn Box for Wood and Paper**

Other waste materials are collected and separated into combustibles, recyclables, and non-combustibles (e.g., aerosol cans and batteries). Combustible waste is incinerated ([Photo 10](#)), cardboard and clean wood are burnt in a burn box ([Photo 11](#)), and recyclables and non-combustibles are collected, stored and then shipped off site.

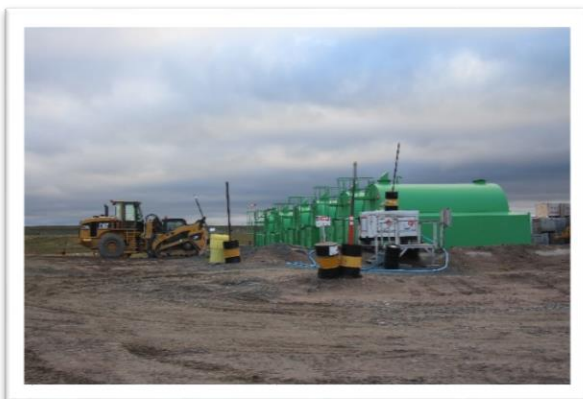
**Photo 12: Fuel Tank Facility**

Bulk diesel fuel was contained in double walled enviro tanks within a lined berm ([Photo 12](#) and [Photo 13](#)). A lined and bermed vehicle refueling area was located next to the fuel storage facility ([Photo 14](#)). Some ponding was observed as there had been heavy rains in the days prior to the site visit. Should the water become an issue (i.e., will not dry up) it will be tested prior to pumping. The Monitoring Officer also observed the fuel barrel and hazardous materials storage area. All materials were organized and stored correctly in insta-berm liners or in a lined area along with spill kits ([Photo 15](#), [Photo 16](#), [Photo 17](#) and [Photo 18](#)). Heating fuel was also contained to prevent spills at the accommodations buildings ([Photo 19](#)).

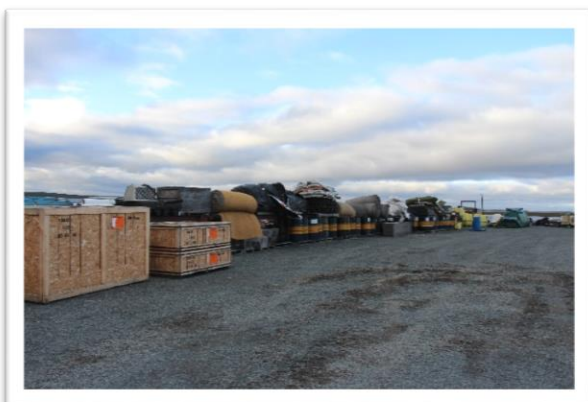
**Photo 20: Material Storage**

Laydown and storage areas at the Goose Lake Camp were tidy. Materials were placed on top of empty fuel barrels so that they could be located and removed during the snow season.

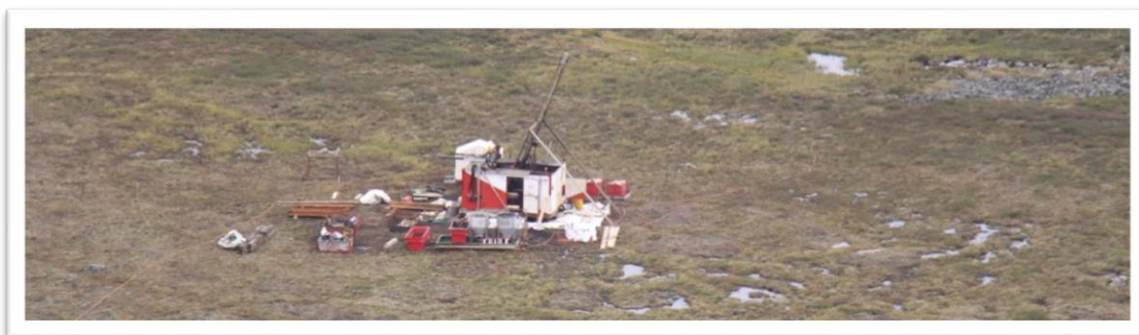
**Photo 27: Exploration Drill Rig on Tundra**

An exploration drill program was being based out of Goose Camp by a contractor. During the site visit helicopter supported geological mapping and sampling was occurring on the Goose Property. Geologists were present on site examining core and collected samples were being sent out for analysis. All drill cuttings were captured and transported by helicopter to a sump located at the Goose Camp ([Photo 30](#)).

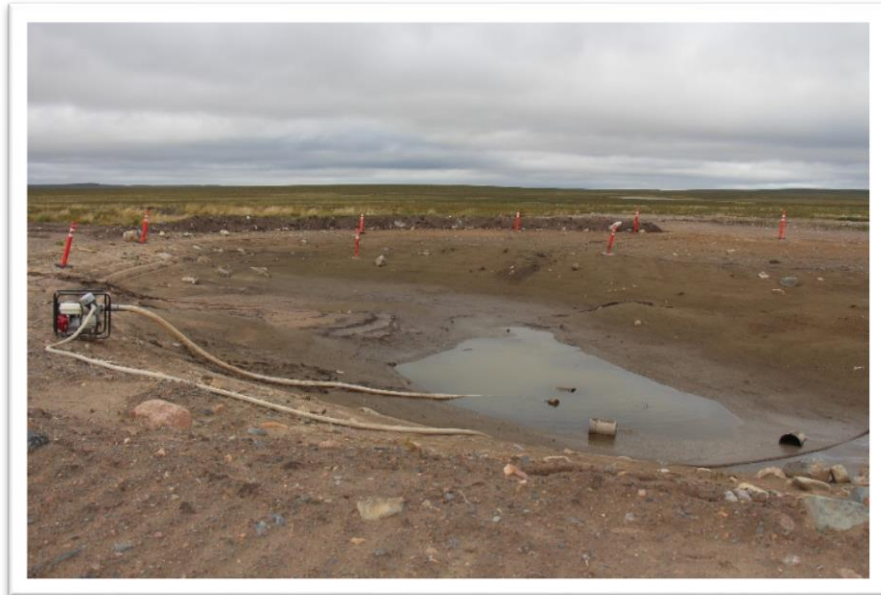
**Photo 31: Goose Pit (future) - water being pumped out of depression**

At the future location of the Goose Pit, Sabina staff brought the attention of the Monitoring Officer that Crown-Indigenous Relation and Northern Affairs Canada inspector was concerned about the erosion and water accumulation in the depression. While on site it was observed that water was being pumped out but the area continued to contain some water from recent heavy rains. Sabina is currently looking at solutions and would likely fill the location with either fill the depression with soil or potentially use it as drill cutting sump.

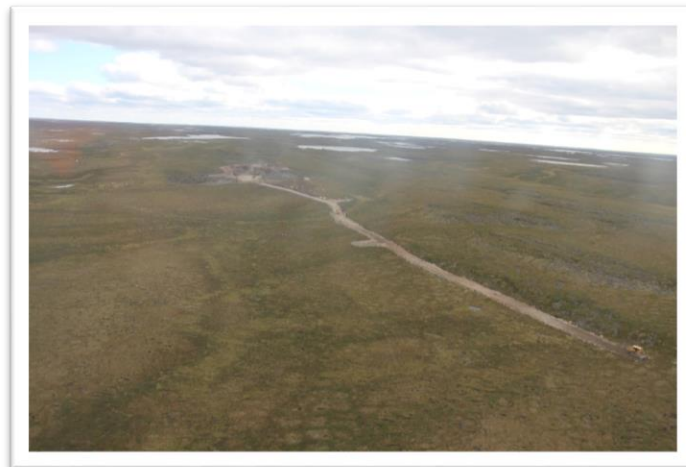
**Photo 35: Quarry - Road Construction**

The Goose Lake quarry east of camp was operational and spur road construction had begun. The Monitoring Officer observed some damage to the tundra from a tracked vehicle near this area ([Photo 36](#)).

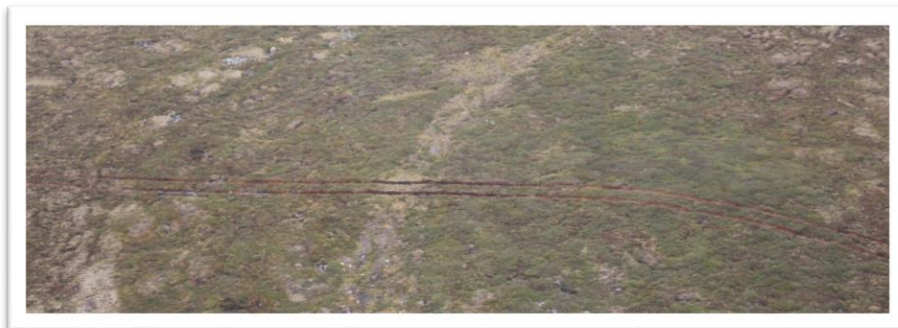
**Photo 36: Damage to Tundra near Quarry**

During the site visit the Monitoring Officer did not observe any items of significant concern however noted that some damage (tracks) had occurred on the tundra near the Goose Lake Quarry and at the Marine Laydown Area from the shore to the camp area as well as at some additional areas at the MLA site.

Sabina staff noted that they would be developing as part of their Vegetation Monitoring Plan a revegetation and reclamation strategy to maximize revegetation to the damaged areas on the tundra.

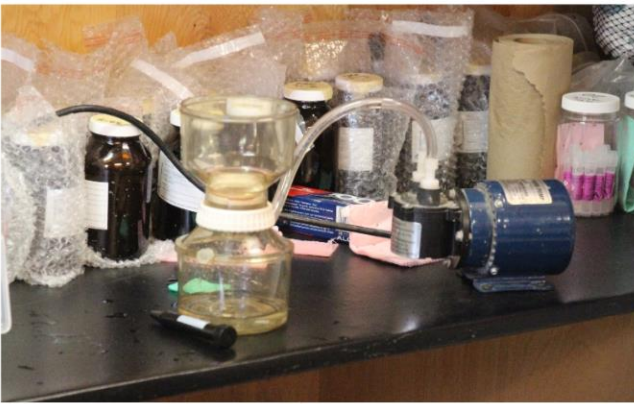
**Photo 38: Water Quality Testing**

During the site visit the Monitoring Officer observed Sabina's consultant who was on site conducting water and sediment quality sampling as part of the Aquatic Effects Monitoring Program.

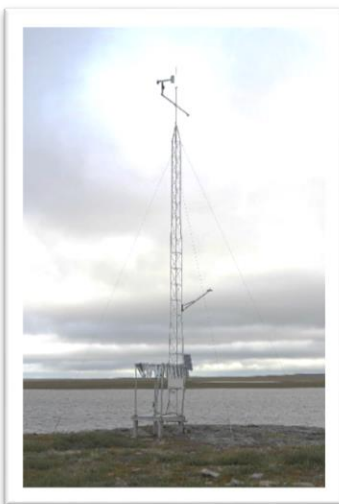
**Photo 40: Weather Station**

A weather station is also located at the camp and collects rainfall, temperature, wind (speed and direction), solar radiation and barometric pressure data.

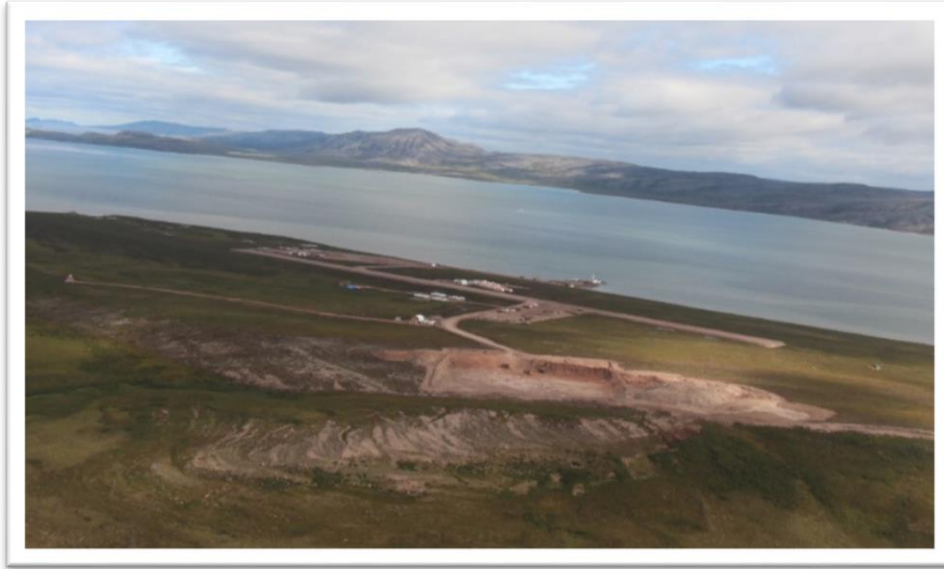
**Photo 42: Marine Laydown Area – Bathurst Inlet**

The MLA is located approximately 130 km north-northwest of the Goose Property and is the primary staging area for equipment, material, fuel, and other supplies required for the construction and operation of the Project. The MLA consists of a single grounded terminal barge, laydown areas, a camp facility, and associated storage and maintenance facilities.

Sabina commenced initial development works at the Marine Laydown Area (MLA) in March 2018. During the winter materials and supplies were moved in via aircraft using an ice strip on Bathurst Inlet. Short snow and ice roads were constructed to protect the tundra from damage; however, the Monitoring Officer during the site visit however observed some damage (tracks) had occurred on the tundra near from the shore to the camp area ([Photo 43](#)) as well as at some additional areas around site ([Photo 44](#)). Sabina staff noted that these areas are to be repaired and monitored as part of the vegetation monitoring program being established.

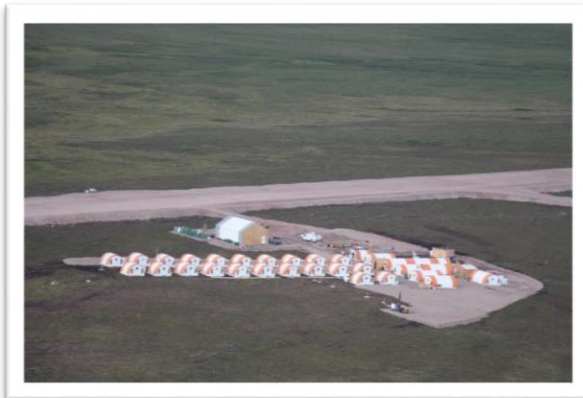
**Photo 45: MLA Camp**

At the time of the site visit, a new permanent 40-person tent camp with associated facilities had been established ([Photo 45](#) and [Photo 46](#)). The new camp was constructed in the same location as the temporary camp, preventing further impact to the tundra. The grey water discharge point was subsequently shifted as a result of the new permanent camp pad location ([Photo 47](#) and [Photo 48](#)).

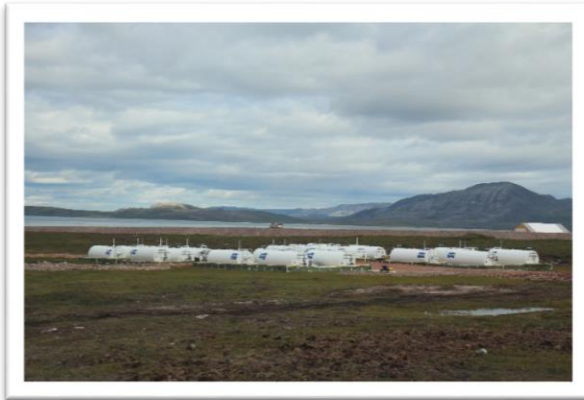
Photo 49: Temporary Fuel Storage

Bulk diesel fuel was contained in 30,000 L double walled enviro tanks within Insta-berms ([Photo 49](#) and [Photo 50](#)). Sabina will be constructing a permanent bulk fuel tank facility within the quarry area and is proposing a stand-alone bulk fuel pipeline and small vehicle access road in order to pump fuel from the fuel vessel to the yet-to-be built bulk fuel storage tanks.

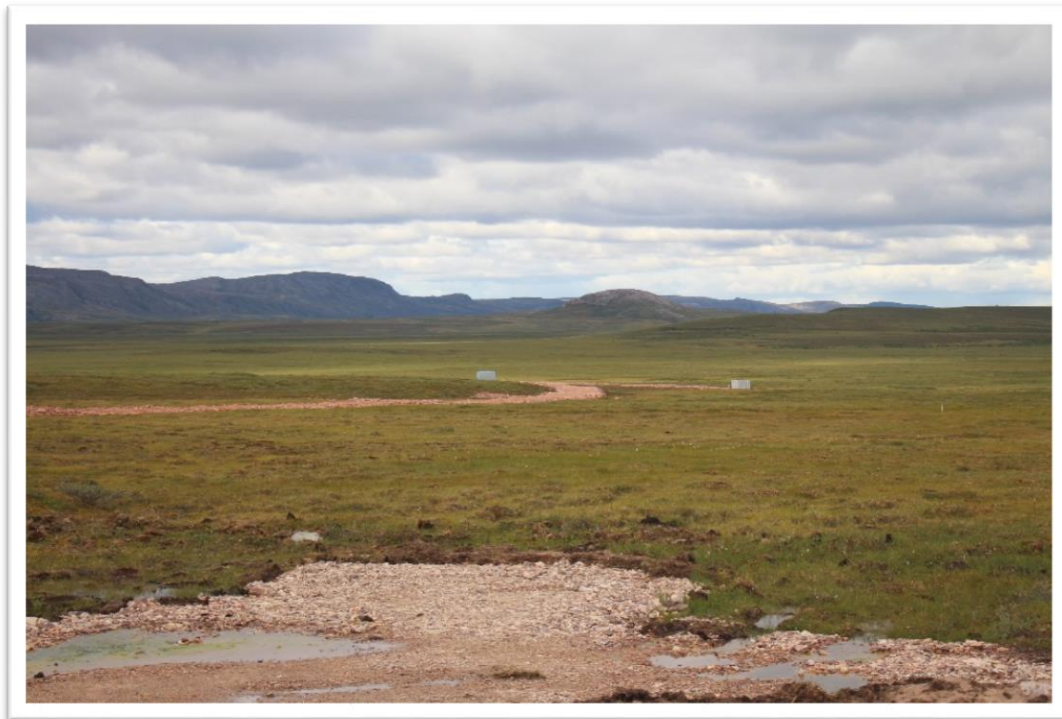
Photo 51: Explosives Storage Area

Permanent roads had been constructed around site, including two (2) trails to access the Explosives Magazine and the Ammonium Nitrate storage ([Photo 51](#)).

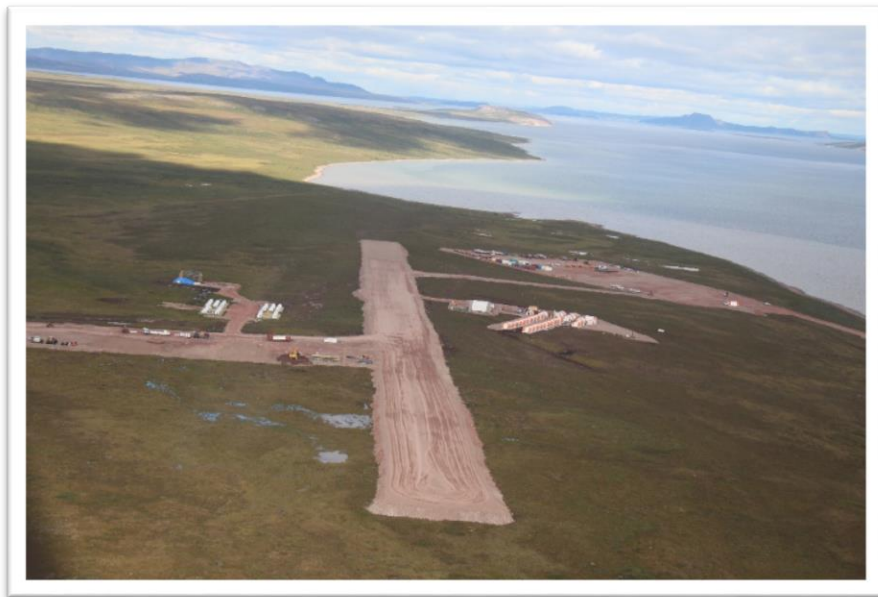
**Photo 52: Airstrip**

A road was re-aligned, lengthened and widened to create a 3,000 foot airstrip for landing larger aircraft, including Medivac aircraft ([Photo 52](#)).

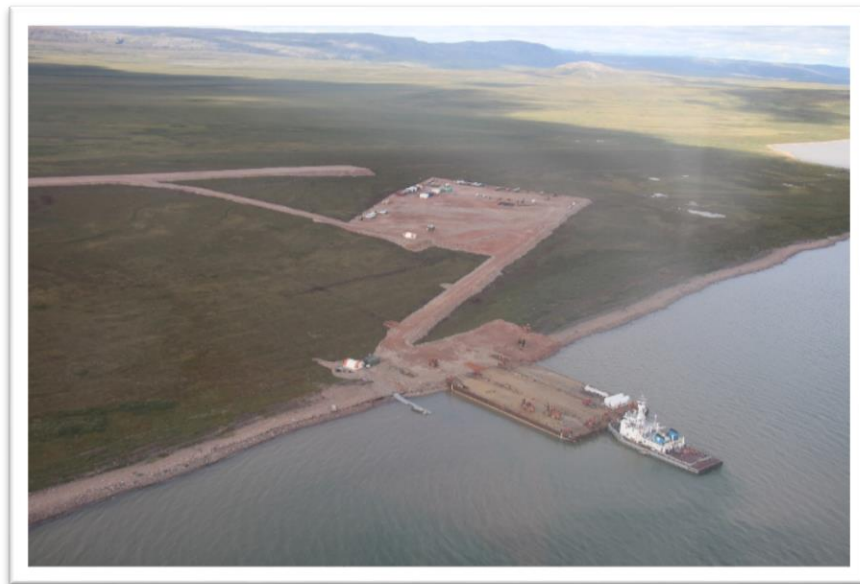
**Photo 53: Laydown Area Pad and Port**

Laydown pads, a freight storage pad and the shoreline pad for the receipt of sealift barges had been constructed ([Photo 53](#), [Photo 56](#), and [Photo 57](#)). During the site visit the first sealift was just completing the offload of supplies ([Photo 54](#) and [Photo 55](#)).

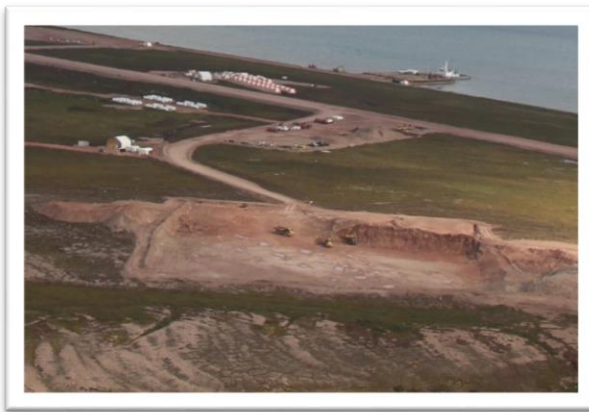
Photo 59: Quarry Site - Future Bulk Fuel Storage Facility

A quarry (Photo 59) was established to supply materials for the permanent roads, laydowns, pads and airstrip. It was noted that the quarry materials did not need crushing and that less quarry materials were required than originally anticipated. At the time of the site visit the quarry site was being leveled creating a solid, flat base area for the bulk fuel storage tanks to be constructed (Photo 60). Overall the footprint of the MLA is less than what was projected during the assessment.

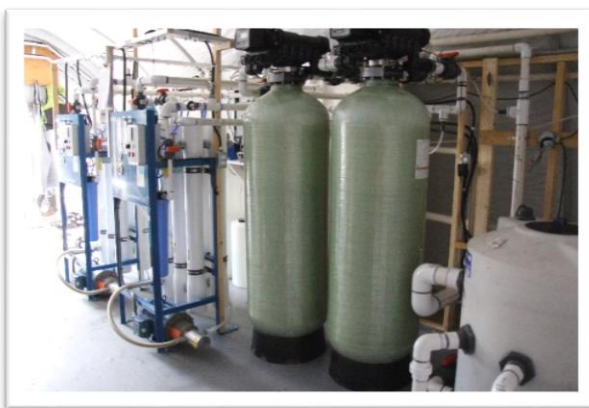
Photo 61: Desalination Plant

Accessing a fresh water supply is a challenge at the MLA so Sabina has commissioned a desalination plant (Photo 61) utilizing temporary intake and discharge lines into the marine environment. Intake lines are placed in the Inlet and then removed after use.

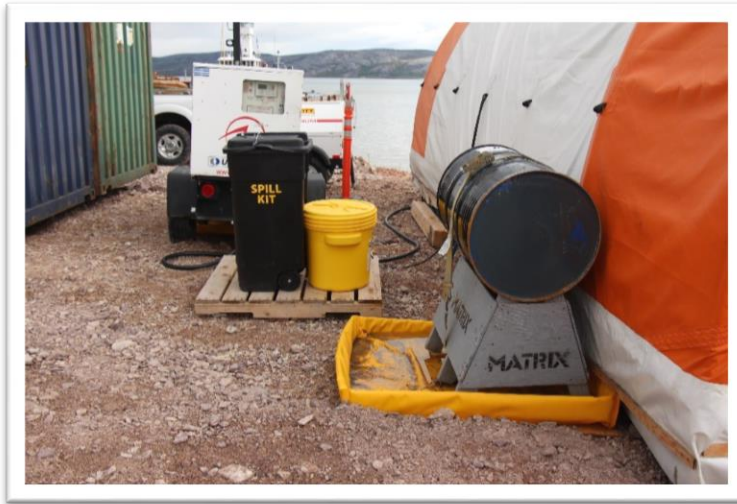
Photo 63: Spill Tray and Spill Response Kits

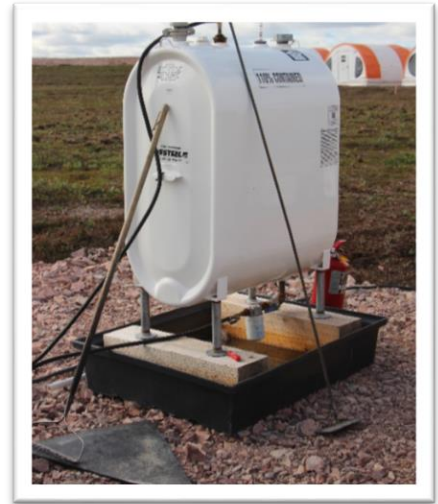
Photo 64: Spill Tray below Fuel Tank

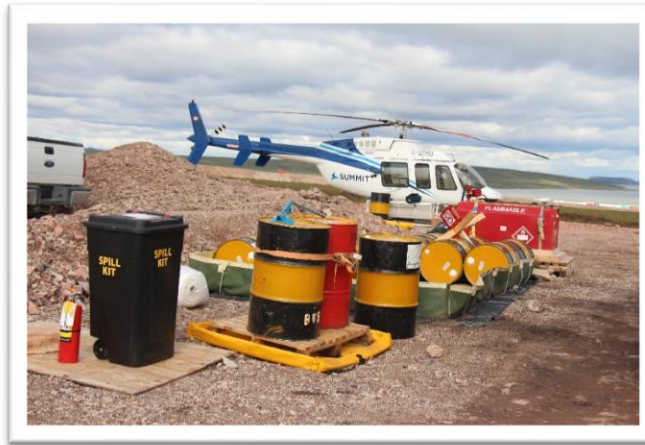
Photo 65: Helicopter Landing Area - Spill kit and Tray for Fuel

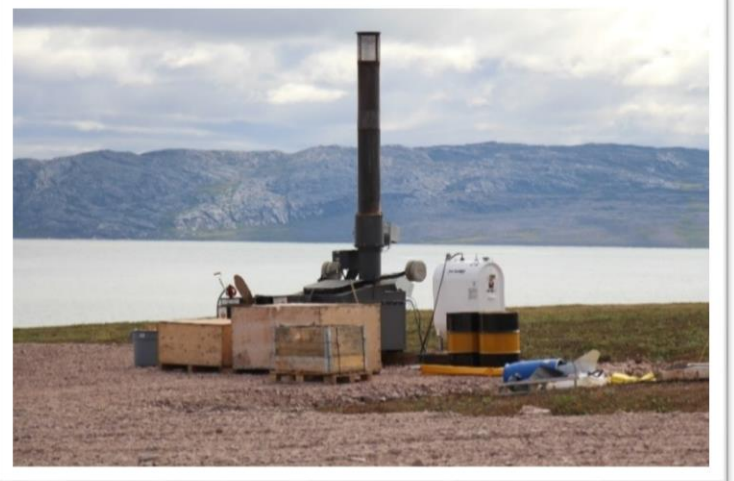
Photo 66: Temporary Incinerator

Sabina reported that the incinerator capacity at the MLA was stretched as the initial development works began to ramp up. They brought in a temporary incinerator (Photo 66) until the new one (1) permanent incinerator that arrived on the sealift can be installed.

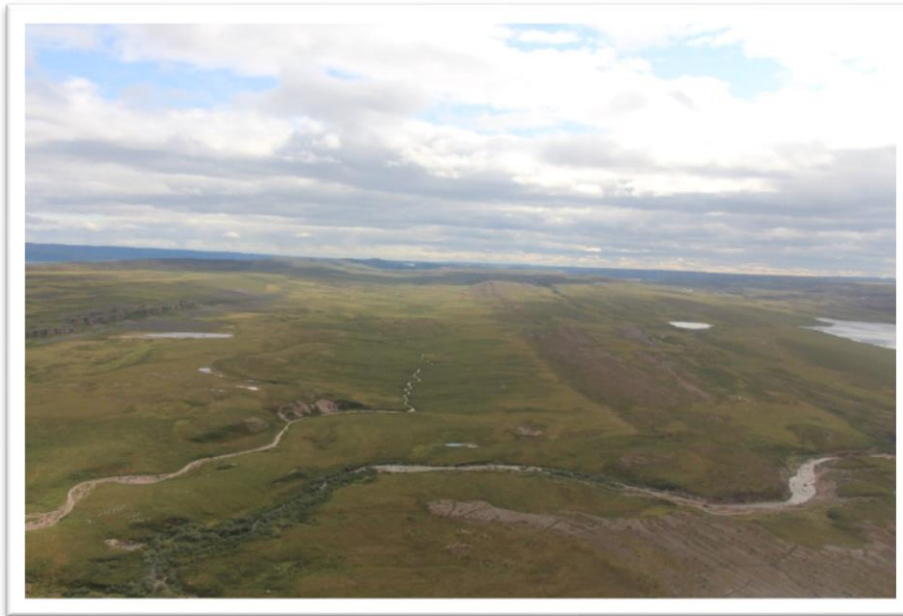
NIRB staff flew the proposed winter road route to observe pre-winter road construction conditions.

**Photo 67: Proposed Winter Road Route (Looking South)**

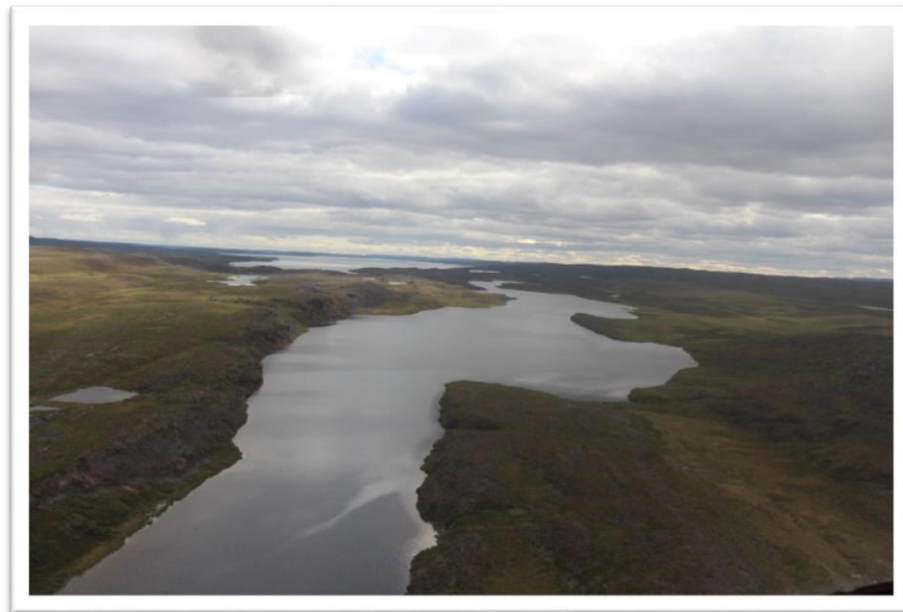
**Photo 68: Bathurst Lake - Proposed Winter Road Route (South)**

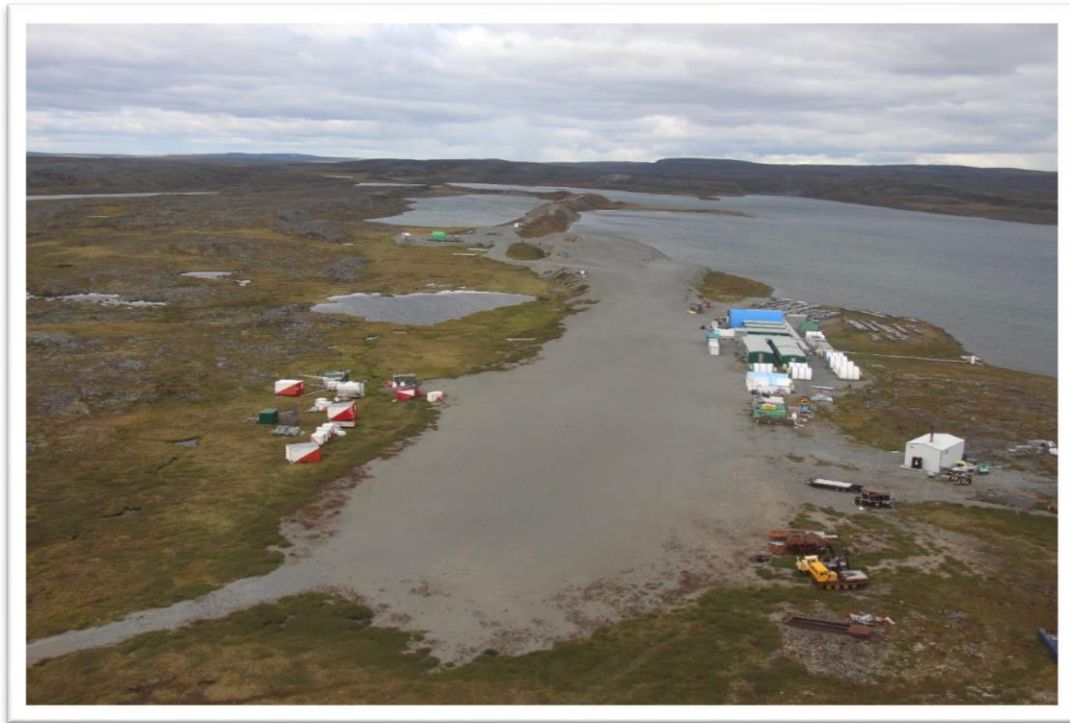
The George Lake Property is an advanced exploration camp located approximately 50 km northwest of Goose Property, and currently has four (4) mineral deposits identified for potential future development. The camp is currently under care and maintenance by Sabina and no personnel were located at the camp and no exploration activities were occurring around the George Property during the site visit. The weather station was operational and still collecting data.

**Photo 69: George Lake Exploration Camp**

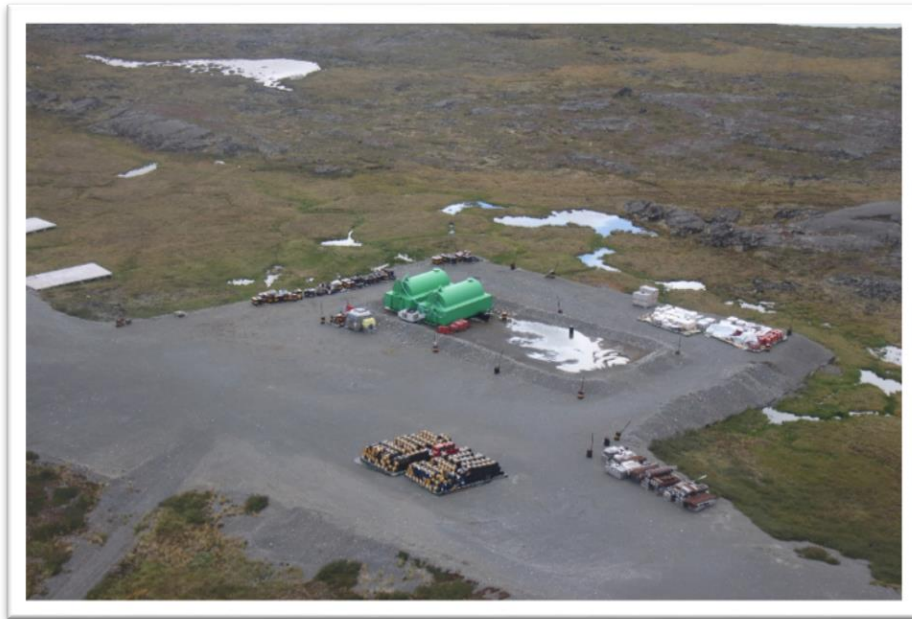
**Photo 70: Fuel Storage / Laydown Area**

Overall, the camp is well maintained, with proper containment of fuels and hazardous materials ([Photo 70](#), [Photo 71](#), [Photo 72](#) and [Photo 73](#)). During the site inspection it was noted that a wolverine had tried unsuccessfully to break into the roof of the airport building. Wildlife tracks such as wolf, caribou and muskox were observed around the site. Caribou also appear to have bedding down in a storage building ([Photo 77](#)) that was left open to allow for air circulation and to dry up the floor of the building. While no wildlife attractants appeared to be visible within the structure, the Monitoring Officer recommended that the Proponent close the structure to prevent further access by wildlife to the building.

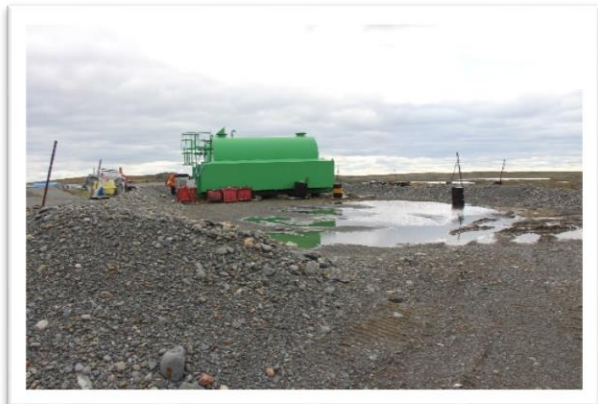
**Photo 72: Equipment Access into berm area**

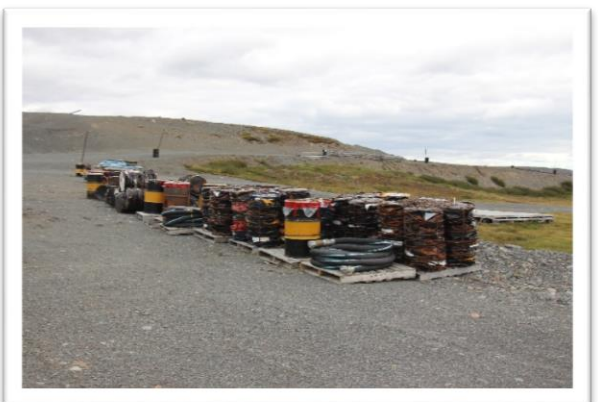
**Photo 74: Crushed Fuel Barrels**

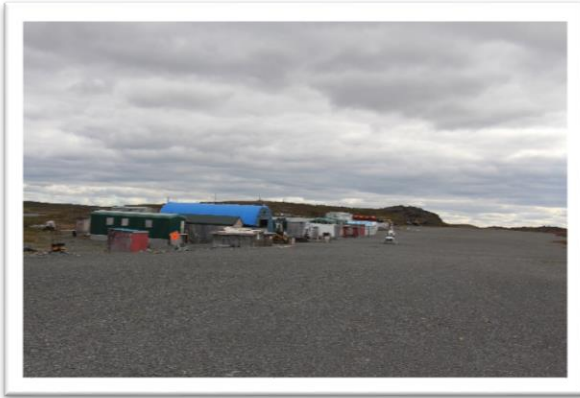
**Photo 75: Goose Lake Camp and Airstrip**

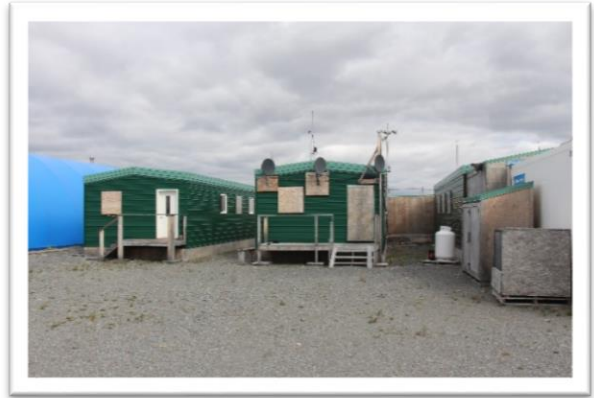
**Photo 76: Accommodations Buildings - George Lake**

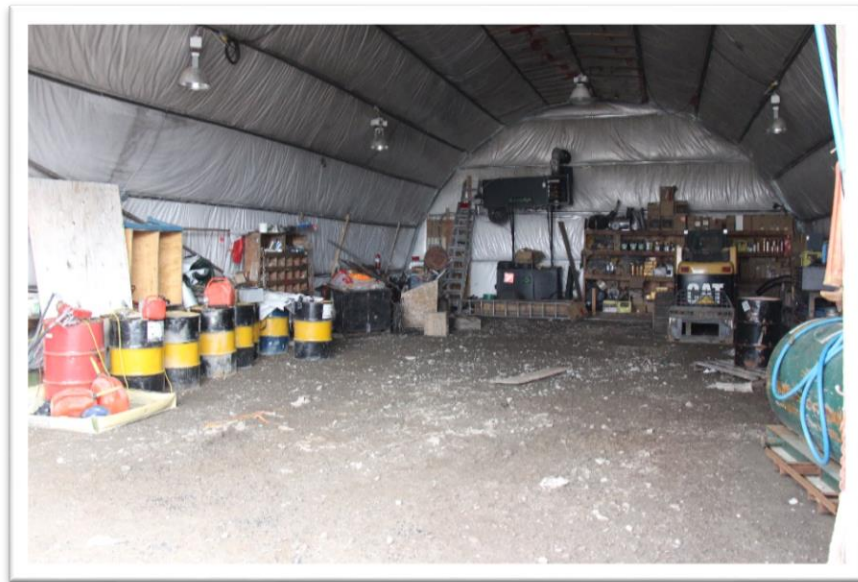
**Photo 77: Open Storage Building (George Lake)**
