Water Licence Inspection Report

On October 21st and 22nd, 2025 Resource Management Officer Kyle Amsel and Resource Management Officer James Bolt (Inspector) for Crown-Indigenous Relations and Northern Affairs Canada (CIRNAC) conducted an Inspection of Water Licence 2AM-BRP1831 (Licence) issued to B2 Gold Corp. for use of water and deposit of waste in support of a Mining Undertaking (Undertaking)

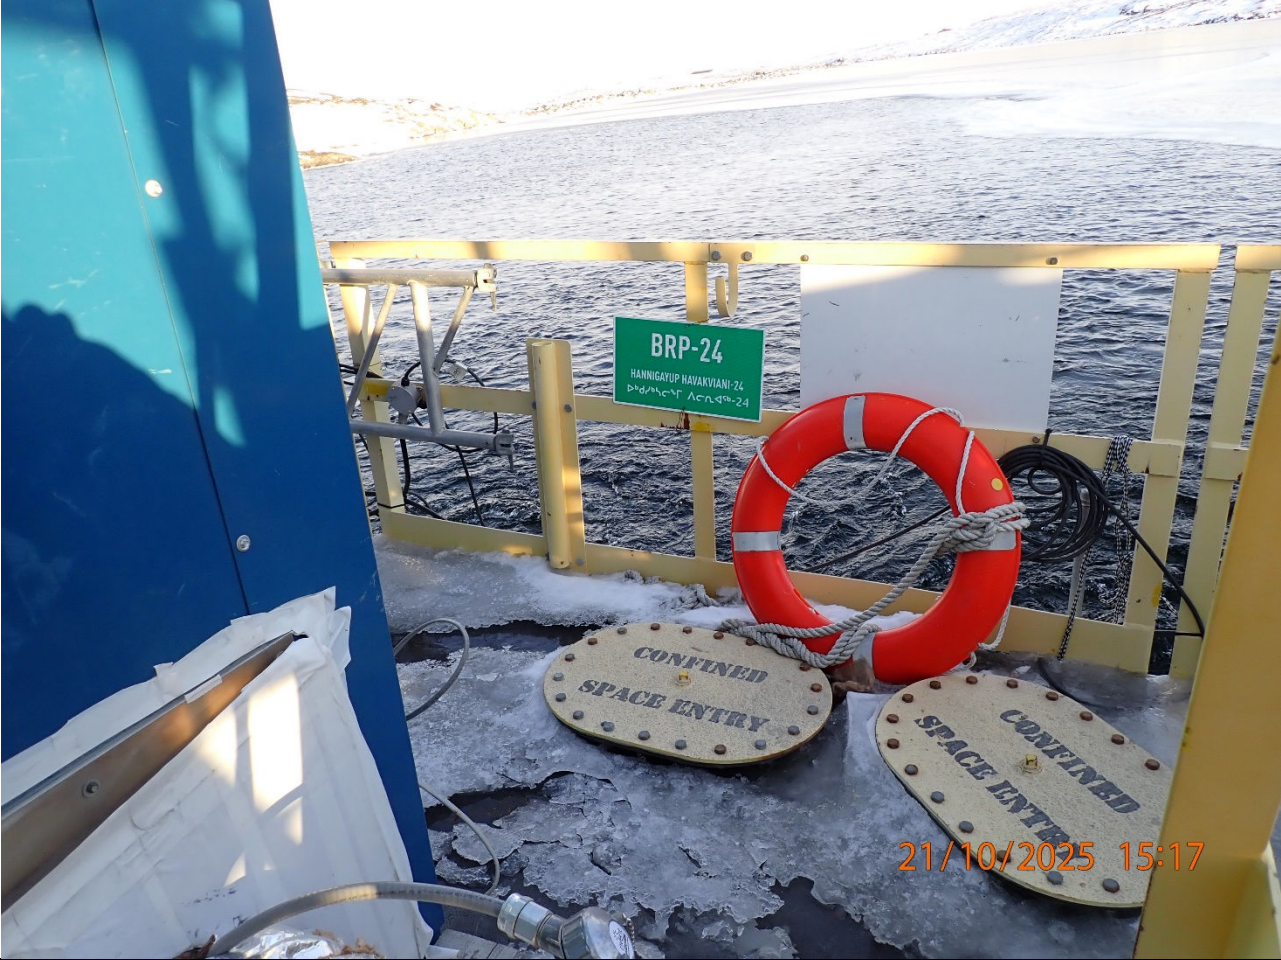
Date:	Authorization Number:	Camera/Model:	Inspector
Tuesday, October 21, 2025	2AM-BRP1831	Panasonic Coolpix	RMO Kyle Amsel
Photo No.	Lat/Long (DD.MM.SS.SS, NAD83)		
Photo 1	NA

b) The sample station sign required under Part I Item 7 is on the intake barge and water quality samples are taken directly in the lake. The Inspector notes that BRP-24 also has a volume metric for water consumption of the camp and an associated water meter which is located in a sea can on shore where a water header is located. A signs indicating the volume is recorded at this location must be installed to be compliant with Part I Item 7. (Photo 1 and 2)

Description:
Water Intake Barge at BRP-24.

-Part I Item 7, failure to sign sample station for volumetric monitoring component of BRP-24
