WATER LICENCE INSPECTION FORM

Licensee	Licensee Representative
Sabina Gold and Silver	Merle Keefe
Licence No. / Expiry	Representative's Title
2AM-BRP1831	Environmental permitting Manager
Land / Other Authorizations	Land / Other Authorizations
	--
Date of Inspection	Inspector
June 19, 2022	Jonathan MESHER
Activities Inspected	
<input checked="" type="checkbox"/> Camp	<input type="checkbox"/> Drilling
<input type="checkbox"/> Roads/Hauling	<input type="checkbox"/> Other:
<input checked="" type="checkbox"/> Mining	<input type="checkbox"/> Construction
	<input type="checkbox"/> Other:
	<input type="checkbox"/> Reclamation
	<input type="checkbox"/> Fuel Storage

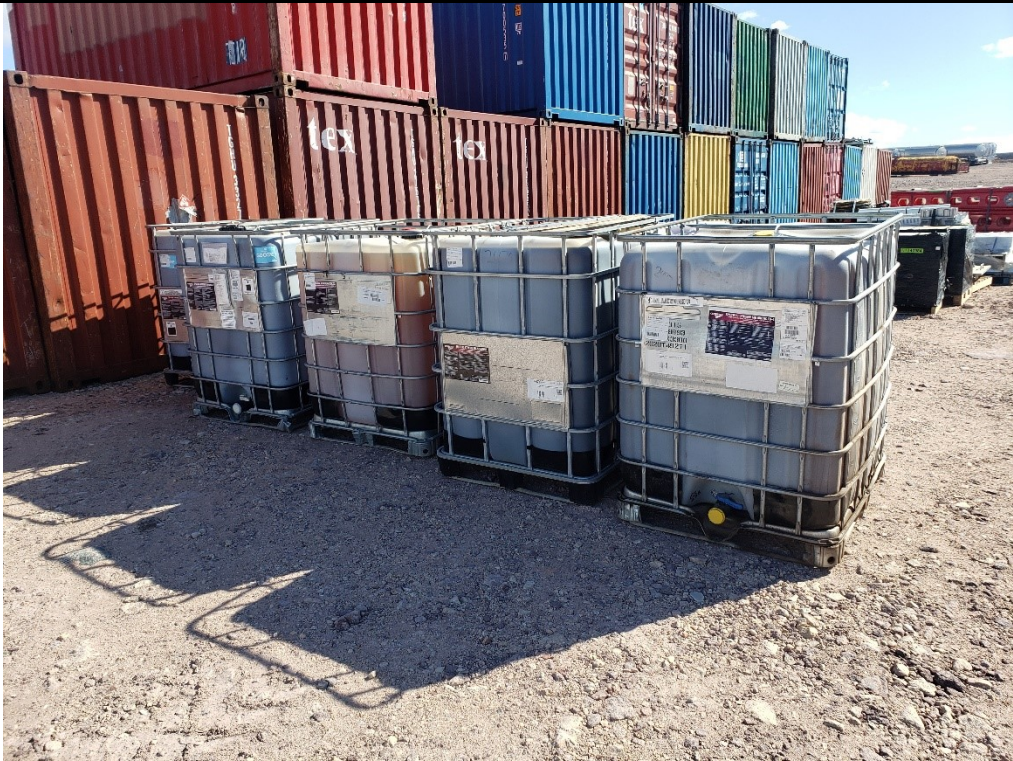
Date	Camera	Inspector	Authorization
June 19, 2022	Sony Cyber-shot	J.Mesher	2AM-BRP
Photoba Log			
Photo 1

Description: Hazardous material outside containment

1. The licensee is to ensure all hazardous material is kept within secondary containment.
2. The licensee is to ensure no waste/water resulting from washing vehicles is enter water and/or causing erosion.
3. The inspector is recommending that licensee install drip trays below the fuel tank noted in a, III.

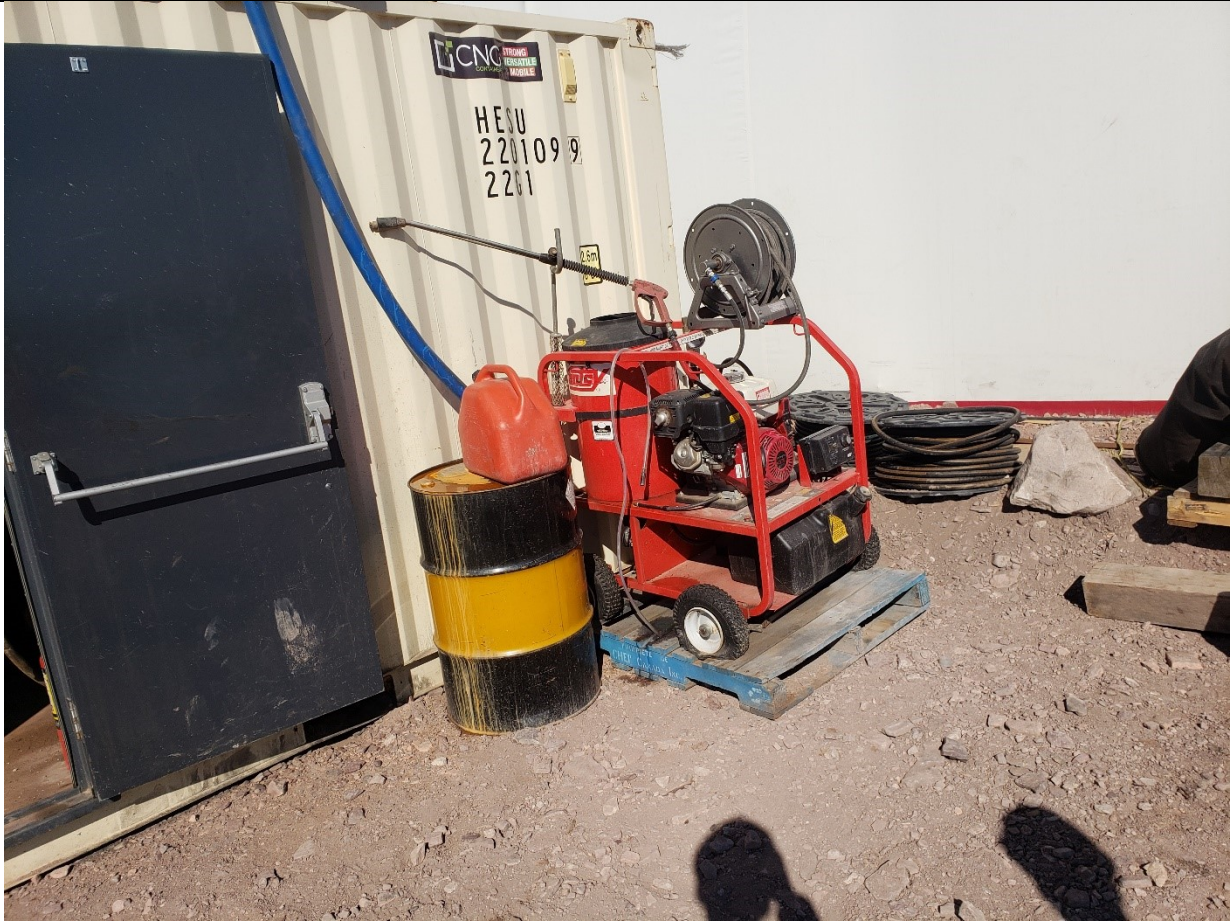
Date	Camera	Inspector	Authorization
June 19, 2022			
	Sony Cyber-shot	J.Mesher	2AM-BRP
Photo Log			
Photo 3

Description: Pressure washer.

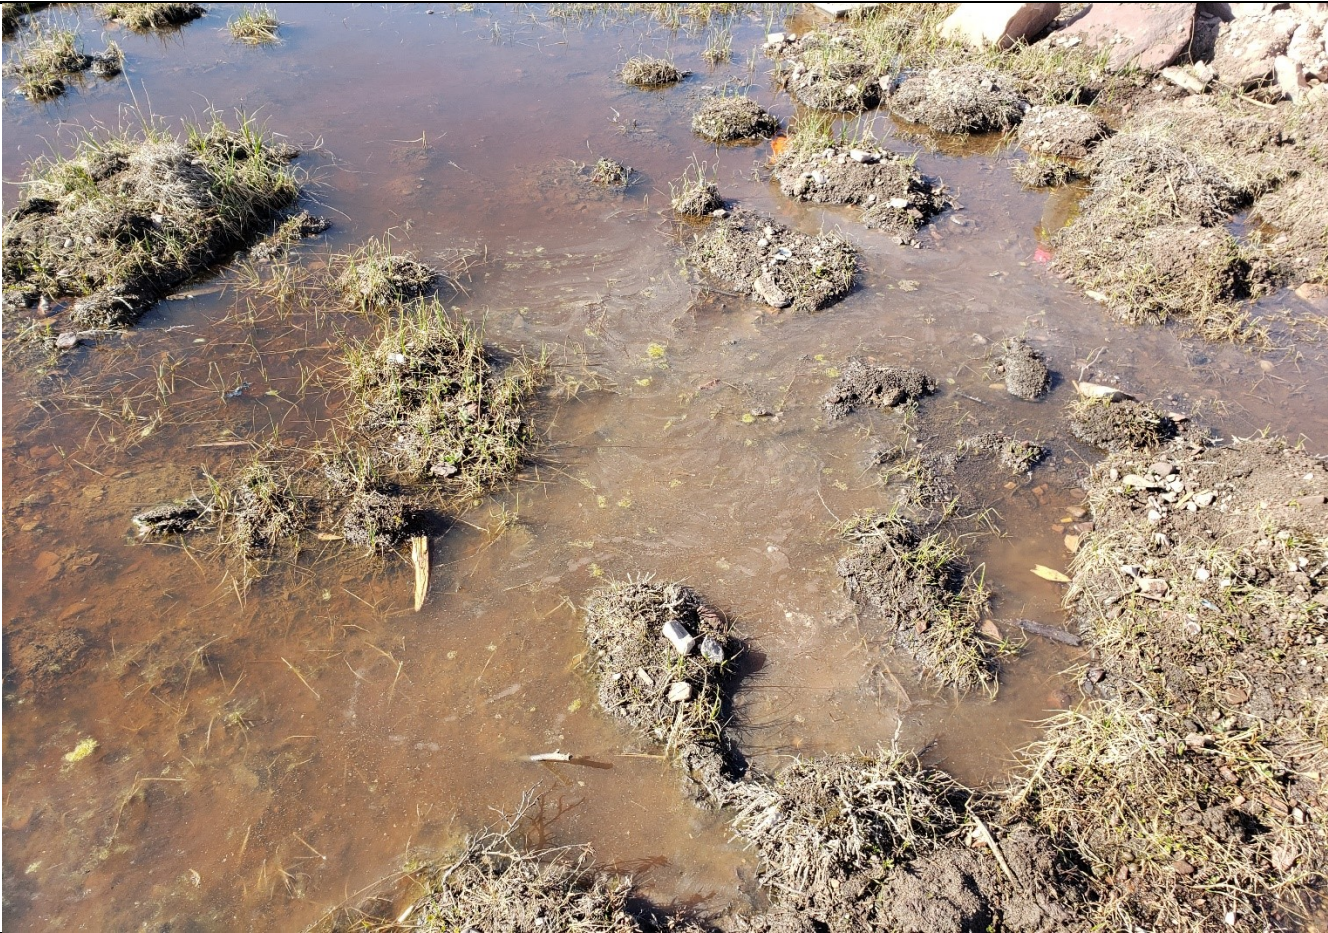
Photo 4

Description: potential oily sheen.

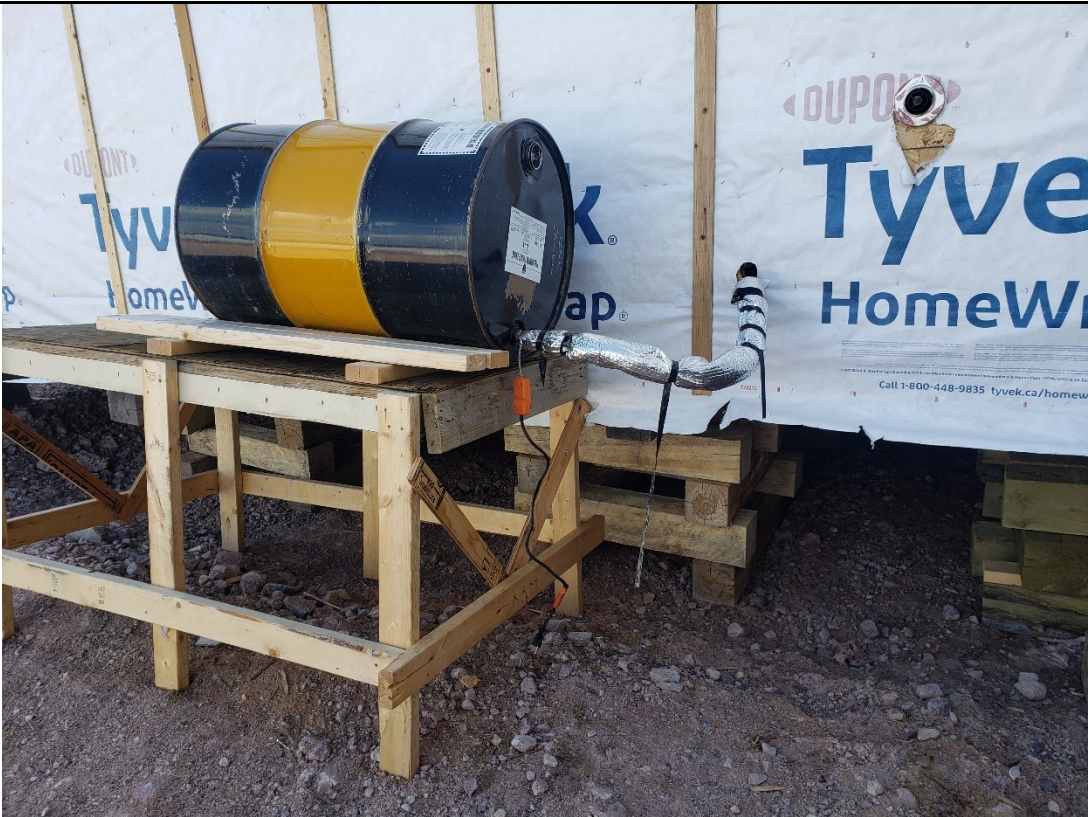
Photo 5

Description: Fuel tank without drip tray.
