Appendix A
2006 Bathymetry (Golder Associates)

BATHYMETRIC SURVEYS HOPE BAY PROJECT HOPE BAY, NUNAVUT

06-1419-007

Phase III Foundation Investigation Proposed Roberts Bay Jetty Location, Doris North Project, Nunavut, Canada

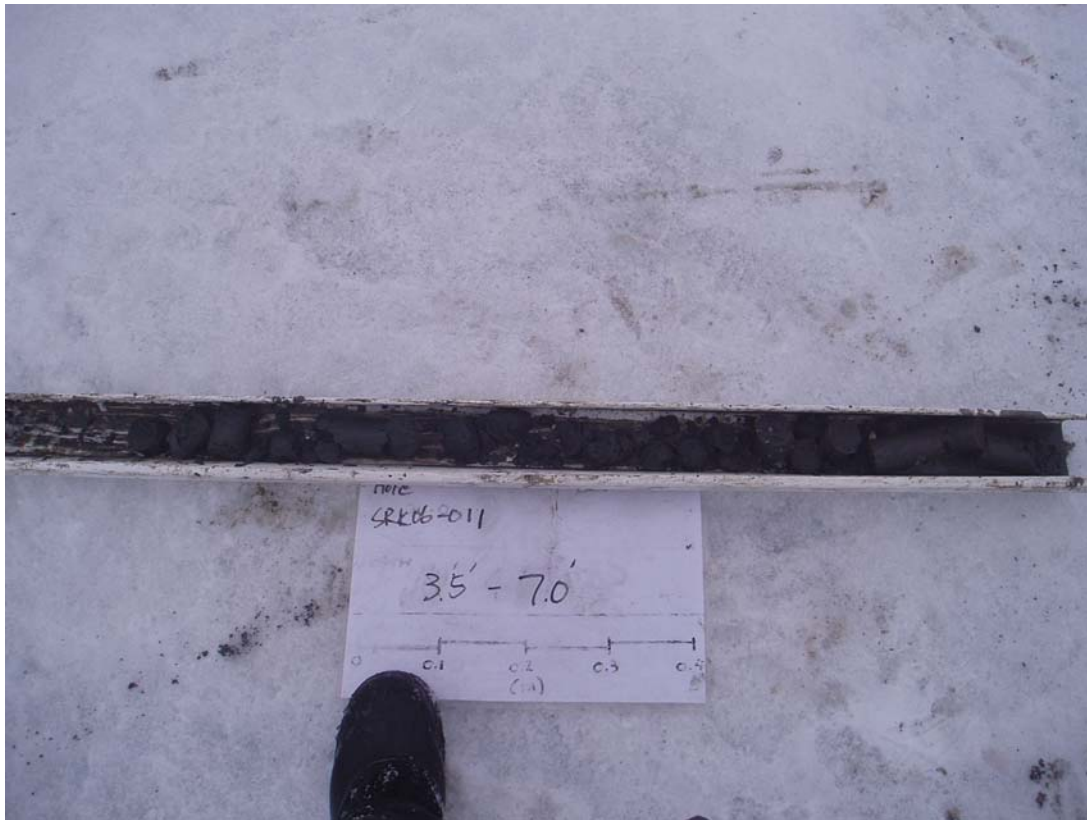
Photo 1: SRK06-11, 3.5' - 7.0' (1.07m - 2.13m)

The sea ice at this hole was about 1.07 m thick. The sea ice was frozen to the bed sediments. The surface sediments consist of a layer of sand and gravel. The drill system used for this program is not well suited to penetrate this type of stratigraphy, and as a result the hole was terminated, before the base of the sand zone was found. Sample recovery in this hole was 100%.

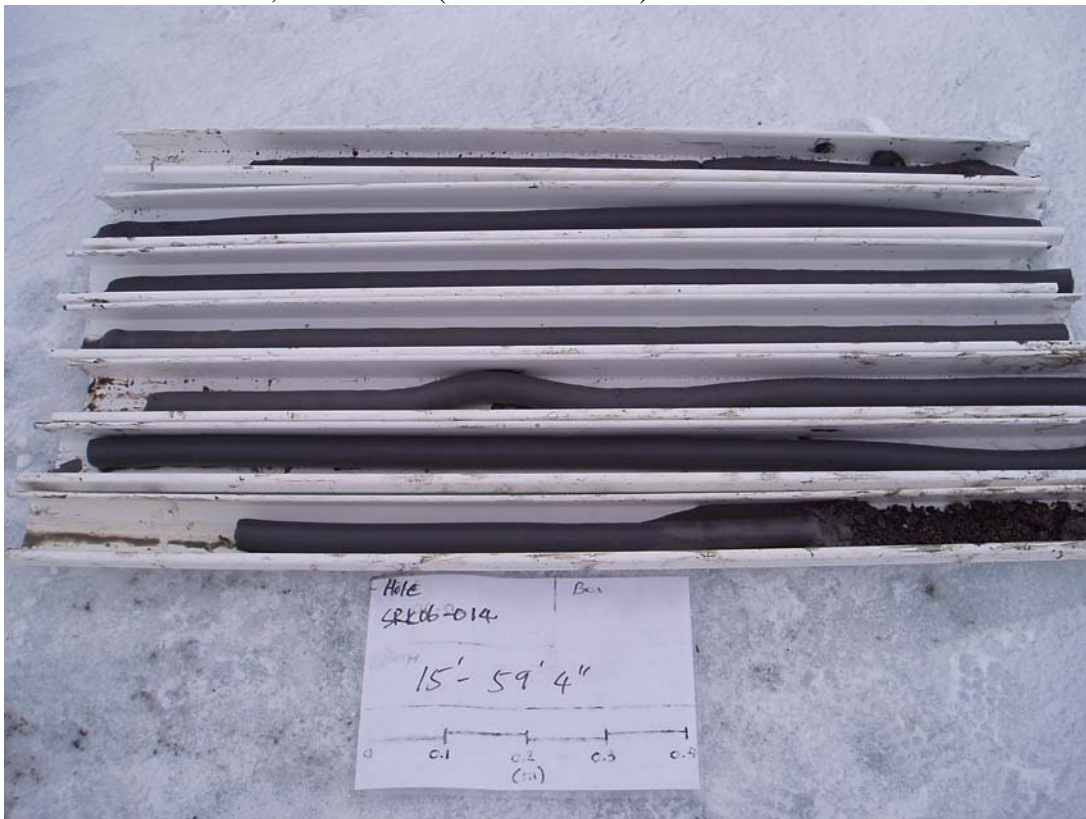
Photo 4: SRK06-14, 15.0' – 59.4' (4.57m – 18.07m)

The sea ice at this hole was about 1.83 m thick, overlying about 2.74 m of unfrozen seawater. The silty clay in this hole was found between 4.57 m to 17.68 m, overlying a sand layer. Drill refusal was encountered about 0.46 m into the sand layer. Sample recovery in this hole was again 100%.

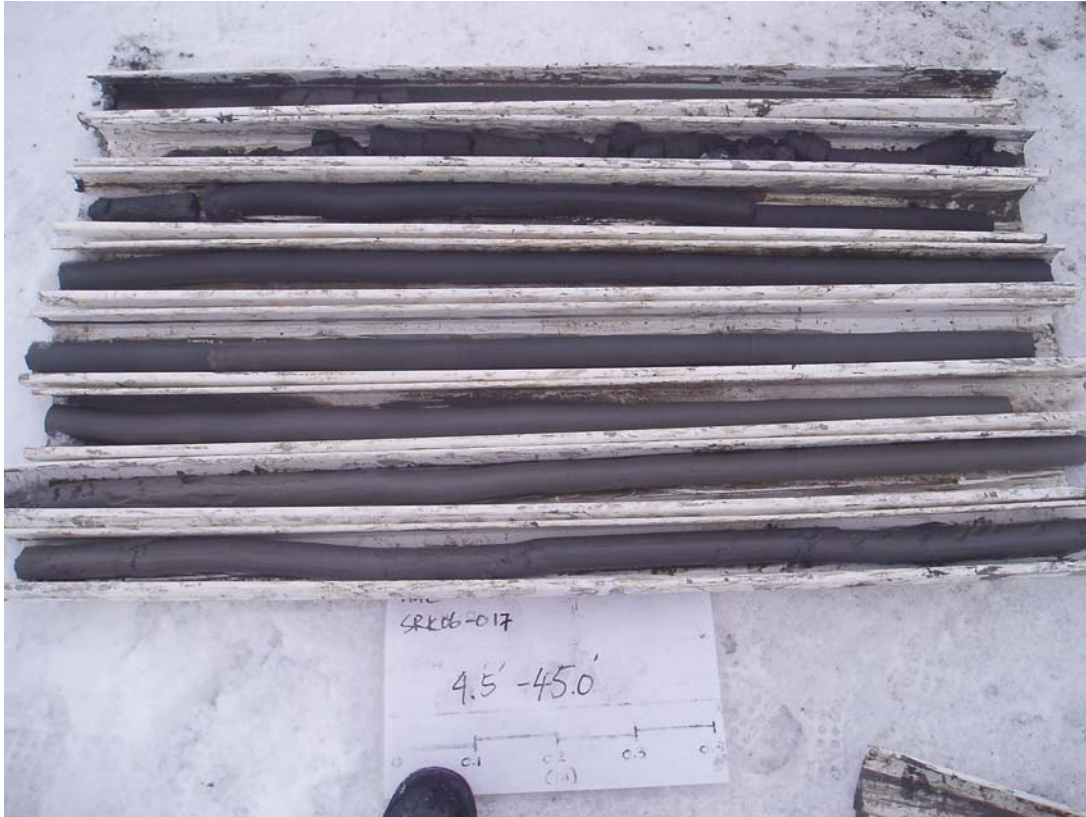
Photo 7: SRK06-17, 4.5' – 45.0' (1.37m – 13.72m)

Sea ice in this hole was only about 1.37 m thick, and extended directly onto the sediments. The surface sediments consist of a layer of sand and gravel from 1.37 m to 3.81 m underlain by 9.91 m of silty clay. Drill refusal was encountered at the base of the silty clay layer; however, it was not clear whether refusal was due to the presence of bedrock or frozen soil. Ice lenses were observed in the silty clay between 9.60 m and 13.72 m, with the ice content about 10%. Recovery in this hole was 100%.

Based on the current drill hole results it would appear as if the deep sand pocket observed in SRK45 during the April 2004 program, which was always questioned, may not be present. Based on the profile found in SRK06-17, it would appear as if there is a thin layer of sand that occasionally overlies the silt and clay layer; however, it is not likely to be more than a couple of meters thick and is likely present as a result of continuously moving shoreline processes.

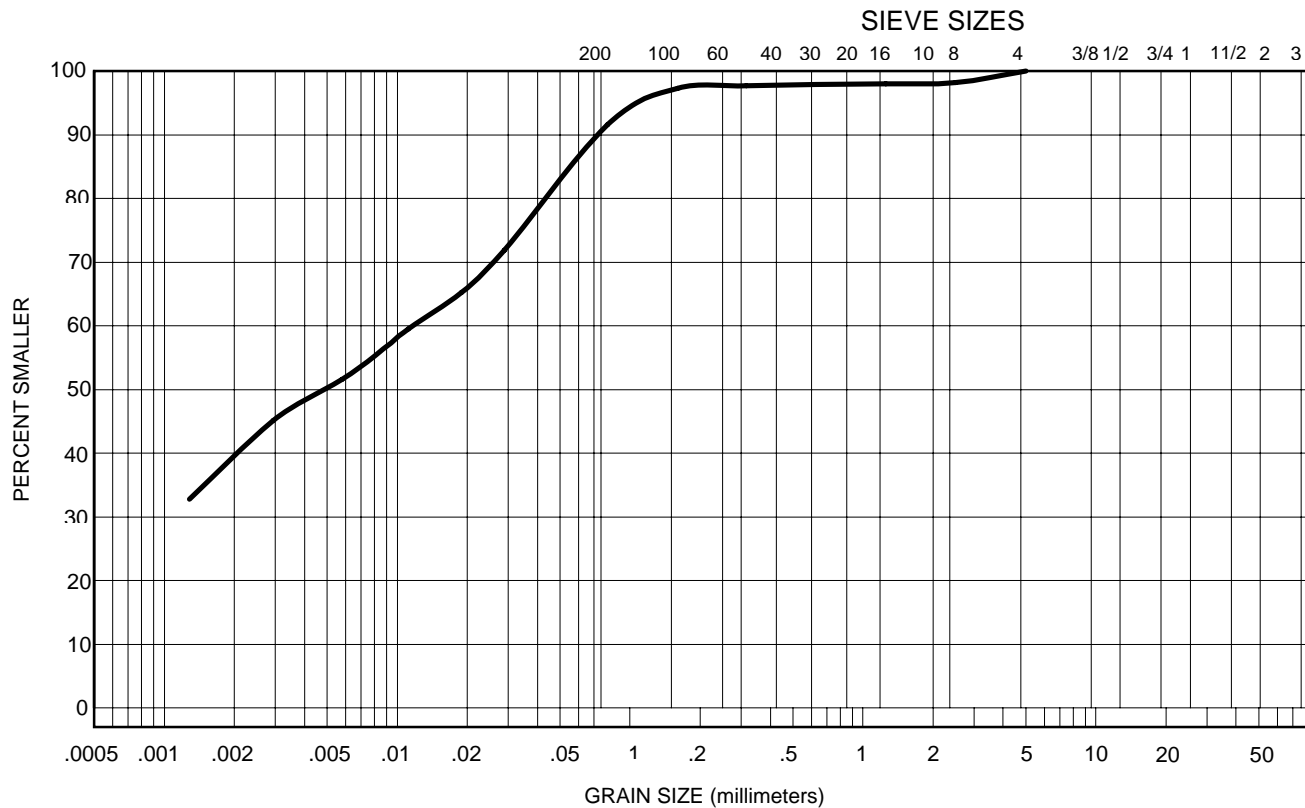
Natural Moisture Content: 46.5%

SIEVE, mm	PERCENTAGE PASSING
5.00	100
2.5	98
1.25	98
0.630	98
0.315	98
0.160	97
0.08	92
0.029	72
0.019	65
0.0112	59
0.0081	55
0.0058	52
0.0029	45
0.0013	33

CLAY	SILT	SAND			GRAVEL	
		FINE	MEDIUM	COARSE	FINE	COARSE

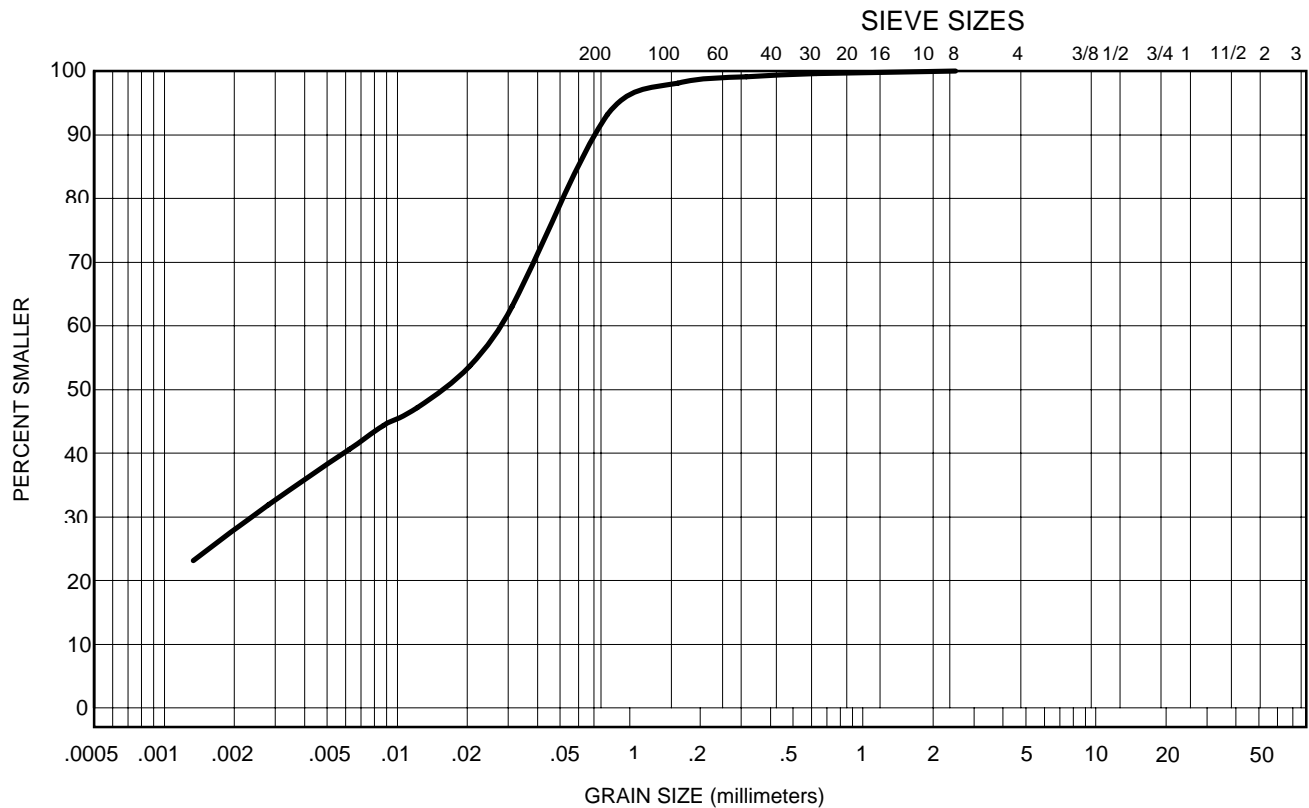
Natural Moisture Content: 43.8%

SIEVE	PERCENTAGE PASSING
2.5	
1.25	
0.630	100
0.315	99
0.160	98
0.08	93
0.031	63
0.021	54
0.0122	47
0.0087	44
0.0063	41
0.0028	32
0.0013	23

CLAY	SILT	SAND			GRAVEL	
		FINE	MEDIUM	COARSE	FINE	COARSE

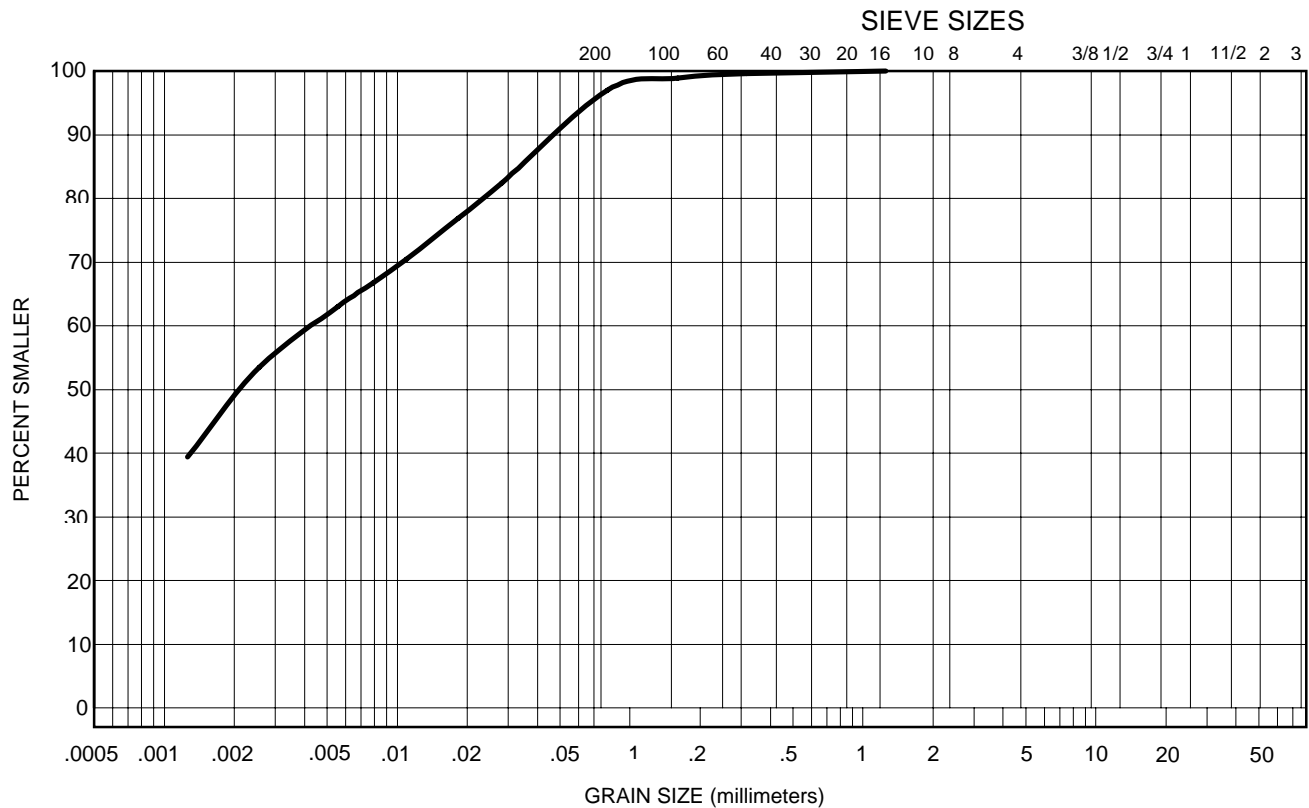
Natural Moisture Content: 49.2%

SIEVE, mm	PERCENTAGE PASSING
2.5	
1.25	
0.630	
0.315	100
0.160	99
0.08	97
0.028	82
0.018	77
0.0109	70
0.0079	67
0.0056	63
0.0026	54
0.0013	39

CLAY	SILT	SAND			GRAVEL	
		FINE	MEDIUM	COARSE	FINE	COARSE

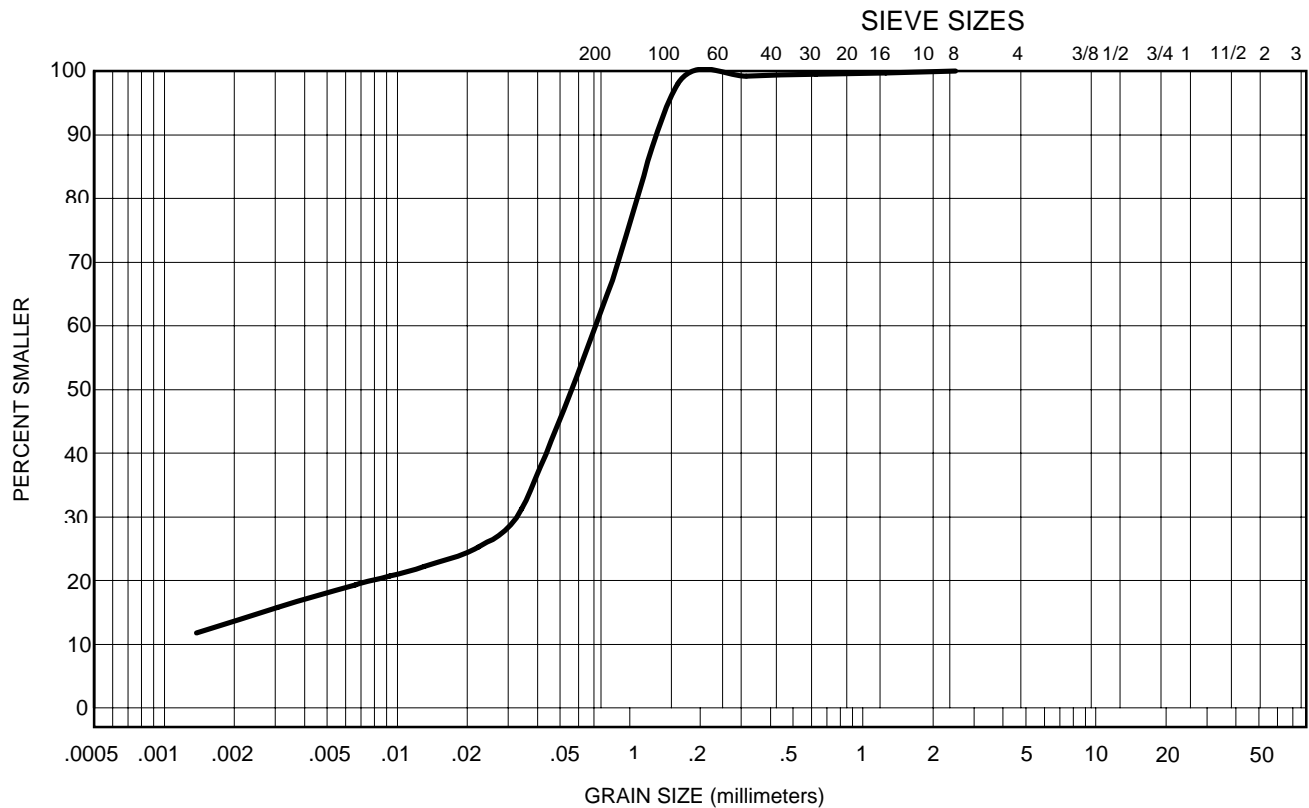
Natural Moisture Content: 27.2%

SIEVE, mm	PERCENTAGE PASSING
2.5	
1.25	
0.630	100
0.315	99
0.160	98
0.08	65
0.034	31
0.022	25
0.0131	22
0.0093	21
0.0066	19
0.0031	16
0.0014	12

CLAY	SILT	SAND			GRAVEL	
		FINE	MEDIUM	COARSE	FINE	COARSE

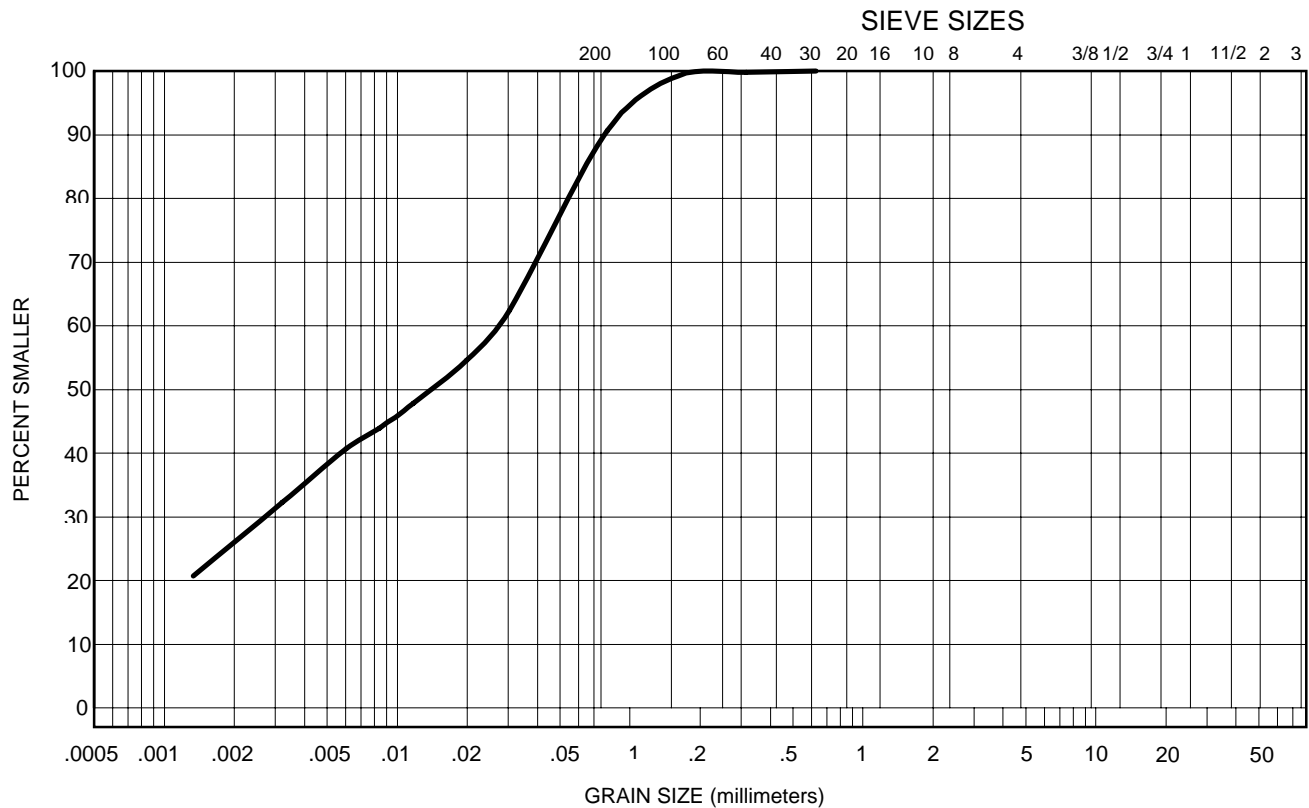
Natural Moisture Content: 43.3%

SIEVE	PERCENTAGE PASSING
2.5	
1.25	
0.630	
0.315	100
0.160	99
0.08	91
0.030	62
0.020	55
0.0117	48
0.0084	44
0.0061	41
0.0032	32
0.0013	21

CLAY	SILT	SAND			GRAVEL	
		FINE	MEDIUM	COARSE	FINE	COARSE

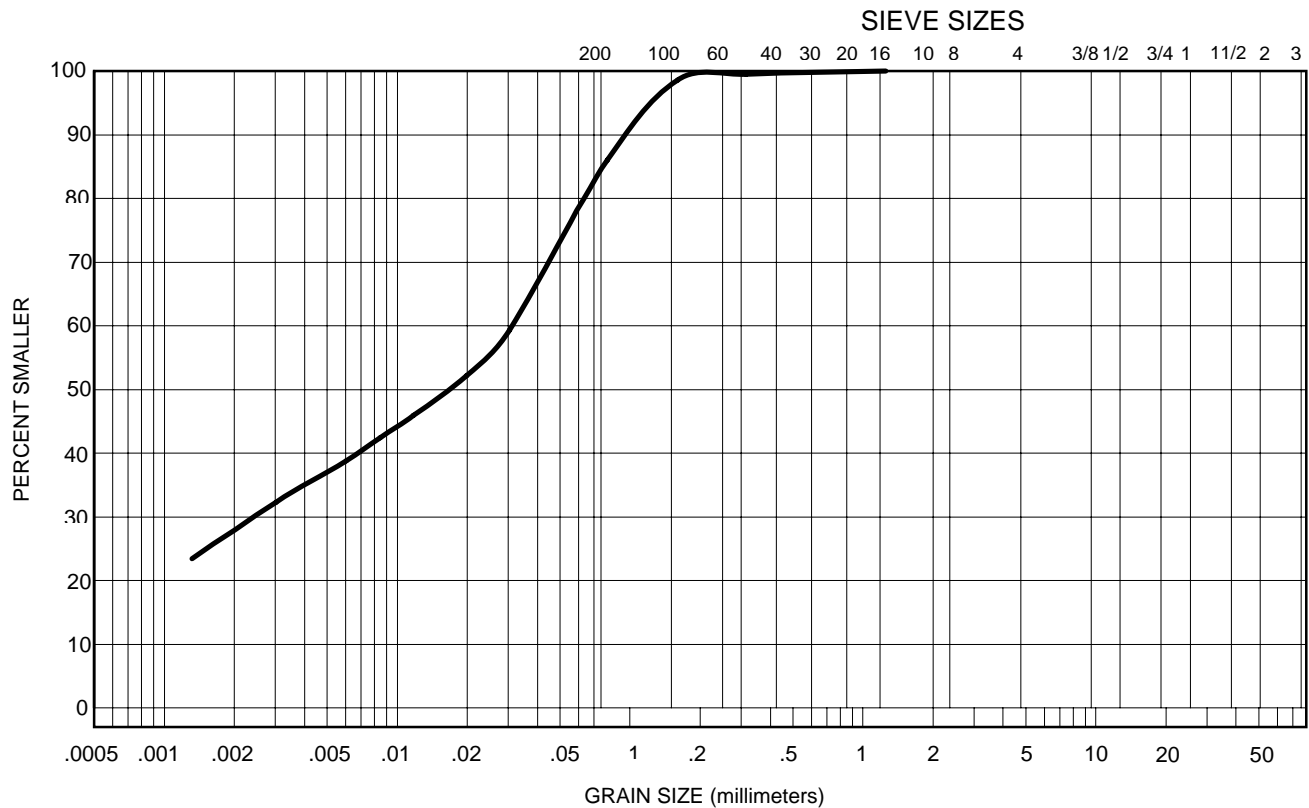
Natural Moisture Content: 37.3%

SIEVE	PERCENTAGE PASSING
2.5	
1.25	
0.630	100
0.315	99
0.160	99
0.08	86
0.030	59
0.020	52
0.0118	46
0.0084	42
0.0061	39
0.0030	32
0.0013	23

CLAY	SILT	SAND			GRAVEL	
		FINE	MEDIUM	COARSE	FINE	COARSE

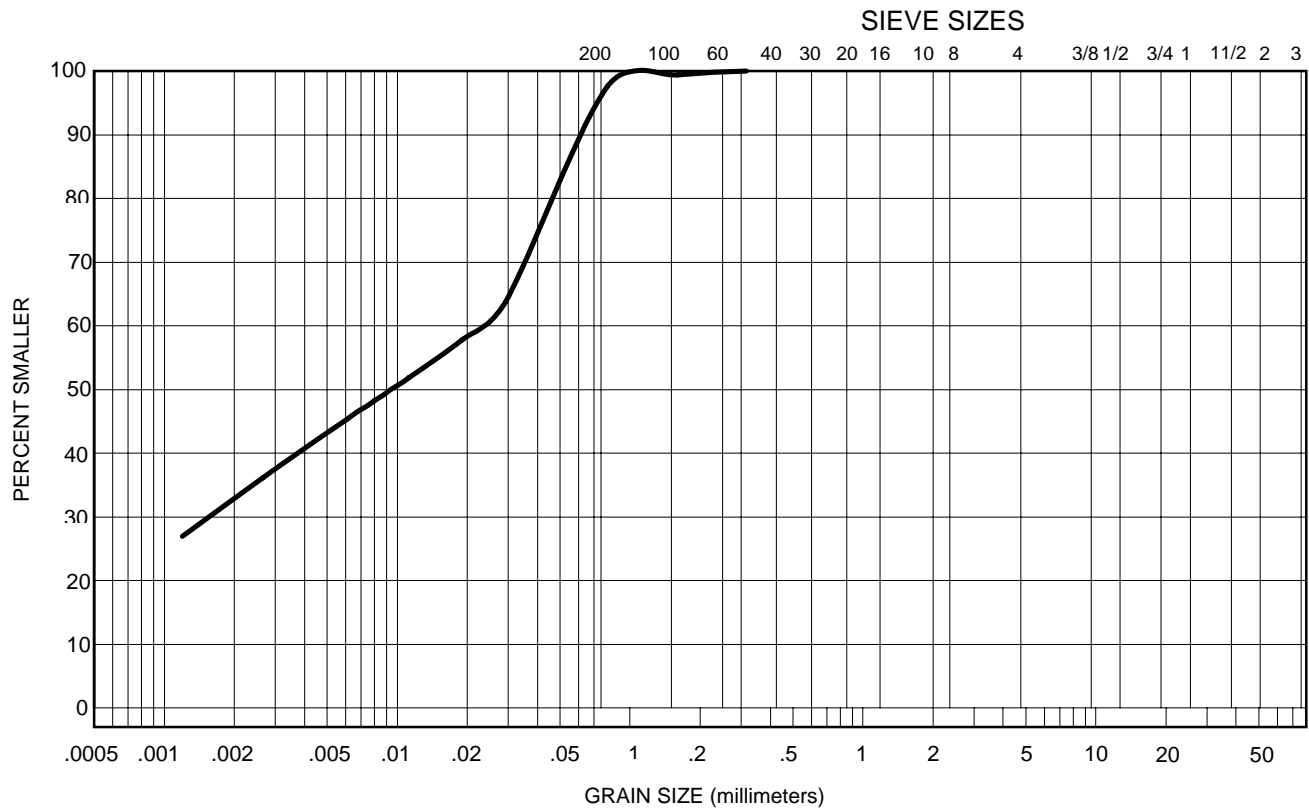
Natural Moisture Content: 43.4%

SIEVE	PERCENTAGE PASSING
2.5	
1.25	
0.630	
0.315	100
0.160	99
0.08	98
0.029	64
0.019	58
0.0112	52
0.0080	48
0.0057	45
0.0026	36
0.0012	27

CLAY	SILT	SAND			GRAVEL	
		FINE	MEDIUM	COARSE	FINE	COARSE
