Design of the Surface Infrastructure Components Doris North Project, Hope Bay, Nunavut, Canada

SRK Project No. 1CM014.008.420

March 2007

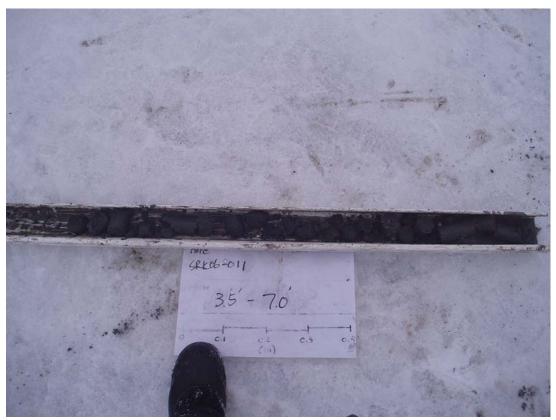
Photo 1: SRK06-11, 3.5' – 7.0' (1.07m – 2.13m)

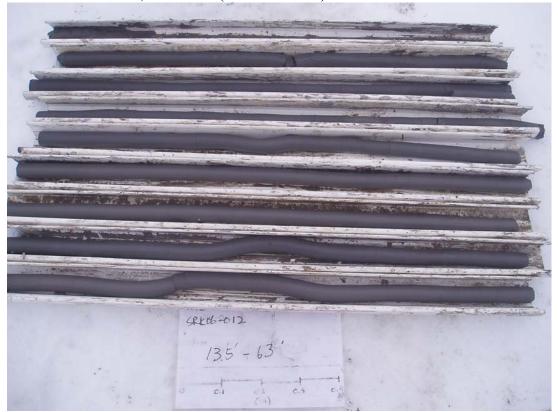
Photo 2: SRK06-12, 13.5' - 63.0' (3.96m - 19.20m)

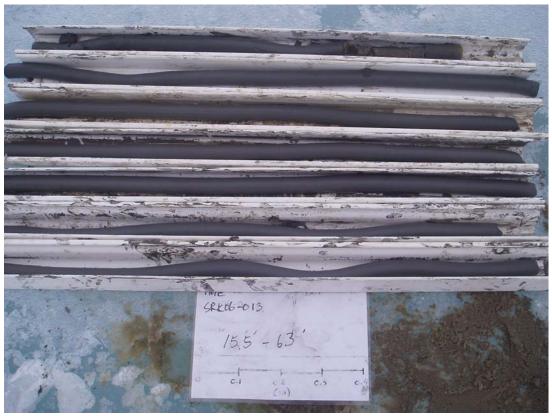
Photo 3: SRK06-13, 15.5' - 63' (4.72m - 19.2m)

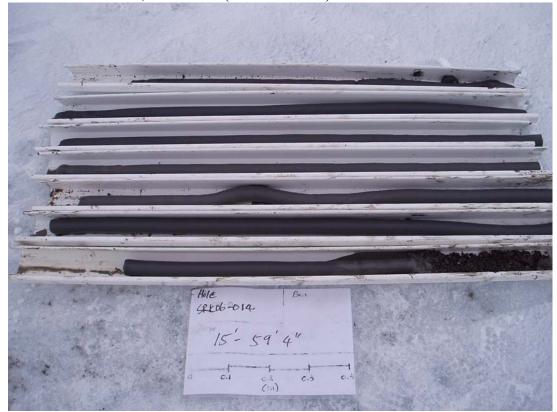
Photo 4: SRK06-14, 15.0' – 59.4' (4.57m – 18.07m)

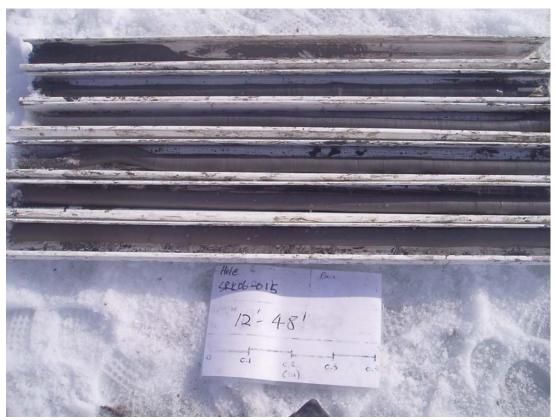
Photo 5: SRK06-15, 12' - 48' (3.66m - 7.62)

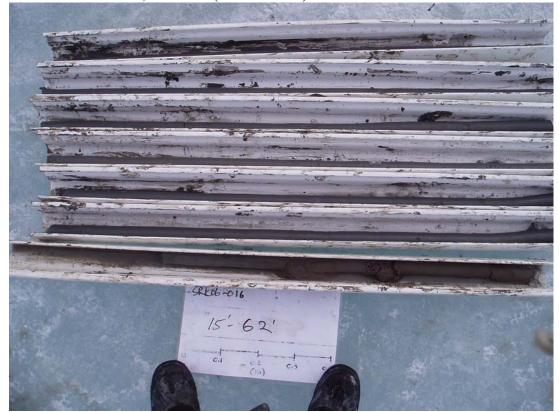
Photo 6: SRK06-16, 15' - 62' (4.57m - 18.14m)

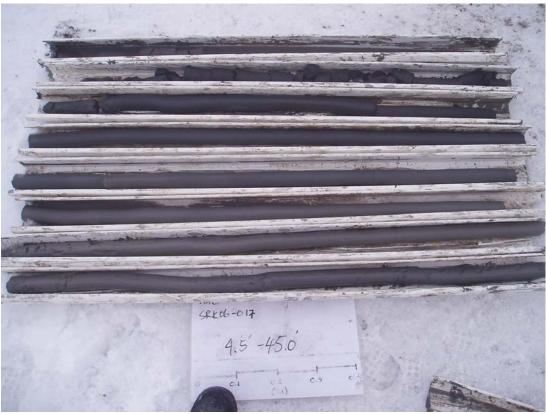
Photo 7: SRK06-17, 4.5' - 45.0' (1.37m - 13.72m)

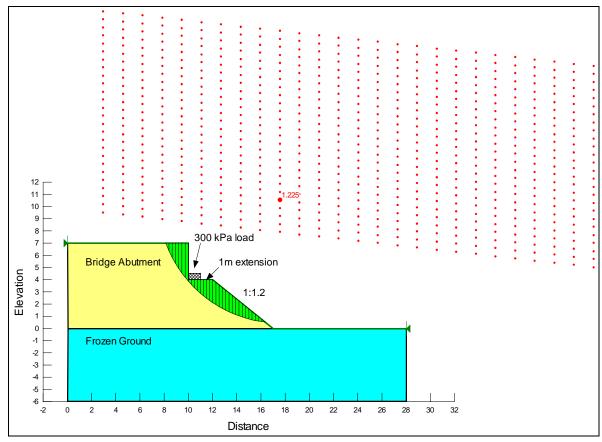
An initial abutment was analyzed, as illustrated in Figure 1. For this configuration the FOS is less than 1.5. Using these dimensions as the baseline, additional sensitivity runs were carried out to determine an optimized configuration that would yield a FOS greater than 2. The variables tested in the sensitivity analysis were:

- Width of the shelf that the sill sits on (vary from 2 m to 3 m)
- Slope of the abutment (vary from 1:1.2 to 1:2)
- Height of the abutment (vary from 4 m to 2 m)
- Width of the footing (vary from 1 m to 1.5 m)
- Embedment of the sill (vary from 0 m to 1 m)

Figure 1: Baseline abutment design

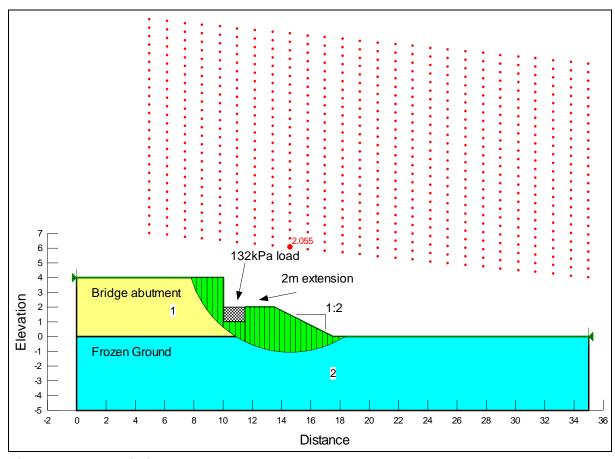
The optimized abutment configuration, which has a FOS greater than 2 are listed below and illustrated in Figure 2.

- Width of the shelf that the sill sits on = 3 m
- The slope of the abutment = 1:2
- The height of the abutment = 2 m
- The width of the footing = 1.5 m
- The embedment of the sill = 1 m

Figure 2: Optimized abutment

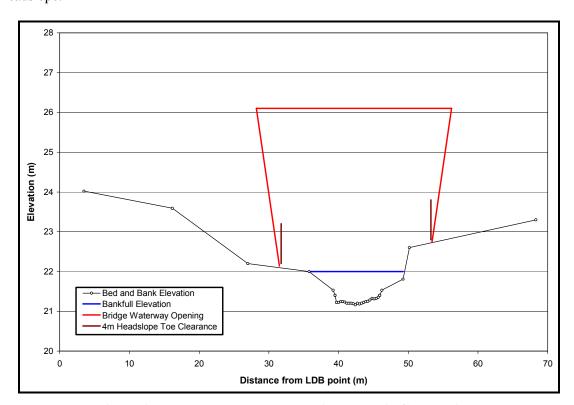
The proposed waterway opening at the bridge is shown in Figure 1. The channel at the crossing has a bed elevation of 21.16 m, maximum bankfull depth of 0.84 m and a bankfull width of 13.5 m. The proposed bridge opening allows for a 4.1 m vertical clearance from the bankfull elevation to the lower stringer of the bridge structure. Based on a lower stringer clear span of 26 m and 1.2H:1V headslopes, this provides approximately 4 m of clearance from the top of bank to the toe of each headslope.

Figure 1 – Proposed waterway opening at Doris Creek bridge

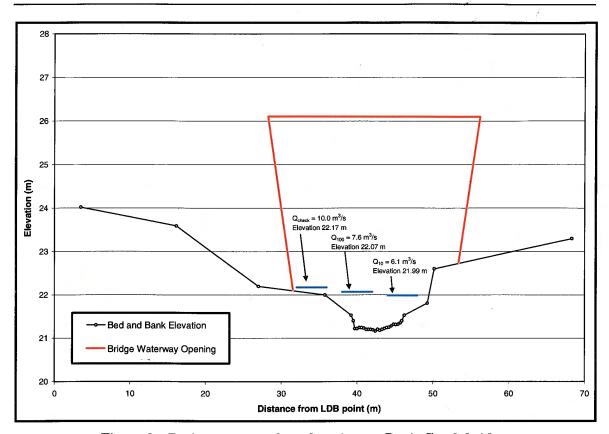
The observed historical high water elevation of 22.2 m at the crossing compares well to the observed lake high water mark elevation of 22.27 m, as it is expected that there would be some drop in elevation from the lake water surface to the downstream channel. Thus, the calculated design water surface elevation and velocities presented in Table 5 are recommended for bridge design purposes. Corresponding water surface elevations are shown on Figure 2.

Figure 2 – Design water surface elevations at Doris Creek bridge

Given that the bridge will span the channel with several metres of setback from the top of bank to the toe of the headslope fill, and that mean channel velocities are expected to be on the order of only 1 m/s, no in-channel erosion protection is recommended for this bridge crossing.

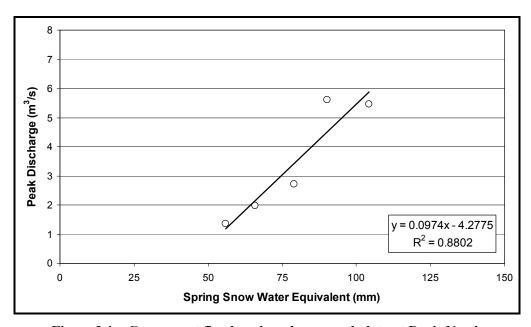
Figure I-1 – Concurrent flood peak and snowpack data at Doris North

Snow water equivalents were estimated based on the derived snowfall record presented by AMEC (2003). Each annual snowfall depth was corrected for undercatch by multiplying by a factor of 1.71, as estimated by AMEC (2003), and further corrected for sublimation by multiplying by a factor of 0.70.

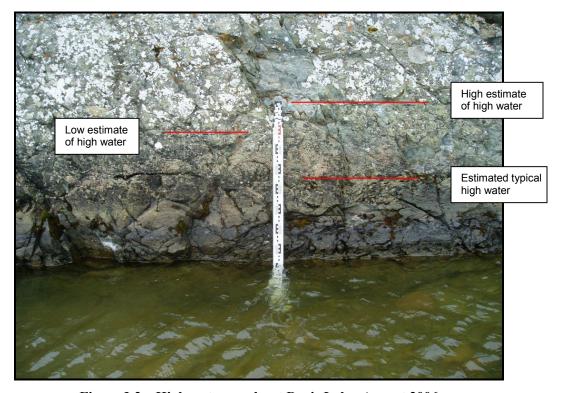
During field work in August 2006, high water marks were observed on a rock face located approximately 100 m south of the Doris Lake hydrometric station. A photograph taken that day is shown in Figure I-2, and elevation and discharge estimates, tied in on the basis of lake water surface elevation data and the lake outlet rating curve, are provided in Table I-4.

Figure I-2 – High water marks at Doris Lake, August 2006
