Project: Doris North Gold Mine Project

Visit conducted by: Li Wan: NIRB's Monitoring Officer
George Taptuna: NIRB's Assistant Technical Advisor

Date of visit: August 18, 2009

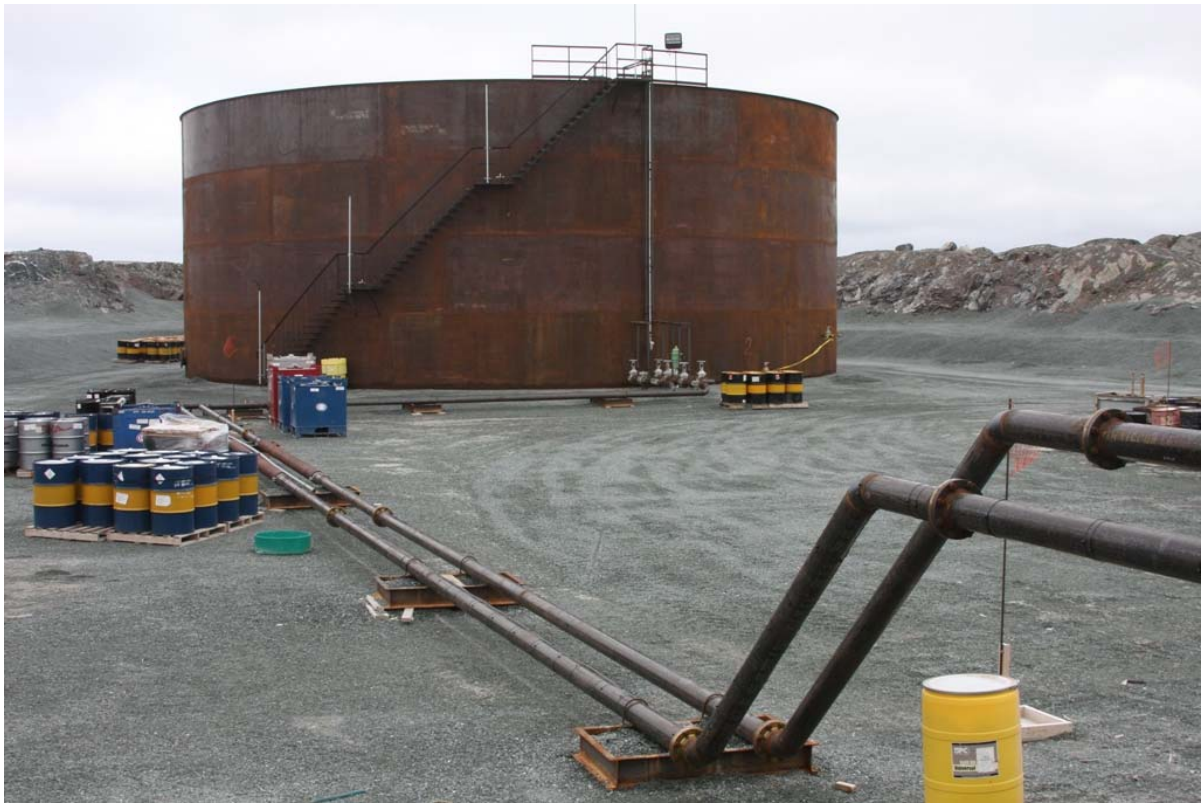
Figure 3. Fuel Tank (5 million liter) at the former Quarry #1 site near Roberts Bay

A 5 million L fuel tank made of carbon steel has been installed in a tank farm within the former Quarry #1 with pipelines connecting it to the pump station (see Figure 3). A secondary berm, with a 110% containment capacity of the fuel tank, has been installed surrounding the fuel tank. An impermeable lining was buried about 0.3 metres (m) under the surface of crushed granular materials within the secondary containment berm. The fuel tank is registered through Indian and Northern Affairs Canada (INAC). The facilities have been in operation since 2008 upon the completion of construction, and have been operating properly (no fuel spills to date).

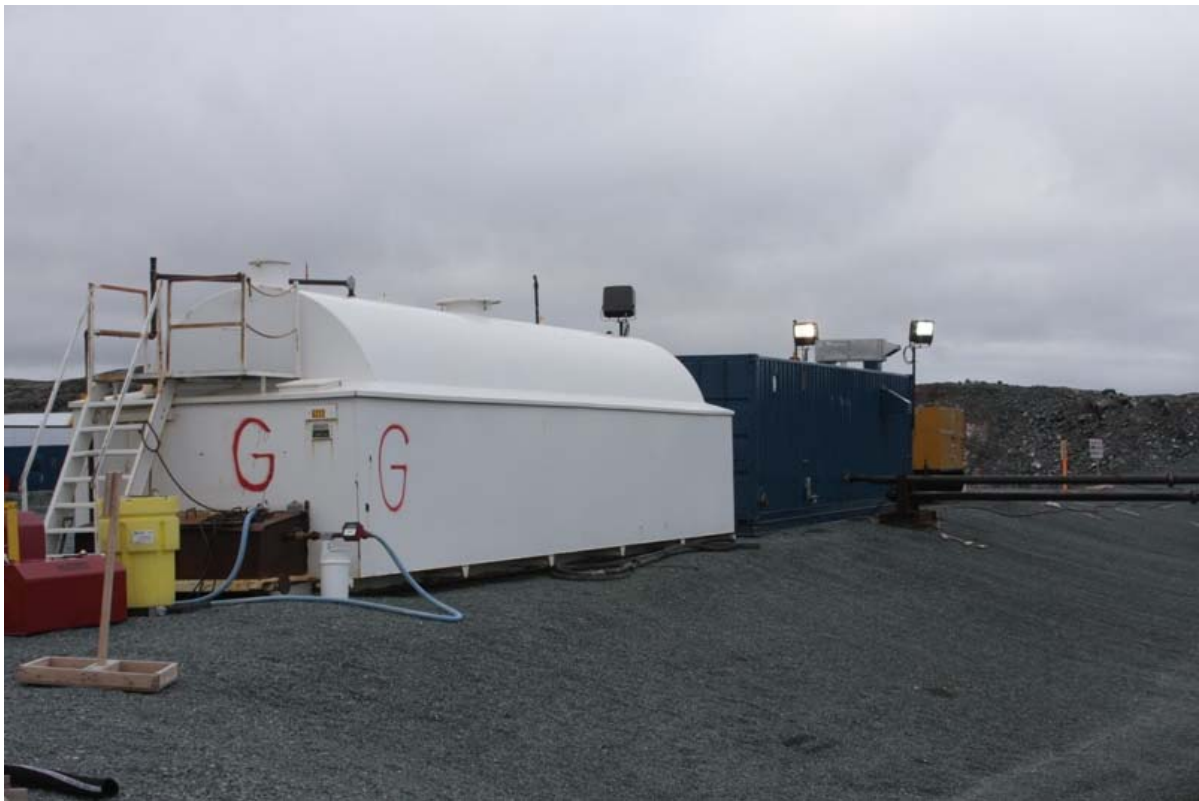
Figure 4. Fuel transfer station and containers beside the fuel tank at Robert Bay

Fuel is pumped from a barge/container through a specifically designed hose system by NTCL. Proper equipment was on site in accordance with NTCL procedures and HBML's Emergency Response/Spill and General Contingency Plan during the transfer of fuel. According to the HBML site personnel during the site visit, booms are deployed and trained personal was at the transfer point throughout the entire operation. This was observed during last year's site visit when fuel was transferred from a barge to an on-shore facility.

The Oil Handling Facility in Roberts Bay has to comply with *Canada Shipping Act* as indicated by TC in correspondence dated July 28, 2008. HBML regards this as the responsibility of it's the oil shipping contractor (NTCL) before the fuel is transferred into HBML's fuel tank. HBML has discussed this issue with NTCL to confirm that NTCL has in place all of the pollution prevention and response plans required by TC under the *Canada Shipping Act*, Part 8 and under the Regulations. HBML is continuing to follow up with NTCL with respect to these requirements. Further communication between HBML and TC may be necessary to determine which company should be responsible for this regulatory requirement.

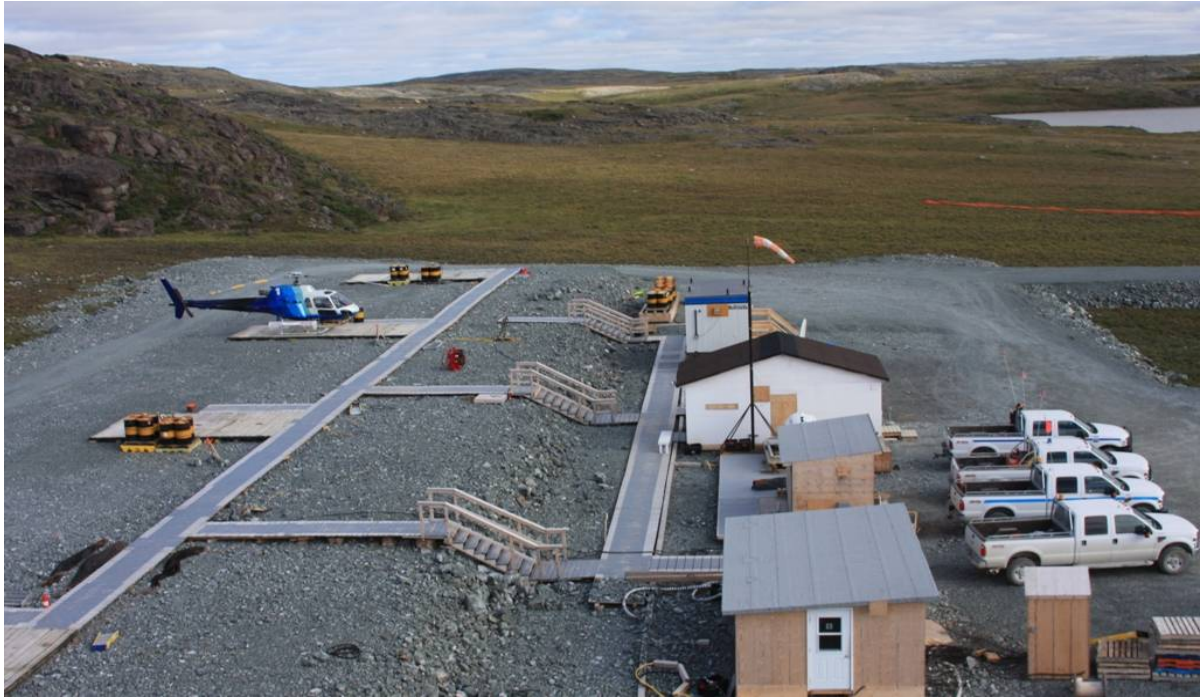
Figure 7. Helicopter pads at original construction site at Doris North

The original construction camp (Matrix Camp) has been demolished and the site has been modified into helicopter pads, with associated communication and office facilities for helicopter operation.

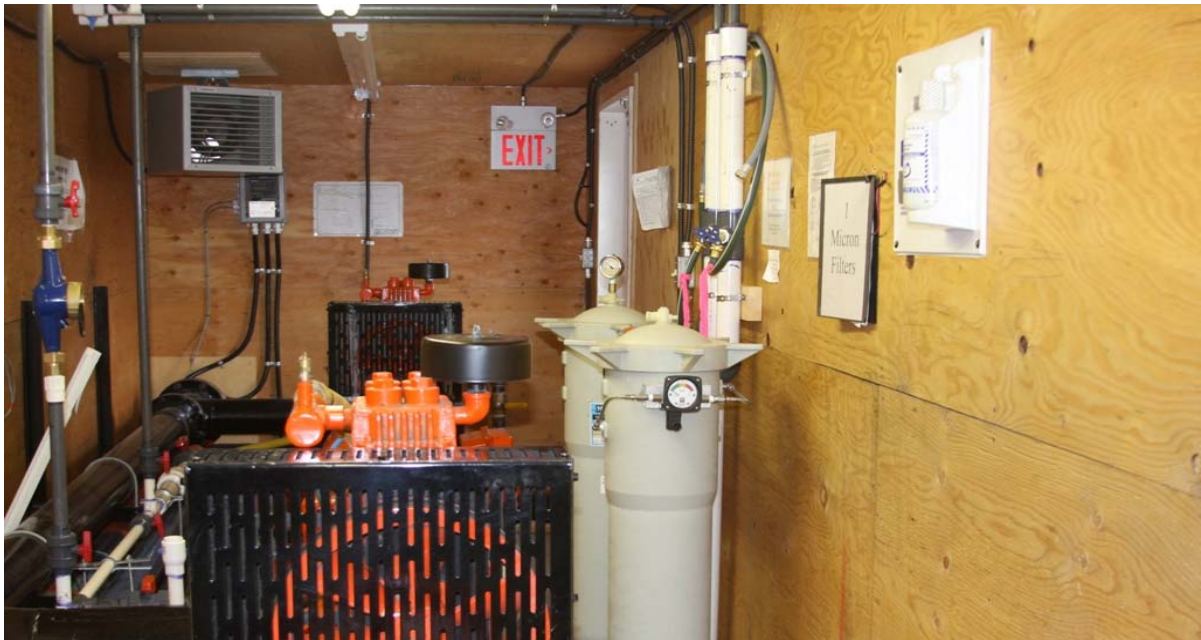
Figure 8. Potable water pump house at Doris Lake shore

Potable water is taken from Doris Lake by a floating device and pumped to the Doris North camp through a water pump house located on the north shore of Doris Lake. A permanent potable water pipeline with insulation and heat tracing routes have been installed along the all-weather road from Doris Lake to the Doris North camp site. All facilities have been in operation and in good condition.

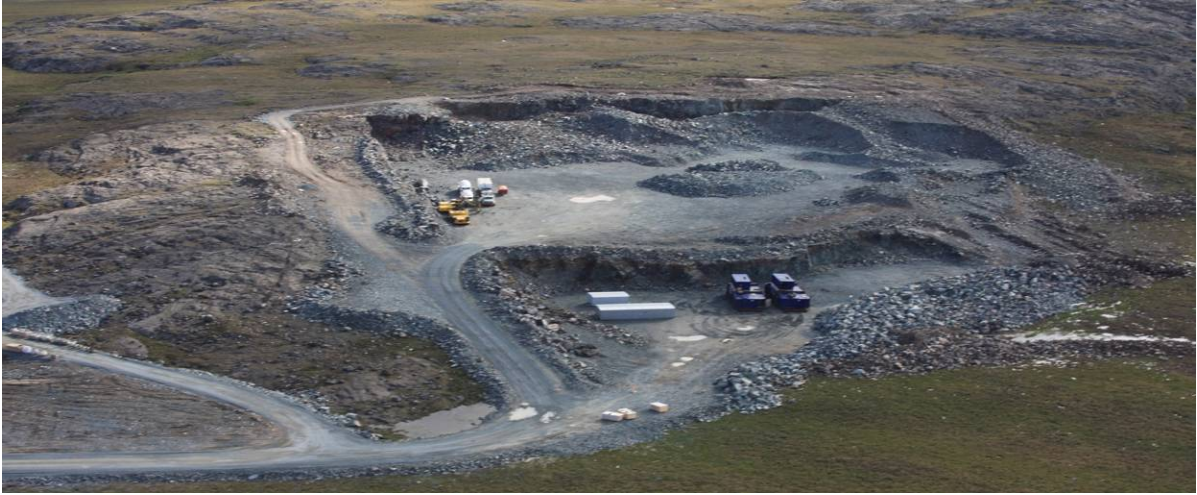
Figure 9. Quarry #2

Quarry #2 is still in full operation, with quarry material being extracted and transported to a nearby facility for crushing and classification of rock fines. This quarry provides granular materials for all site construction. During this site visit, Quarry #2 was well organized. All wastes were properly segregated and stored appropriately at the site.

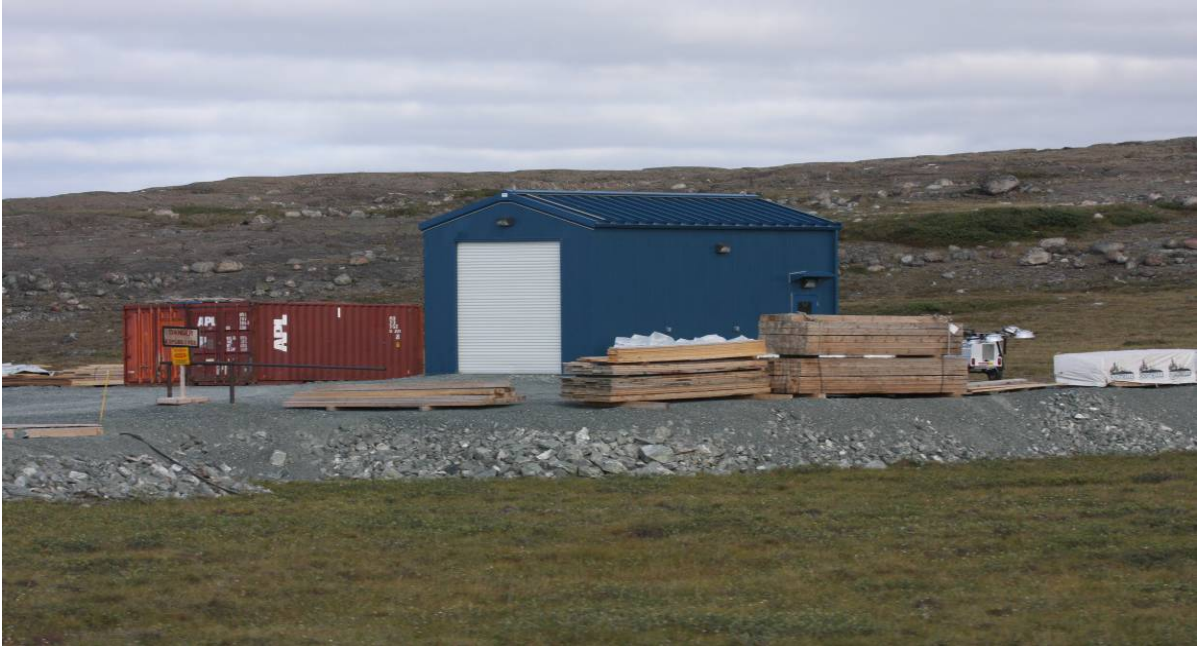
Figure 10. Explosive storage and manufacturing facility

HBML indicated during the site visit that currently explosives required for use in Quarry #2 are ready-made off-site and brought to site for immediate use. An explosive preparation and storage unit has been built at the east side of the all weather road, a good distance from the road away from other facility in the area. Currently this facility is not in use but will be put into operation in the future.

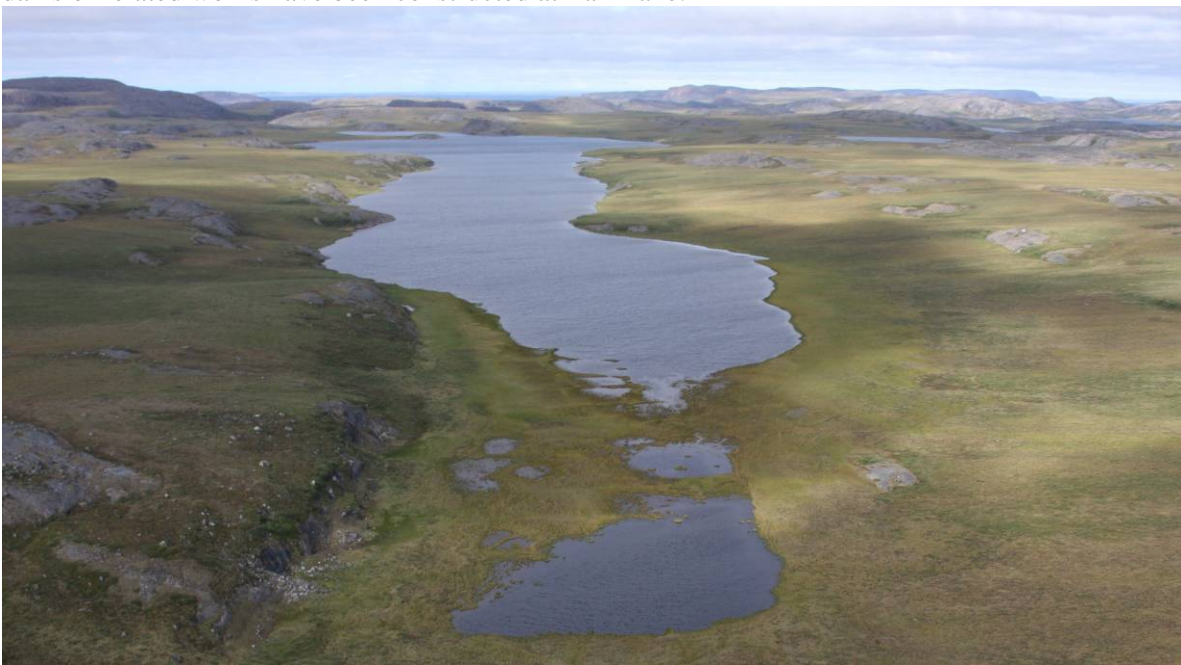
Figure 11. Northern aerial view of Tail Lake

According to the Environmental Impact Statement for the Doris North project, Tail Lake, which is located at east side of Doris Lake, will be used as a tailings impoundment area. A North dam and a South dam would be constructed, and built prior to operation of a mill at the mine site. To date, no dams or related works have been constructed at Tail Lake.

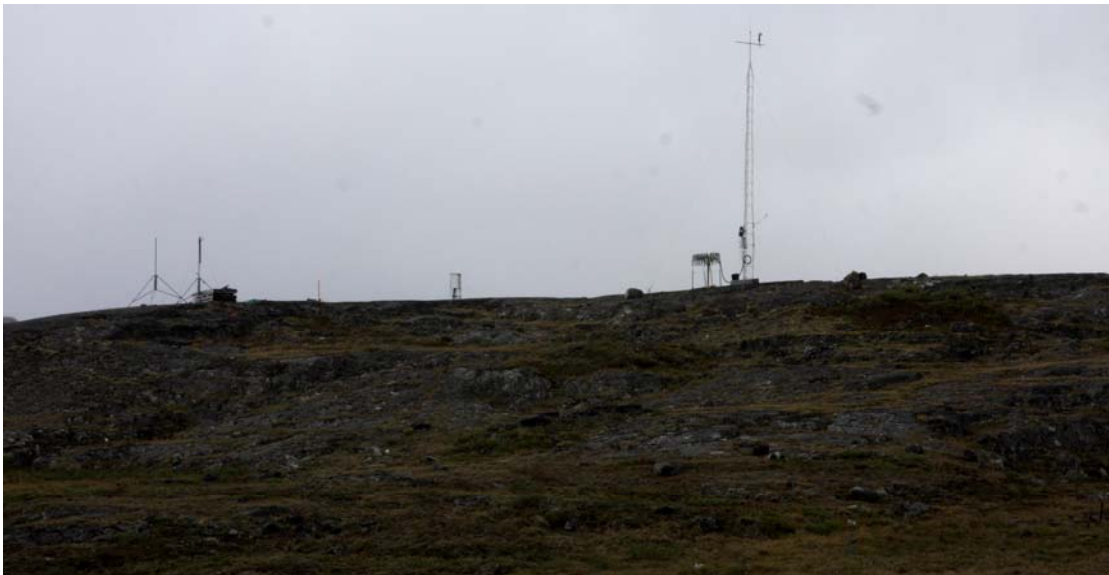
Figure 12. Meteorological monitoring station on the north shore of Doris Lake.

Metrological monitoring stations have been installed on the north Shore of Doris Lake in 2007 and the southwest side of the Doris camp, and are fully operational. These monitoring stations are operated and maintained by trained professionals, and appeared to be in good working condition. HBML stated the collected meteorological data has been reported to the NIRB's Monitoring Officer in 2008 *Air Quality Monitoring Summary report* as per Condition 23.

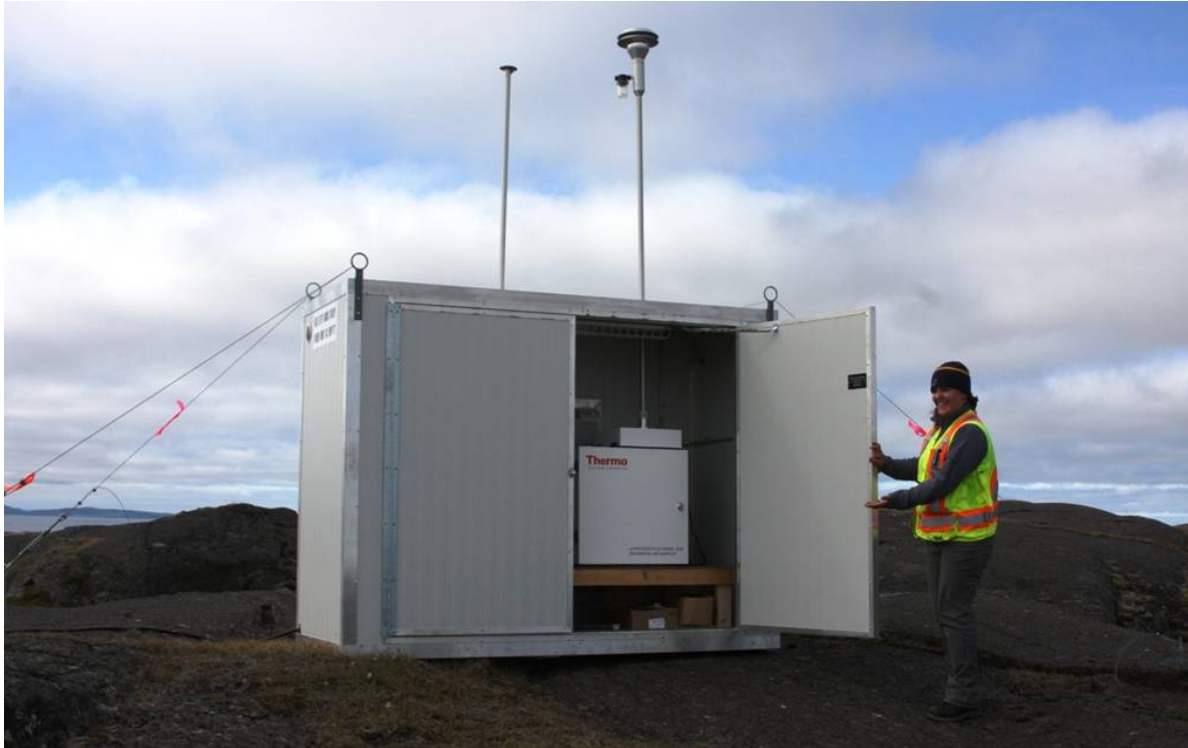
Figure 13. Atmospheric monitoring station on Doris Mountain.

An atmospheric monitoring station has been built on the Doris Mountain near a radio repeater station and has been put into operation since August 17, 2009. Total Suspended Particulate ("TSP") for PM10 and PM2.5 are being collected in accordance with the National Air Pollution Surveillance Network, the air quality monitoring data and analysis is expected to be reported in the next report.
