Re: The NIRB's 2011-2012 Monitoring Report for the Doris North Gold Mine Project and Board Recommendations

2011-2012 MONITORING REPORT

DORIS NORTH GOLD MINE PROJECT (NIRB FILE NO. 05MN047)

2012 SITE VISIT REPORT

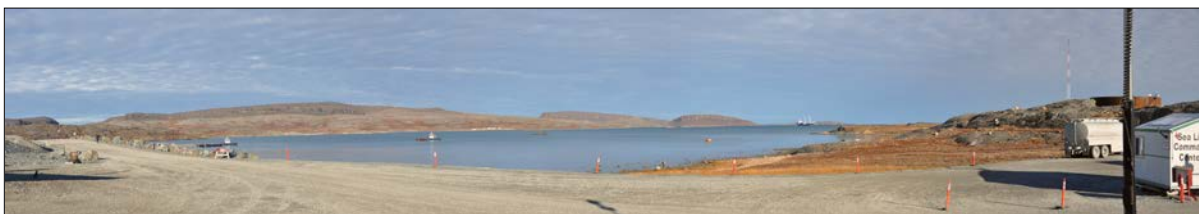
Photo 1

The Roberts Bay area which serves as the Project's logistical hub is linked to the Doris North camp and mine site by a 4.8 km all weather road. During the site visit, the area was used to stage equipment and materials for removal in preparation for the care and maintenance phase of the Project. The major facilities at Roberts Bay included the Roberts Bay jetty, a 15 million litres (ML) fuel tank farm southeast of the jetty area, a laydown area, waste management facilities, incinerator and a 5 million litres empty fuel tank (with an insufficient berm) in the abandoned quarry. Fuel was being balanced between the Roberts Bay area and the Doris Camp site prior to seasonal abandonment and in preparation for the care and maintenance phase. Photo 1: Roberts Bay Area

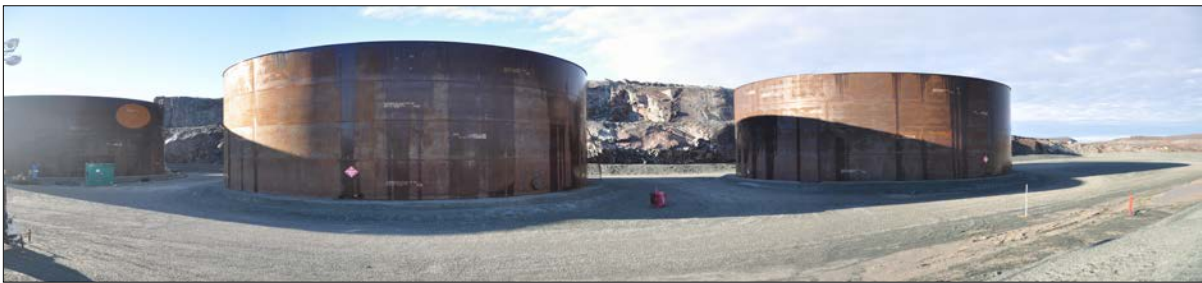
Photo 2

During the site visit, three 5.7 ML diesel tanks at the Roberts Bay area were in operation (Photo 2). The construction of additional Diesel and Jet A tanks had not commenced prior to the announcement that the Project would be placed into care and maintenance.

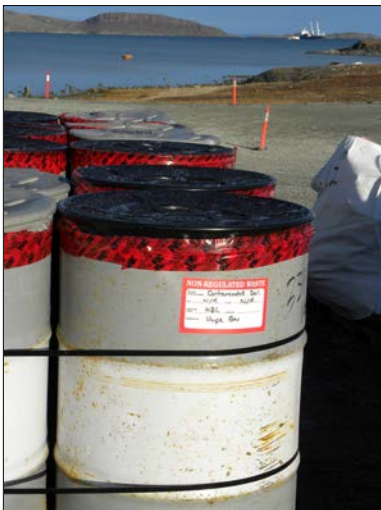
Photo 3

During the site visit, hazardous wastes were observed to have been segregated and stored in designated containers both in the waste management building and at the outdoor storage area in accordance with HBML's Waste Management Plan. All hazardous waste materials are regularly shipped off-site to an approved waste disposal facilities in the Northwest Territories.

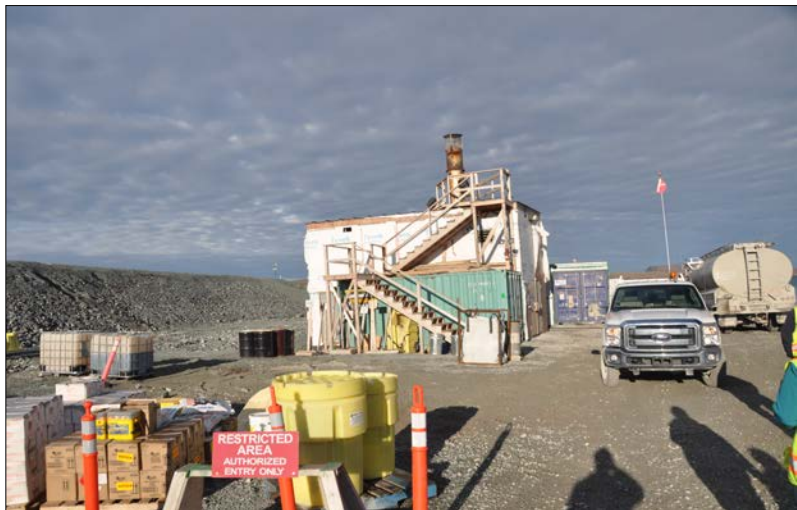
Photo 4

An incinerator was established at the Roberts Bay waste management area in 2009 to manage food waste and other waste suitable for incineration. Stack emissions testing was conducted in late September and early October 2009, and testing results showed that the dioxin and furan emissions exceeded the limits required by

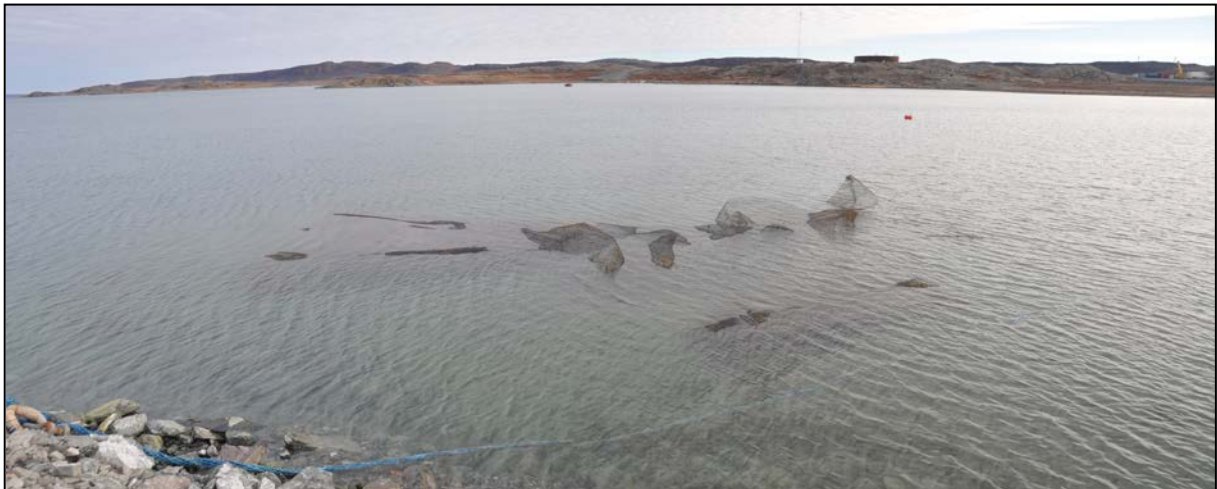
Photo 5

The Board notes that a section of geo-mat® has protruded from the water near the Roberts Bay Jetty and is concerned that this may create a risk for wildlife entrapment, presents a marine navigation hazard and poses a safety concern for snowmobiles travelling in the area. The Board further notes that these impacts have not been given full consideration within HBML's current suite of environmental mitigation and monitoring plans.

The Jetty structure requires protection from wave and ice erosion, which is often provided in Arctic environments by the use of sandbags, concrete mats, or quarried rock. The technique observed instance is a design change from a bin wall structure to a geo-mat® laid on a fine sediment seabed. During the NIRB's 2012 site visit, it was noted that the mat appears to have been damaged, and that geo-mat® is protruding from the ocean at the Roberts Bay site.

The protruded geo-mat® has created a risk for wildlife entrapment and may present a marine navigation hazard and/or a safety concern for snowmobiles travelling in the area. These impacts have not been given full consideration within HBML's current Wildlife Mitigation and Monitoring Plan. Wildlife Mitigation and Monitoring Plan.

The Jetty structure requires protection from wave and ice erosion. Protection in an arctic environment may be provided by sandbags, concrete mats, or quarried rock. The technique used in this instance is a design change from a bin wall structure to a geo-mat[®] laid on a fine sediment seabed. The geo-mat[®] was observed to be protruding from the ocean (Photo 5). There were also several instances of exposed "mesh material" observed along both sides of the jetty on the seabed that have an elevated risk of failure.

The protruded mesh has created a risk for wildlife entrapment, a marine navigation hazard and a safety concern for snowmobiles travelling in the area. This impact should be assessed, mitigated and reflected in the Wildlife Mitigation Monitoring Plan; the Aquatic Effects Monitoring Plan; Roberts Bay Jetty Monitoring Plan; and, the Health Safety and Loss Prevention Plan.

Recommendation 2: The Board requests that HBML assess the potential impacts posed by geo-mat® mesh materials protruding from marine waters at the Roberts Bay area, and further, that the mitigation of any identified potential impacts be reflected in updates to the Wildlife Mitigation Monitoring Plan, the Aquatic Effects Monitoring Plan, Roberts Bay Jetty Monitoring Plan, and, the Health, Safety, and Loss Prevention Plan and any associated and/or annual reporting.

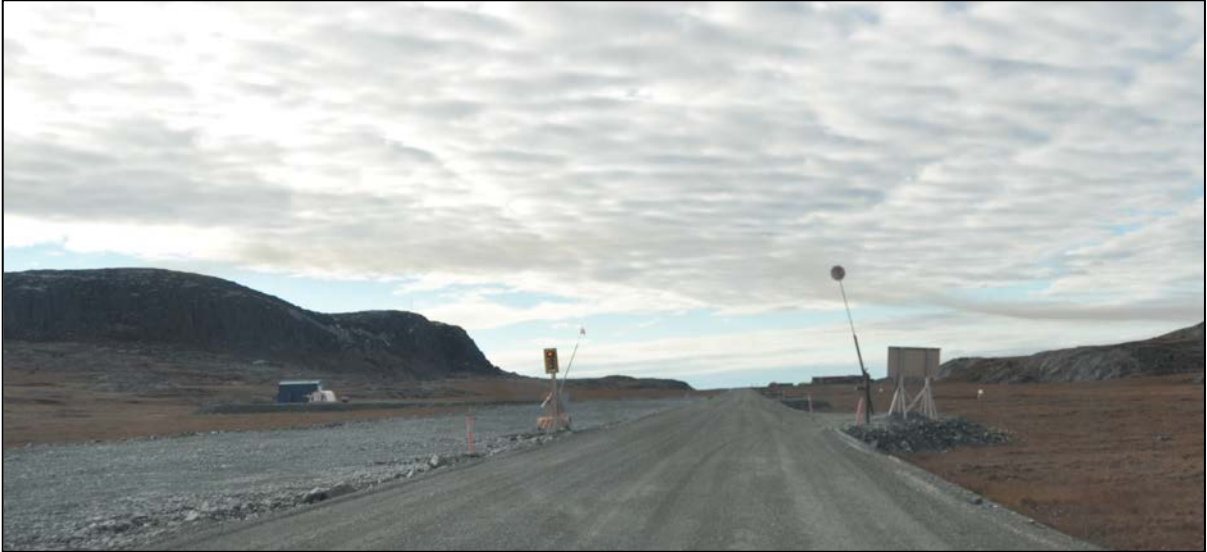
Photo 6

During the 2012 site visit, HBML staff indicated that the quarry material removed from the new fuel tank farm in 2011 had been used for airstrip expansion (Photo 6). The decision to place the Project in care and maintenance has resulted in HBML's cancellation of all construction projects. As a result of the airstrip expansion being postponed, per HBML's Health Safety and Loss Plan (HSLP), vehicles approaching the airstrip on the all-weather road must wait at either end of the airstrip during aircraft landing and take-off.

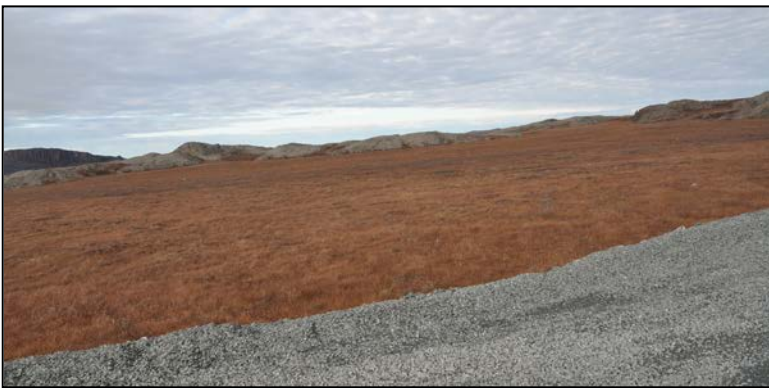
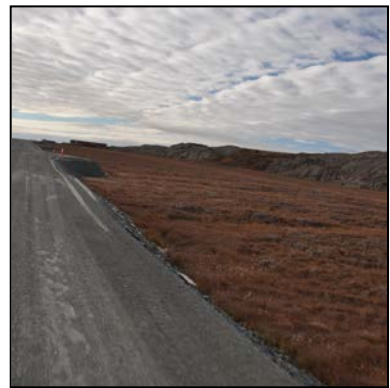
HBML continues to use EK-35 as a dust suppressant for the airstrip and roads during the snow and ice-free seasons. HBML indicated that use of this dust suppressant continues to mitigate dust concerns identified in the EA process (Photo 7 and 8).

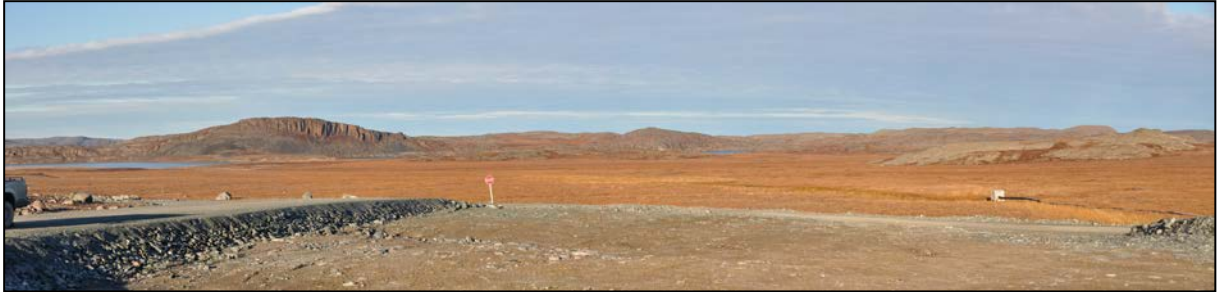
Photo 9

The Board notes that HBML relocated its sewage outfall at Doris North to an outcrop which serves as a natural diffuser and helps to mitigate erosion caused by direct discharge of sewage effluent.

HBML has employed an adaptive management approach by relocating the sewage outfall to an outcrop which acts as a natural diffuser with a flow inhibitor installed at the outlet in order to mitigate erosion caused by direct discharge. HBML staff noted instances of glaciation occurring during freezing while discharge was occurring in cold periods. This may need to be monitored for long term effects, however during the site visit, no surficial impacts were observed.

The Three Cell Land farm and Laydown Area are located north of the Doris North camps, on the west side of the all-weather road. The No. 2 quarry and the sewage discharge outfall are adjacent to this area (Photo 9).

Through utilization of their adaptive management plan potential erosion caused by direct discharge has been mitigated. Site staff reported incidents of glaciation occurring during freezing discharge periods that may have to be monitored for long

term erosion effects. During the site visit no surficial impacts were observed.

Recommendation 4: The Board requests that HBML provide the Monitoring Officer with its plan to monitor the relocated sewage outfall in terms of potential impacts of erosion, as well as any part of site operations which involve the discharge of sewage effluent during winter months.

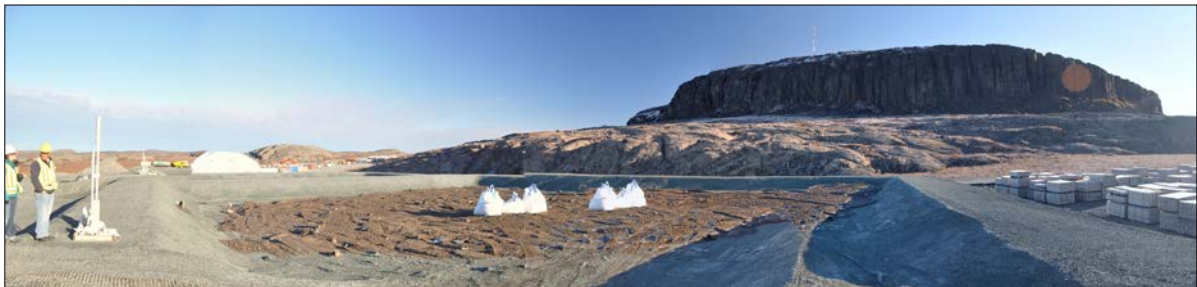
Photo 10

A three cell land farm to be used for the treatment of contaminated soil and snow has been constructed on the north side of Quarry #2 (Photo 10). This land farm is operational with a minimum amount of soil to be remediated due to the reduced

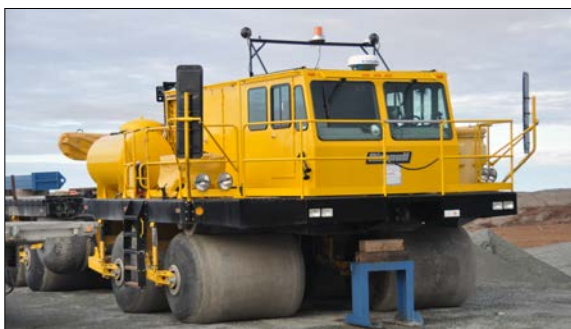
Photo 11

During the 2012 site visit, the Board's Monitoring Officer observed areas where the tundra had been rutted near the Doris North camp. HBML staff indicated that these tracks were from the movement of equipment called a "rimple rolygon" and some test trials that had been conducted during HBML's research of the impacts from overland travel.

A large laydown area located on the west side of the all-weather road close to the Doris North camp site had been in use as a staging area for various construction materials, equipment and sea cans. During the flyby over the site, the Monitoring Officer observed instances of scarification occurring on the tundra adjacent to the staging area. HBML staff indicated that these tracks were from the rimples used in trials conducted to research overland travel impacts. The rimple rolygon is used in Northern Alaska petroleum activities with success for overland travel; there is limited data on operationality within the Canadian Arctic to which HBML conducted their site specific research. The impacts of this type of overland activity should continue to be monitored.

A large laydown area located on the west side of the all weather road close to the Doris North camp site has been used as a staging area for various construction materials, equipment and sea cans. During the flyby over the site, the Monitoring Officer observed instances of scarification occurring on the tundra adjacent to the staging area.

HBML staff indicated that these tracks were from the rimple rolygon trials conducted to research overland travel impacts (Photo 11). The rimple rolygon is used in Northern Alaska petroleum activities with success for overland travel; however there is limited data on the operations of this equipment within the Canadian Arctic in the manner that HBML conducted its site specific research.

Recommendation 3: The Board requests that HBML monitor the impacts of rimple rolygon trials conducted overland and report the results of these trials, including impacts and proposed mitigation measures, in its future Annual Reporting to the NIRB.

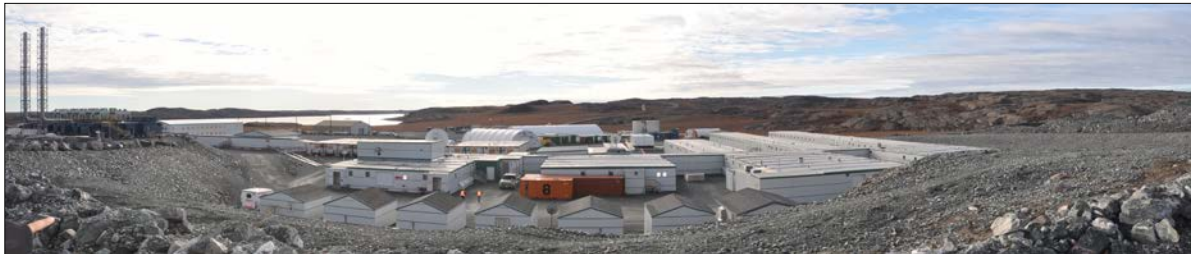
Photo 13

The Doris North camp and mine site are located approximately 5 km south of Roberts Bay at the north shore of Doris Lake and serve as the major components of the Project (Photo 13). In addition to the camp site which has been in full operation since 2008, the Doris North mine site hosts infrastructure which would be directly associated with future mine operation.

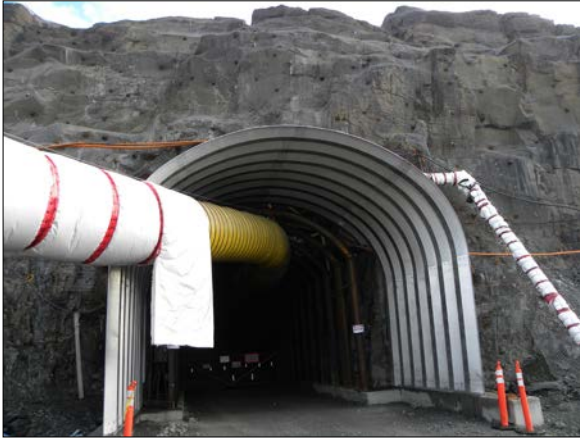
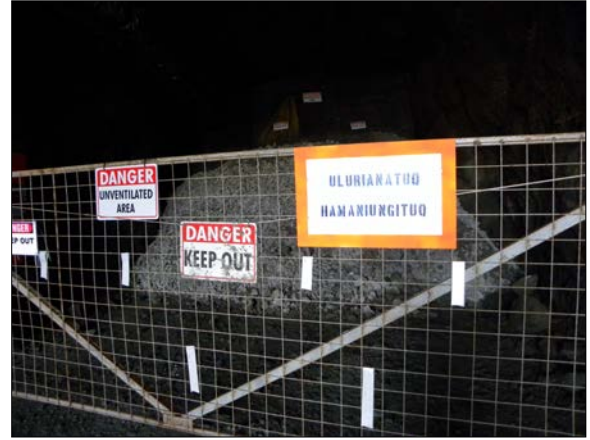
Accompanied by HBML site personnel, the NIRB staff conducted a walking tour of the mine facilities with a focus on environmental, health and safety management and performance as per Appendix D of the NIRB Project Certificate #003 (Photo 14 and 15).

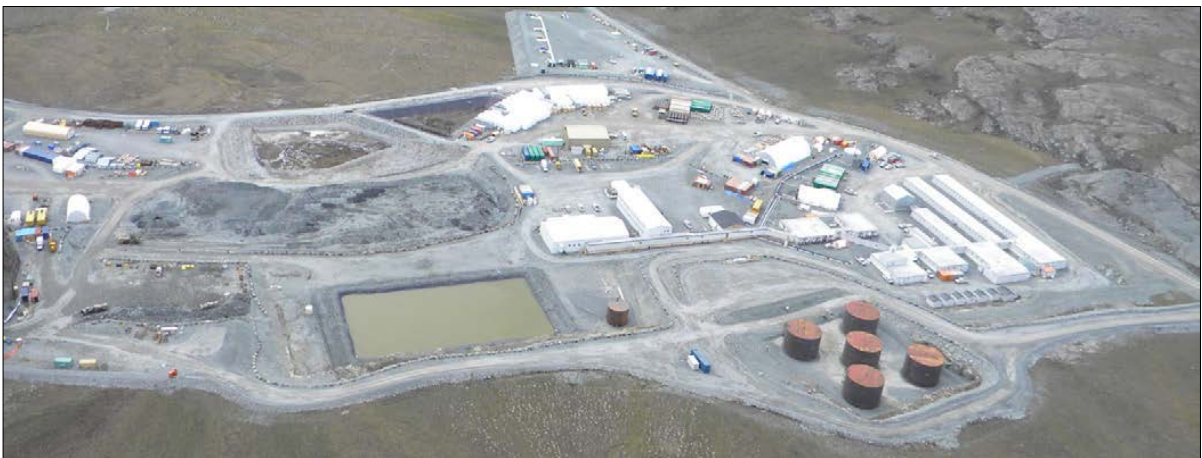
Photo 16

In order to collect and manage surface runoff from the ore and waste rock stockpile areas, HBML indicated that it had constructed a water control pond on the south side of waste rock pad. HBML personnel further noted that along the west side of the pollution control pond, a temporary sedimentation pond had been constructed at the location intended for the mill; designed to collect freshet and runoff from facility contact water. Site staff further noted that should the Tailings Impoundment Facility (TIF) at Tail Lake be put into operation, the temporary pond would be removed and the crusher and mill would be built on its place. Under the proposed care and maintenance plan, HBML indicated it would maintain this facility to manage contact water (Photo 16).

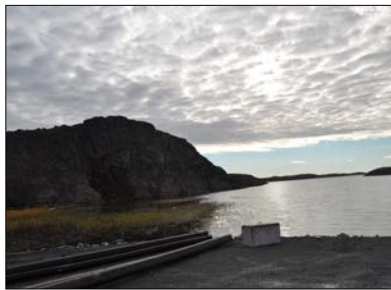
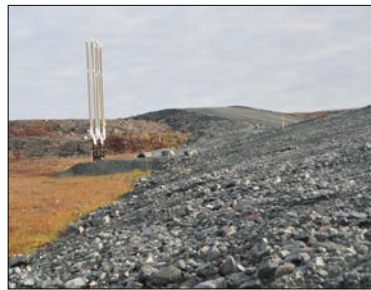
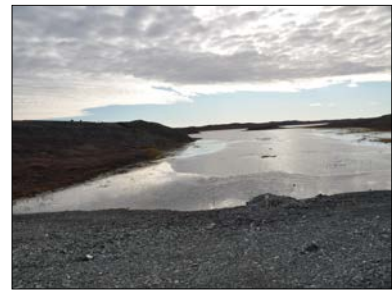
Tail Lake is located on the east side of Doris Lake and is the planned site for the Tailings Impoundment Area facility (TIA). The TIA was to be utilized during mine production, with a tailings transport pipeline planned for installation along the service road at the eastern shore of Tail Lake and which would connect the North Dam with the South Dam (Photos 17, 18 and 19).

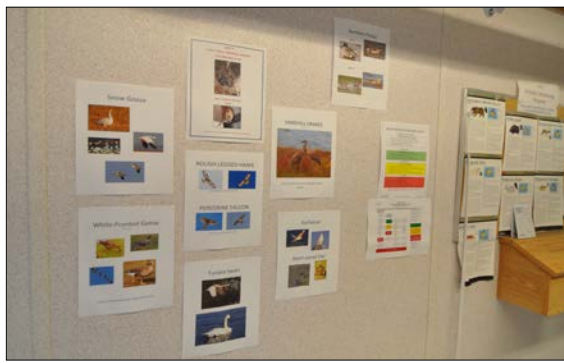
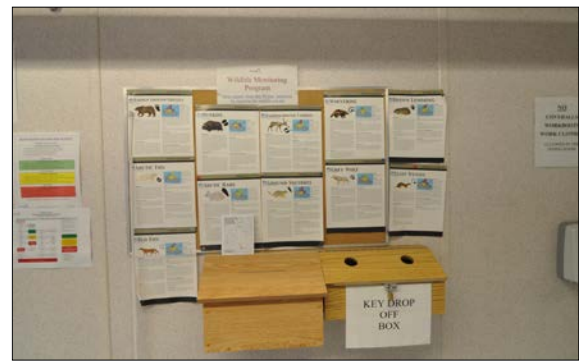
During the site visit a monitoring station for wildlife incidents was observed, this station included pictures of regional wildlife indicators of occurrence (tracks) for staff to report through a ballot box system. These reports were collected, recorded and reported to the response team. It was indicated that wildlife was an additional workplace hazard that was the employee's responsibility to report or address under the Wildlife Monitoring and Mitigation Plan (Photos 20 and 21).

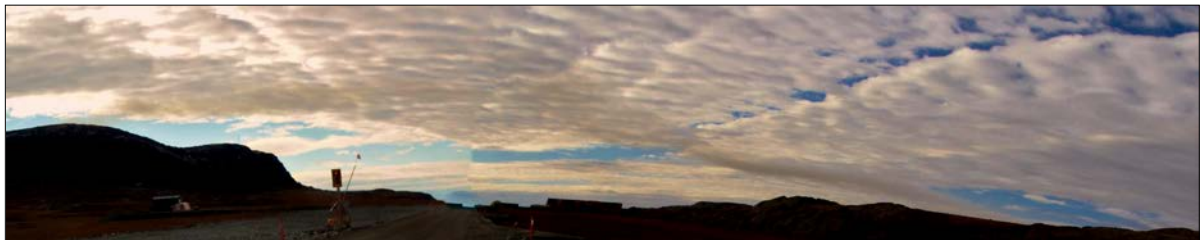
Photo 22

During the site visit, HBML was engaged in the surface detonation of project explosives as a means to dispose of pre-mixed explosives materials. This activity was not anticipated to continue over a long period of time but the Monitoring Officer found that the sound and dust produced from the detonation were significant when they did occur (Photo 22). No caribou or other wildlife were observed in the mine area during the explosives detonation and HBML's HSLP procedures were followed before each detonation, with staff communicating clearly via site radio.

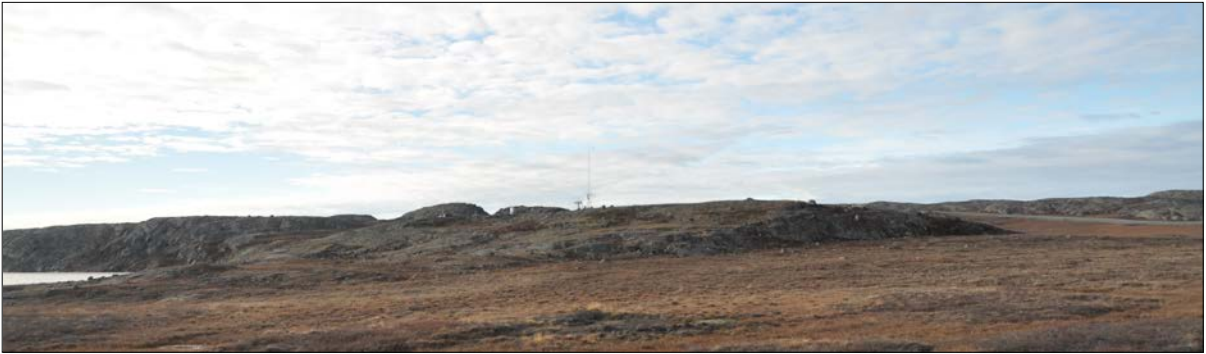
Photo 23

An air quality monitoring station was initially installed on the top of Doris Mountain cliff in September 2009, though both Environment Canada (EC) and the NIRB expressed concerns related to the suitability of the chosen location. At the request of EC and with the support of the NIRB, HBML completed a re-evaluation of the air quality monitoring station location. The NIRB, Health Canada and EC recommended that HBML move the station to a more accessible location on the north Shore of Doris Lake (Photo 24). During the 2012 site visit it was confirmed that HBML has relocated the air quality monitoring station as recommended, which, HBML staff noted, has allowed for more frequent checks of the equipment.

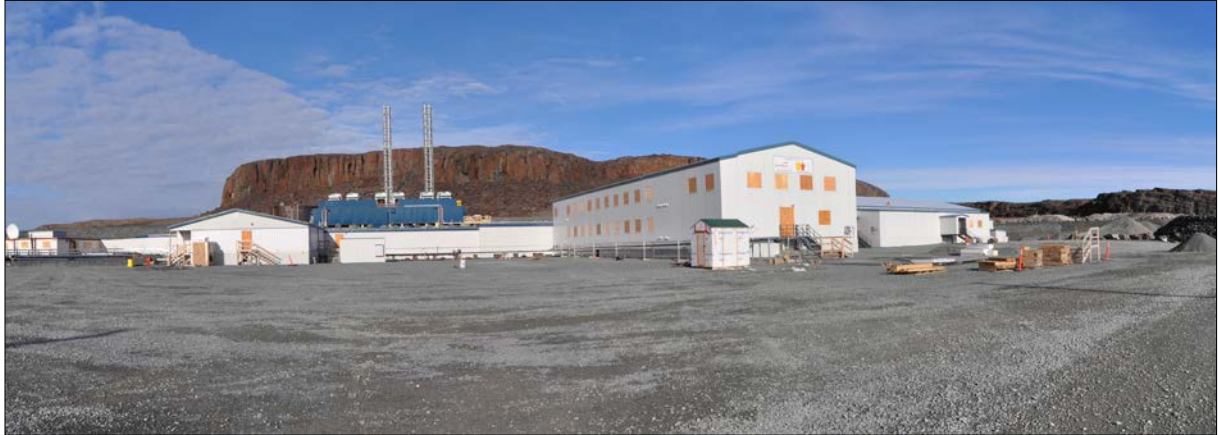
Photo 24

During the site visit, HBML indicated that it had been preparing site facilities for placement of the Doris North project into care and maintenance for October 2012 (Photo 25). Buildings and facilities were being secured and winterized during the Monitoring Officer's site visit, and HBML noted that it anticipated that all individuals would be vacated from Doris North by mid-October.
