Appendix DFO-3.4.1-1 Proposed Access Road Fisheries
Assessments, Doris North Project, 2015

Date: November 24, 2015

Subject: **Proposed Access Road Fisheries Assessments, Doris North Project, 2015**

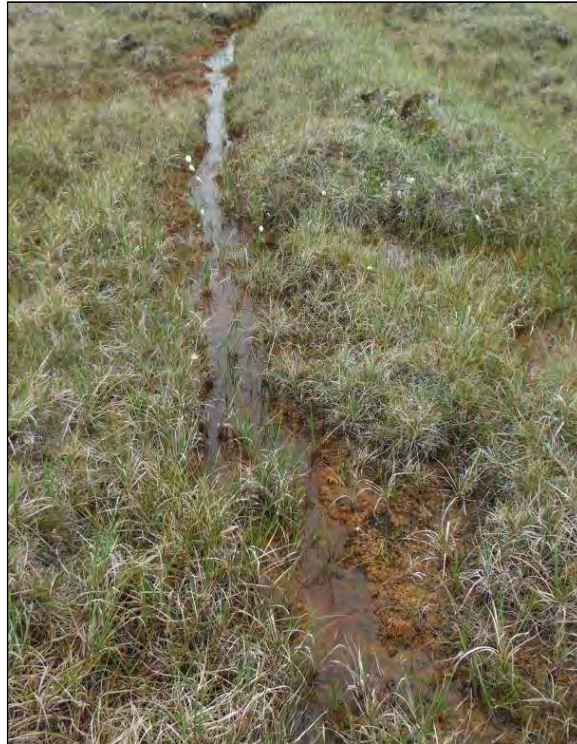
Plate 3.2-1. The upper stream section consists of small, braided channels with poor connectivity to the lower section of the stream, August 13, 2015.

The upper section of the watershed provides poor quality fish habitat. The braided channels are poorly defined, narrow (mean width 0.28 m), shallow (mean depth 0.11 m), and have poor connectivity with each other and with the lower section of the creek (Plate 3.2-1). Dense in-channel terrestrial vegetation and low discharge even during peak periods limit fish

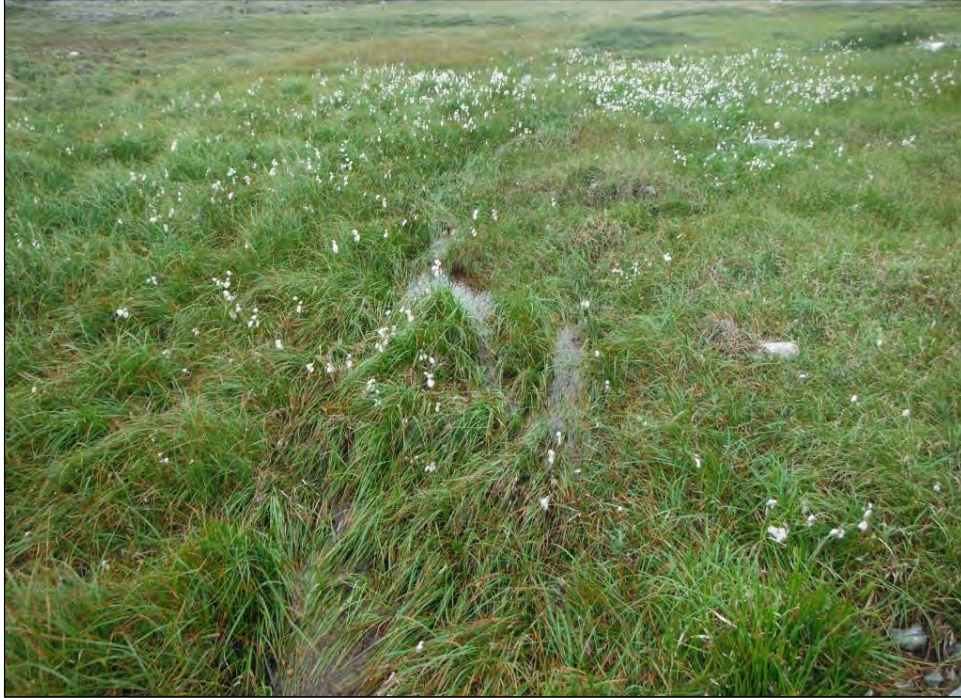
Plate 3.2-2. The stream section upstream of the culvert is poorly defined due to heavy in-channel vegetation, August 13, 2015.

movement and the habitat value in this section. Where the proposed road route crosses the stream, the stream channel is poorly defined and is dominated by terrestrial vegetation, suggesting that it contains flow for a short period during most years (Plate 3.2-2). This area did contain a small amount of flow during August 2015 due to anomalous weather conditions; however, it is expected that this area would cease flowing soon after freshet in most years. Habitat throughout this section is of poor quality.

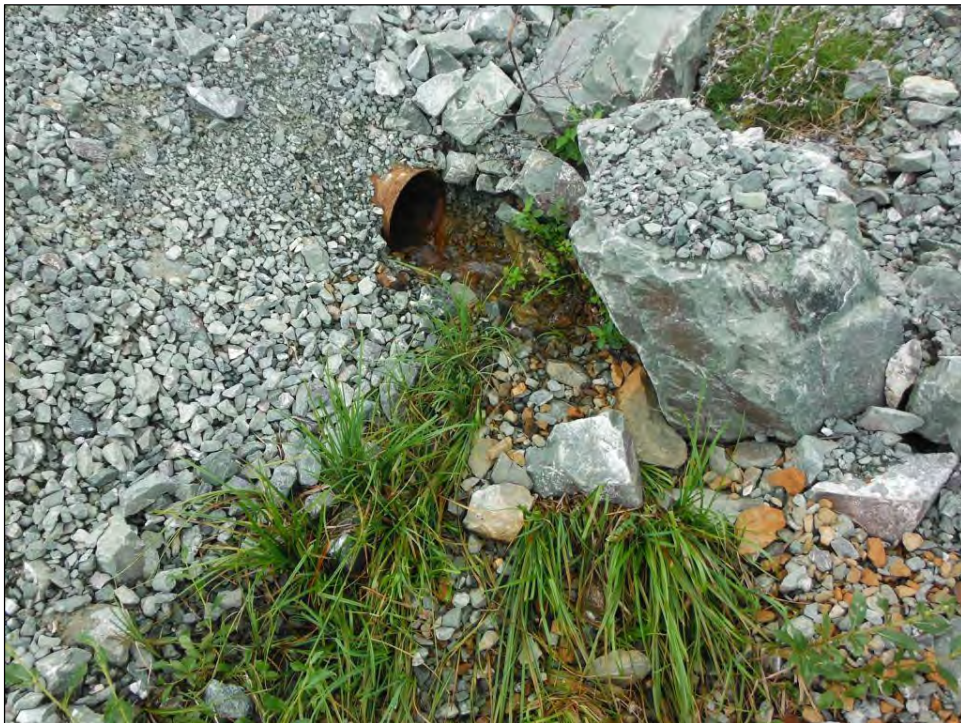
Plate 3.2-3. Discharge from the Doris Lake boat launch culvert percolates into loose gravels, August 13, 2015.

Just upstream of Doris Lake the stream flows through a single 6" diameter culvert under the Doris Lake boat launch ramp. Just upstream of the culvert there is a 3 m section of creek that has a defined channel that could provide some rearing habitat to coarse fish. During the site visit, the channel downstream of the culvert was poorly defined and contained little flow; the majority of water discharging from the culvert percolated subsurface through loose gravels before entering Doris Lake (Plate 3.2-3).
