2016 Waste Rock and Quarry Monitoring Report, Doris Mine, Hope Bay Project

SRK Consulting (Canada) Inc.
1CT022.009
March 2017

To:	Shelley Potter, TMAC	Client:	TMAC Resources Inc.
From:	Eduardo Marquez Lisa Barazzuol	Project No:	1CT022.009
Cc:	Oliver Curran, TMAC John Roberts, TMAC	Date:	March 27, 2017
Subject:	2016 Hope Bay Construction Rock Monitoring - FINAL

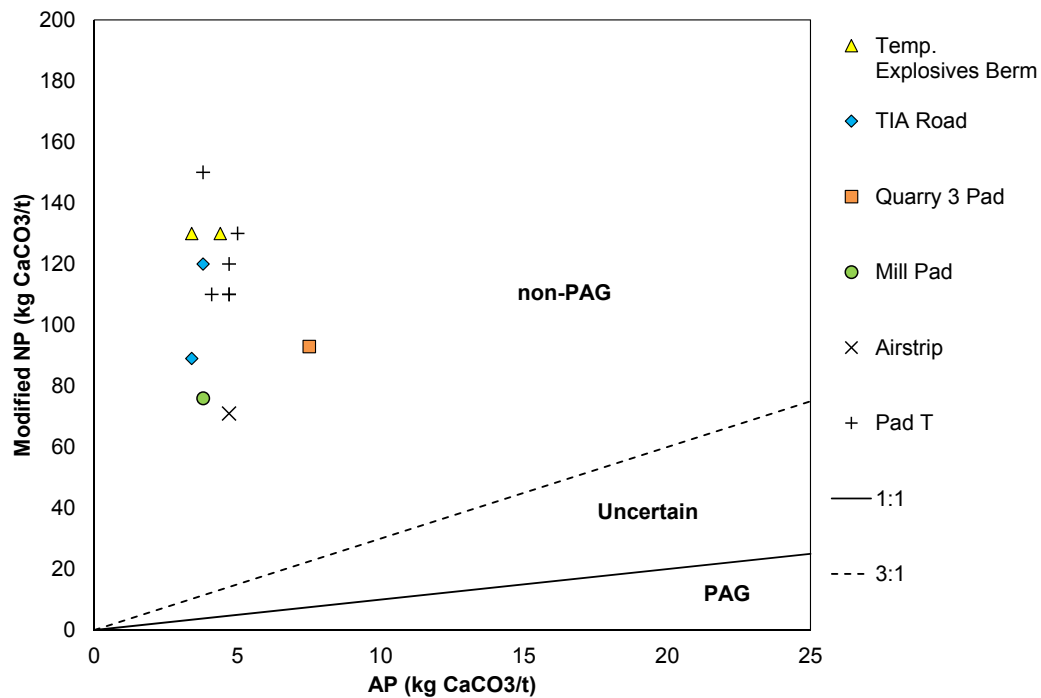
Figure 3: Acid Generation Potential vs. Modified Neutralization Potential

Modified NP levels ranged from 97 to 160 kg CaCO₃/t. Levels of NP values were higher than TIC, the latter which ranged from 77 to 140 kg CaCO₃/t. This suggests that silicates, that are not expected to be highly reactive under field conditions, contributed to the buffering capacity in the test. All samples were classified as non-potentially acid generating (non-PAG) on the basis of TIC/AP and NP/AP (ratios greater than 3).
