Hope Bay Madrid East Naartok Pad 6209-400-132-REP-001_R0

CONSTRUCTION SUMMARY REPORT

CIMA+ file number: CA000820D 16-May-2025 - Review 0

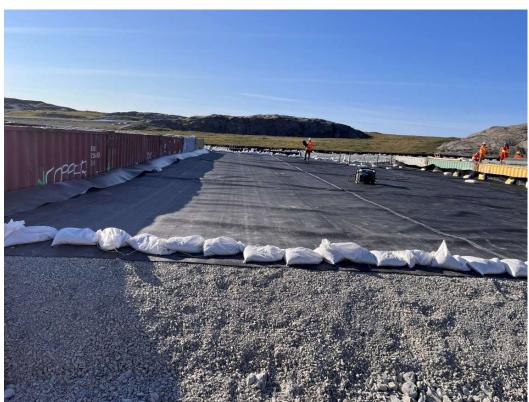
Photo 1 Maintenance Dome HDPE Liner Installation

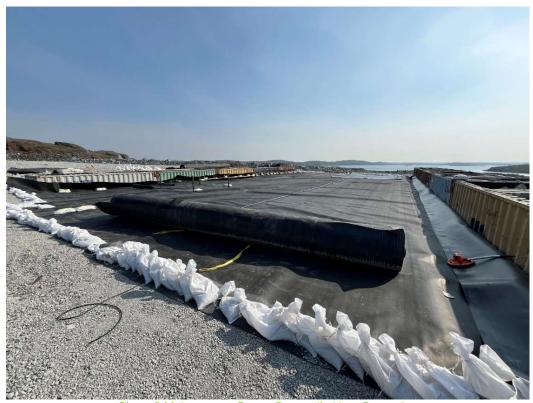
Photo 2 Maintenance Dome Geotextile Liner Protection

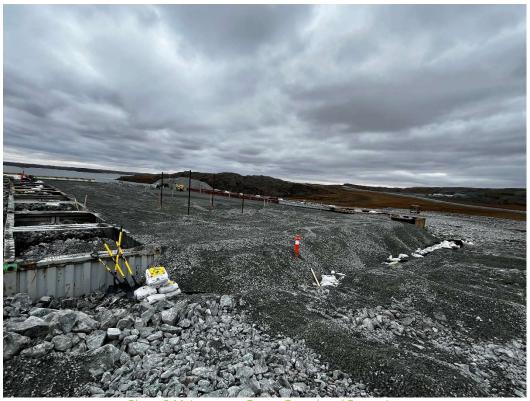
Photo 3 Maintenance Dome Completed Protection

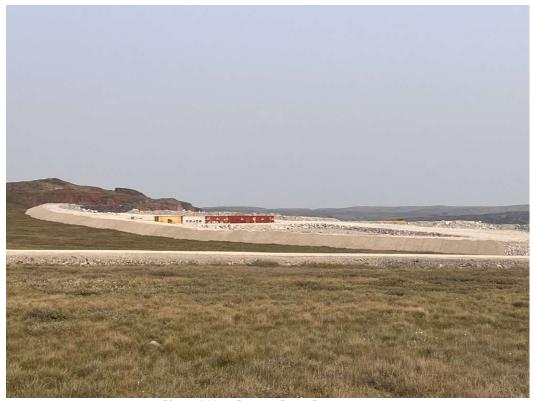
Photo 4 Non-Contact Berm Preparation

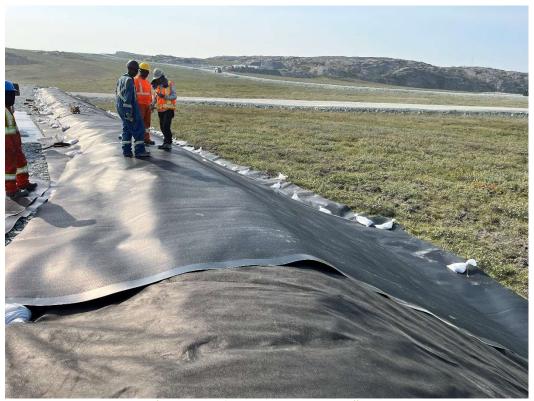
Photo 5 Non-Contact Berm Liner Installation

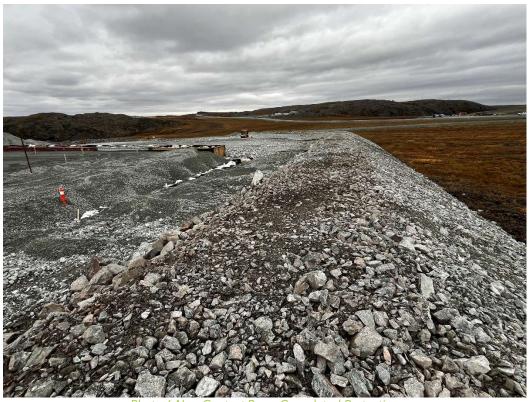
Photo 6 Non-Contact Berm Completed Protection

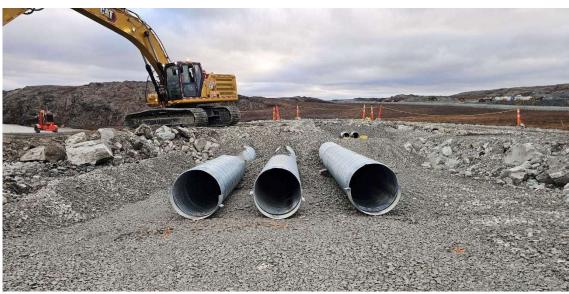
Photo 7 Non-contact Culvert Installation

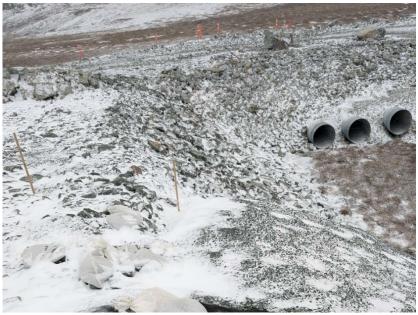
Photo 8 Non-contact Culvert Completion

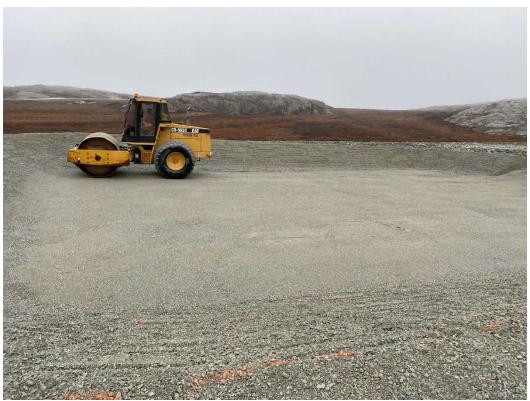
Photo 9 Fuel Storage Secondary Containment Preparation

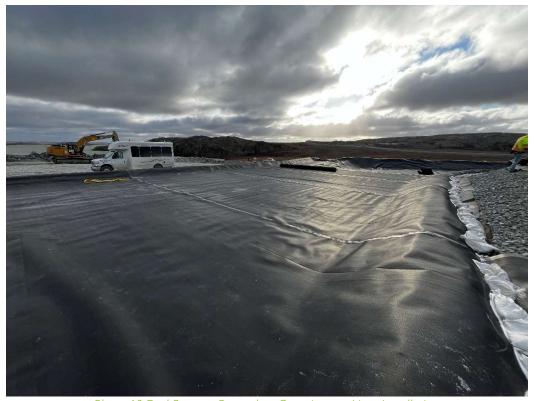
Photo 10 Fuel Storage Secondary Containment Liner Installation

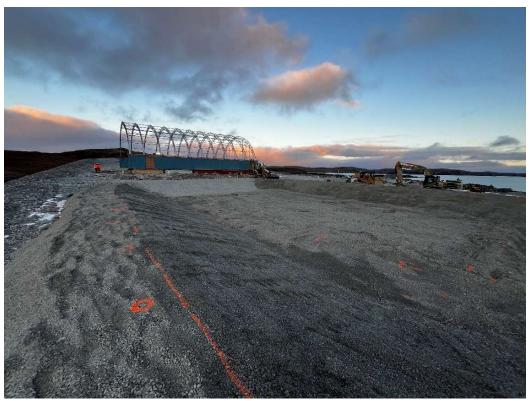
Photo 11 Fuel Storage Secondary Containment Completion

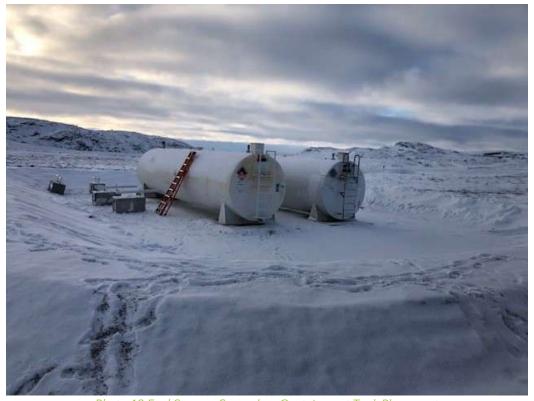
Photo 12 Fuel Storage Secondary Containment Tank Placement
