DAILY REPORT #02 – DORIS NORTH INFRASTRUCTURE/ NORTH DAM

NORTH DAM/FROZEN CORE PLANT PAD:

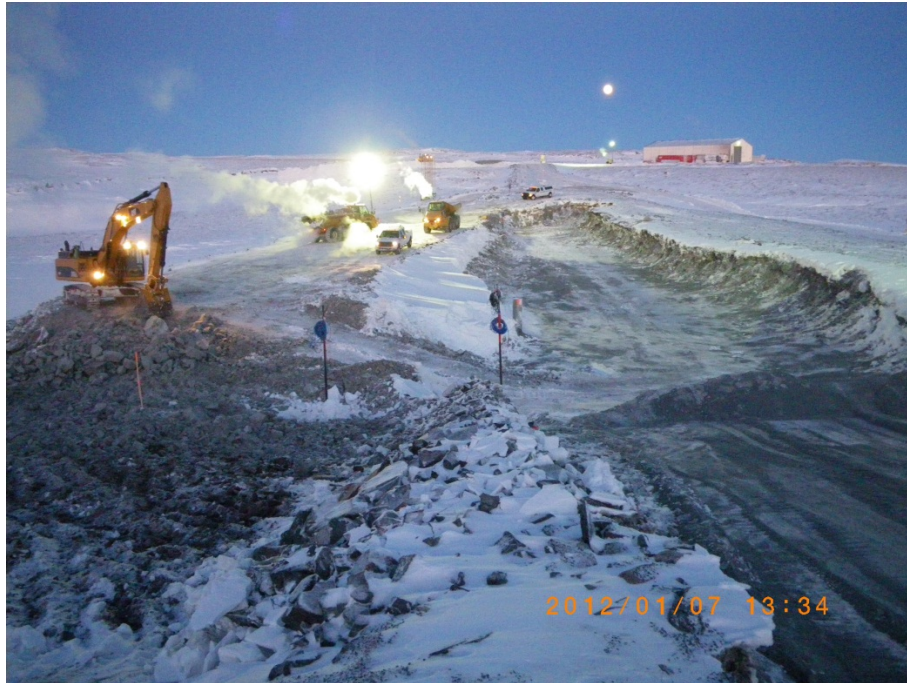
Photo 1: Snow has been removed from the keytrench. At the right of the picture, some of the 5/8" clear material has been pushed into a wind-row which will be mixed with the ROQ that will be removed from the upstream side of the keytrench and placed within the downstream footprint of the dam. Snow removal continues along the top of the ROQ surface along the downstream side of the dam, as shown at the left of the picture. Photo looking east from the west side of the keytrench.

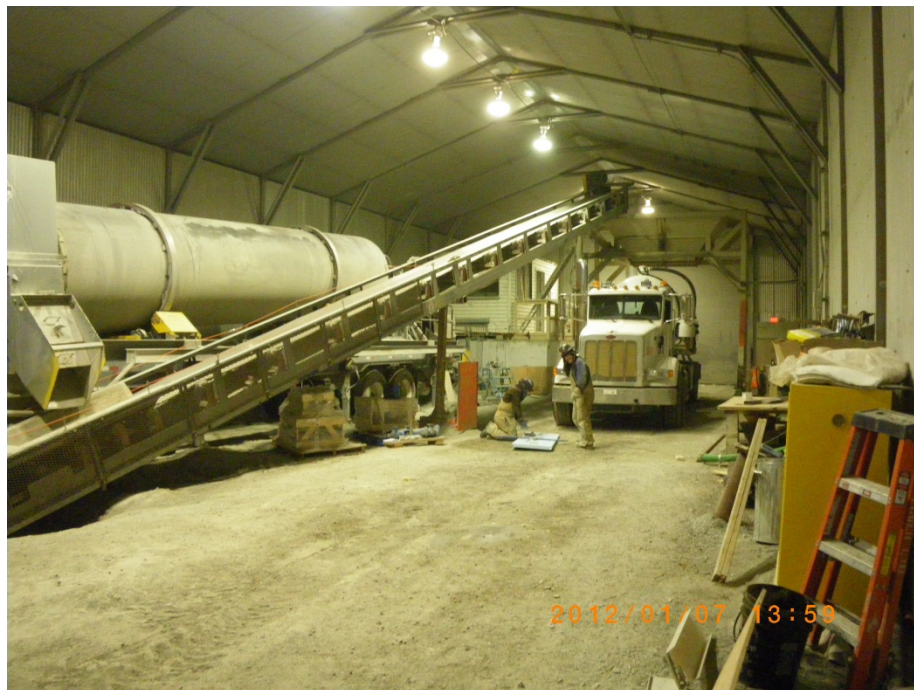
Photo 2: Servicing the Frozen Core Plant continues.
