DAILY REPORT #05 – DORIS NORTH INFRASTRUCTURE/ NORTH DAM

Prepared by:	Lowell Wade	Date:	2012.01.10
Reviewed by:		Project #:	1CH008.058.0340
Role	Company	Personnel – Position	On Site
Client	Hope Bay Mining Limited (HBML)	David Vokey – ESR Coordinator Don Ethelston – HSLP Advisor Dean Wold - Safety Jill Turk – ESR Coordinator Katsky Venter – ESR Manger Stirling Kelly – HSLP Advisor Angela Holzapfel – ESR Compliance Manager Michelle Tanquay – ESR Site Manager	No No Yes No Yes Yes No No
	JDS	Lloyd Jackson – Mechanical Superintendent Sven Archimowtiz – Electrical Superintendent Doug Fielding – Construction Manager Ishan Fechter – Construction Coordinator Jerry Graham – Construction Manager Kevin Whieldon – Project Coordinator Mark Valeriote – Construction Manager	Yes Yes No No Yes Yes Yes
Engineering Design Consultants	SRK Consulting (Canada) Inc.	John Kurylo – Site Engineer Megan Miller – Site Engineer Lawrence Borowski – Site Engineer Murry McGregor – Site Engineer Lowell Wade – Senior Engineer	No No No No Yes

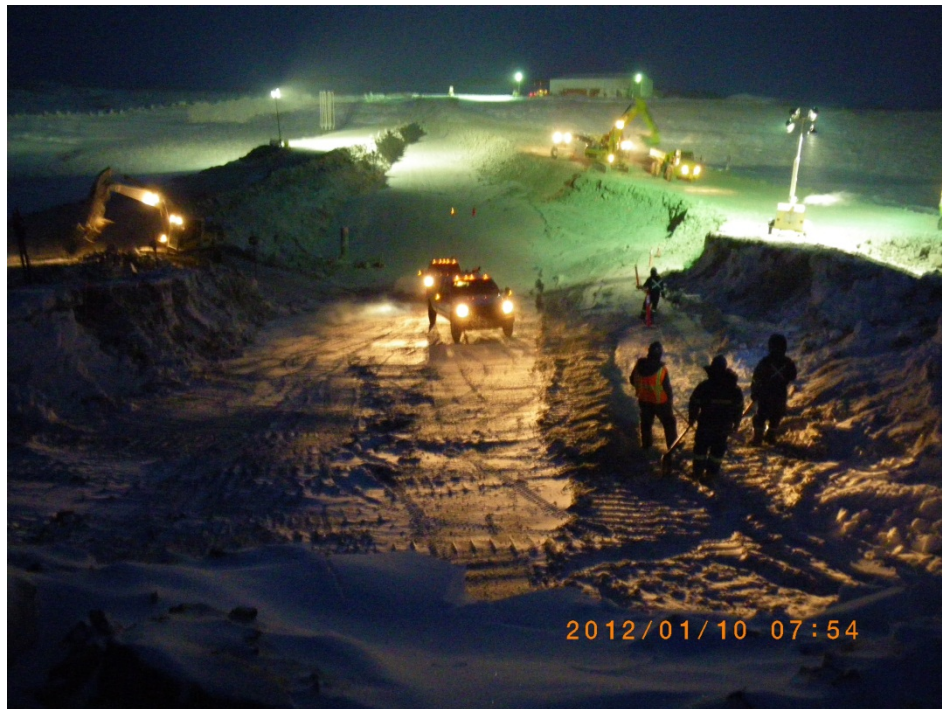
Photo 1: In the foreground, an attempt to expose the damaged liner, by hand, was unsuccessful as the material over the liner was frozen.

- Labours tried to remove the granular material covering the damaged liner but were unsuccessful as it was frozen. The granular material will have to be hoarded and allowed to thaw so the liner can be exposed and repairs made.

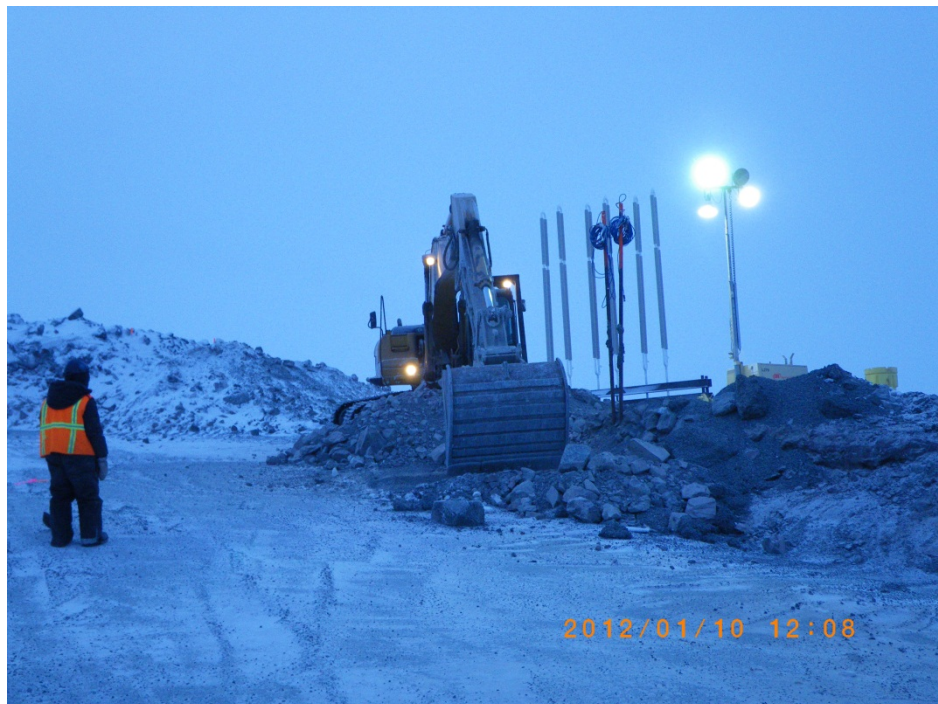
Photo 2: Careful excavation around the ground temperature cables at the west end of the key trench. Final excavation was completed by hand and the steel pipes housing the cables were carefully laid onto the base of the key trench.

- The 10 tonne compacter was applied to the placed ROQ.
- The 325 excavator with a clean-up bucket was used to carefully remove the ROQ placed around the protective steel pipes housing ground temperature cables ND-VTS-040-KT and ND-HTS-040-31.5. Once the steel pipes were freed from the ROQ material they were carefully laid down and the ground temperature cables were measured using an RST TH2016 thermistor readout to ensure the cables were functioning properly.

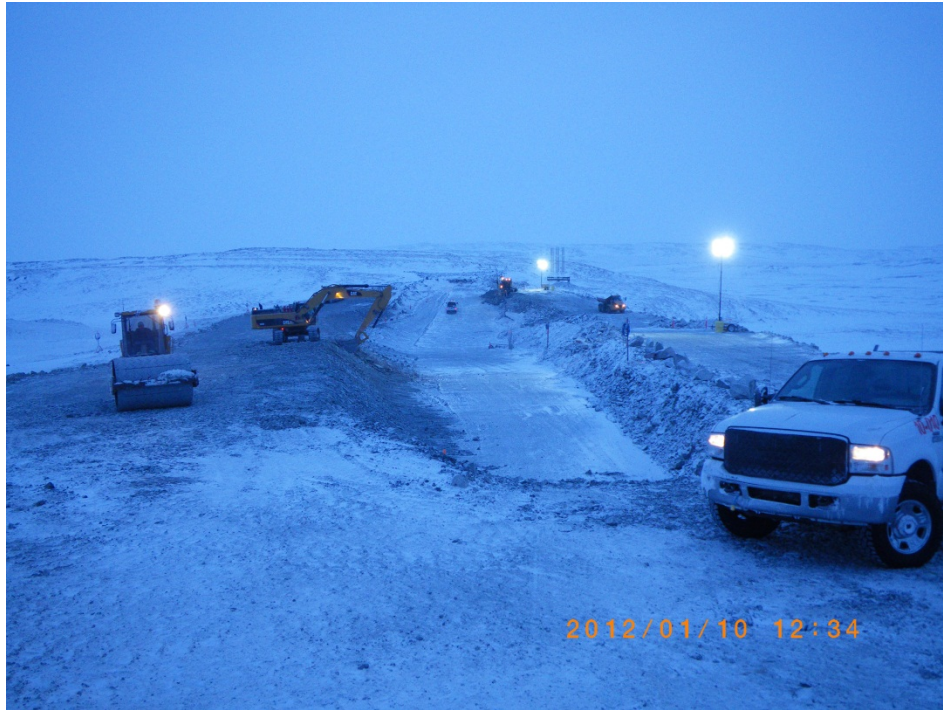
Photo 3: Removal and relocation of the protective material continues. The 10 tonne compactor works the ROQ surface within the upstream ROQ shell of the dam

- Continued removal of protective ROQ cover removal along the upstream edge of the key trench using the 345 excavator.
- The ROQ material was placed in a lift ~ 1 m thick across the upstream face of the dam

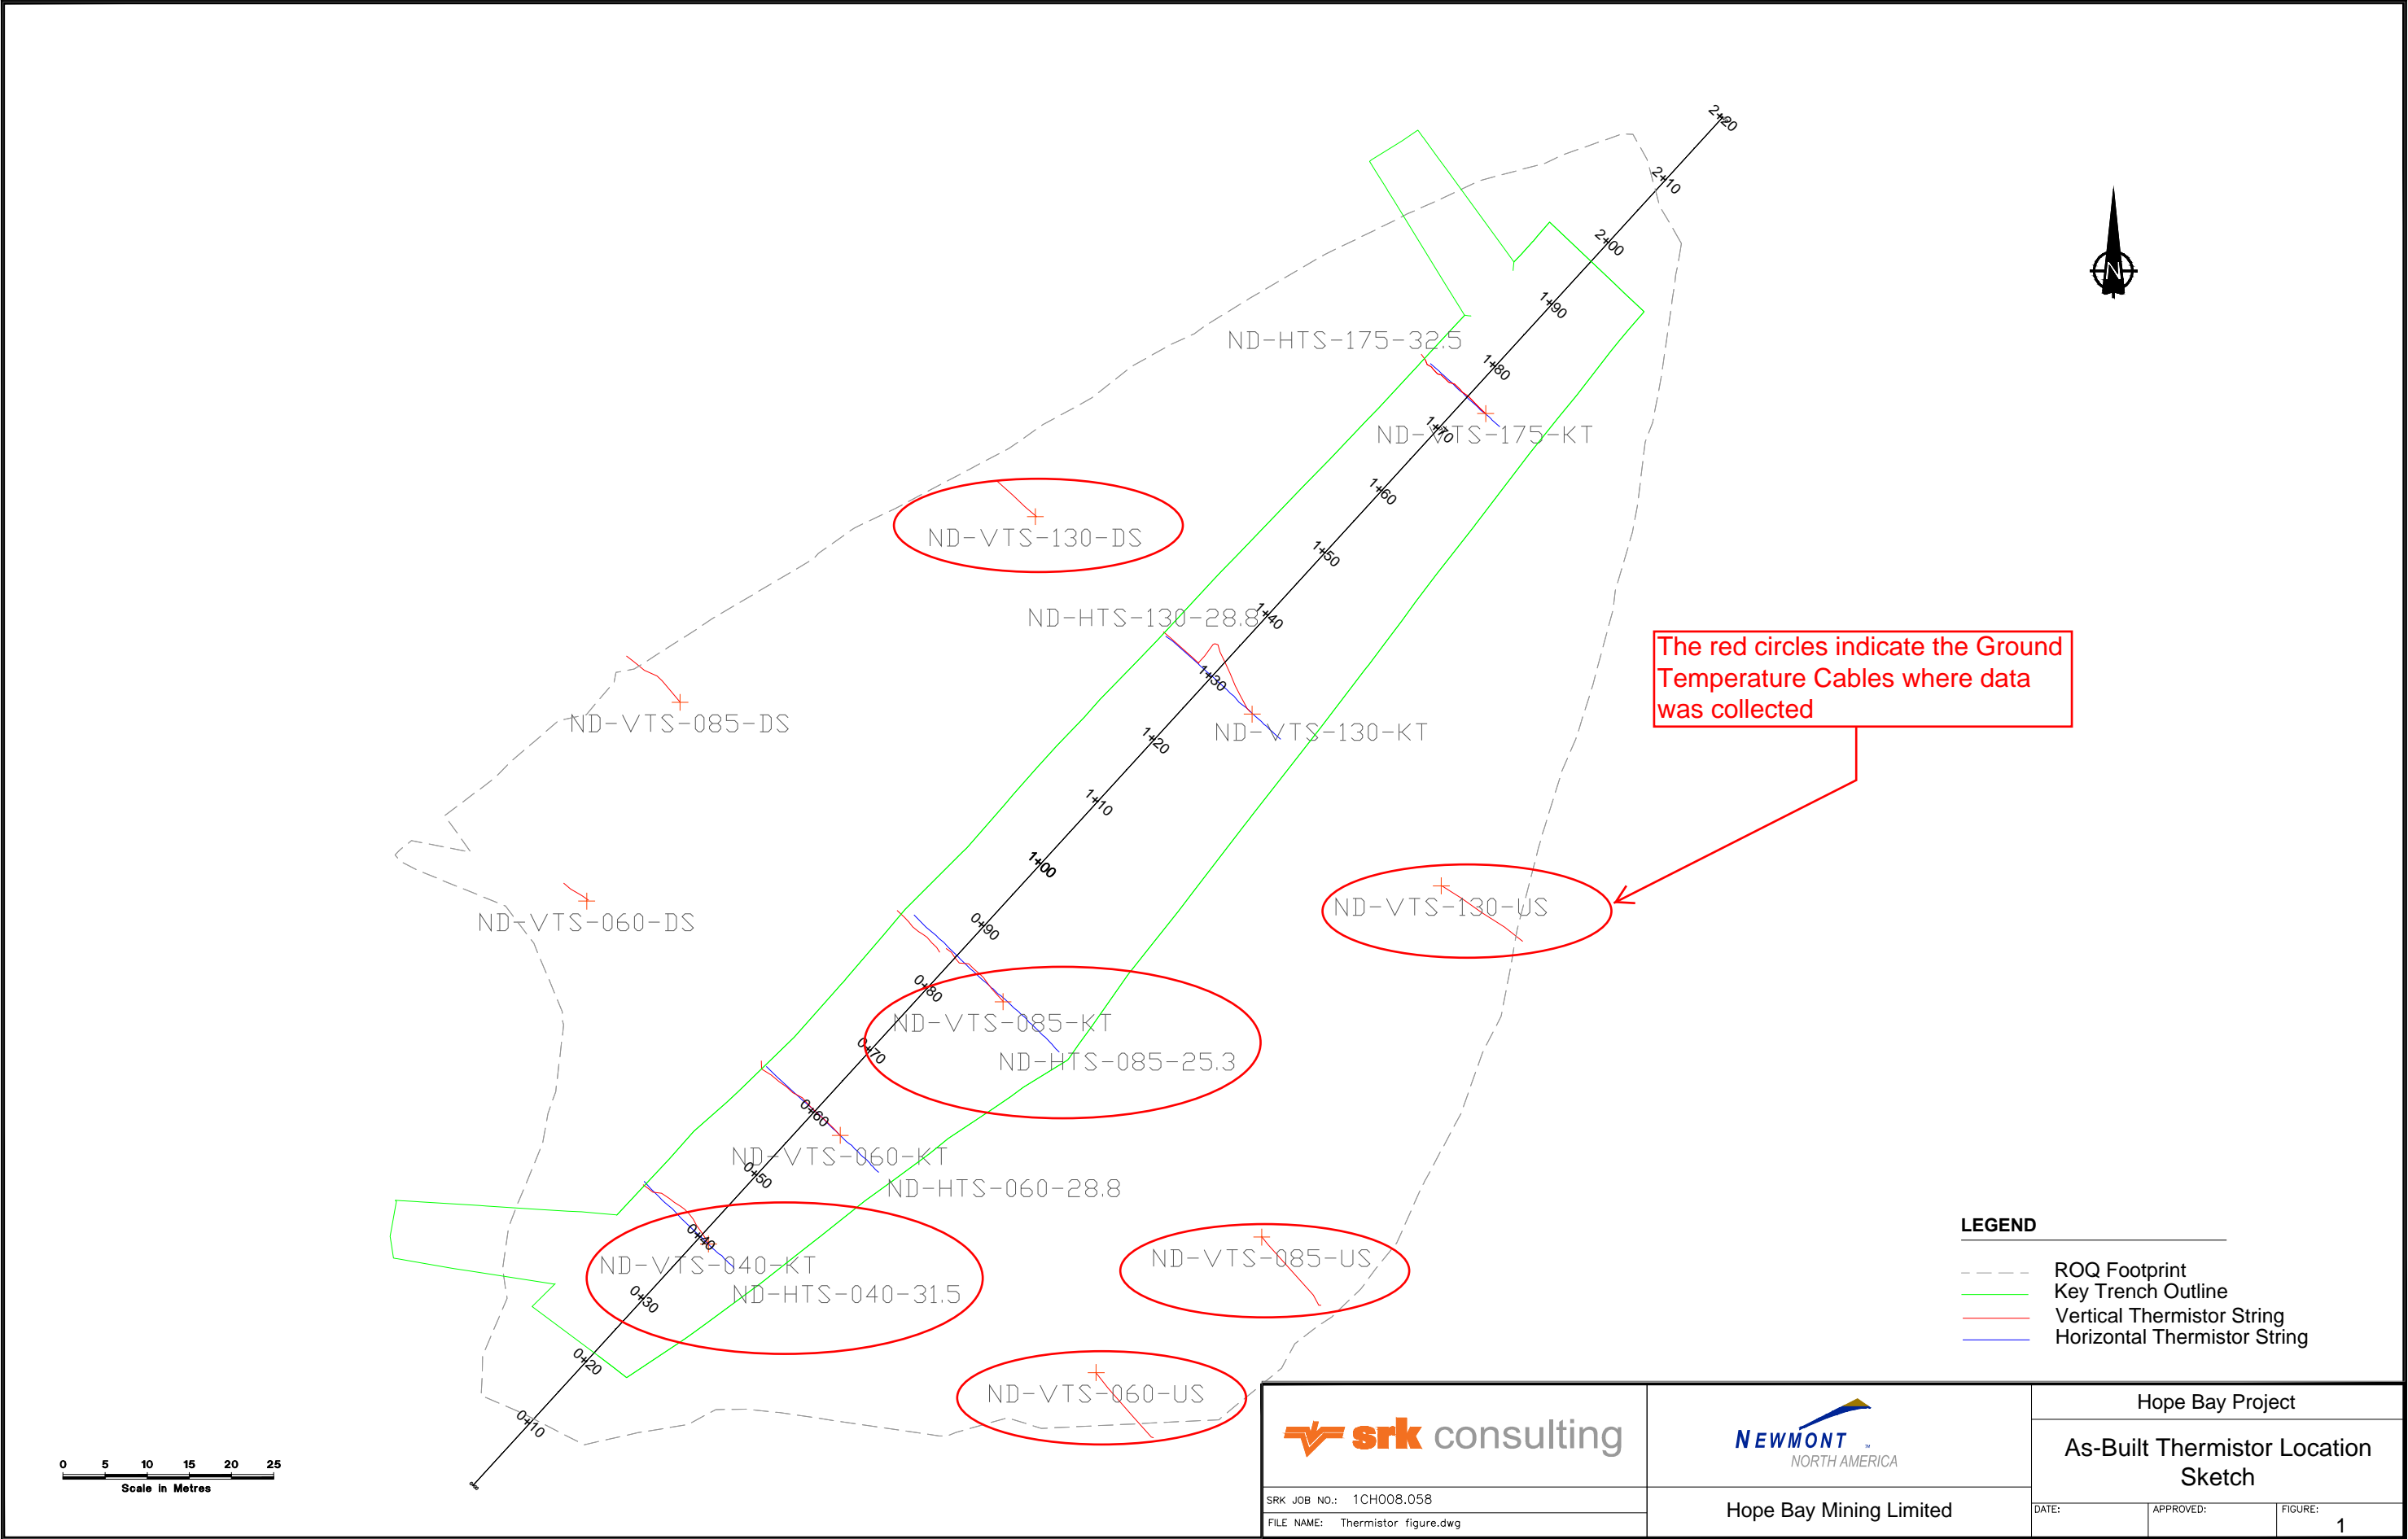
- Based on accessibility, some of the ground temperature cables installed in the North Dam were read. The current location of the ground temperature cables are shown on the sketch at the end of the report.
