DAILY REPORT #07 – DORIS NORTH INFRASTRUCTURE/ NORTH DAM

Prepared by:	John Kurylo/ Lowell Wade	Date:	2012.01.12
Reviewed by:		Project #:	1CH008.058.0320
Role	Company	Personnel – Position	On Site
Client	Hope Bay Mining Limited (HBML)	Angela Holzapfel – ESR Compliance Manager David Vokey – ESR Coordinator Don Ethelston – HSLP Advisor Dean Wold - Safety Jill Turk – ESR Coordinator Katsky Venter – ESR Manger Michelle Tanquay – ESR Site Manager Stirling Kelly – HSLP Advisor	Out In No Out No Out In Yes
	JDS	Lloyd Jackson – Mechanical Superintendent Sven Archimowtiz – Electrical Superintendent Doug Fielding – Construction Manager Ishan Fechter – Construction Coordinator Jerry Graham – Construction Manager Kevin Whieldon – Project Coordinator Mark Valeriote – Construction Manager	Yes Yes No In Yes Out Out
Engineering Design Consultants	SRK Consulting (Canada) Inc.	John Kurylo – Site Engineer Megan Miller – Site Engineer Lawrence Borowski – Site Engineer Murry McGregor – Site Engineer Lowell Wade – Senior Engineer	In No No No Out

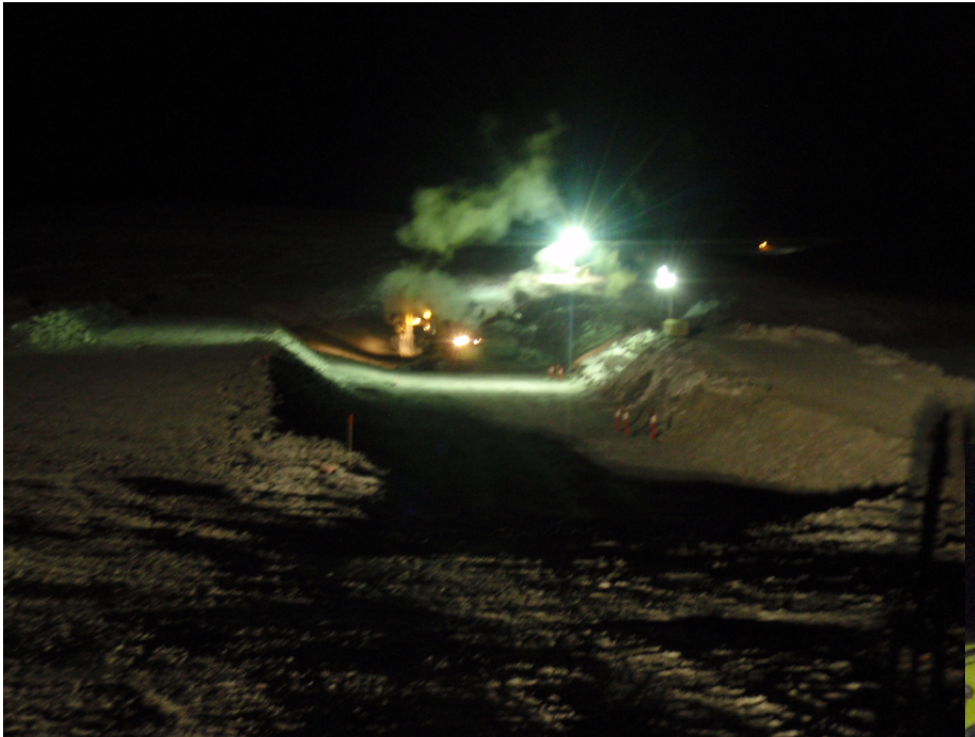
Photo 1: Excavators working on removing frozen 5/8" clear material in North Dam Key Trench, ~ WNW view.

- An excavator was used to remove snow around the FCP Plant Pad and North Dam area.
- Two excavators were used during the day and night shift to remove frozen 5/8" clear material from the key trench footprint. Primarily the central area and the side slopes of the key trench were worked on.

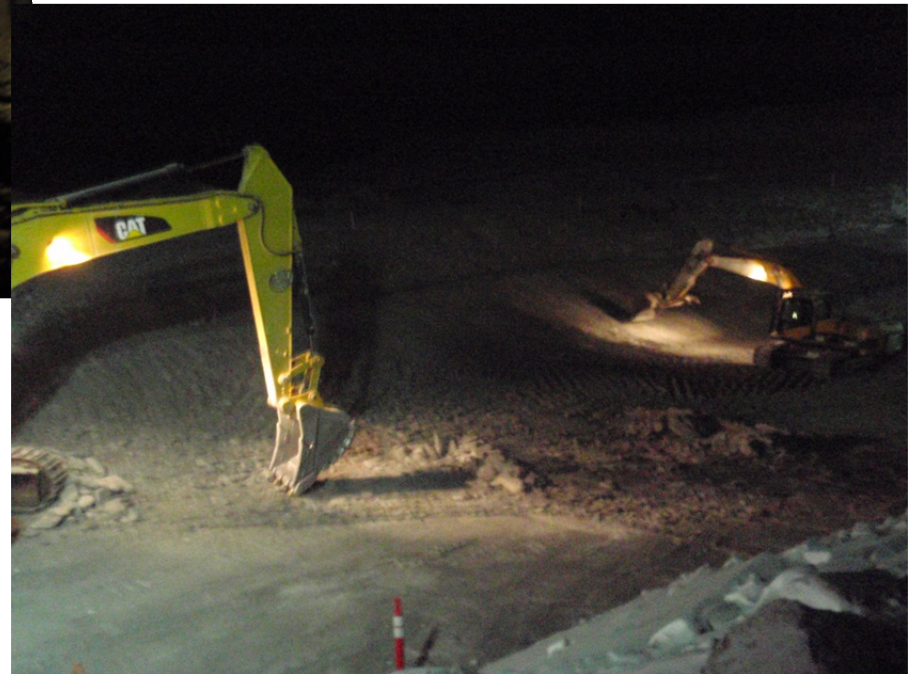
Photo 2: Excavators working on removing frozen 5/8" material in Key Trench, ~ SSW close-up view.
