DAILY REPORT #118 – DORIS NORTH INFRASTRUCTURE/ NORTH DAM

Prepared by:	Lowell Wade	Date:	2012.05.02
Reviewed by:		Project #:	1CH008.058.0320
Role	Company	Personnel – Position	On Site
Client	Hope Bay Mining Limited (HBML)	Angela Holzapfel – ESR Compliance Manager David Vokey – ESR Coordinator Dean Wold - Safety Jill Turk – ESR Coordinator Katsky Venter – ESR Manger Michelle Tanquay – ESR Site Manager Stirling Kelly – HSLP Advisor	No No No Yes No No Yes
	JDS	Doug Fielding – Construction Manager Ishan Fechter – Construction Coordinator Jerry Graham – Construction Manager Mark Valeriot – Construction Manager Calvin Goldschmidt – Construction Coordinator	No No Yes No Yes
Engineering Design Consultants	SRK Consulting (Canada) Inc.	Lowell Wade-Site Engineer Lawrence Borowski – Site Engineer	Yes No
Earthworks Contractor	Nuna Logistics	Doug Haverland – Area/Site Superintendent Gary Sodhi – Field Engineer Georges Cornelissen – Survey Manager Jeff Roberts - Surveyor Jim Cardinal – Site Services Foreman Mike MacMaster – Surveyor Mike Price – Field Engineer Rick Peter – Foreman Trevor Sorken – Area/Site Superintendent	No Yes Yes No Yes No No Yes Yes

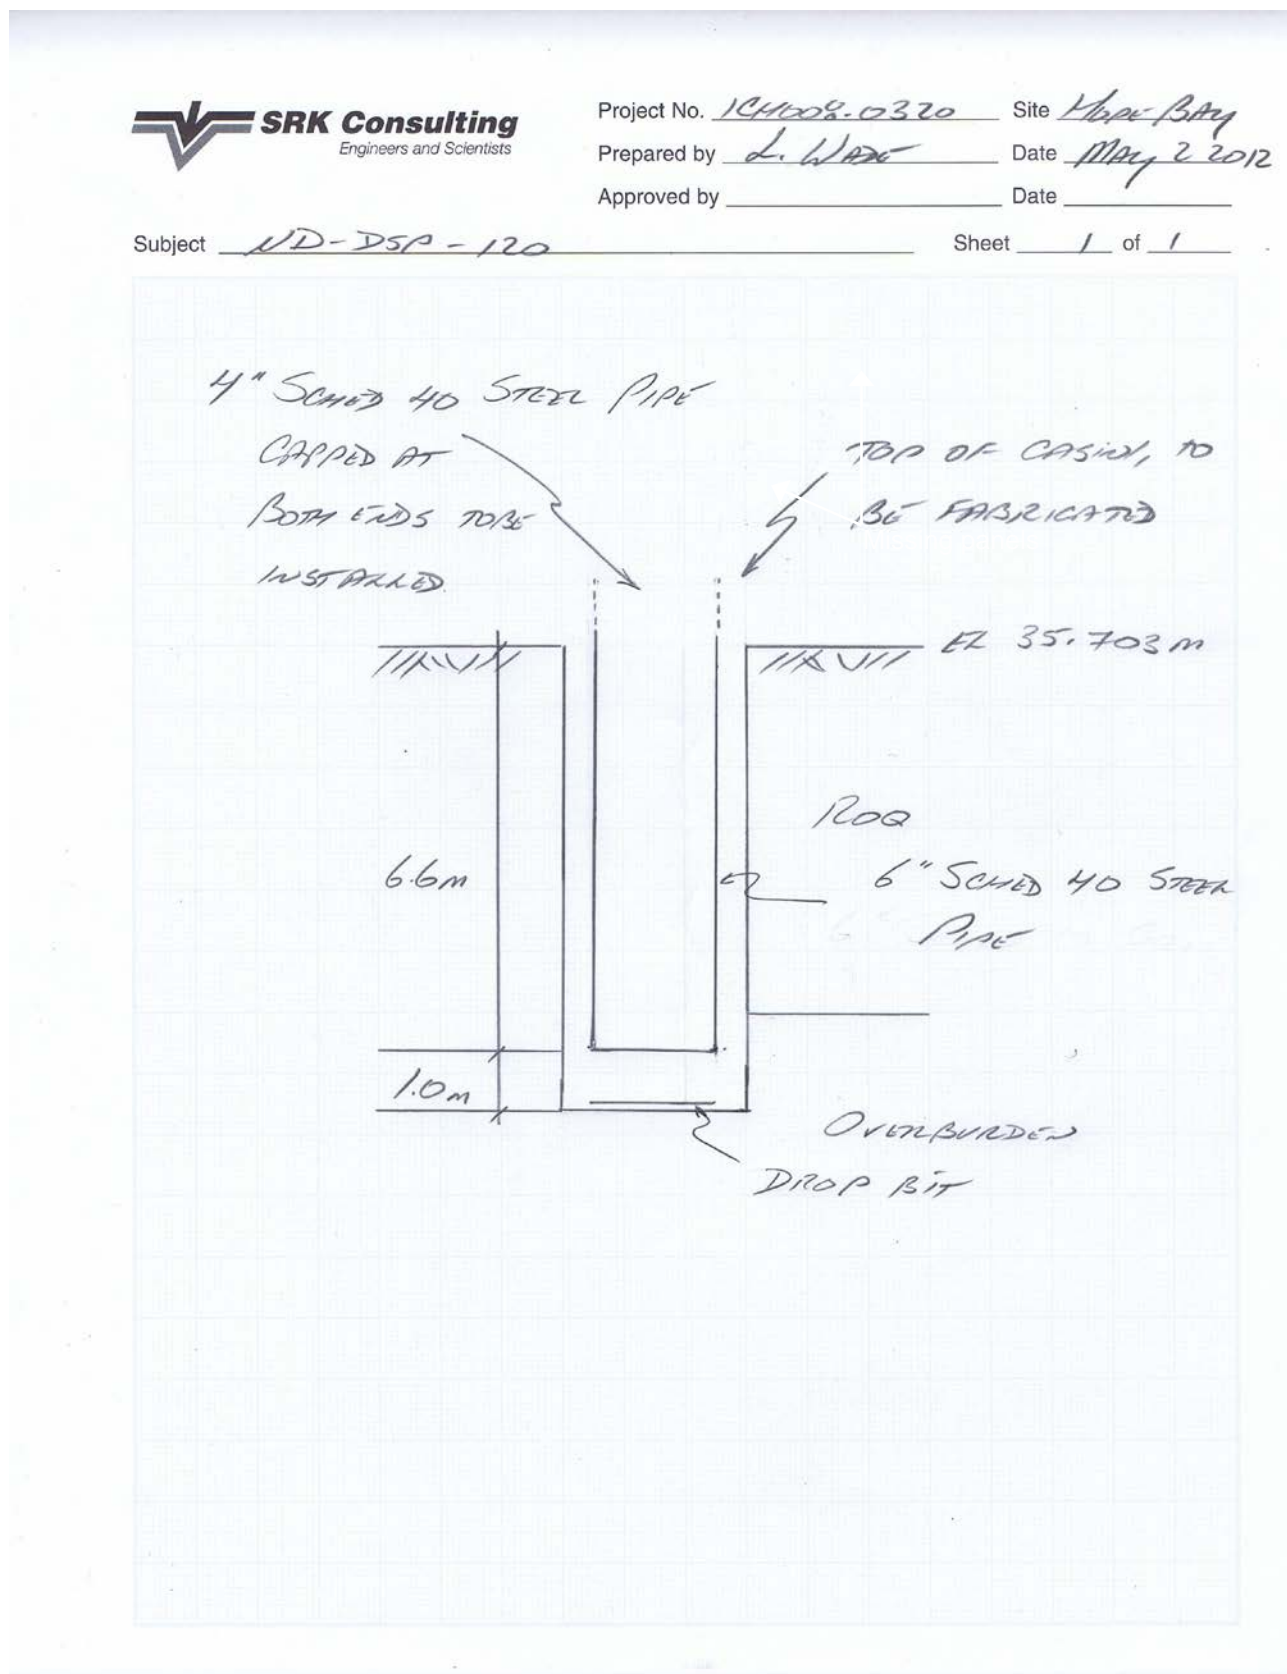
Figure 1: Borehole log for ND-DSP-120.

- ND-DSP-120 was completed (Figure 1).
- ND-DSP-100 was started:
 - Late in the day the weld broke on the outer steel casing and the casing as well as the down hole hammer was lost down the borehole.

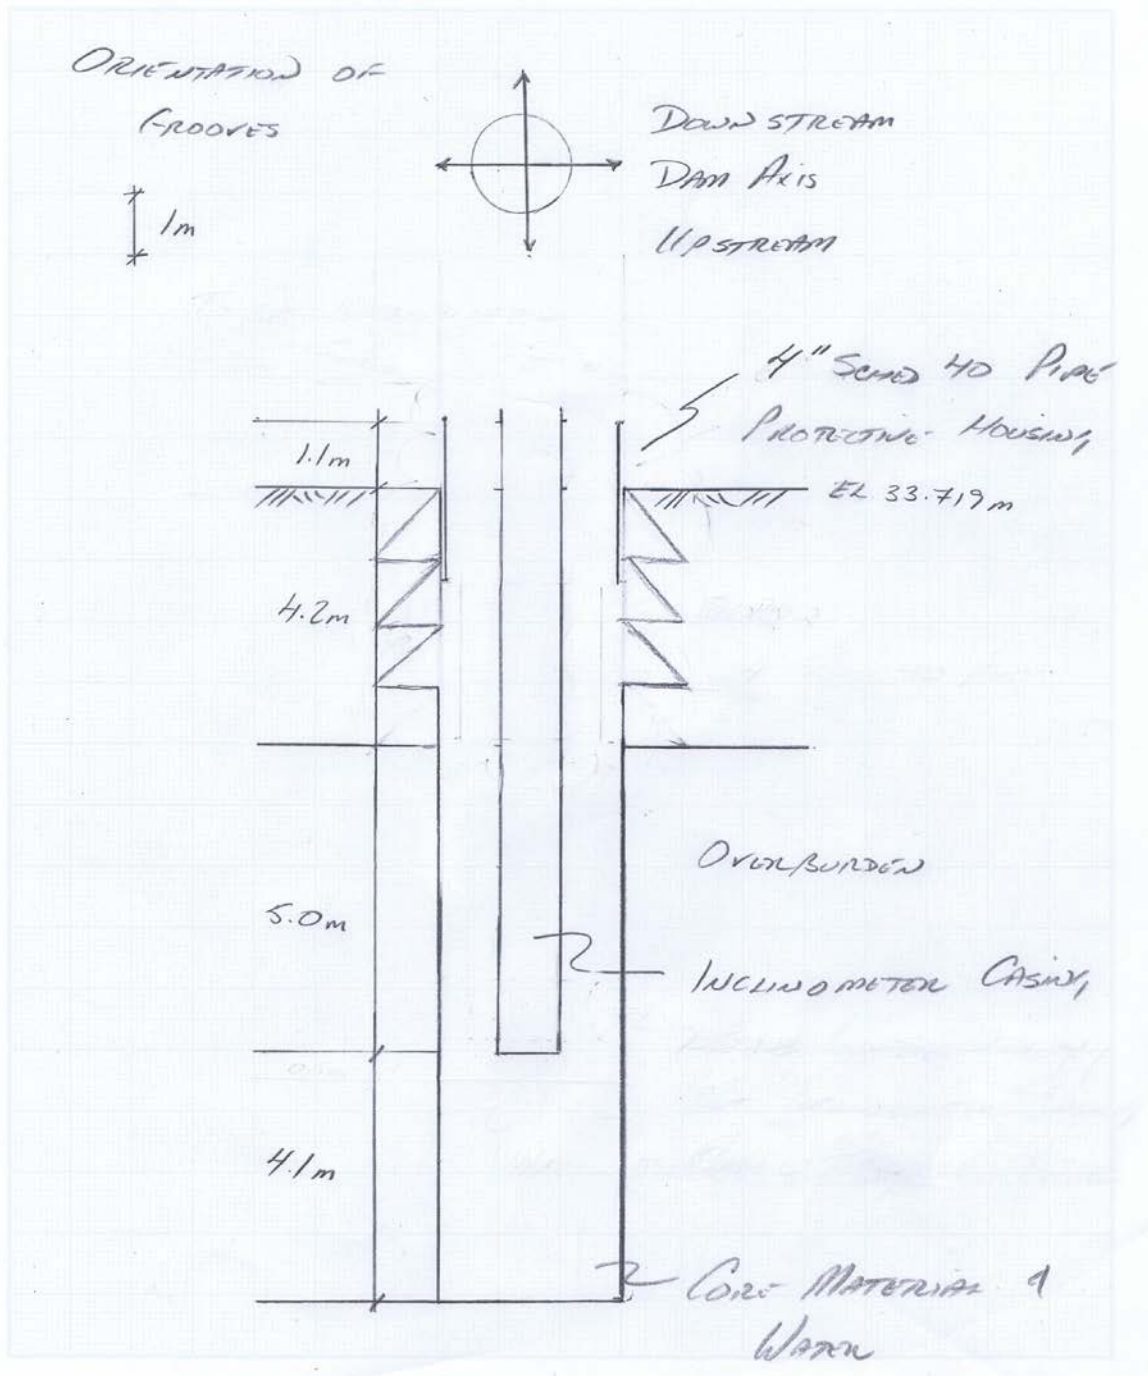
Subject ND-IN-120-3 Sheet 1 of 1

- Collar elevation = 33.719 m
 - Bottom of inclinometer casing elevation = 24.5 m [9.2 m]
 - Borehole previously drilled to 20.4 m [13.3 m].
 - The ROQ around the borehole was excavated with a 345D excavator to expose the upper 6" Sched 40 steel pipe. The slurry material was removed from around the steel pipe using hand shovels

Figure 2: As-built of slope indicator casing installation for ND-IN-120-3.

- West Arc was able to retrieve the outer steel casing and down hole hammer later in the evening.
 - Installation to be completed the following day.
- ND-IN-120-3 was reconstructed to design (Figure 2):

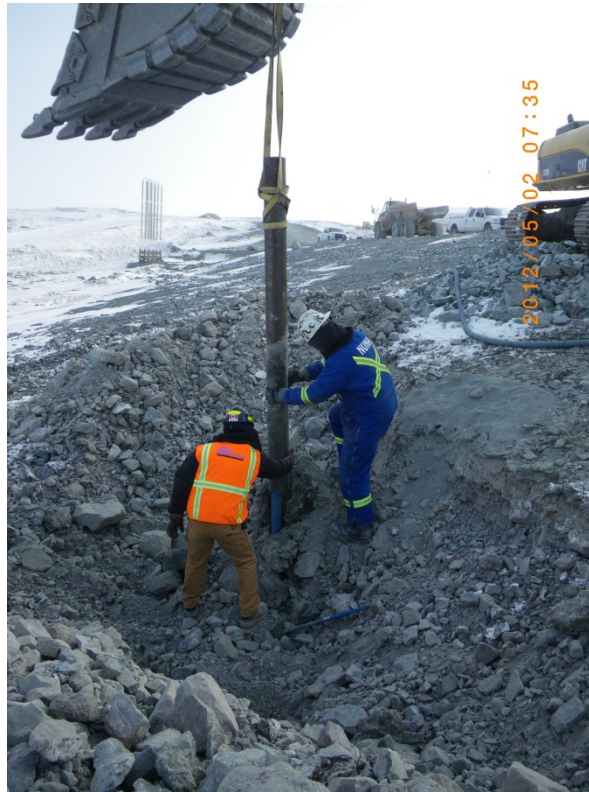
- The 6" Sched 40 steel pipe was gently lifted off the Inclinometer Casing without any problems by using slings and the 345D excavator.
 - Continued excavation and hand shoveling was required to expose the top 0.3 m of the 4" Sched 40 steel pipe. The top of this steel pipe was ~1.7 m below the ROQ surface.

Photo 1: Excavation and removal of 6" steel pipe from around ND-IN-120-3

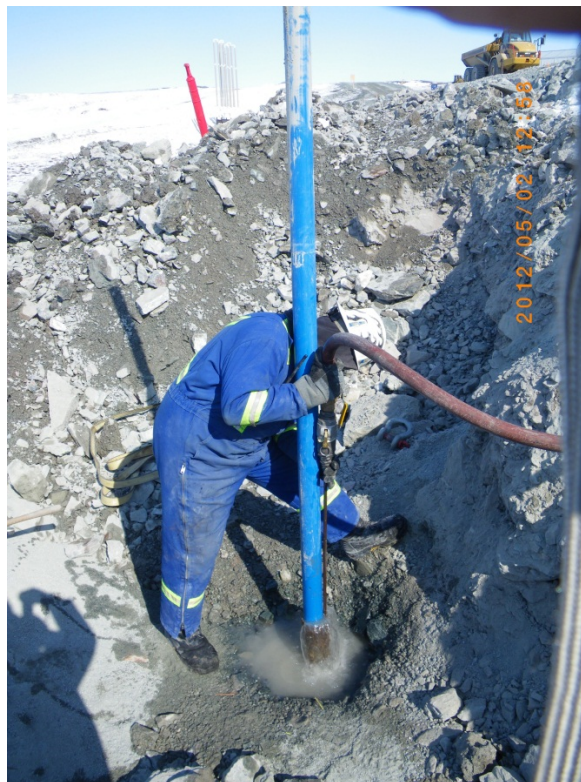
- The initial attempts to lift the 4" steel pipe, with slings and the 345D excavator, also started to lift the Inclinometer Casing.
 - A water lance was fabricated to flush most of the granular material from between the 4" steel pipe and the Inclinometer Casing.

Photo 2: Water lance used to flush material from between the 4" steel pipe and the Inclinator Casing.

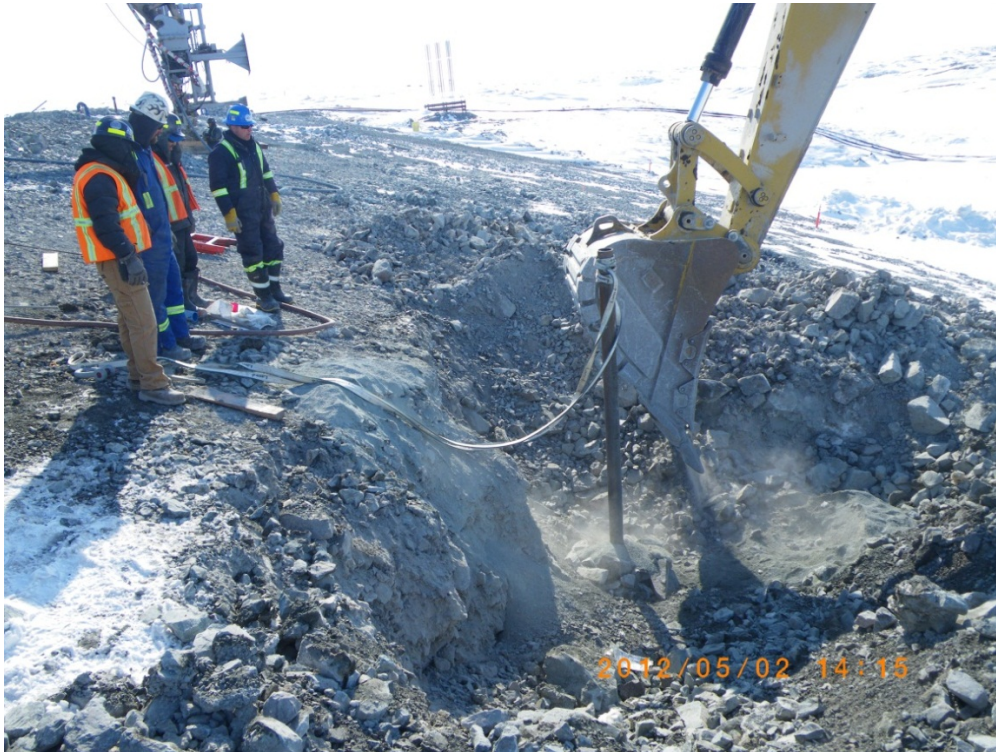
- Once the 4" steel pipe was freed from the borehole it was held in-place over the Inclinometer Casing at the final elevation of 1.1 m above the ROQ surface. Core material and ROQ was placed back into the excavation up to the original ROQ surface.

Photo 3: Back-filling of ND-IN-120-3 in lifts of core material and ROQ.

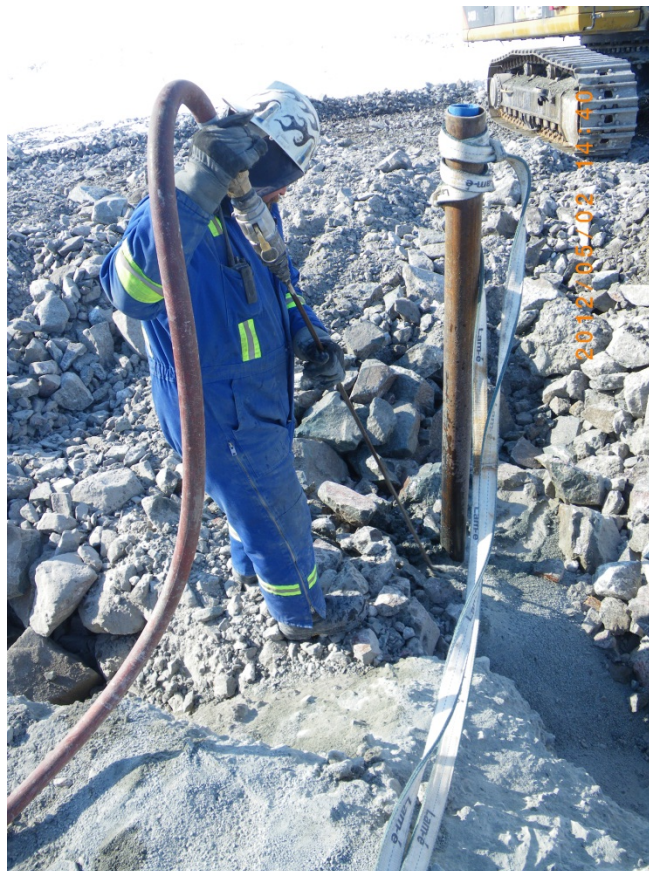
Photo 4: The water lance was used to saturate the core material around the Inclinator Casing and 4" steel pipe.

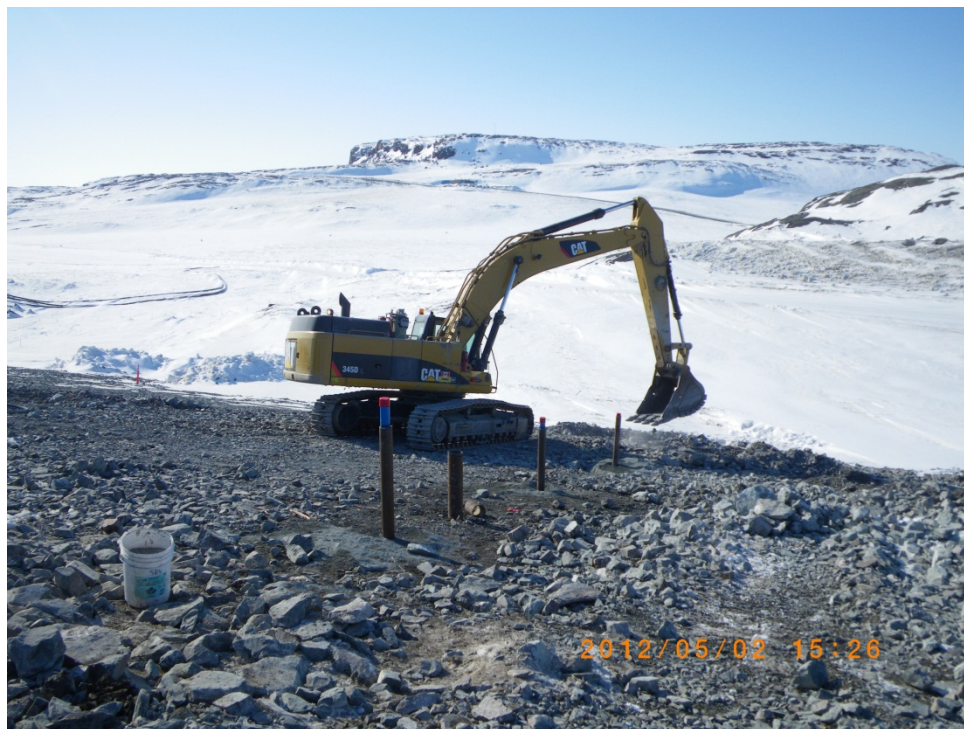
Photo 5: All instrumentation along Station 1+20 installed. The 4" Sched 40 Steel Pipe still to be installed in ND-DSP-120 and the top caps fabricated and installed on all instrumentation.

- A protective cap has yet to be manufactured.
 - The dummy probe was run down both tracks of the Inclinometer Casing. Some fine granular material had entered the Casing which was cleared by the dummy probe. Water was encountered at the bottom of the casing. The Vacuum Truck fitted with a 2" diameter hose will be used to remove the water and fine granular material.
