DAILY REPORT #121 – DORIS NORTH INFRASTRUCTURE/ NORTH DAM

Prepared by:	Lowell Wade	Date:	2012.05.05
Reviewed by:		Project #:	1CH008.058.0320
Role	Company	Personnel – Position	On Site
Client	Hope Bay Mining Limited (HBML)	Angela Holzapfel – ESR Compliance Manager David Vokey – ESR Coordinator Dean Wold - Safety Jill Turk – ESR Coordinator Katsky Venter – ESR Manger Michelle Tanquay – ESR Site Manager Stirling Kelly – HSLP Advisor	No No Yes Yes No No No
	JDS	Doug Fielding – Construction Manager Ishan Fechter – Construction Coordinator Jerry Graham – Construction Manager Mark Valeriot – Construction Manager Calvin Goldschmidt – Construction Coordinator	No Yes Yes No No
Engineering Design Consultants	SRK Consulting (Canada) Inc.	Lowell Wade-Site Engineer Lawrence Borowski – Site Engineer	Yes No
Earthworks Contractor	Nuna Logistics	Doug Haverland – Area/Site Superintendent Gary Sodhi – Field Engineer Georges Cornelissen – Survey Manager Jeff Roberts - Surveyor Jim Cardinal – Site Services Foreman Mike MacMaster – Surveyor Mike Price – Field Engineer Rick Peter – Foreman Trevor Sorken – Area/Site Superintendent	Yes Yes Yes No Yes No No Yes No

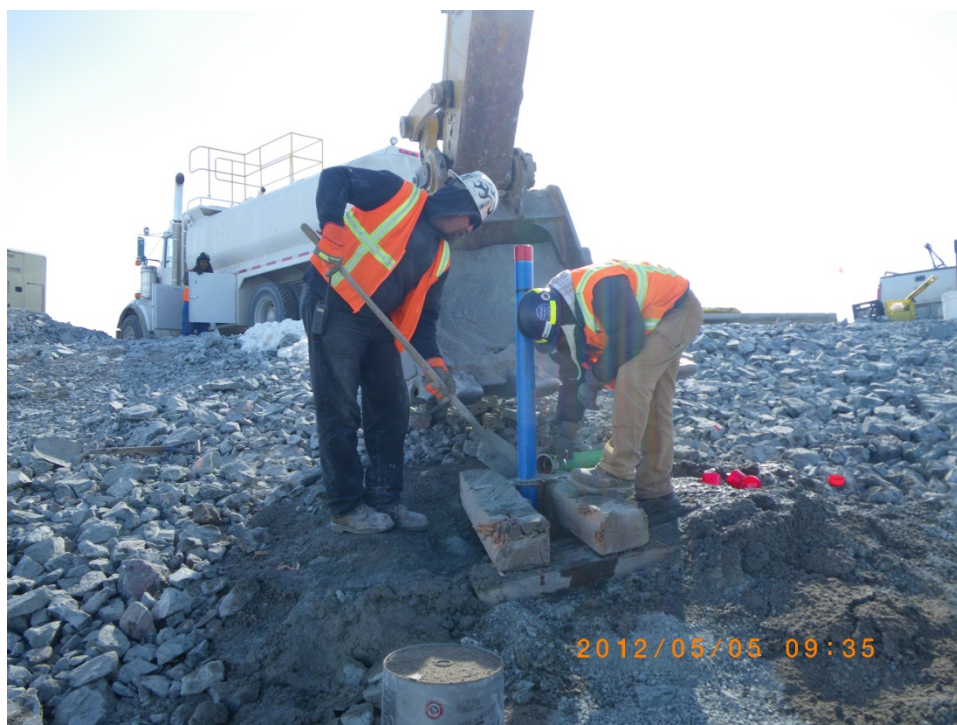
Photo 2: Installation of the last Inclinometer Casing into ND-IN-070-1.

- ND-IN-070-1 was drilled and the Inclinator Casing installed. The dummy probe was used to confirm both grooves were functional (Figure 1).
- The remaining six ND-SSP large ROQ boulders were installed. The survey pins to be installed tomorrow.

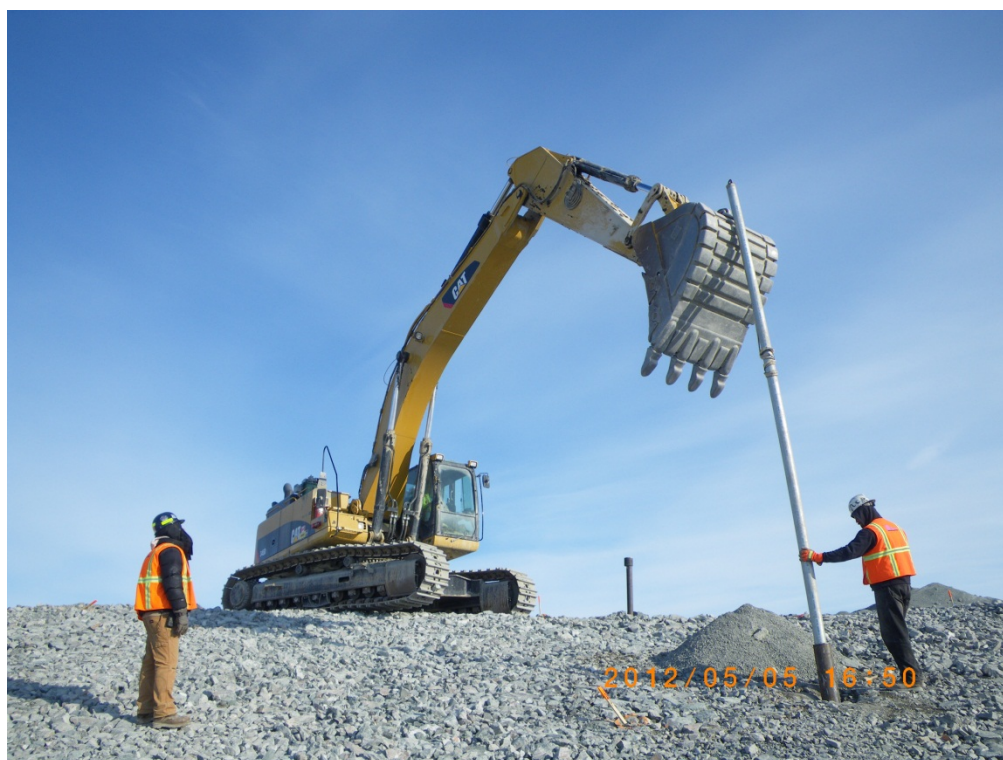
Photo 3: The Deep Settlement Pipe being lowered into the outer steel casing of ND-DSP-100.

- Survey control points on bedrock outcrops on the east side of the dam to be installed tomorrow.
- ND-DSP-100 deep settlement pipe was installed [Borehole log to follow]. The outer steel casing to be welded to 1.1 m above grade and protective cap to be fabricated.

- The Deep Settlement Pipe was fabricated for 6 m lengths of 4" Vitriolic pipe was welded together and the ends sealed
 - The Deep Settlement Pipe was then lifted into place, using the excavator, and used to sound the borehole.

- It was determined the borehole had re-opened to the drilled depth of 12.8 m
 - While the Deep Settlement Pipe was then suspended, at the correct elevation, ¾" crush material was poured down the annulus until the Deep Settlement Pipe was supported by the back-fill material.

- The Deep Settlement Pipe was finally used to compact the back-filled borehole to make sure it was founded on firm material.
- General clean-up and compaction around the dam continues.
