## DAILY REPORT #20 – DORIS NORTH INFRASTRUCTURE/ NORTH DAM

Prepared by:	John Kurylo/ Jeff Orr / Megan Miller	Date:	2012.01.25
Reviewed by:		Project #:	1CH008.058.0320
Role	Company	Personnel – Position	On Site
Client	Hope Bay Mining Limited (HBML)	Angela Holzapfel – ESR Compliance Manager David Vokey – ESR Coordinator Don Ethelston – HSLP Advisor Dean Wold - Safety Jill Turk – ESR Coordinator Katsky Venter – ESR Manger Michelle Tanquay – ESR Site Manager Stirling Kelly – HSLP Advisor	No Yes Yes No No No Yes No
	JDS	Lloyd Jackson – Mechanical Superintendent Sven Archimowtiz – Electrical Superintendent Doug Fielding – Construction Manager Ishan Fechter – Construction Coordinator Jerry Graham – Construction Manager Kevin Whieldon – Project Coordinator Mark Valeriote – Construction Manager	No Yes Yes Yes No No Out
Engineering Design Consultants	SRK Consulting (Canada) Inc.	John Kurylo – Site Engineer Megan Miller – Site Engineer Lawrence Borowski – Site Engineer Murry McGregor – Site Engineer Iozsef Miskolczi – Site Engineer	Yes Yes No No No

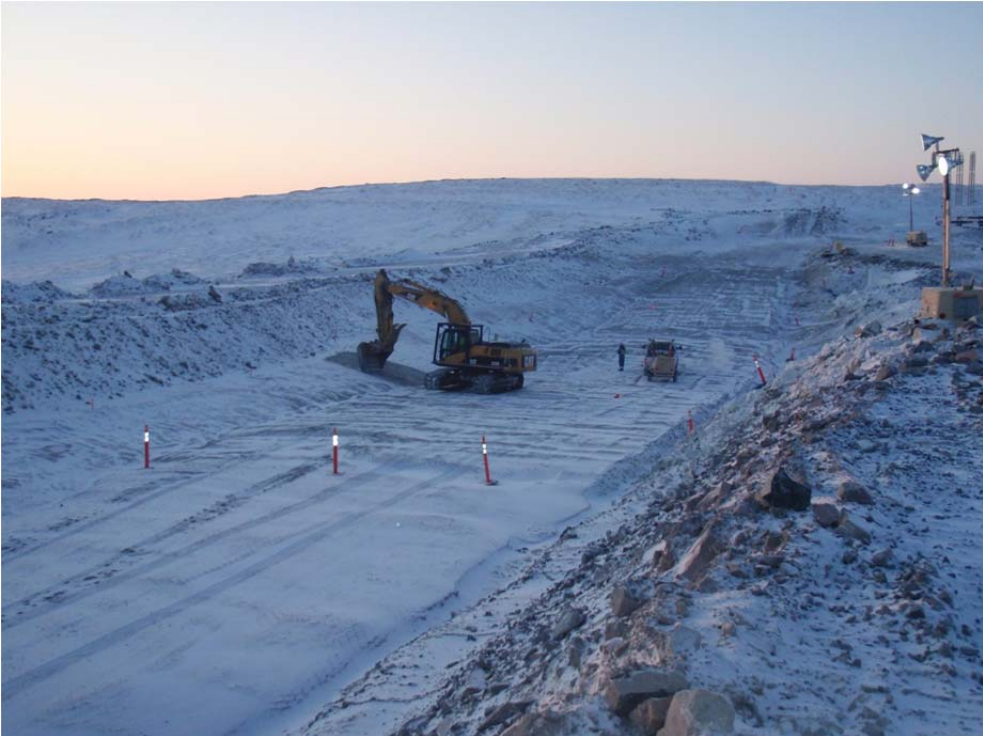
**Photo 1:** ~ SSW view of the 325 excavator (with finishing bucket) cleaning the upper side slopes of 5/8" material around 1+10.

- The 325 excavator, equipped with finishing bucket was used to scrape down addition 5/8" material around 1+10, from ~ 0+60 to 0+40 on the upstream fillet slopes and from ~0+40 to 0+20 on the base of the existing key trench.

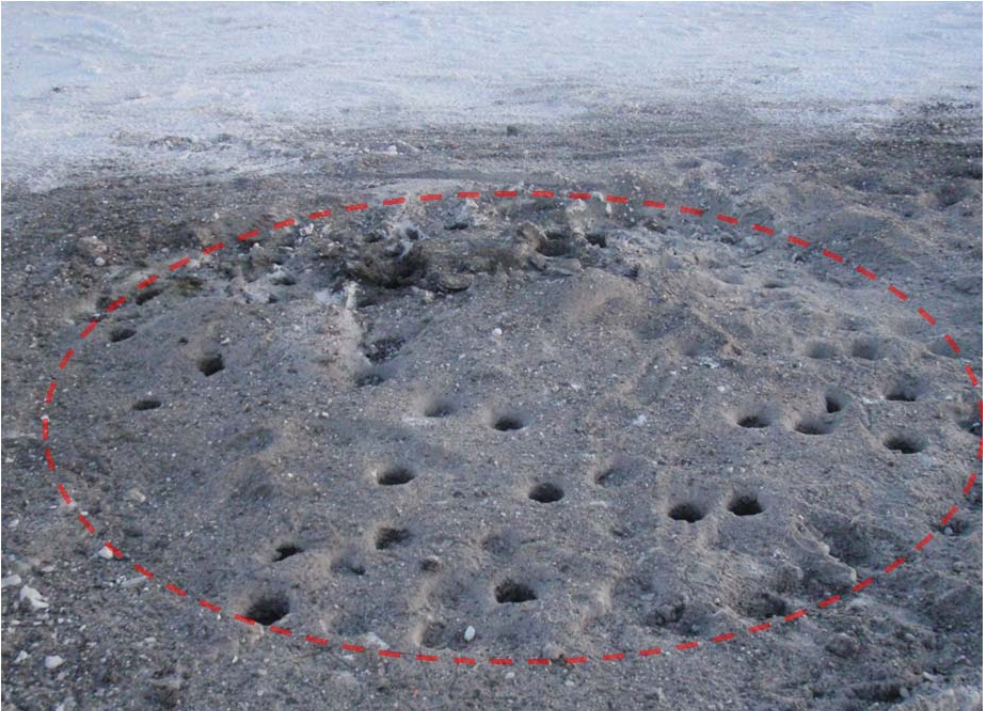
**Photo 2:** Close-up view of the Sump #2 location after drilling was completed. Note that some of the drilled holes are not visible due to the cutting in the area. The Sump location has a 'honeycomb' appearance

- Westarc completed drilling activities at Sump 2 today.
- Snow road construction around the DN Diversion Berm continues slowly.
- Snow and a thin layer of soil was stripped off the main bedrock outcrop noted towards the east central area of the DN Diversion Berm. The Westarc drill was mobilized to this location.
- Snow was removed along the eastern extents of the DN Diversion Berm key trench alignment. Tomorrow SRK plans to do a field inspection of this location.

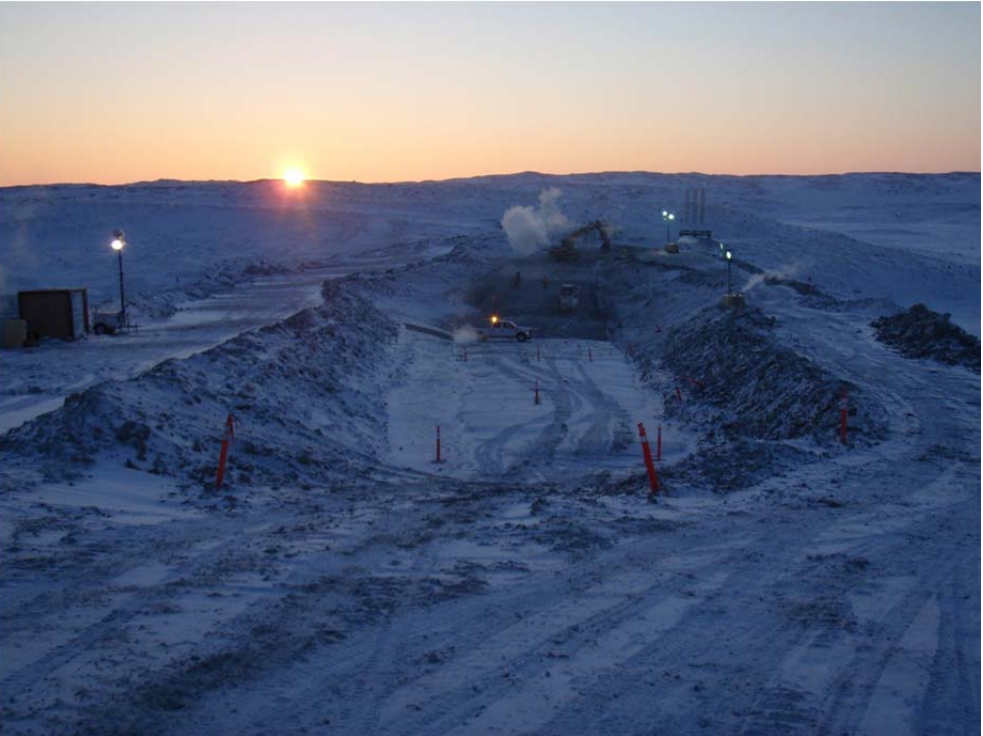
**Photo 3:** ~ WNW view down key trench towards construction activities. Note that the most WSW area of the key trench is being cleaned in preparation for placement.

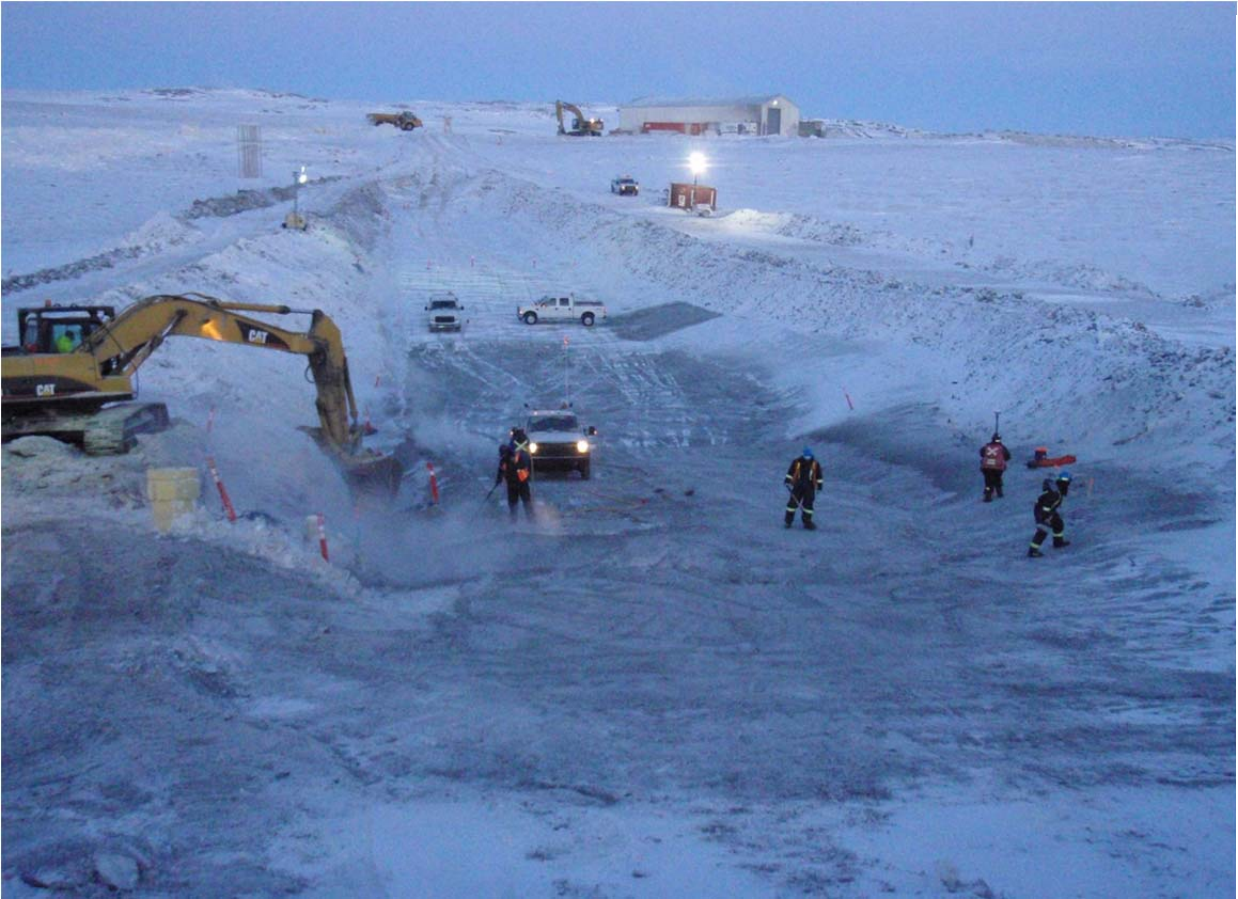
**Photo 4:** ~ NEE view of cleaning activities along the downstream edge of the key trench around station 0+50.

- While FCM was placed to the south west labourers were cleaning the floor of the key trench north east of sta. 1+10 with the air compressor.
  - The bobcat with the broom attachment was not available during night shift as it was in the shop being repaired.

- Compacted snow from driving on the key trench prior to cleaning remained after being cleaned by the air compressor.
  - The CAT 325 excavator was used to scrape the compacted snow. The labourers then blew the surface clean of loose debris. This area was looking very good by the end of nightshift.

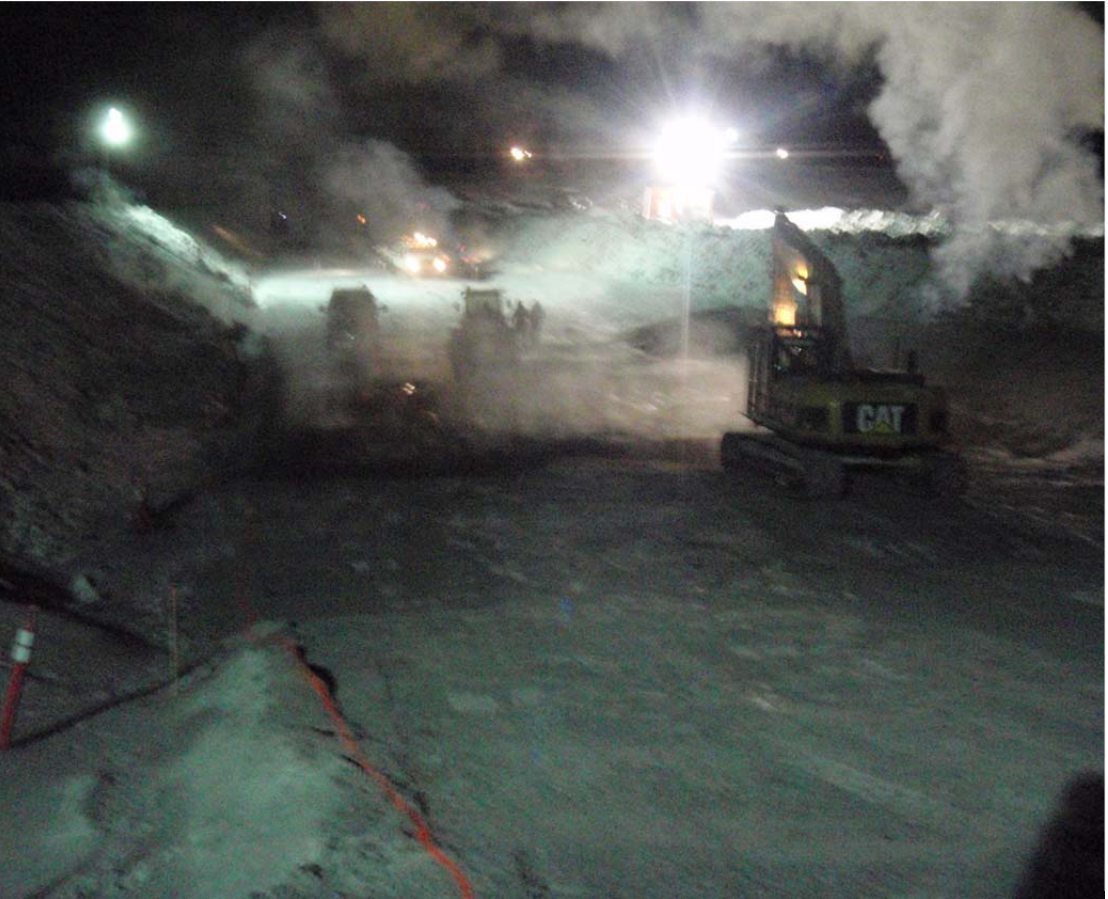
**Photo 5:** ~ NEE view of FCM placement around 0+90 late in dayshift.

- Core material placement was started at around 16:30 and ran to the end of dayshift.
- FCM was placed from ~ 1+10 to 0+85 on dayshift.
  - Material was of good quality (slightly wetter and hotter) and was observed to be more workable. Less compactive effort was required to get saturation and densities and a cleaner finished surface was left (less sticking to the vibratory drum).
- Nuna's shift change was done on the fly in order to not stop the frozen core plant. Placement of core material did not stop at shift change (i.e. hot change).
- A progress figure showing the approximate extent of day shift placement is provided as Figure 1.

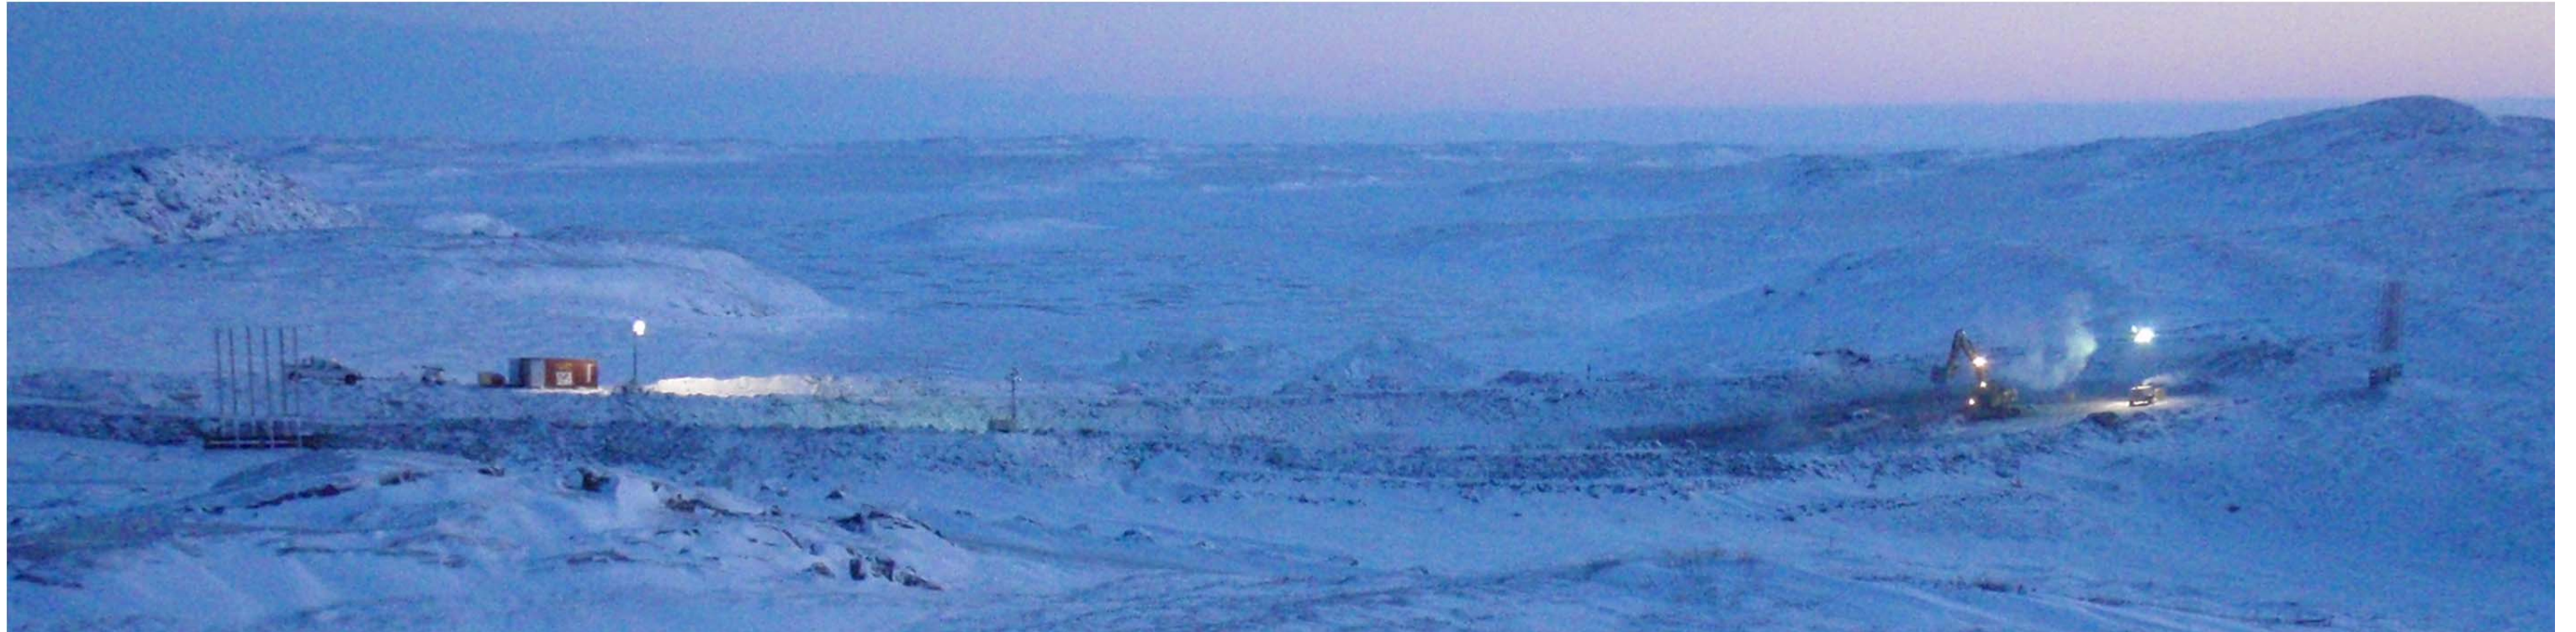
**Photo 6:** Progress photo of North Dam from photo point 1. ~SW view.

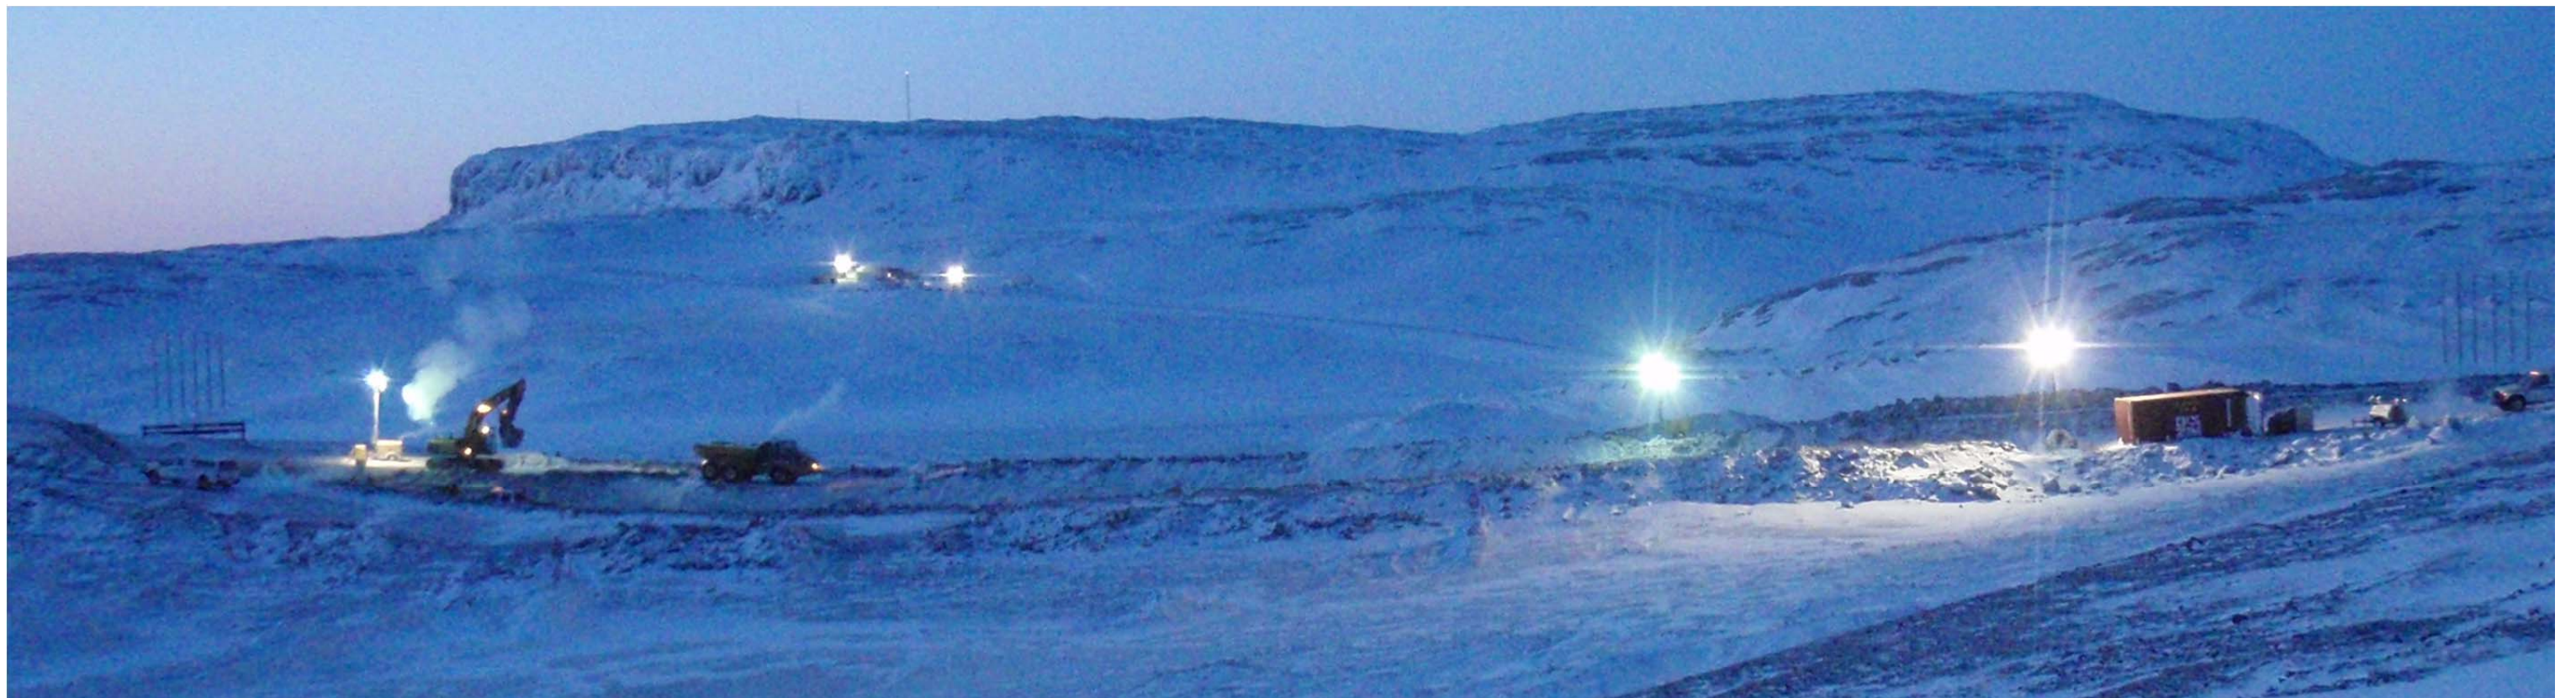
**Photo 7:** Progress photo of North Dam from photo point 2. ~WNW view.

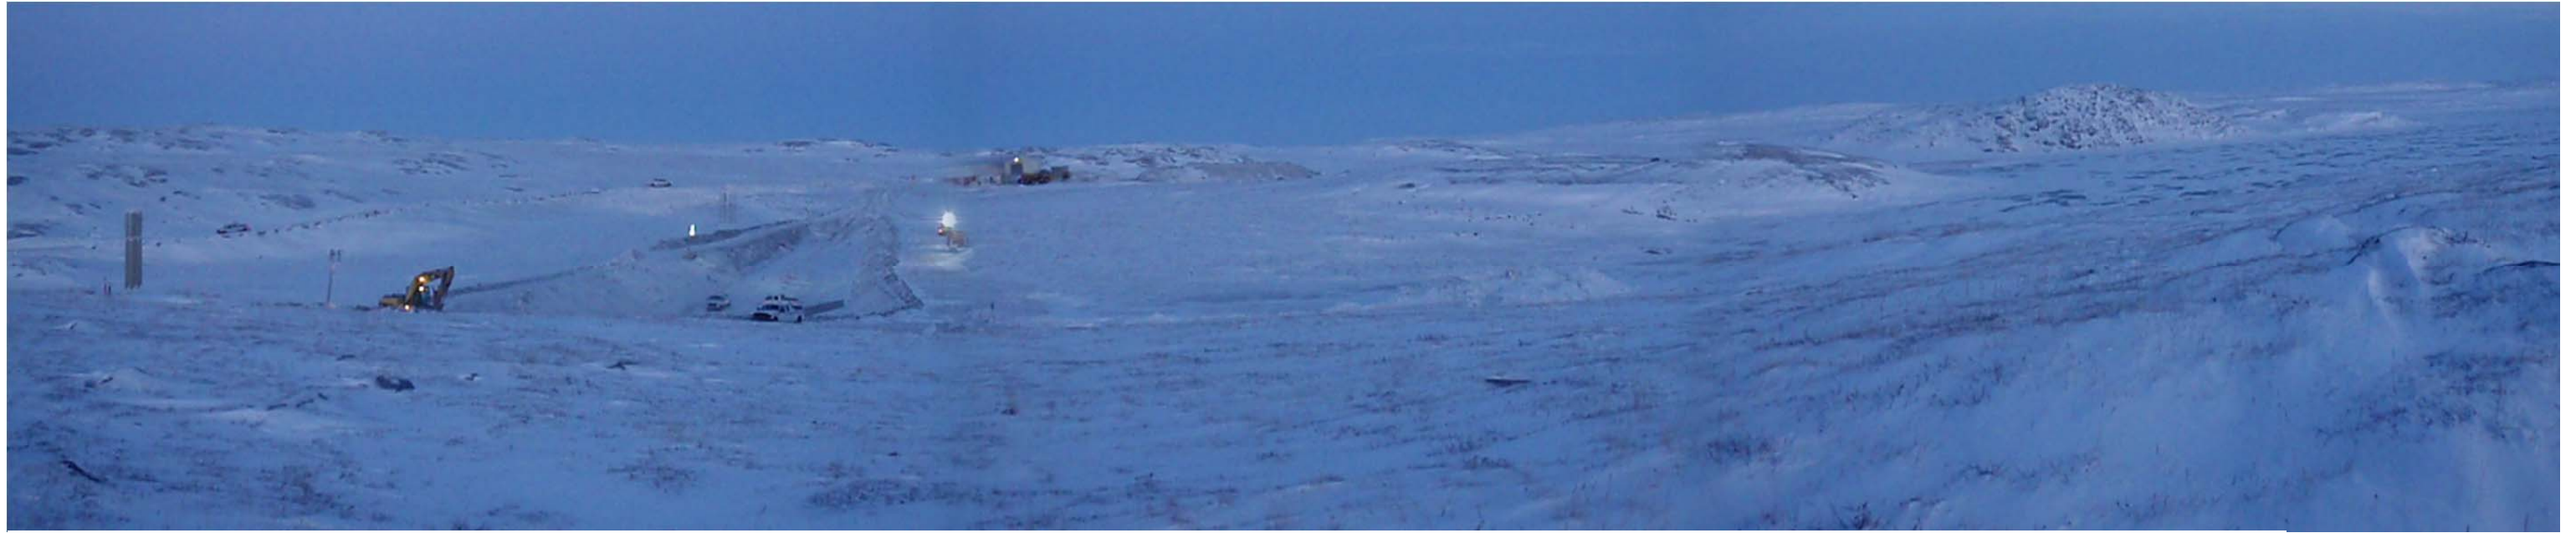
**Photo 8:** ~ NEN stitched panoramic view of the North Dam (left forefront), Frozen Core Plant (back center) and Tails Lake.

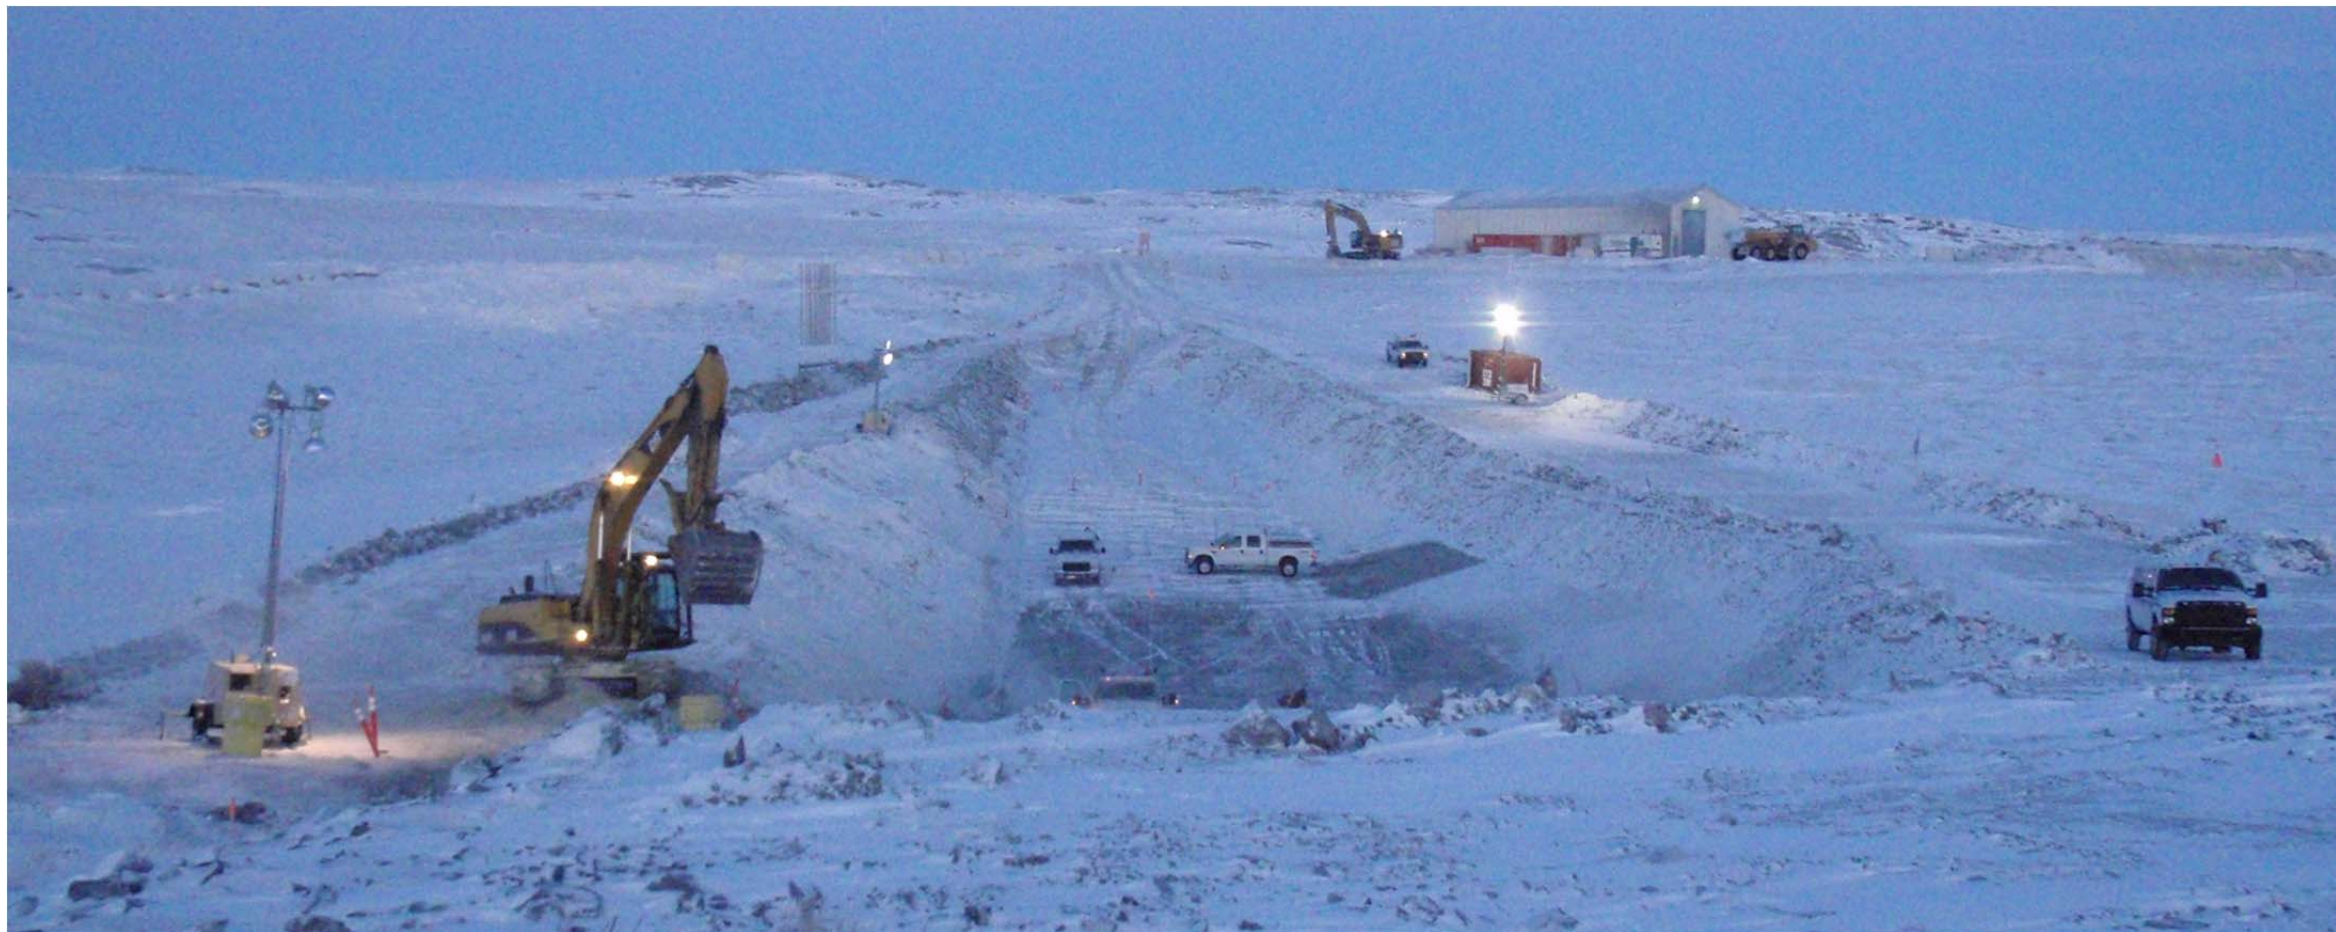
**Photo 9:** Progress photo of North Dam from photo point 3 (newly established point). ~ENE view.

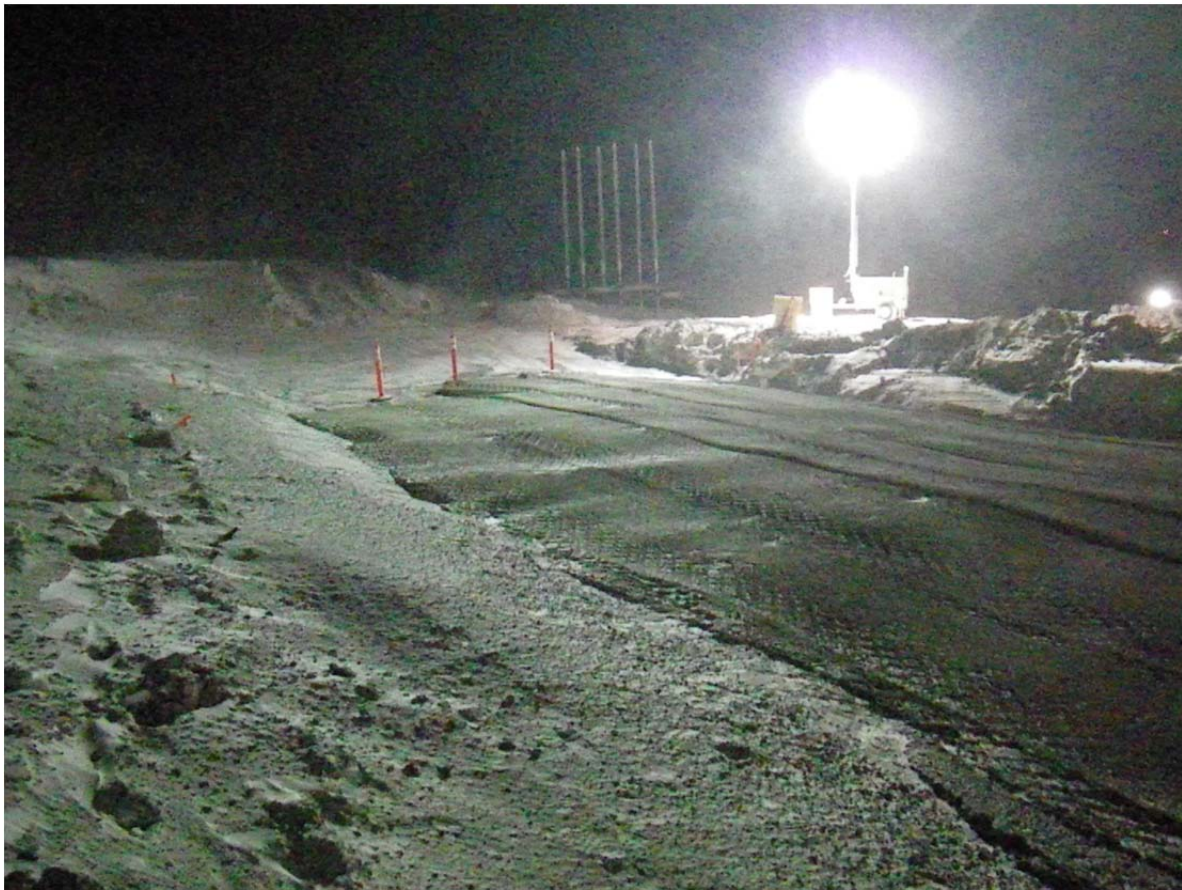
**Photo 10:** Placed FCM looking west along key trench from approximately station 0+60. Material placement ended at the delineators ~sta. 0+40.

- Five of the multi-bead thermistors are missing their protective caps.
- Placement of saturated FCM continued towards the south west with a hot change between shifts. Night shift started at ~0+85 working south west up the hill until approximately stn. 0+40.

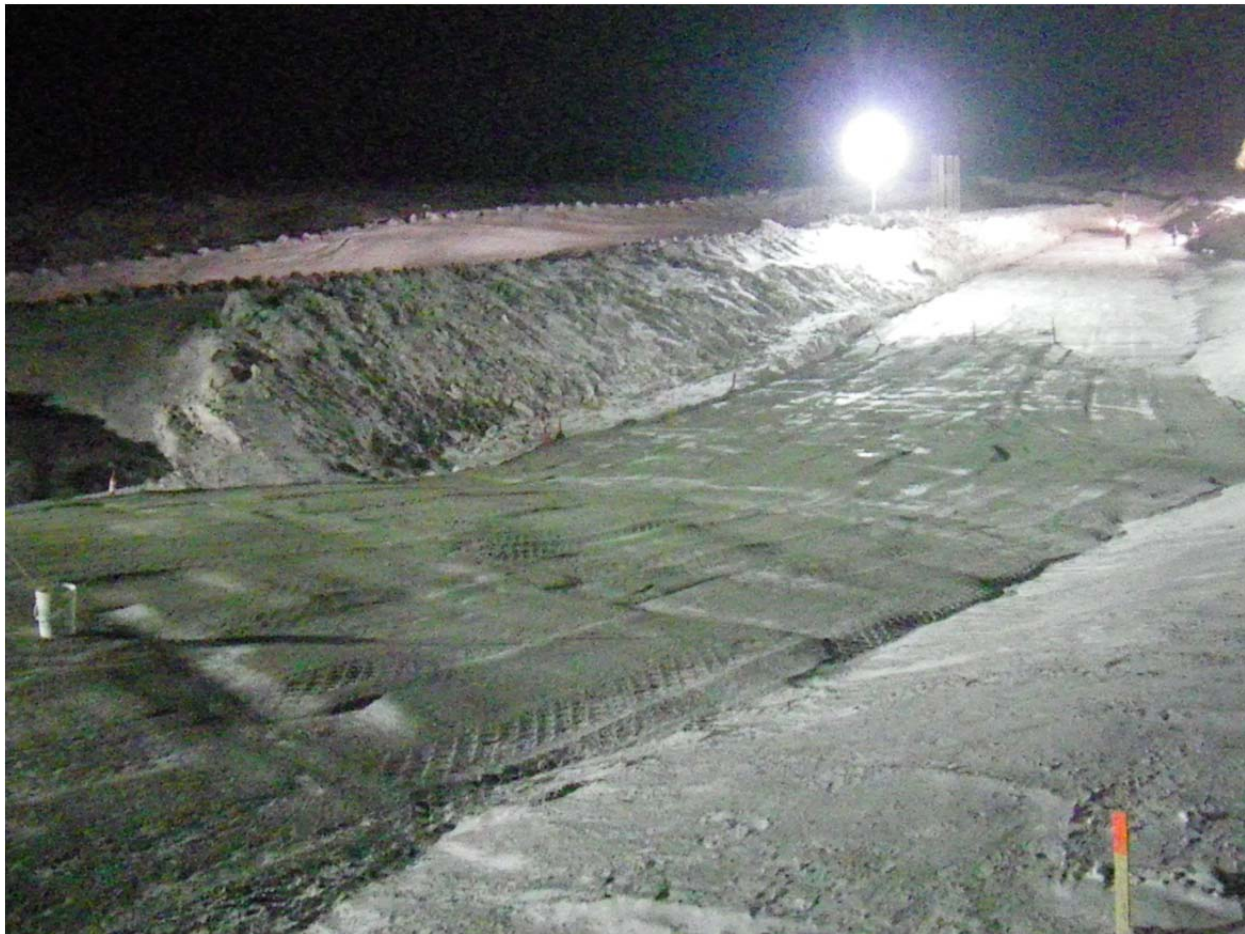
**Photo 11:** Placed FCM looking NE along key trench from ~station 0+60. Placed material ends where the photo transitions from grey to white.

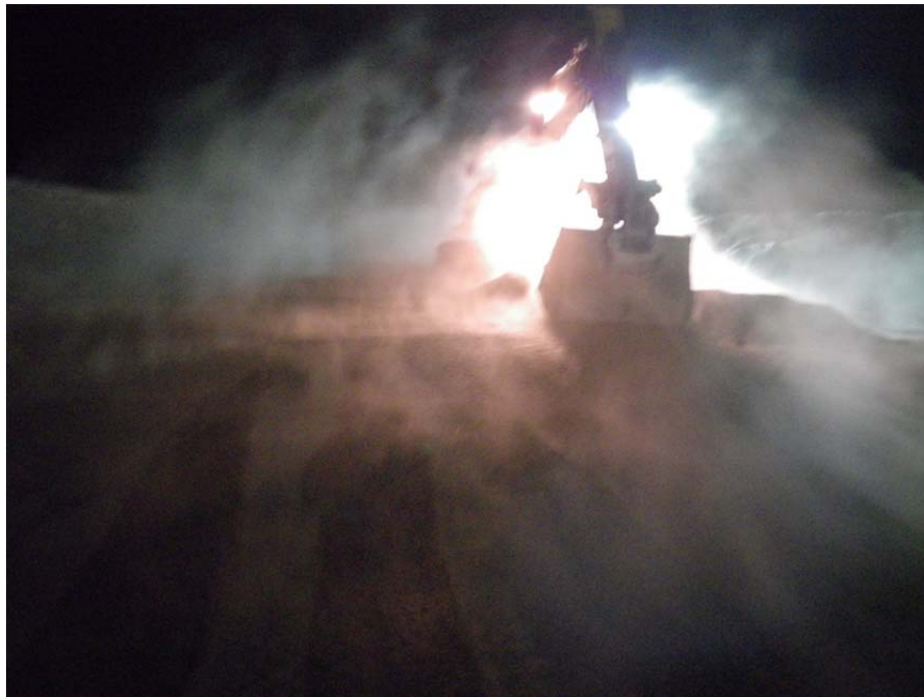
**Photo 12:** Lots of steam during material placement.

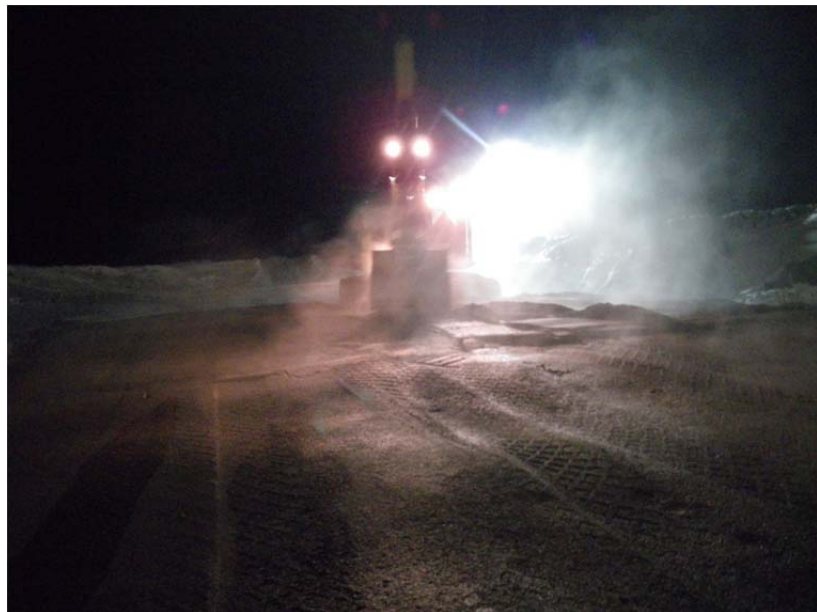
**Photo 13:** CAT 325 excavator placing FCM.

- The material was placed with the CAT 325 excavator and static rolled with the compactor.
  - The material was coming from the plant was on the wet side and coming out at hotter temperatures. Due to the temperature increase the time between trucks was slightly increased.

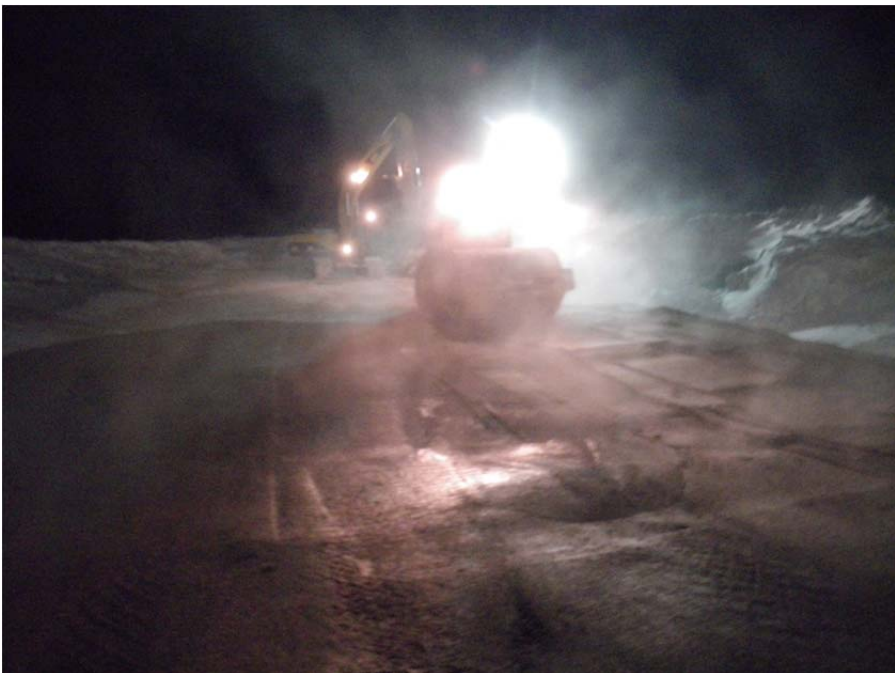
**Photo 14:** Packer compacting the placed FCM. Looking SW along key trench.

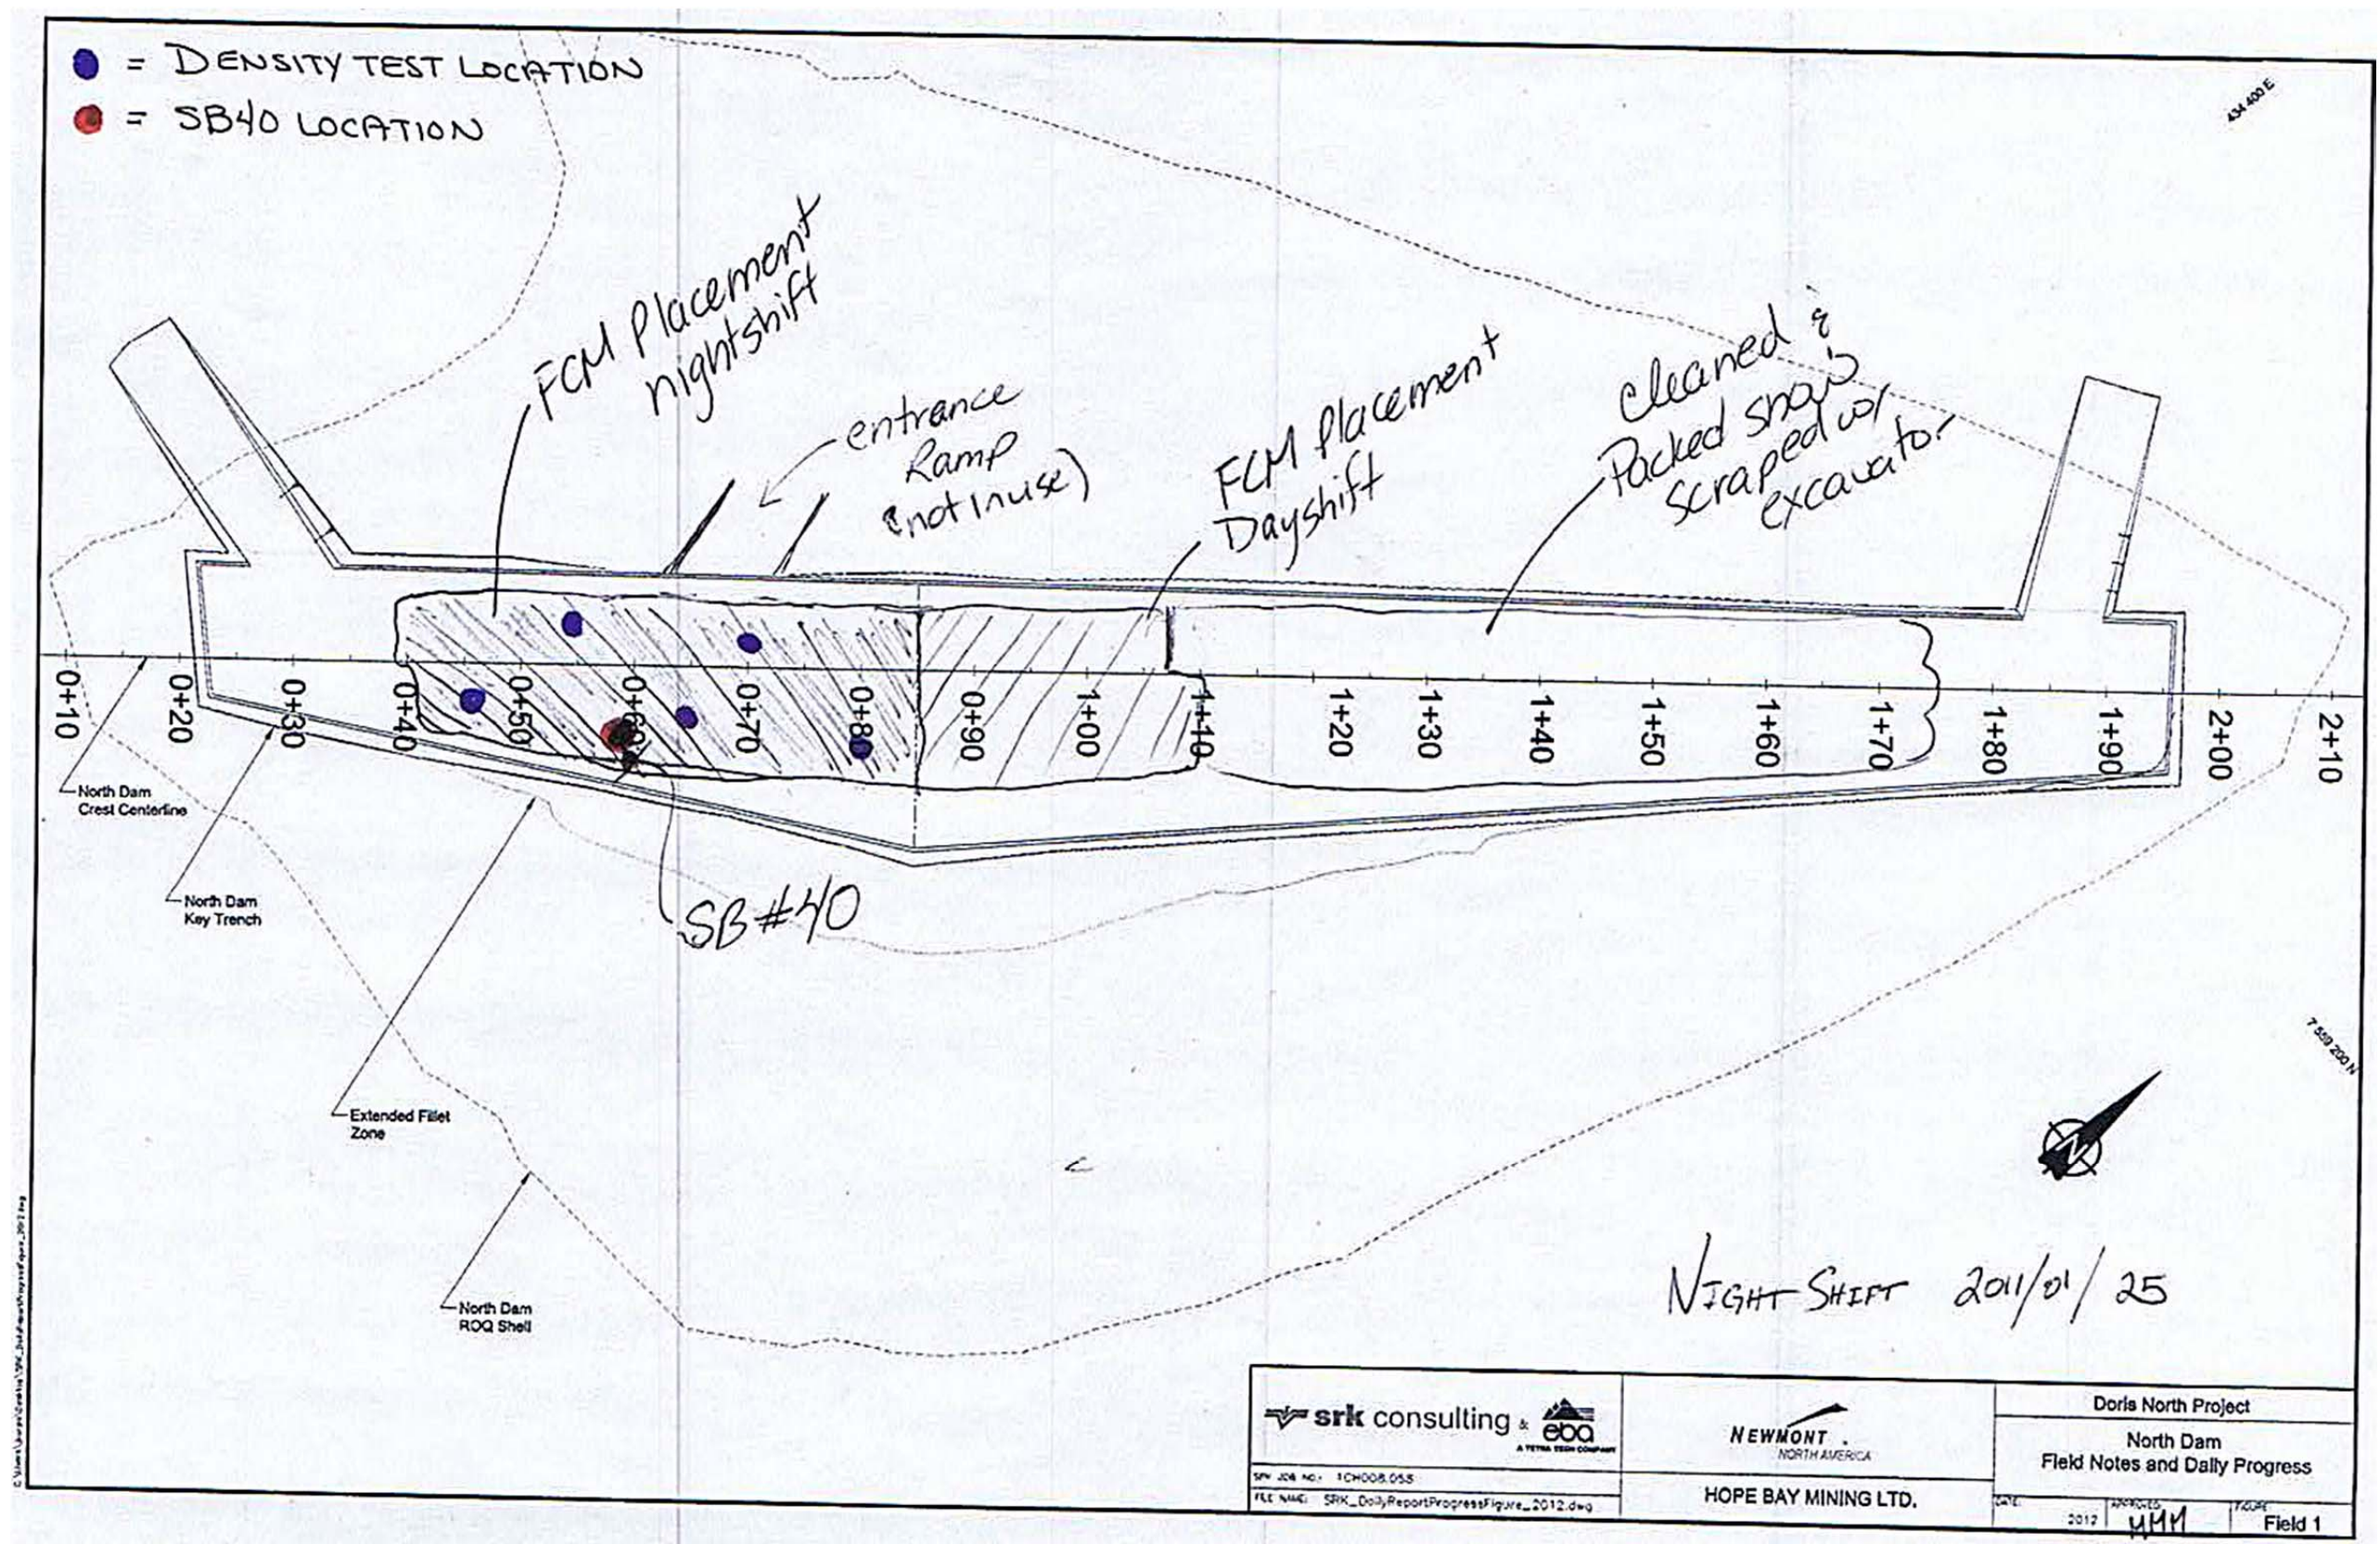
Figure 2 - FCM Progress/ Placement – Jan 25<sup>th</sup> NIGHTSHIFT

- A progress figure showing the approximate extent of night shift placement is provided as Figure 2.
