DAILY REPORT #37 – DORIS NORTH INFRASTRUCTURE/ NORTH DAM

Prepared by:	Murray McGregor Megan Miller	Date:	2012.02.11
Reviewed by:		Project #:	1CH008.058.0320
Role	Company	Personnel – Position	On Site
Client	Hope Bay Mining Limited (HBML)	Angela Holzapfel – ESR Compliance Manager David Vokey – ESR Coordinator Don Ethelston – HSLP Advisor Dean Wold - Safety Jill Turk – ESR Coordinator Katsky Venter – ESR Manger Michelle Tanquay – ESR Site Manager Stirling Kelly – HSLP Advisor	No No No No Yes No Yes Yes
	JDS	Lloyd Jackson – Mechanical Superintendent Doug Fielding – Construction Manager Ishan Fechter – Construction Coordinator Jerry Graham – Construction Manager Kevin Whieldon – Project Coordinator Mark Valeriote – Construction Manager	Yes No Yes Yes No Yes
Engineering Design Consultants	SRK Consulting (Canada) Inc.	John Kurylo – Site Engineer Megan Miller – Site Engineer Lawrence Borowski – Site Engineer Murray McGregor – Site Engineer Iozsef Miskolczi – Site Engineer	No Yes No Yes No

NORTH DAM/FROZEN CORE PLANT PAD:

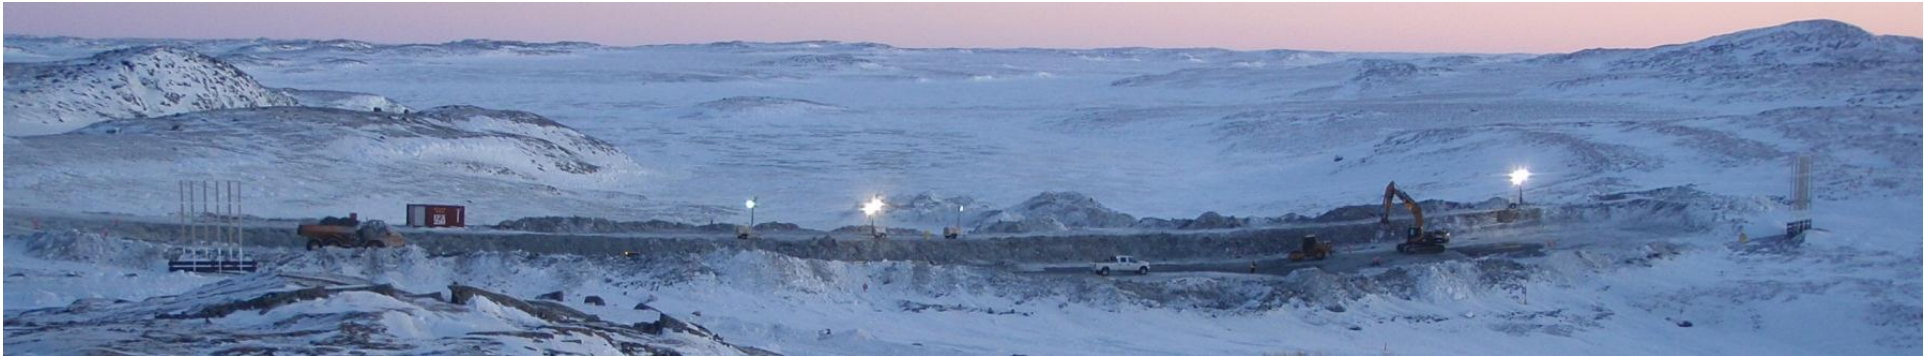
Photo 1: Progress photo of North Dam from photo point 1. ~SSE view.

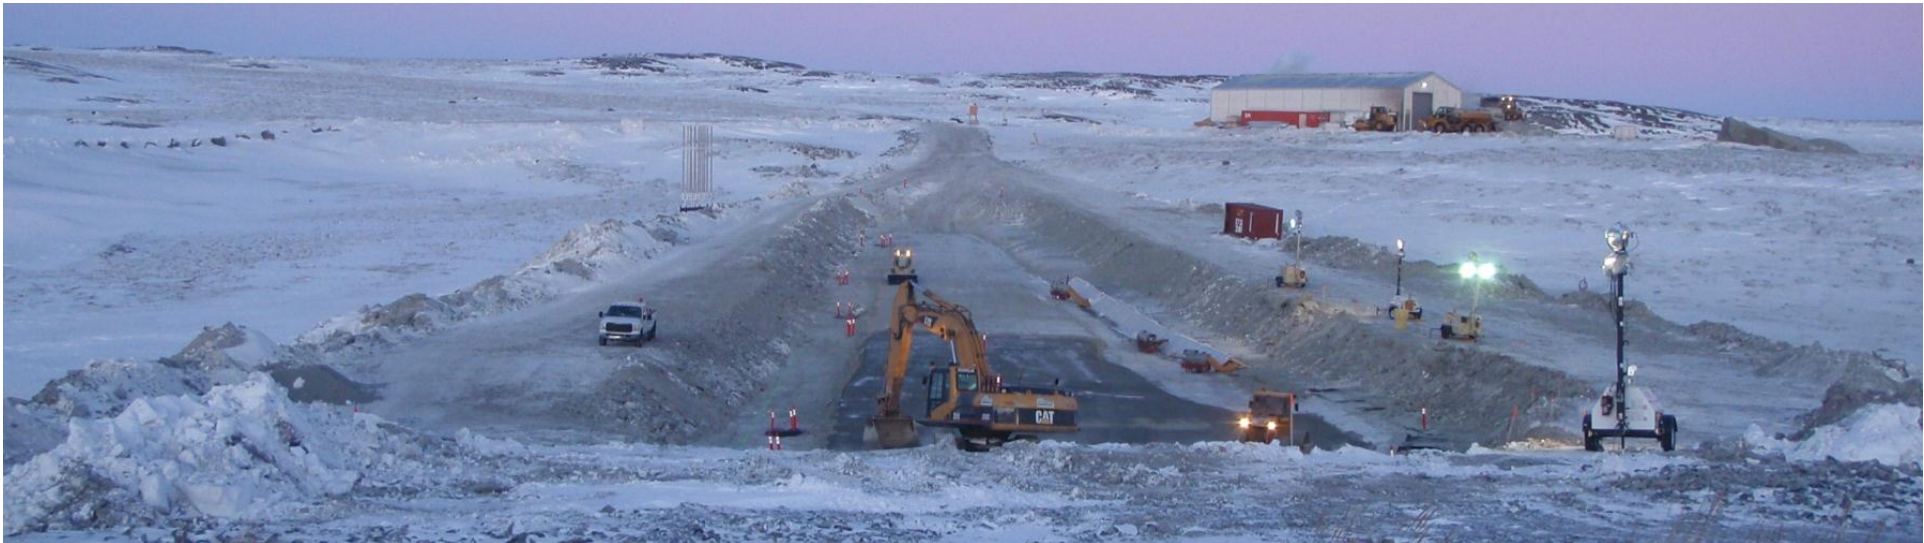
Photo 2: Progress photo of North Dam from photo point 2. ~NW view.

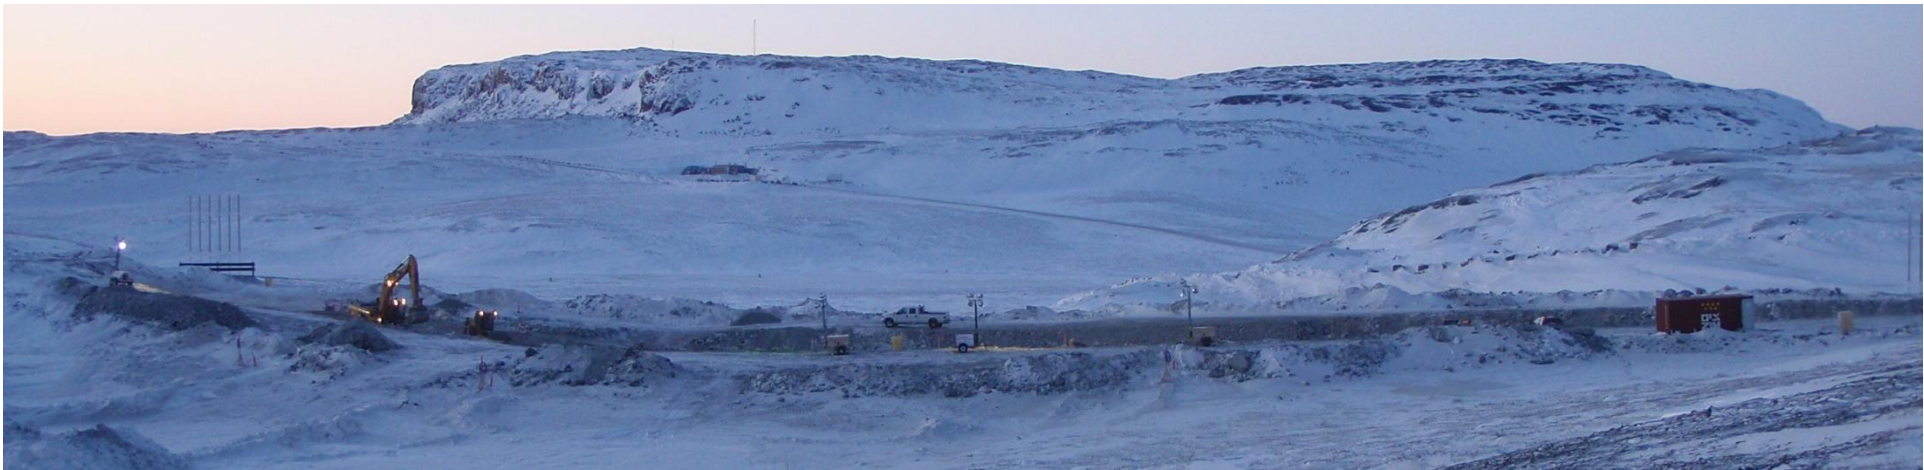
Photo 3: Progress photo of North Dam from photo point 3. ~NE view.

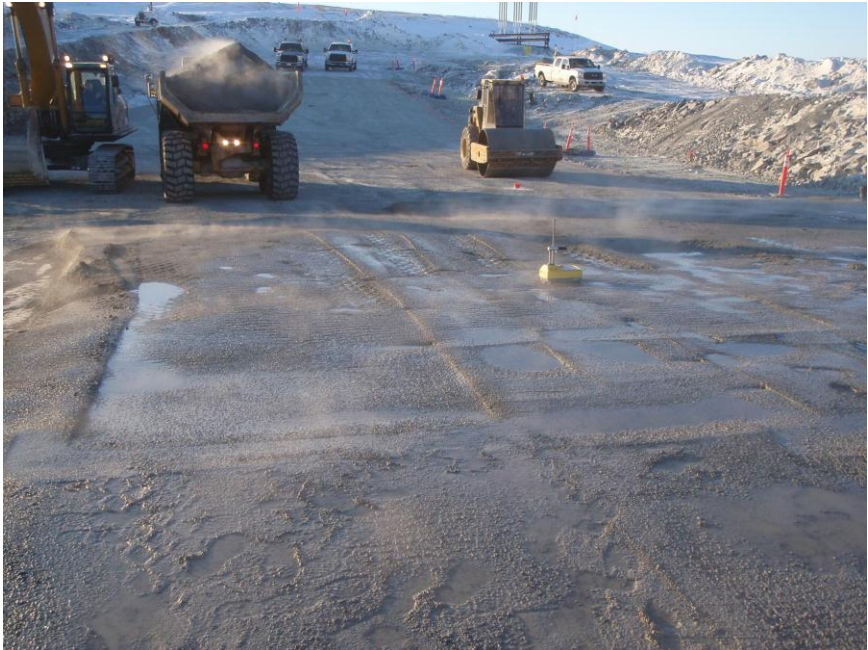
- SRK approved a clean surface for immediate placement of FCM.
- Material started slightly wet and was bleeding after several compaction passes.
- Throughout the day, moisture kept reducing. The water was increased at least four times throughout the day.
- It was suspected that the center of the FCM stockpile was drier than the outside, explaining the need to increase added water throughout the day.
- The last lifts seemed dry, but passed both moisture and saturation tests from the Troxler.
- Thermistor cable ND-HTS-085-29.4 was installed and covered with 250mm-300mm of FCM. Only static rolling was completed to compact the material covering the thermistor cable.
- One single bead was installed near either end of today's placement.

Photo 4: The first several truck loads were slightly over-wetted; water was bleeding out in into thin puddles. All material passed density testing.

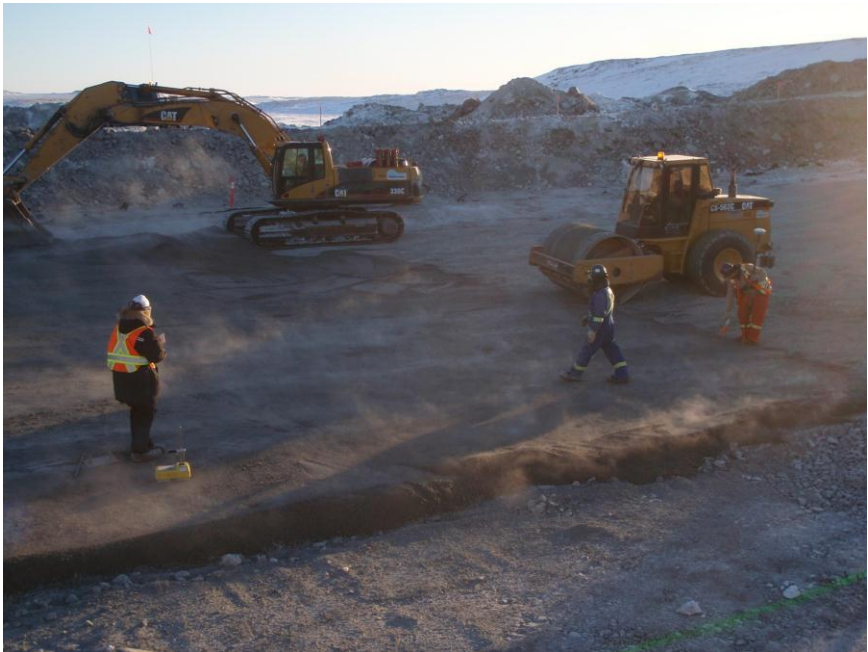
Photo 5: Material as it became drier toward the center of the key-trench. Minimum saturation recorded at 84% after compaction.

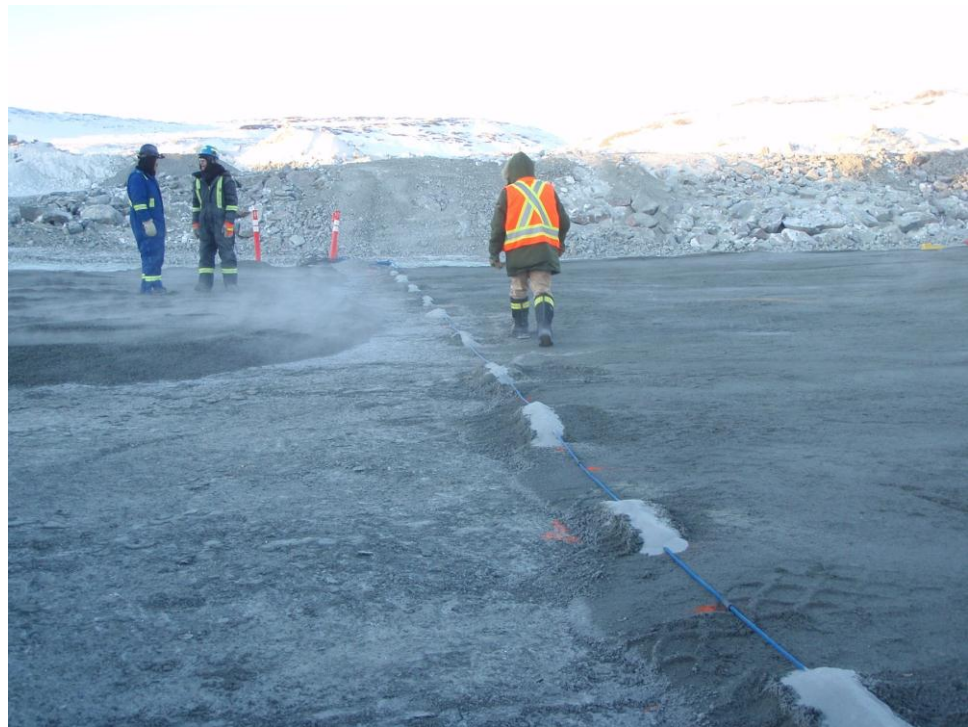
Photo 6: Thermistor cable was graded within the accuracy of the DGPS (20mm). Bentonite water stops were poured between beads. View looking to the downstream side.

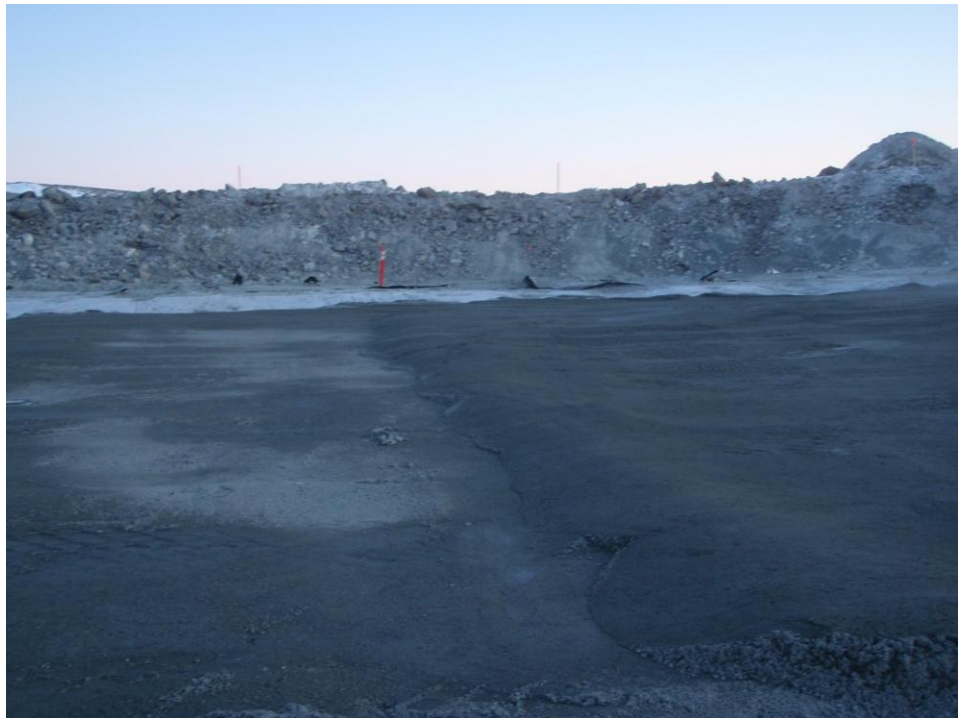
Photo 7: Thermistor cable buried with a slight speed bump of protective FCM cover. View looking to the upstream side.

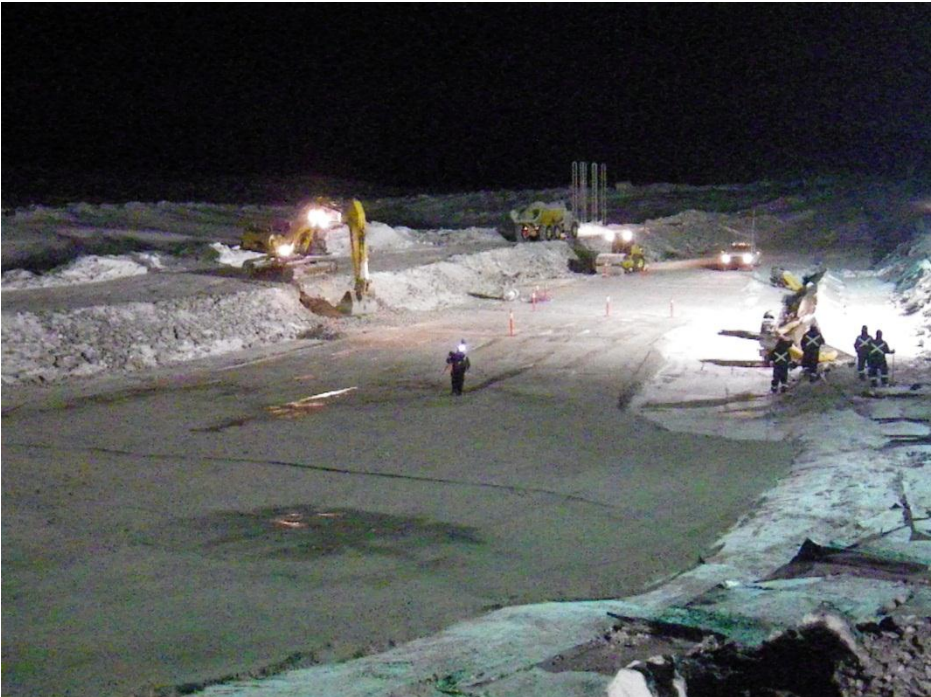
Photo 8: View of nightshift activities, photo looking north east.

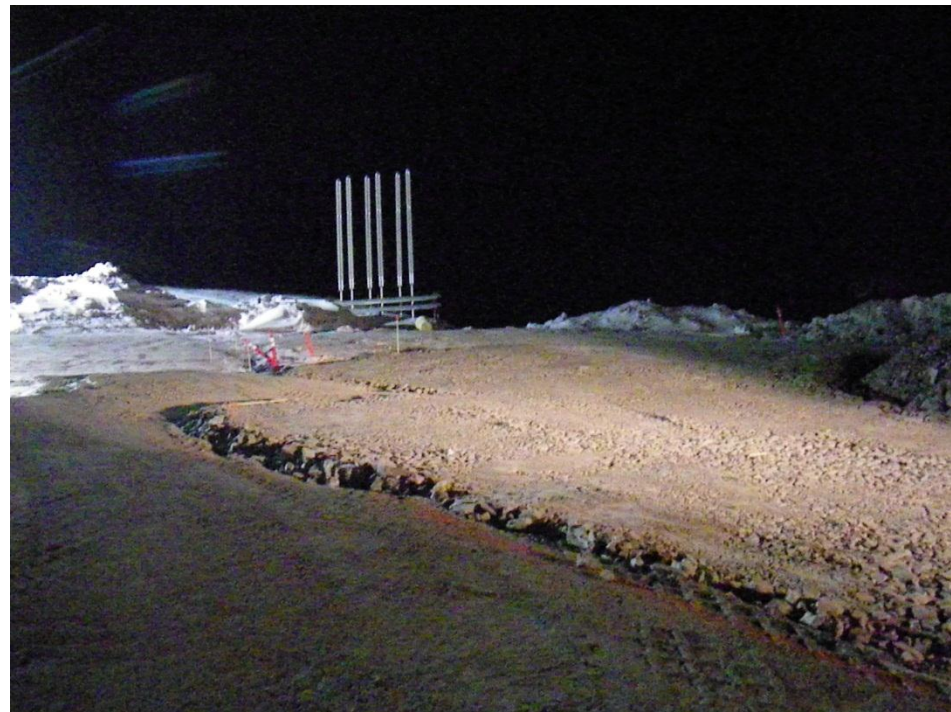
- Transition and ROQ material was placed along the downstream side of the core material. This material was placed with the CAT 330 excavator and compacted with the vibratory packer.
 - ROQ material was obtained from stockpiled ROQ material on the upstream side of the dam.
 - Transition material was obtained from the stockpile on the frozen core plant pad.
 - By the end of nightshift the area between 0+40 and 0+55 was even with the placed core.
- The CAT 330 excavator cleared snow from the edge of the ROQ berm stockpiled on the downstream crest of the shell material.

Photo 9: Transition and ROQ material placed from approximately station 1+55 to 0+40.

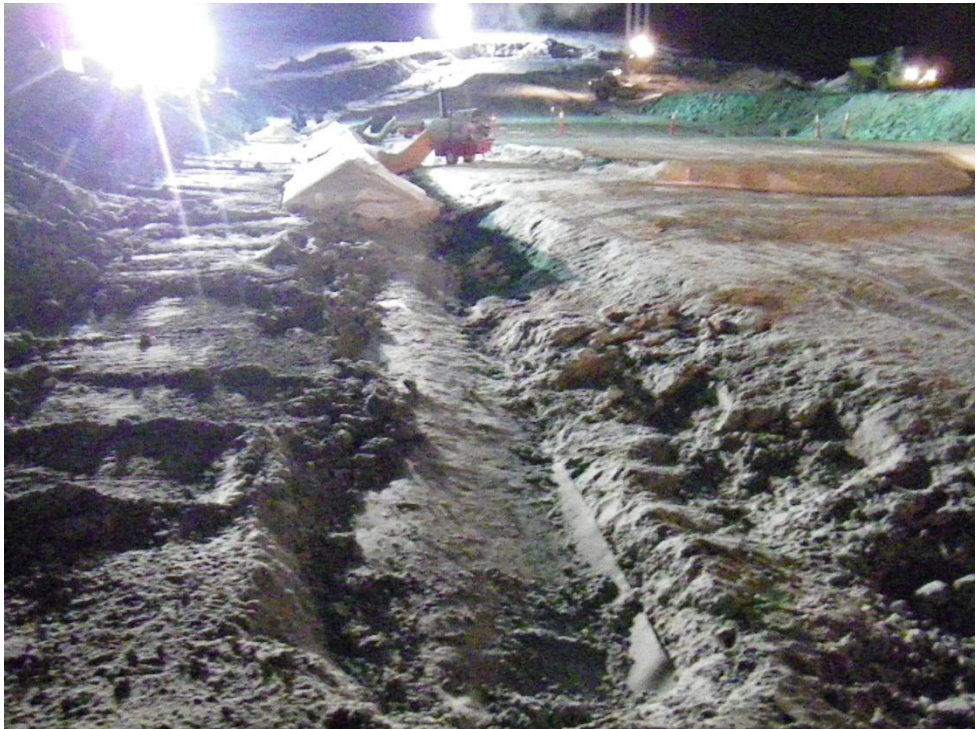
- No FCM placement.
- Heating of the 5/8" material covering the GCL liner on the upstream side continued.
- Labourers used a small electric jackhammer to carefully breakup the frozen 5/8" material on the upstream side. Only a ~1 m wide area was cleared. Approximately half the HDPE liner covering the GCL liner remains under the 5/8" material.
 - Clearing additional width along the HDPE liner was discussed with the foreman. It was discussed that all HDPE liner must be removed; an excavator could be used for the portion of

Photo 10: Looking south west along trench at exposed HDPE liner and hoarding over liner. Photo taken from around station 1+60.

HDPE which does not cover the GCL.

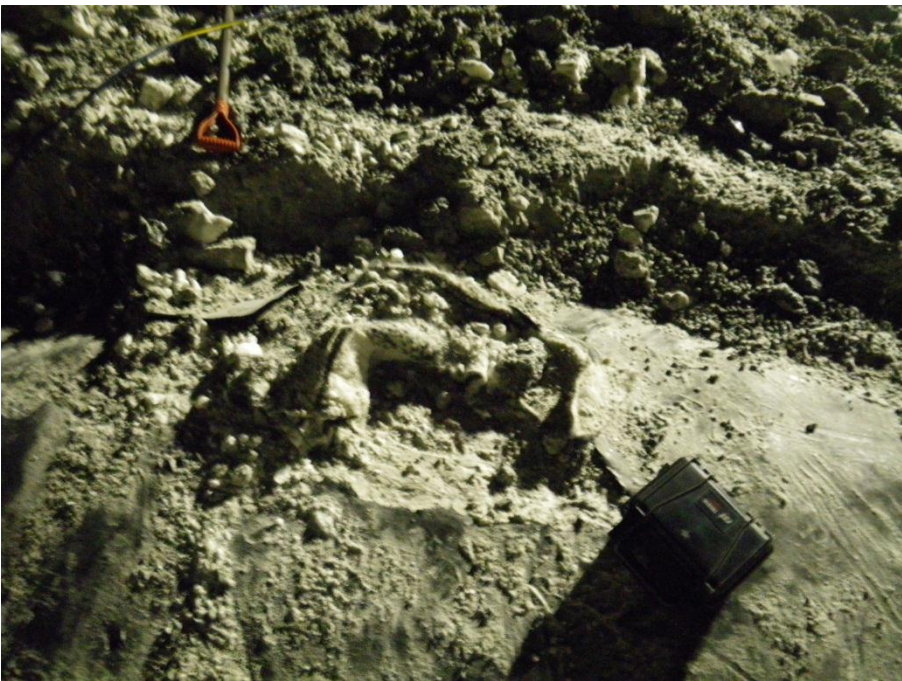
- A tear in the GCL liner was noted at station 1+55, see photo below.
- Near the end of shift the skid steer with the broom attachment swept the core surface from the end of dayshift placement (~1+20) to the north end of the trench. The area from 1+20 to 1+50 was inspected and looked ready to place.
- The FCM placed on dayshift was not frozen back by the end of nightshift. This material was at 0°C at the end of shift.

Photo 11: Tear in GCL observed at station 1+55 note the RST readout box for scale.
