DAILY REPORT #41 – DORIS NORTH INFRASTRUCTURE/ NORTH DAM

Prepared by:	Murray McGregor Iozsef Miskolczi	Date:	2012.02.15
Reviewed by:		Project #:	1CH008.058.0320
Role	Company	Personnel – Position	On Site
Client	Hope Bay Mining Limited (HBML)	Angela Holzapfel – ESR Compliance Manager David Vokey – ESR Coordinator Don Ethelston – HSLP Advisor Dean Wold - Safety Jill Turk – ESR Coordinator Katsky Venter – ESR Manger Michelle Tanquay – ESR Site Manager Stirling Kelly – HSLP Advisor	No No No No Yes No Yes Yes
	JDS	Lloyd Jackson – Mechanical Superintendent Doug Fielding – Construction Manager Ishan Fechter – Construction Coordinator Jerry Graham – Construction Manager Kevin Whieldon – Project Coordinator Mark Valeriote – Construction Manager	Yes No Yes Yes No Yes
Engineering Design Consultants	SRK Consulting (Canada) Inc.	John Kurylo – Site Engineer Megan Miller – Site Engineer Lawrence Borowski – Site Engineer Murray McGregor – Site Engineer Iozsef Miskolczi – Site Engineer	No No No Yes Yes

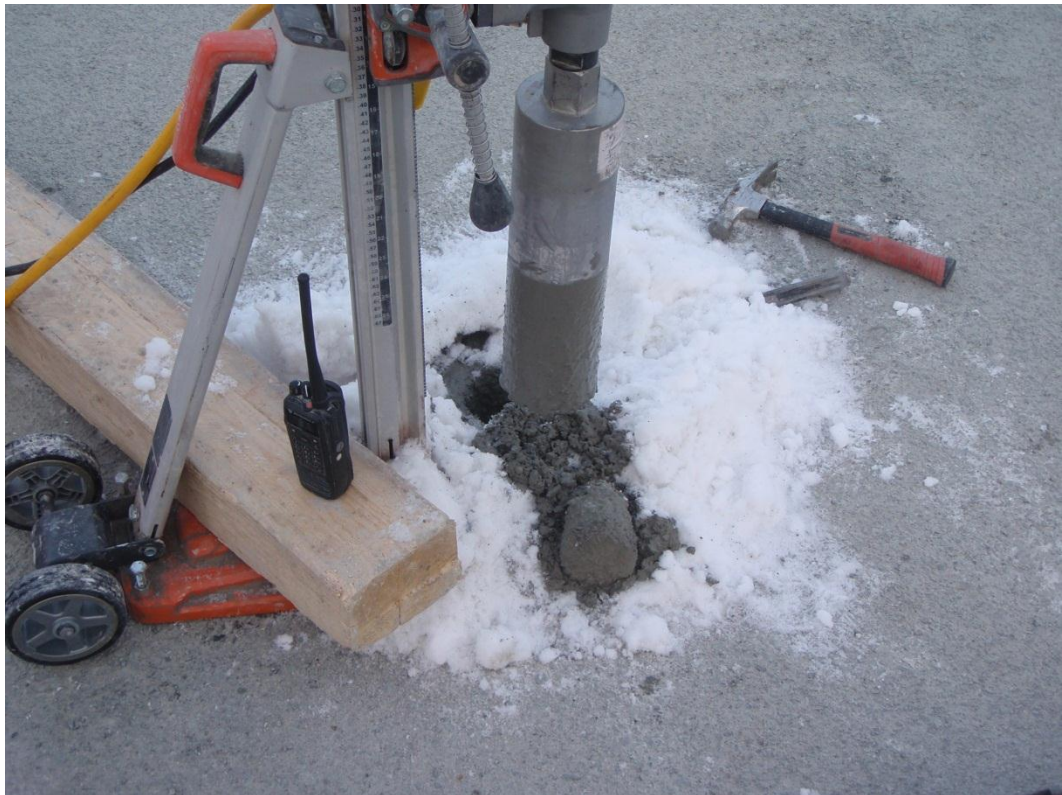
Photo 1: Drilled core attempt near the center of the dam. Melted core prompted a change in placement direction.

- Placement started near 9:00AM; it was planned to work through the center.
- One drilled core turned out melted and prompted a change of placement direction to the northeast end.
- Some sweeping was required during placement due to the change in plans.
- Thermistor cable ND-HTS-175-33.5 was installed in the pre-dug trench.

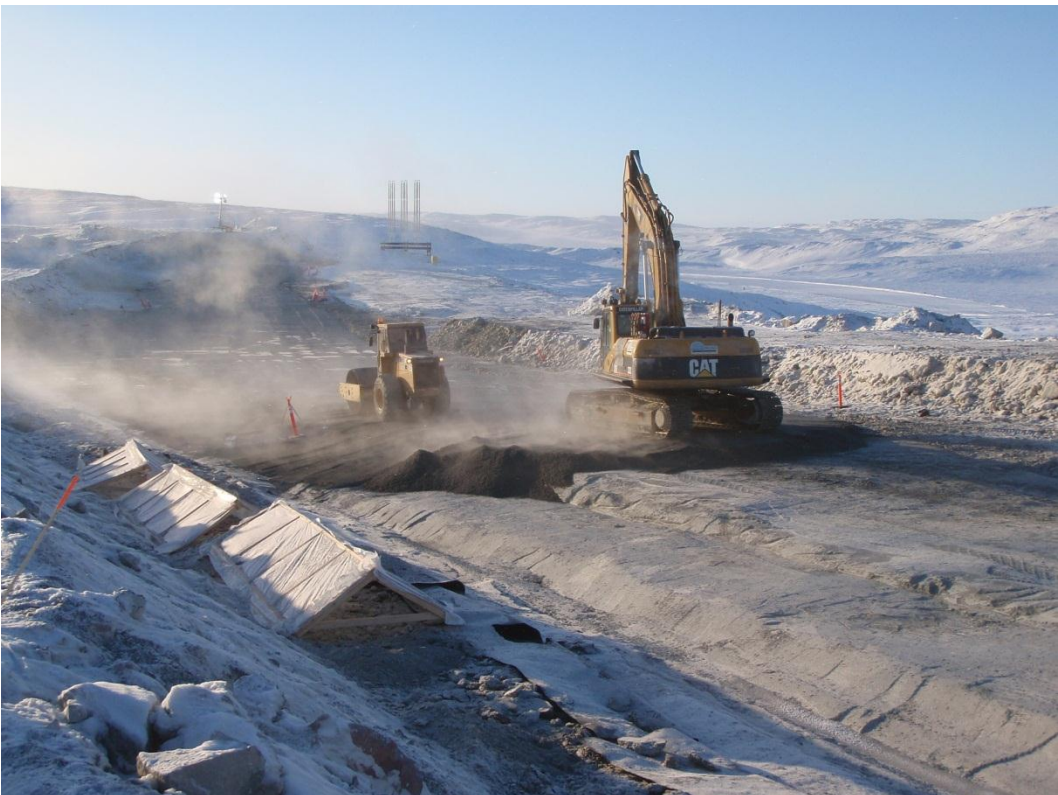
Photo 2: Placement progressing toward the northeast.

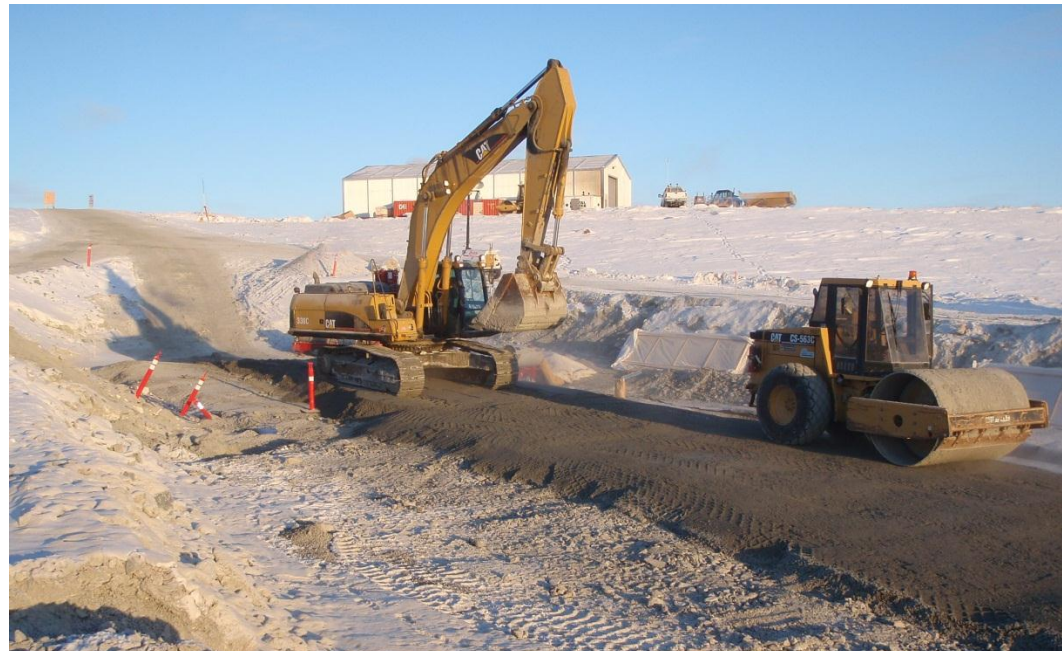
Photo 4: End of today's placement up to chainage 1+90.

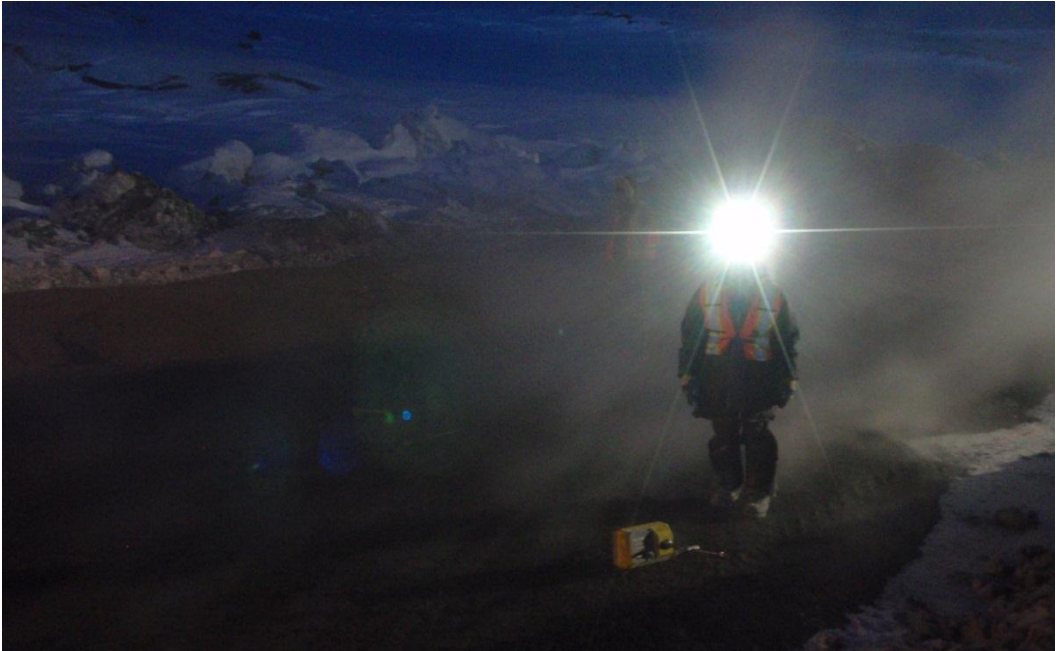
Photo 5: Test batches of new frozen core material at the end of dayshift.

- The plant had a smooth start-up and material was ready for placement within the first 15 minutes.
- Material was identified as wet after the first couple loads were placed and the water was dialed back.
- One truck load was sent to reject when the feed was temporarily jammed.
- The plant was turned off in the afternoon and the belts were cleaned; then it was started up again using new crush for test batches.

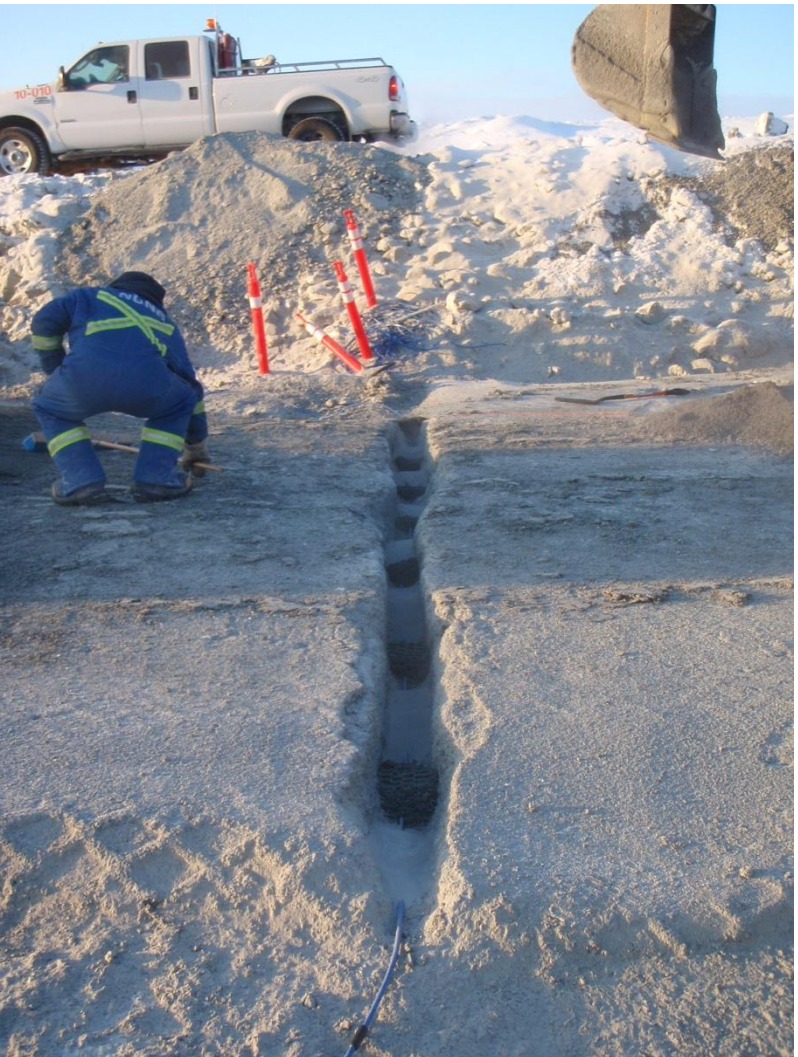
Photo 3: Thermistor string ND-HTS-175-33.5, installed with bentonite powder water stops.

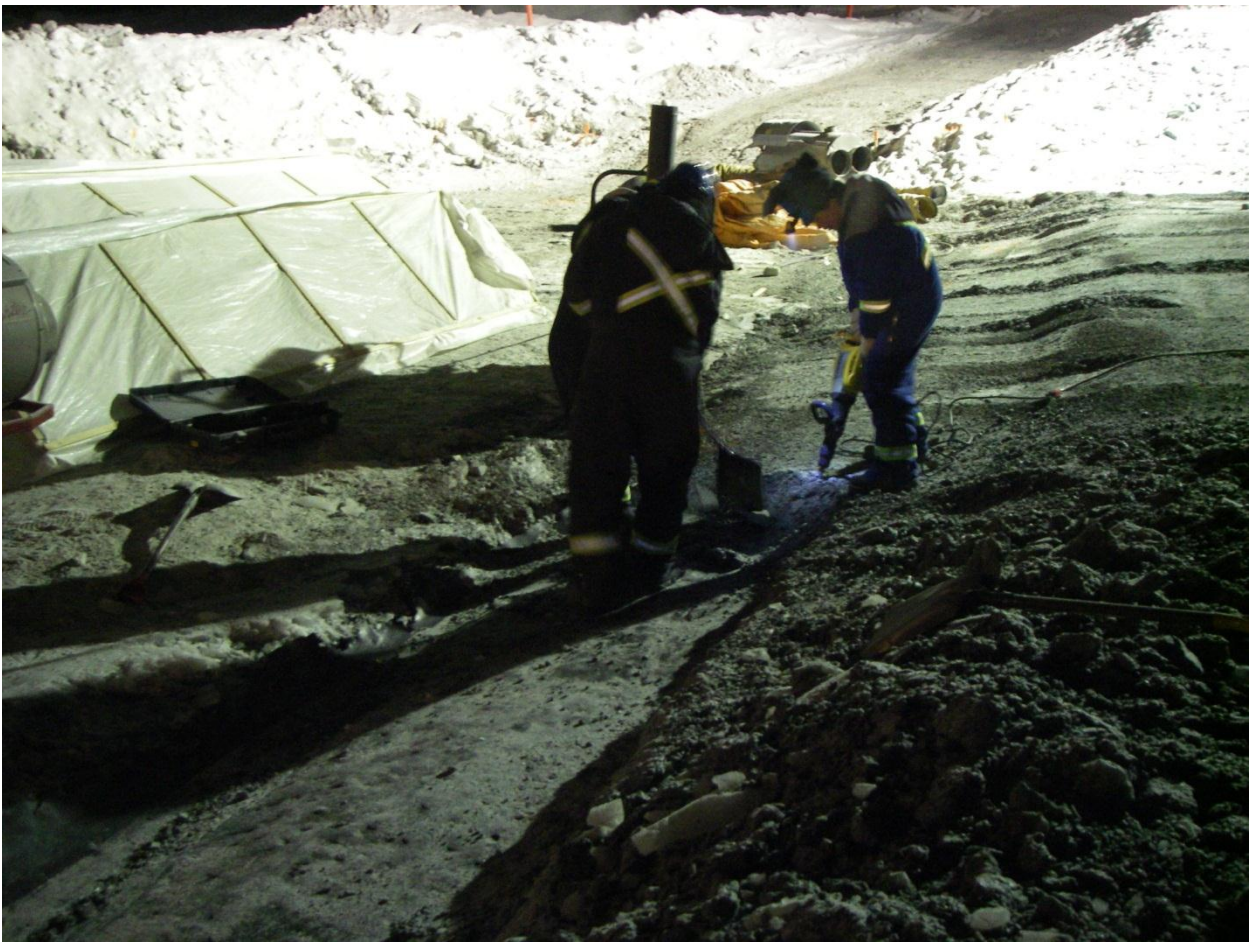
Photo 6: Workers exposing the HDPE liner around Sta. 1+80. A jackhammer was used to loosen up frozen the 5/8 crush. A few holes punched in the HDPE and the underlying GCL by the jackhammer can be seen in the foreground.

- No FCM placement.
- Removal of the frozen 5/8 crush from above the HDPE liner continued. The HDPE was exposed from station 1+70 to about station 1+85. The 5/8 crush from the remainder of the HDPE was partially removed using the CAT 345 excavator equipped with special digging teeth, aka "tiger teeth".
- The single bead thermistors were monitored throughout the night for freeze-back. At the end of the night shift temperature was hovering around zero degrees.

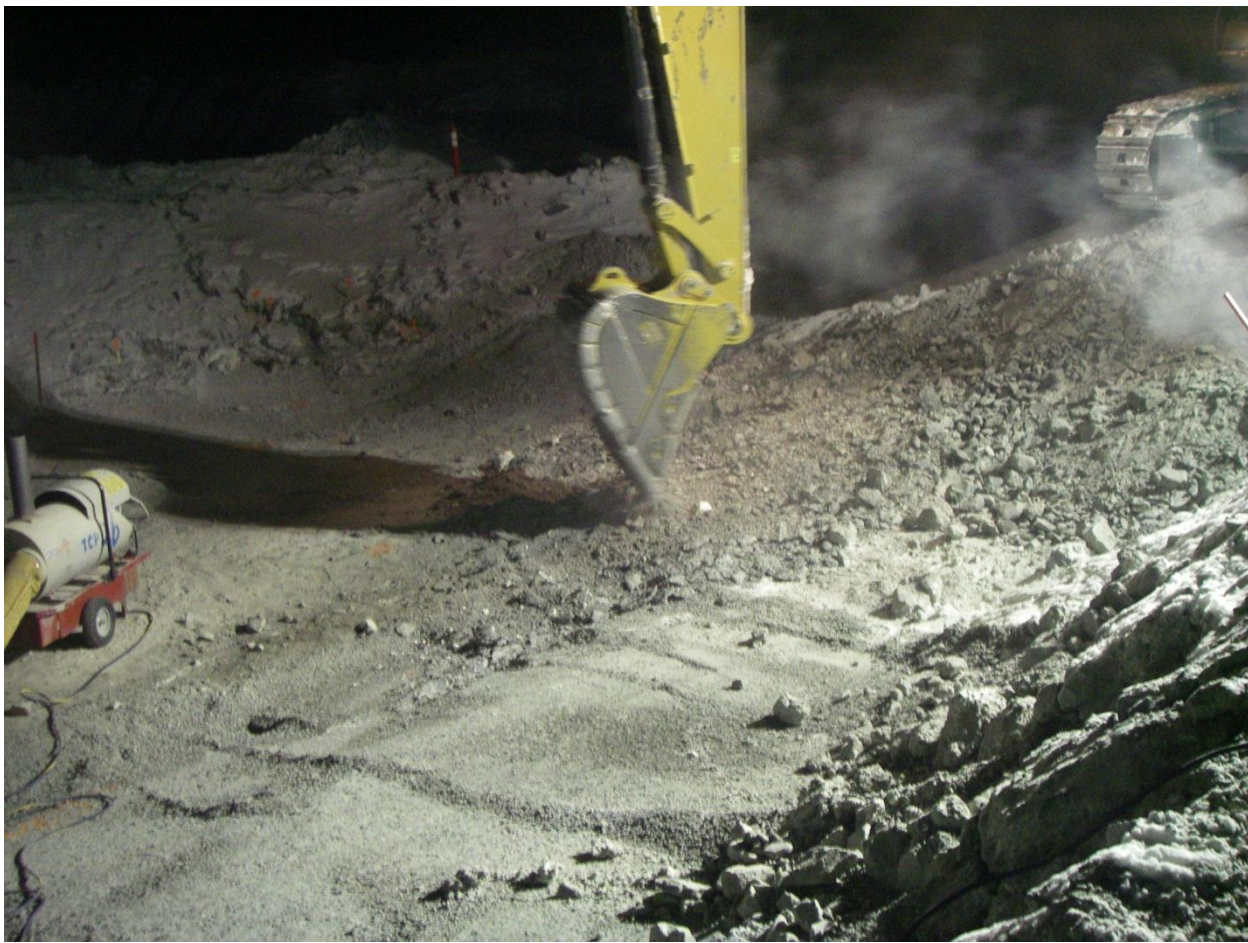
Photo 7: The CAT 345 excavator equipped with tiger teeth is removing the 5/8 crush in the north-east corner of the key-trench.

- The CAT 345 excavator was used to remove the 5/8 crush placed in the north-east end of the keytrench. The crush from the ramp into the key-trench was also removed and reconstructed using transition material.
- The extent of the core placed in the key-trench in the north-east end was marked up by survey, with cut/fill indicators to help with removal of the 5/8 crush.
