DAILY REPORT #45 – DORIS NORTH INFRASTRUCTURE/ NORTH DAM

NORTH DAM/FROZEN CORE PLANT PAD:**Multi-Bead Thermistors**

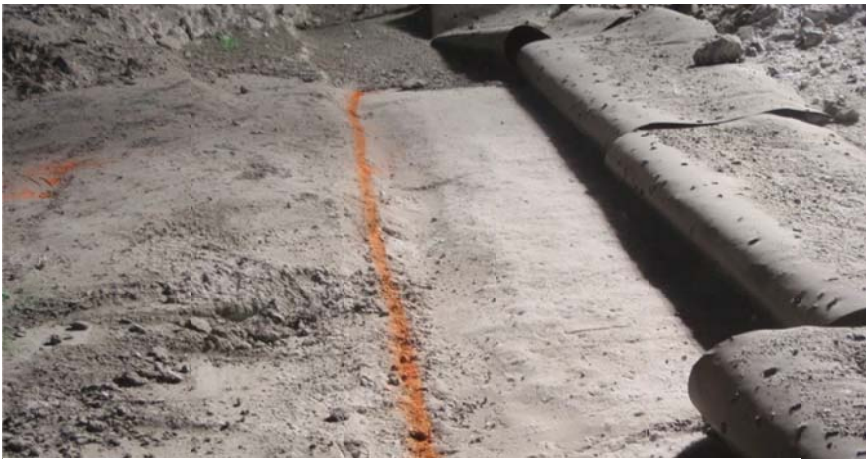
Photo 4: Hoarding tents set up on liner exposure. Fewer tents are currently being used with the same number of frost fighters.

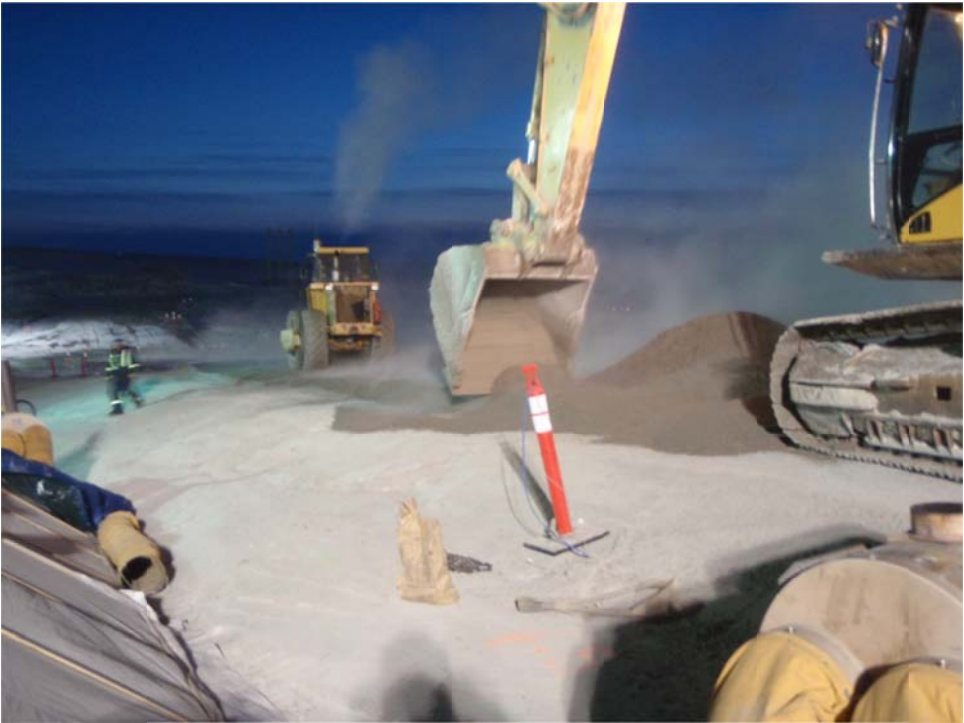
Photo 5: Excavator spreading a thinner lift towards the northeast end of the dam.

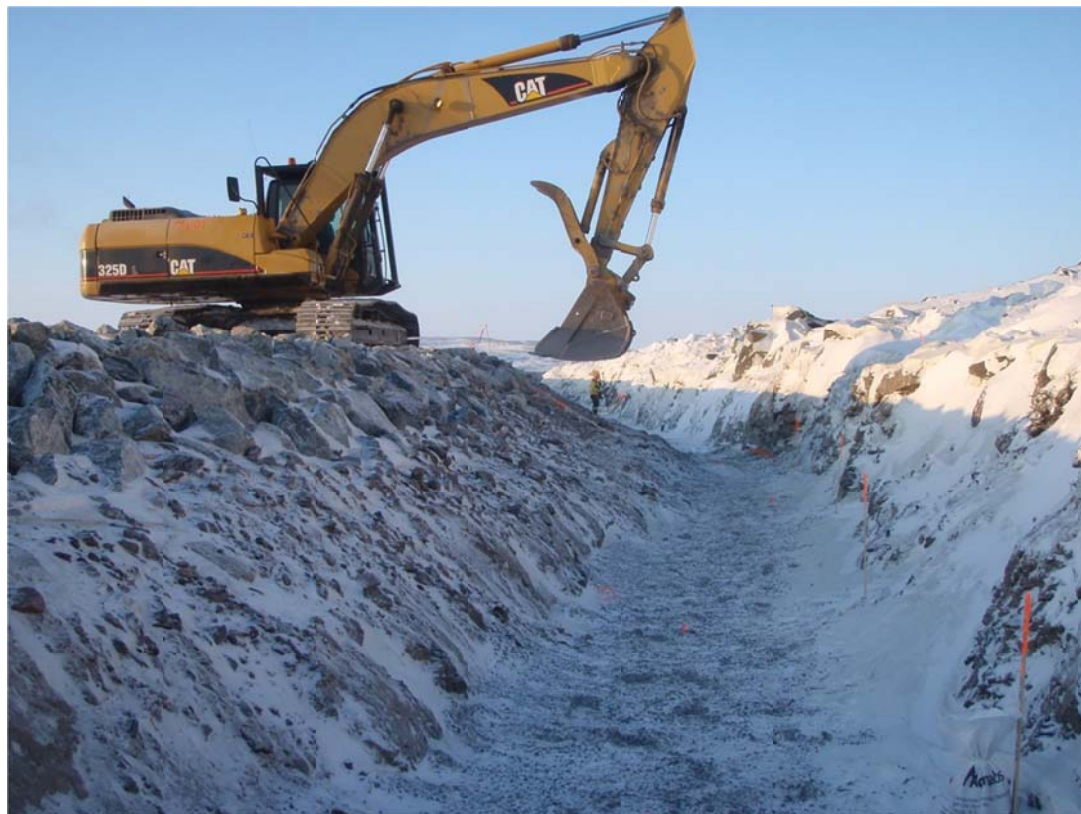
Photo 9: Foreground: Labourers cleaning snow prior to liner placement.
Background: Layfield installing non-woven geotextile.

- Layfield placed and welded non-woven geotextile from the east wall to approx. chainage 5+80.
- Cat 330 filled ¾ inch crush on the sloped section of the installed liner; blasted rock was removed where Westarc drilled yesterday.
- Labourers cleaned snow and loose debris from the slope before liner placement.
- Cat 345 Excavator completed some mucking and snow clearing.
- Survey was present throughout Diversion Berm activities.

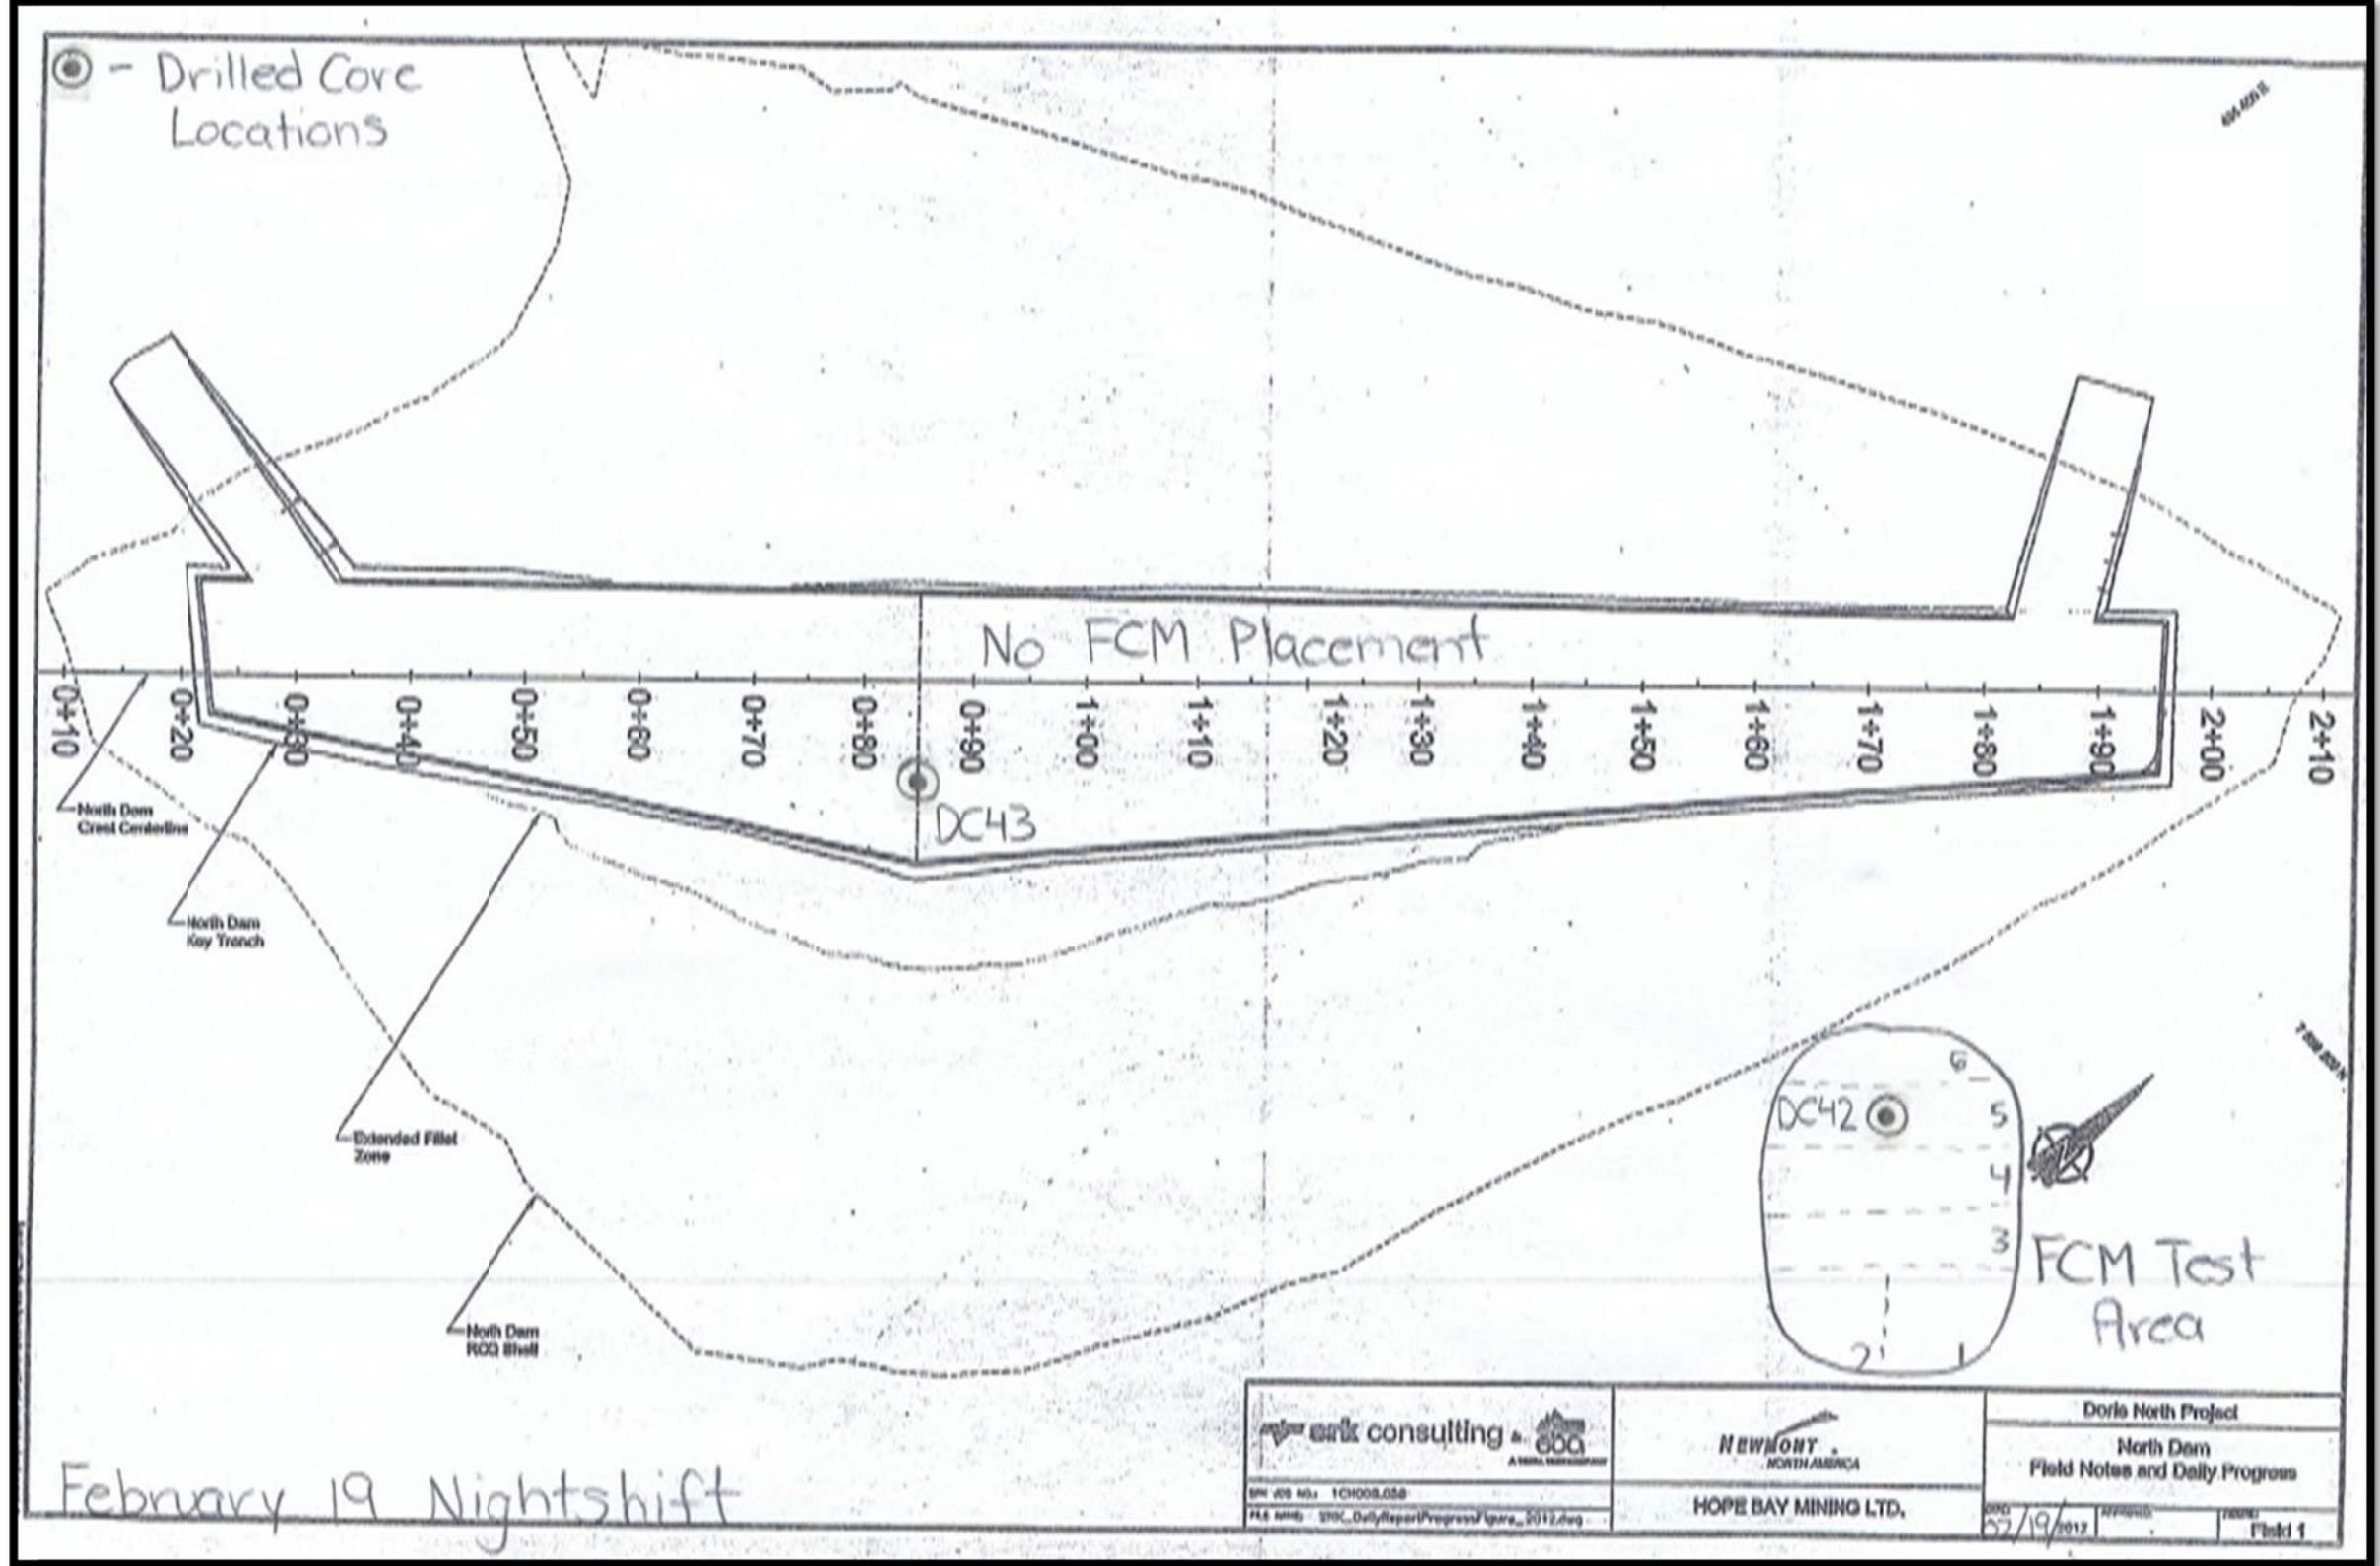
Figure 2 – North Dam Progress – February 19th Nightshift

- No FCM placement.
- Clearing the upstream edge of the 2011 frozen core continued throughout the night shift. Two heating tents with Frost Fighters were set up and the melted water and ice slush was periodically cleaned up by workers.
- Freeze-back of the previously placed core was monitored throughout the night. Freeze-back of the core material placed on Saturday (Feb. 18) was confirmed by 3AM. Core material placed on day shift was about +5 °C at the end of the night shift.
- Two core samples were collected, one from the core placed on Feb. 18, and a second one from Test Pad#5 placed on Feb. 16.
