DAILY REPORT #89 – DORIS NORTH INFRASTRUCTURE/ NORTH DAM

Prepared by:	Iozsef Miskolczi Megan Miller	Date:	2012.04.03
Reviewed by:		Project #:	1CH008.058.0320
Role	Company	Personnel – Position	On Site
Client	Hope Bay Mining Limited (HBML)	Angela Holzapfel – ESR Compliance Manager	No
		David Vokey – ESR Coordinator	No
		Dean Wold - Safety	No
		Jill Turk – ESR Coordinator	Yes
		Katsky Venter – ESR Manger	Yes
		Michelle Tanquay – ESR Site Manager	No
		Stirling Kelly – HSLP Advisor	Yes
		JDS	Lloyd Jackson – Mechanical Superintendent
	Doug Fielding – Construction Manager		No
	Ishan Fechter – Construction Coordinator		No
	Jerry Graham – Construction Manager		Yes
	Kevin Whieldon – Project Coordinator		No
	Mark Valeriote – Construction Manager		In
	Engineering Design Consultants	SRK Consulting (Canada) Inc.	Calvin Goldschmidt – Construction Coordinator
Megan Miller – Site Engineer			Yes
Lawrence Borowski – Site Engineer			No
Earthworks Contractor	Nuna Logistics	Iozsef Miskolczi – Site Engineer	Yes

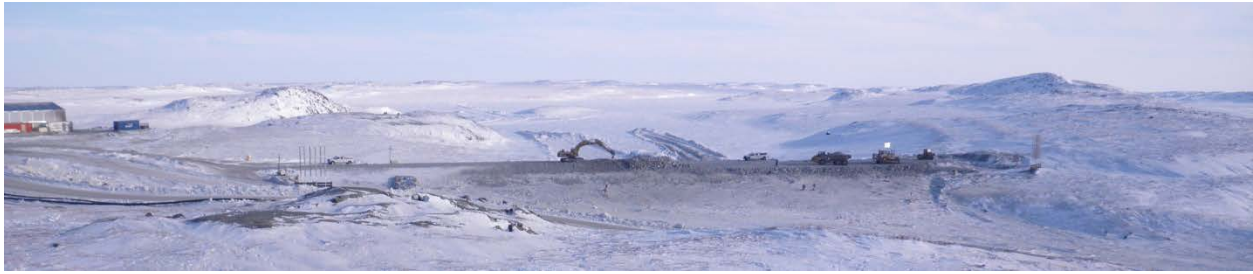
Photo 1: Progress photo of North Dam from photo point 1. Looking south west.

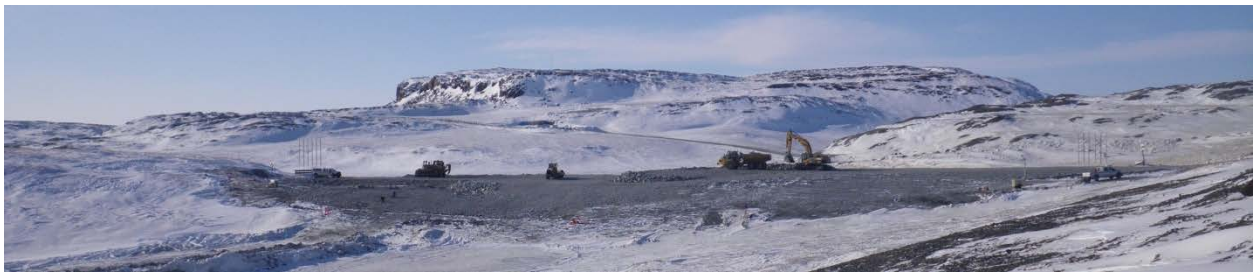
Photo 2: Progress photo of North Dam from photo point 2. Looking north west.

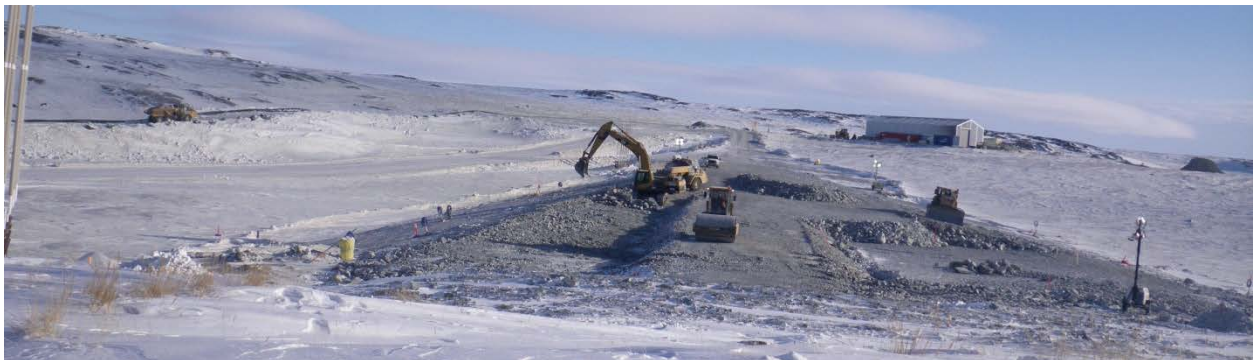
Photo 3: Progress photo of North Dam from photo point 3. Looking north east along dam alignment.

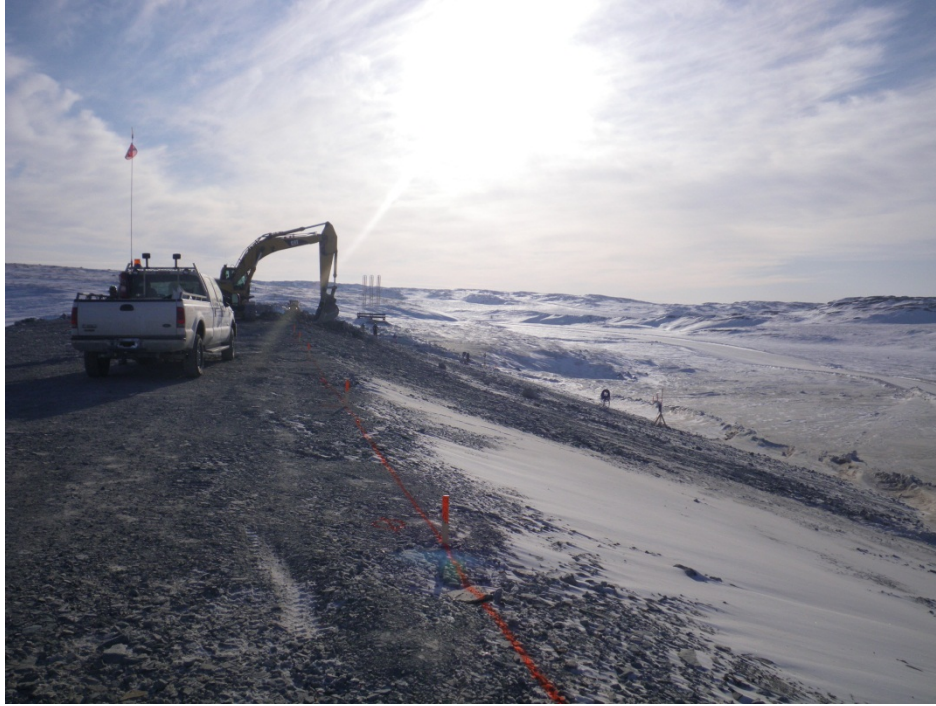
- As of end of the nightshift, placement of ROQ on the dam shell is essentially complete from the north end of the dam to Station 1+00. Also the upstream and downstream slopes are essentially complete for the entire length of the dam, with only the top lift remaining to be placed. Further sloping and finishing, as well as compaction is required to complete the dam shell.

Photo 4: North Dam – View of progress on north dam. Line and stakes mark the final crest which is at grade.

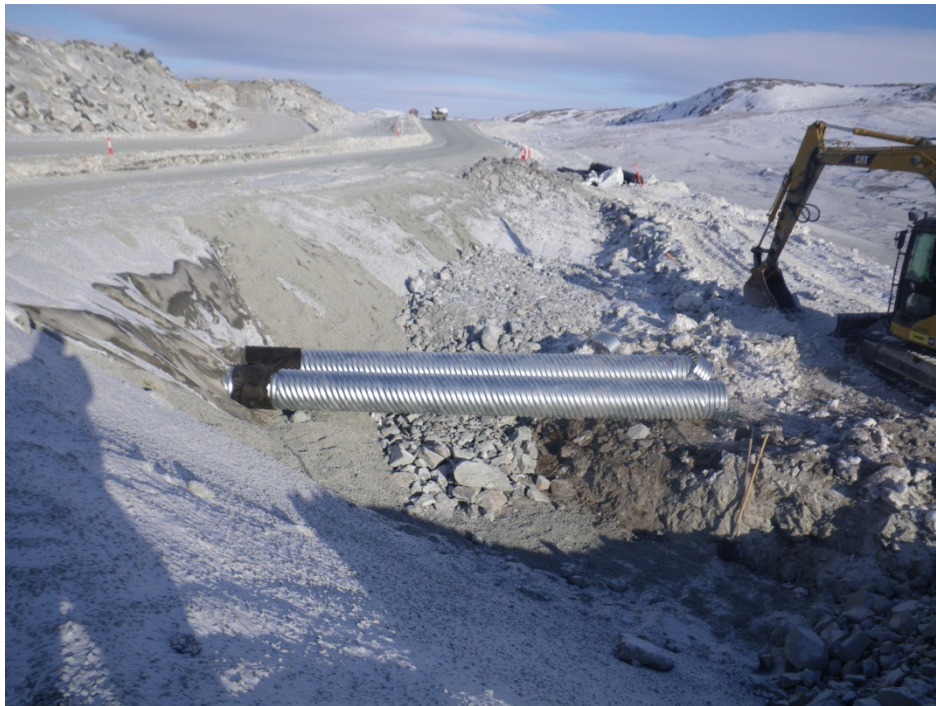
- ROQ material was placed in the corner by the culverts under the Primary Road. Once the first lift of ROQ was placed in this area the culverts were extended and the overliner crush was placed above the culverts.
- The culverts were backfilled with crush and the second lift of ROQ material was placed in the area.
- The first lift of ROQ material was completed in the section which has previously been covered with snow. After the first lift of ROQ was complete the CAT 308 excavator continued to clear snow from the footprint of the second lift.
- No compaction was observed on any material.

Photo 5: Diversion Berm – Culvert extensions installed at crossing through Primary Road.

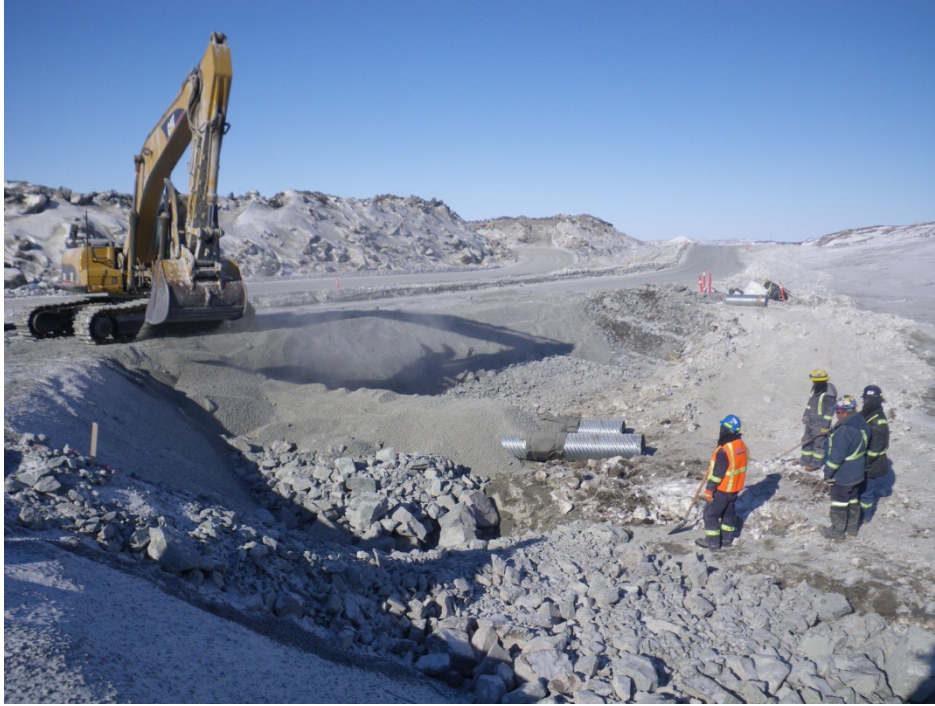
Photo 6: Diversion Berm – Culverts after placement of first lift of ROQ and crush material.

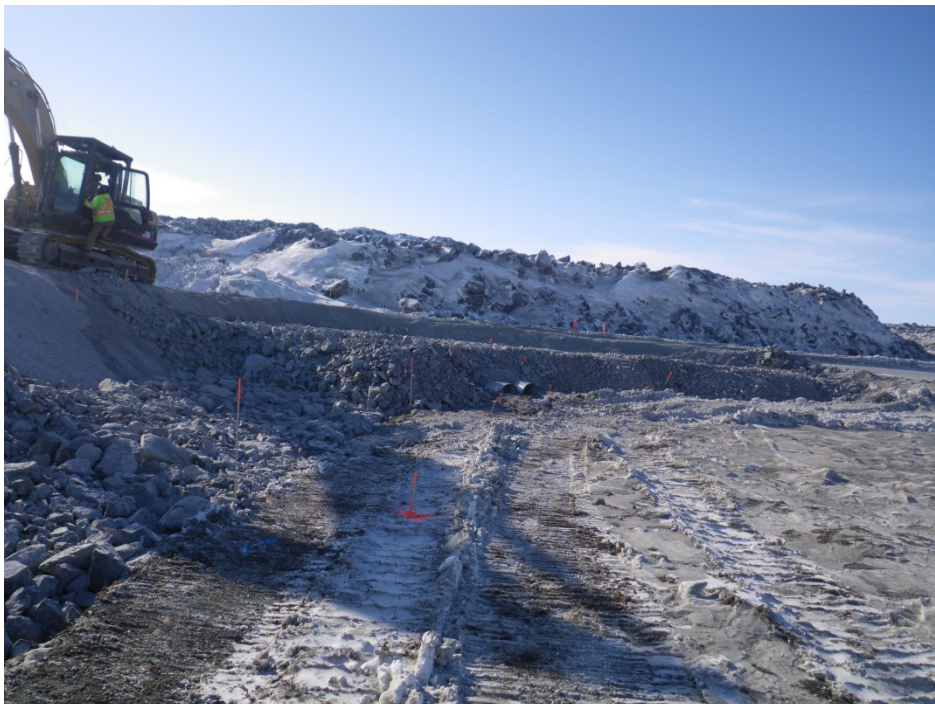
Photo 7: Diversion Berm – culverts after backfilling with second lift of ROQ material.

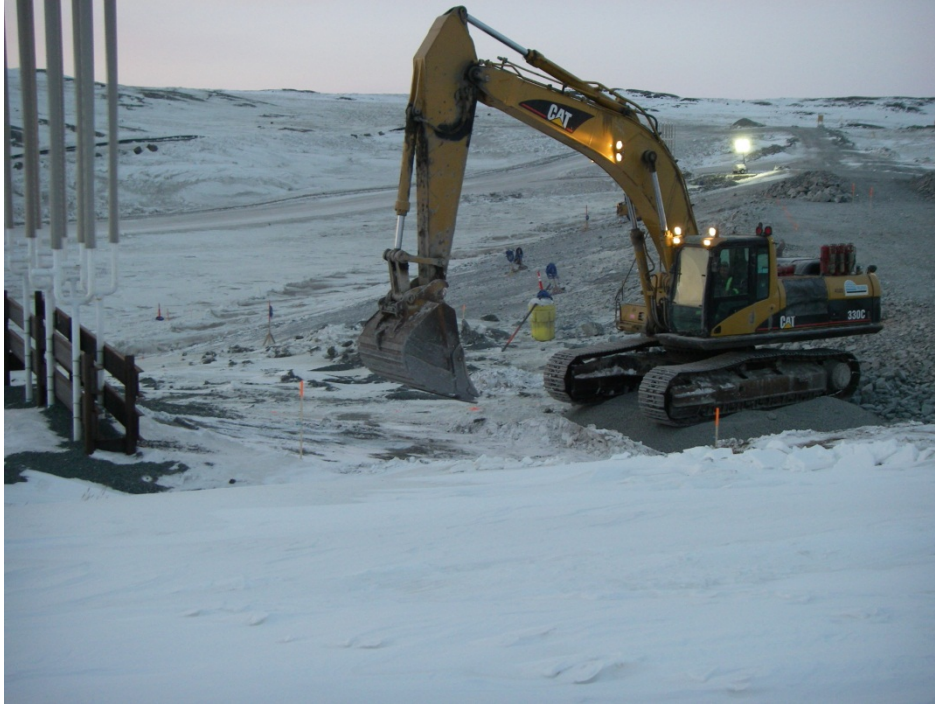
- Snow was cleared from the south end of dam footprint where it had blown in overnight.
- The surveyor marked the area where additional crush material has to be placed over the thermistor pipes where they extend out to the radiators. Additional snow cleaning is required prior to crush placement; however the snow clearing will have to be done carefully as in a few areas the pipes are only covered by a thin layer of crush (6" in one section).

Photo 8: North Dam – excavator clearing snow before additional crush placement at south thermosyphon radiators. Photo looking north-east.

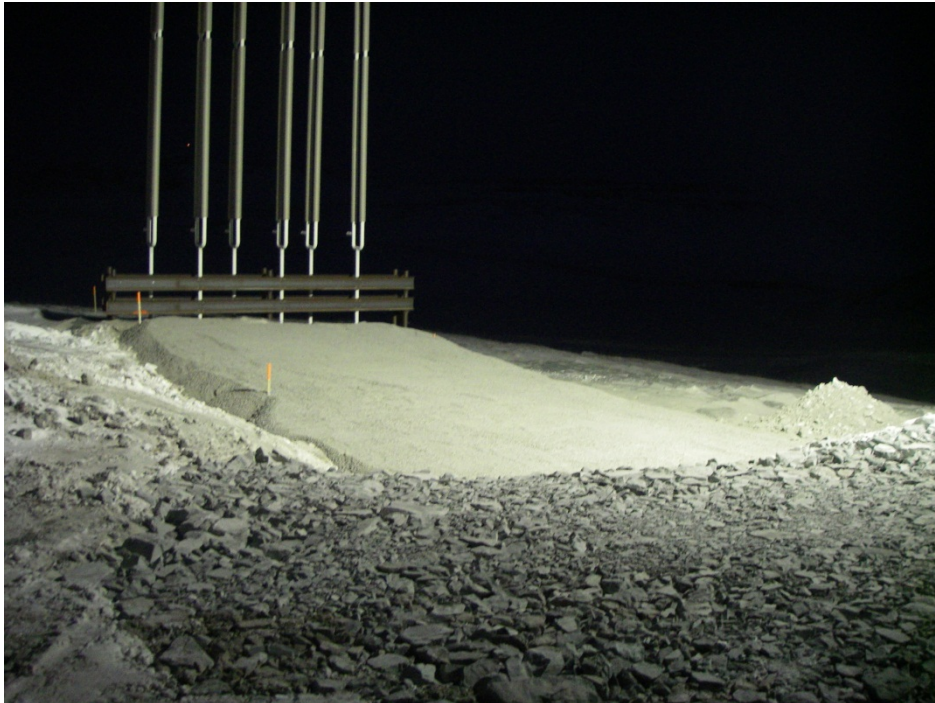
- The 4H:1V downstream slope was shaped and finished by the excavator to the crest of the third lift of ROQ between Station 0+35 and Station 1+00.
- A lift of crush was placed over the thermosyphon pipes near the radiators, as laid out by survey. A few rocks were noted by the excavator operator embedded in the old crush, and were manually removed before the new crush was placed. No compaction of the crush was done.

Photo 9: North Dam – completed crush placement at the south thermosyphon radiators. Photo looking west.

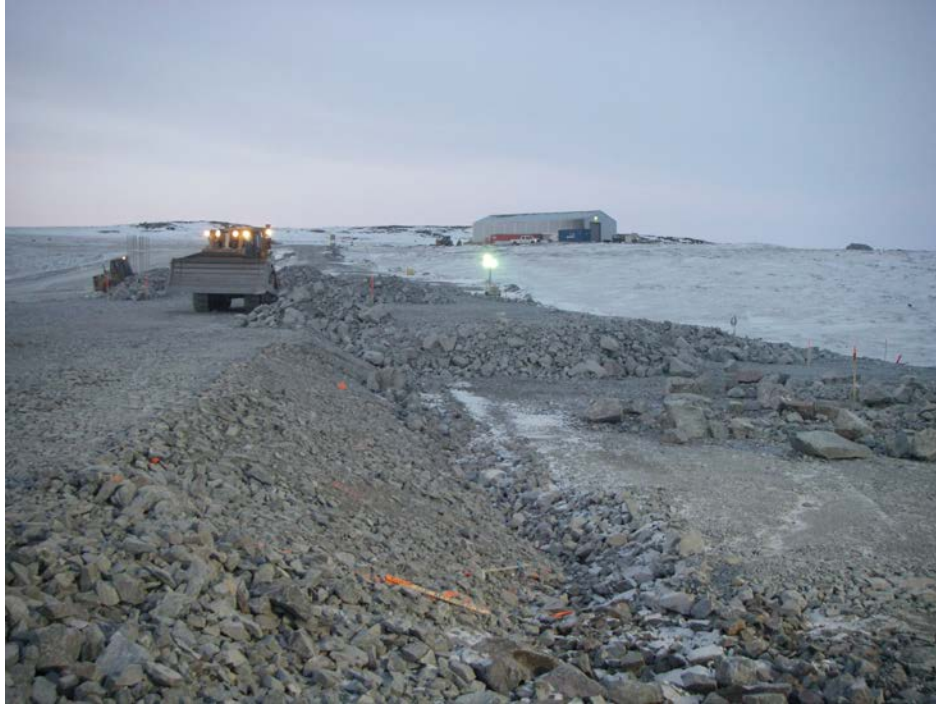
- ROQ placement continued with the CAT D8 dozer placing ROQ in a third lift (to the same elevation as the top of transition material) on the upstream side of the dam. The slopes in this area were placed as the front moved forward.

- The CAT 330 excavator sloped the upstream side of the final lift of ROQ material approximately station 1+00 to 1+30.
- Material from the excavator sloping was hauled to the dozer and placed in the fill. Some of the material was within specification but bony. This material was spread over the thicker part of the next lift where the finer ROQ material can become mixed in.

Photo 10: North Dam – CAT D8 dozer placing the third lift of ROQ. Note the boulders spread out in the right side of the photo, to prevent creation of large cavities. Photo looking north-east from Sta. 0+40

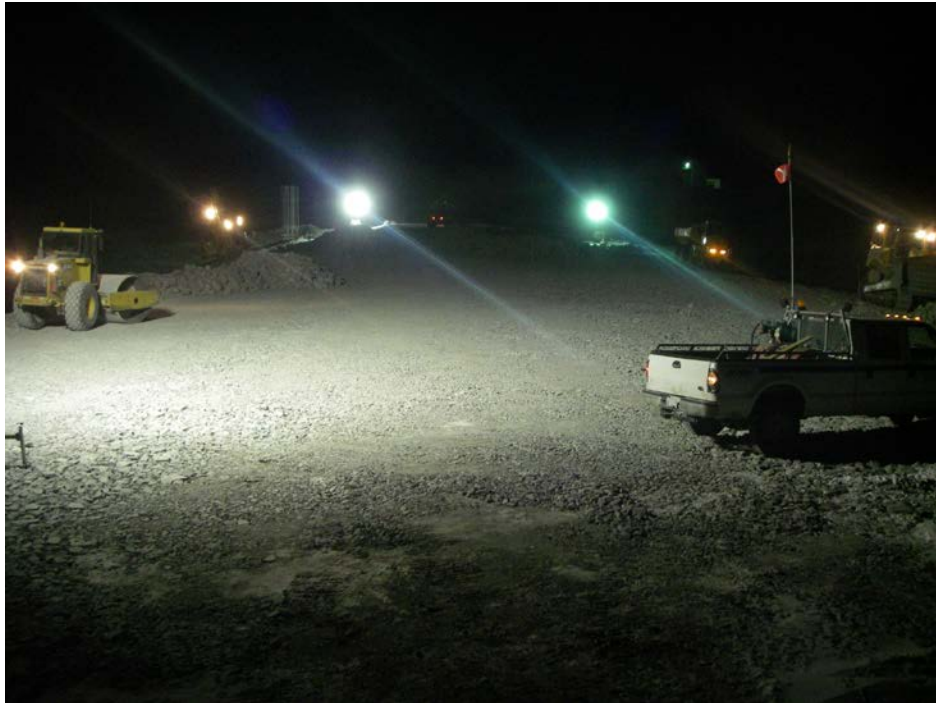
- Placement of ROQ continued on nightshift. The third lift was completed around 3 AM, and the crew was working on placing the final lift for the balance of the nightshift.

Photo 11: North Dam – completed third lift of ROQ. Compactor is compacting the ROQ as well as the transition surfaces. Photo taken from Sta.0+10, looking north-east.

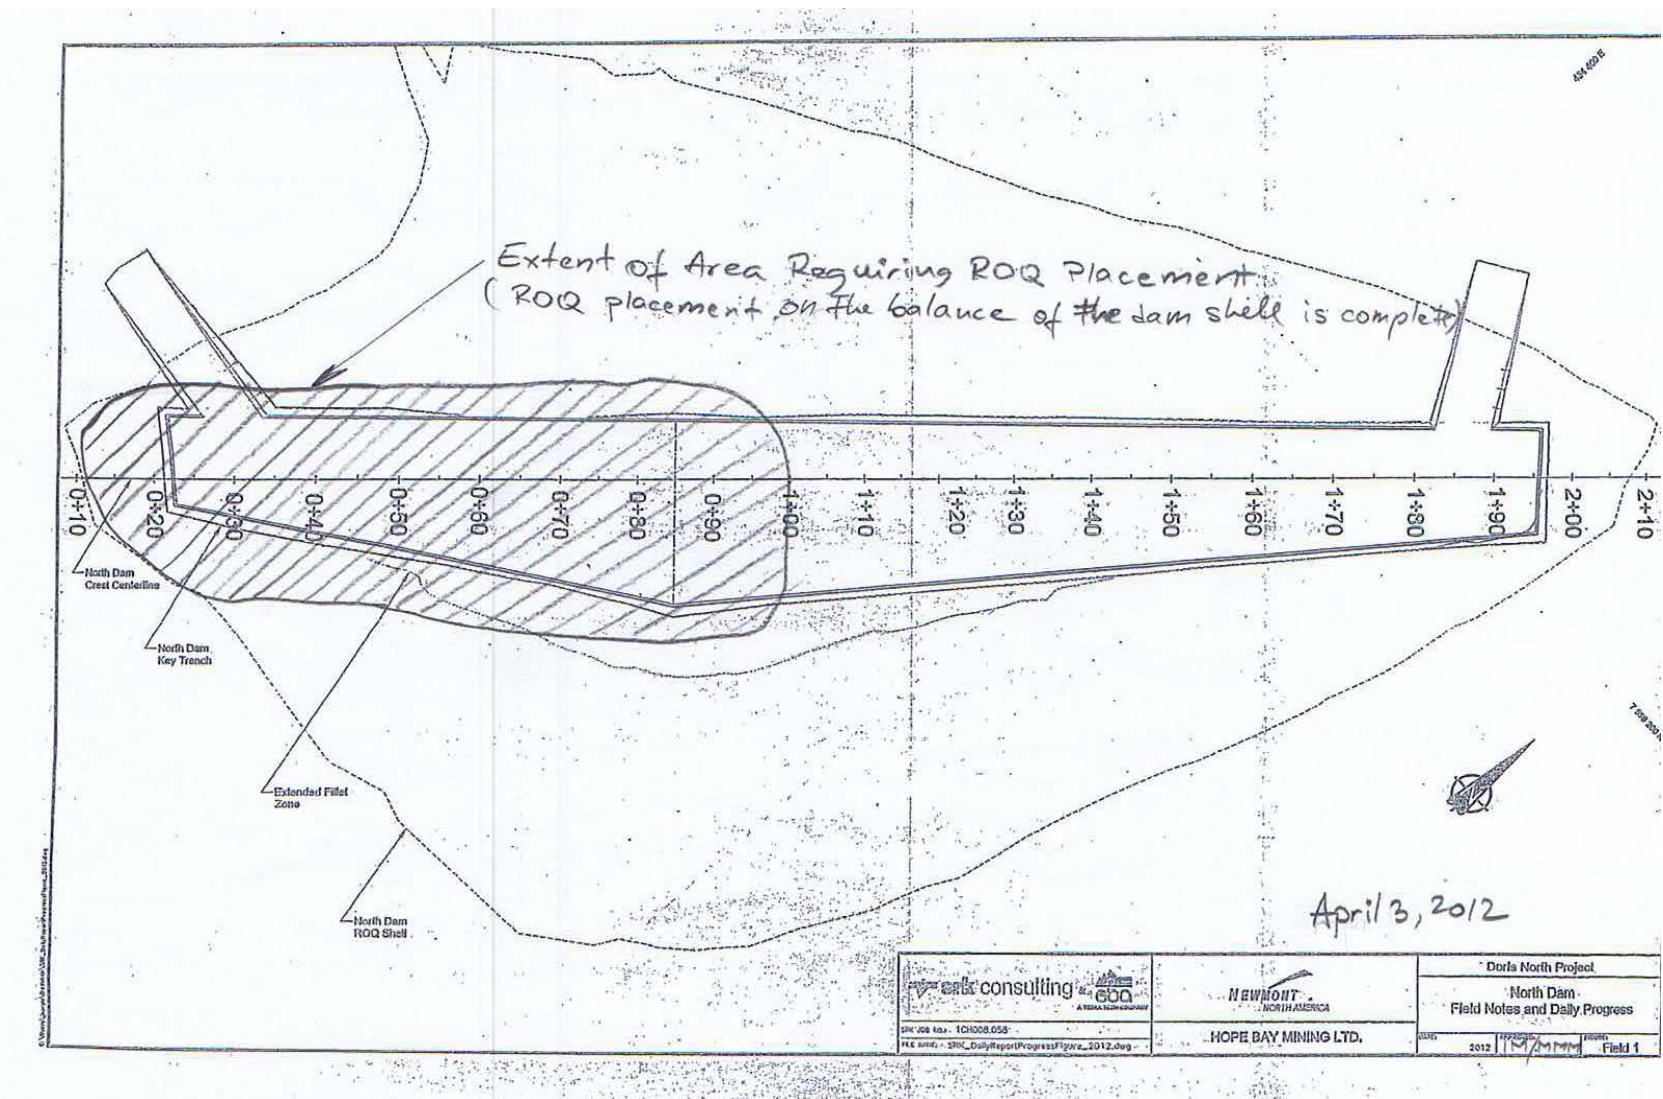
Figure 1: North Dam Progress Figure
