7DAILY REPORT #94 – DORIS NORTH INFRASTRUCTURE/ NORTH DAM

Prepared by:	Lawrence Borowski Iozsef Miskolczi	Date:	2012.04.08
Reviewed by:		Project #:	1CH008.058.0320
Role	Company	Personnel – Position	On Site
Client	Hope Bay Mining Limited (HBML)	Angela Holzapfel – ESR Compliance Manager David Vokey – ESR Coordinator Dean Wold - Safety Jill Turk – ESR Coordinator Katsky Venter – ESR Manger Michelle Tanquay – ESR Site Manager Stirling Kelly – HSLP Advisor	No Yes Yes No No Yes No
	JDS	Doug Fielding – Construction Manager Ishan Fechter – Construction Coordinator Jerry Graham – Construction Manager Mark Valeriote – Construction Manager Calvin Goldschmidt – Construction Coordinator	No Yes Yes Yes No
Engineering Design Consultants	SRK Consulting (Canada) Inc.	Megan Miller – Site Engineer Lawrence Borowski – Site Engineer Iozsef Miskolczi – Site Engineer	No Yes Yes
Earthworks Contractor	Nuna Logistics	Benny Vostermans – Foreman (Day Shift) Doug Haverland – Area Superintendent Gary Sodhi – Field Engineer Georges Cornelissen – Survey Manager Jeff Roberts - Surveyor Jim Cardinal – Foreman Jordan Gunter – Foreman (Day Shift) Kyle Kuntz – Project Engineer Margaret Caley – Surveyor Mike MacMaster

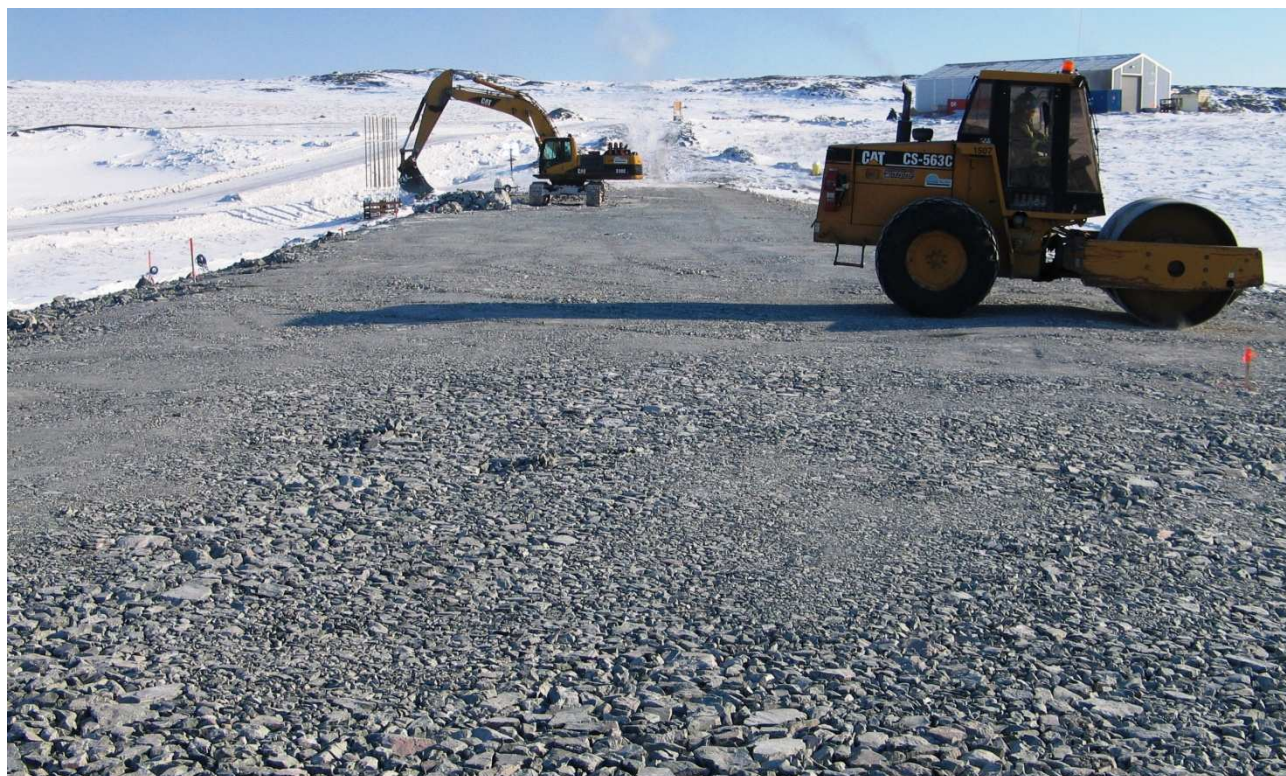
Photo 2: Packer and excavator working at north dam. Photo facing north.

- Some grading and finishing work on the downstream slope, near the crest. Excavator down after lunch..

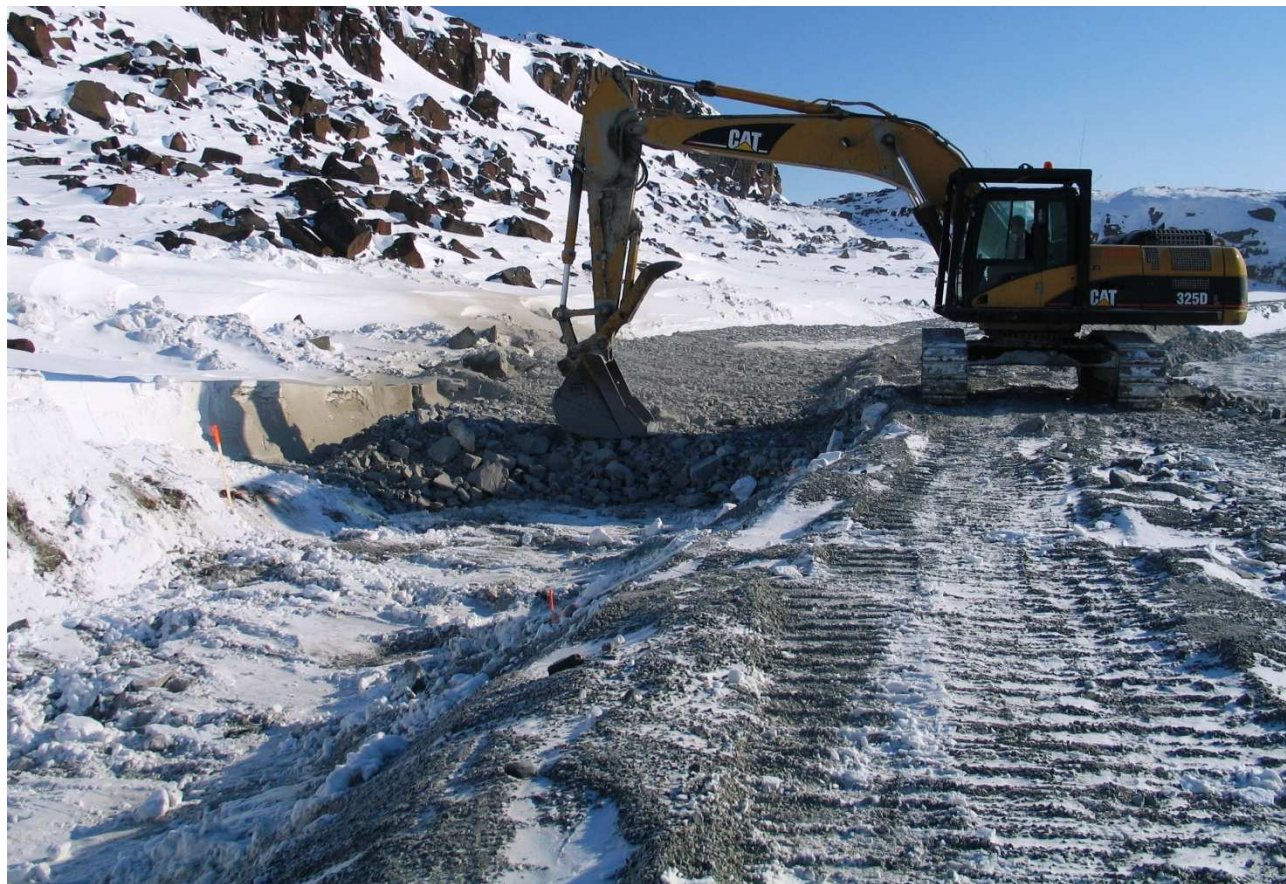
Photo 3: Placing second lift of ROQ ~ Sta 5+30.325 excavator was down for much of the day.

- Second lift of ROQ was placed at the berm starting at Sta. 0+530 and progressing west.
- The excavator broke down early in the afternoon and ROQ placement stopped.

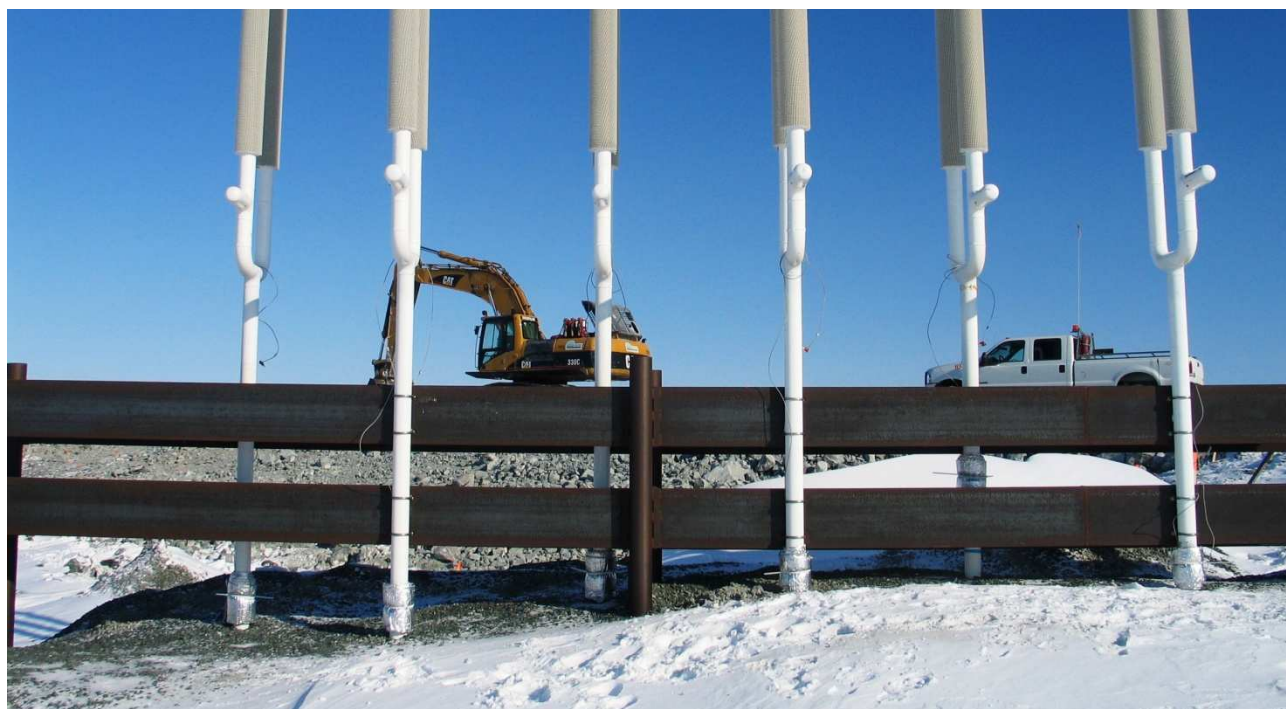
Photo 4: Test on thermosyphons . Readings will be taken early Monday morning

- Final compaction by mechanical methods will be done at a later time.
 - Termination in a junction box will be undertaken at a later date.
- Tests on the thermosyphons were continued from yesterday. The single bead thermistors fastened to Thermosyphons 1, 2, and 3 in the North cluster, left attached overnight, were read to determine evaporator return temperature. The thermistors were subsequently moved to thermosyphons 4, 5, and 6 and the procedure was repeated.

- The south cluster of thermosyphons could not be tested today, as daytime temperatures have risen above -20 degrees recommended for testing. Nevertheless single bead thermistors were attached to each thermosyphon (all six of them) and will be measured tomorrow early morning, before the temperatures rise again.

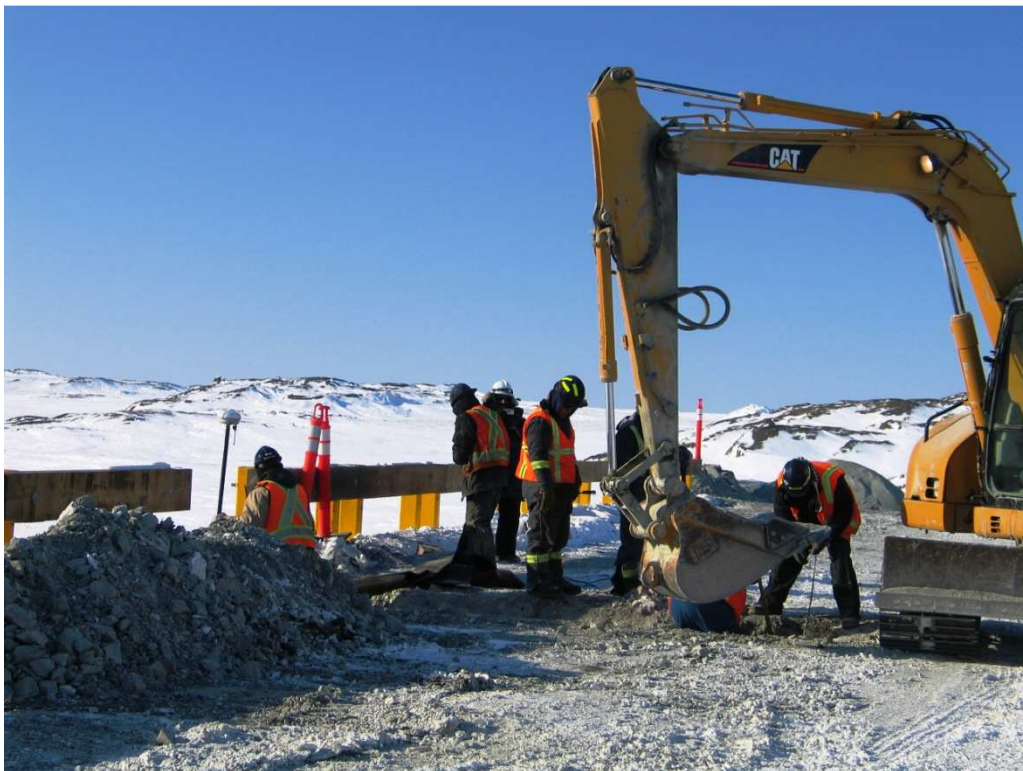
Photo 5: Installing thermister SRK-DWB2. Excavator is filling hole. Surveyor is surveying bedding layer.

- Multibead thermistors SRK10-DWB1, SRK-DWB2 and SRK-DWB3 were installed and read at bridges 2 and 3, following the same procedure as for the installation of the thermistors at Bridge#4.

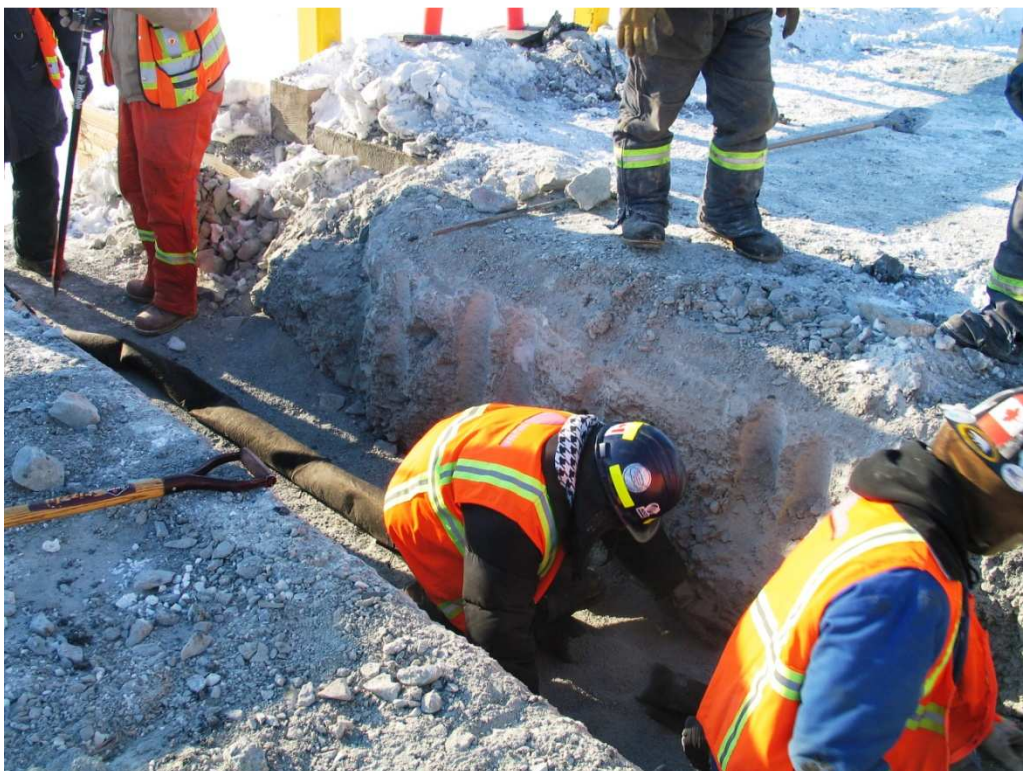
Photo 6: Cable wrapped with geotextile.

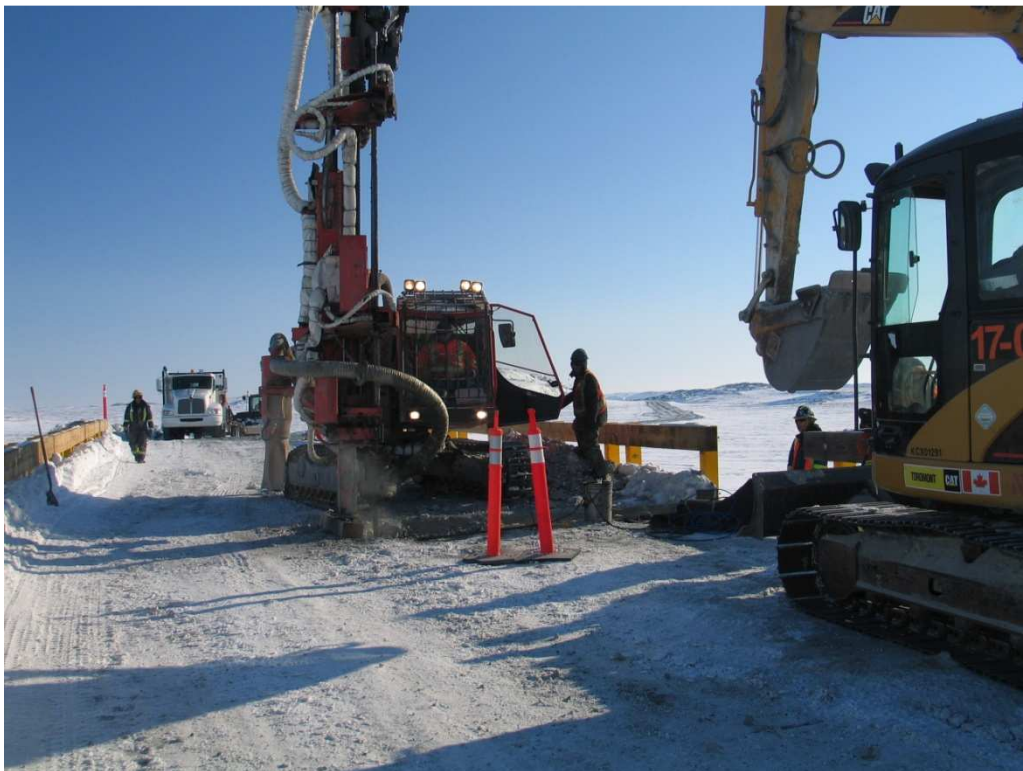
Photo 7: Long wait times were common for large vehicles that couldn't pass the drill.

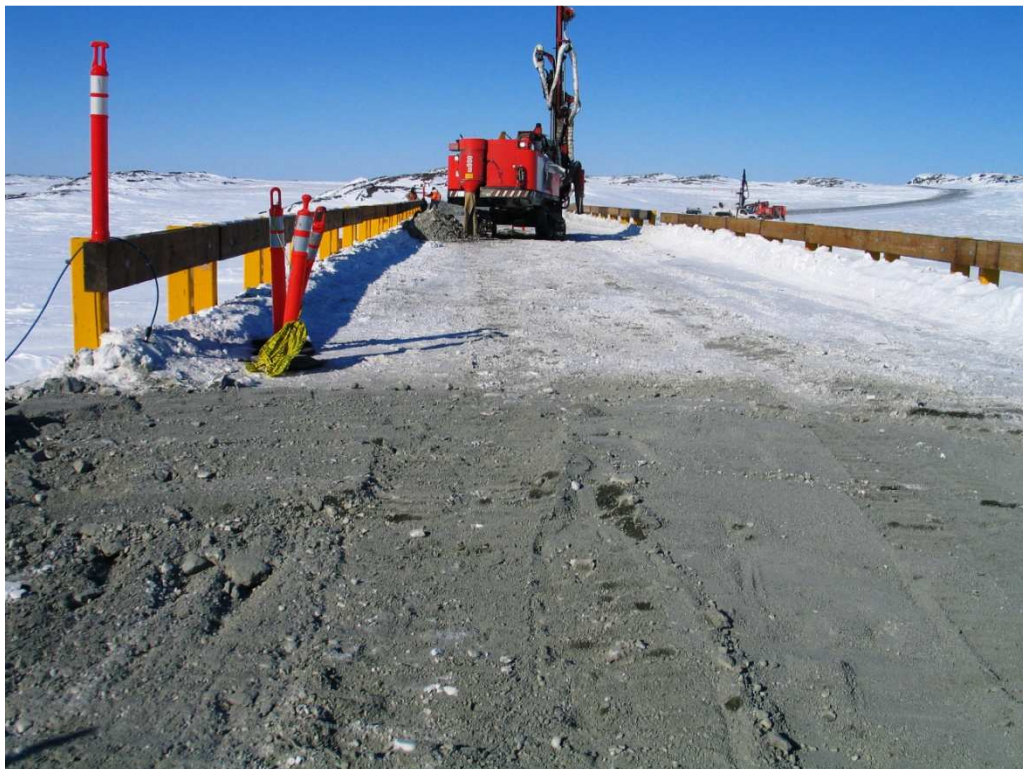
Photo 8: The finished product at thermister SRK-DWB3
