Appendix D: Memos

To:	Mark Valeriotte (JDS) Greg Blaylock (JDS)	Date:	January 24, 2011
cc:	Maritz Rykaart (SRK)	From:	Lowell Wade (SRK)
Subject:	Doris North – North Dam Fillet Construction	Project #:	1CH008.033

SRK Consulting Engineers and Scientists Vancouver B.C.	  NEWMONT NORTH AMERICA	Doris North Project		
		North Dam Fillet Construction		
SRK JOB NO.: 1CH008.027	HOPE BAY MINING LTD.	DATE:	APPROVED:	FIGURE:
FILE NAME: DN-ND-02_Fillet Cons 01.dwg		Jan. 2011	LW	1

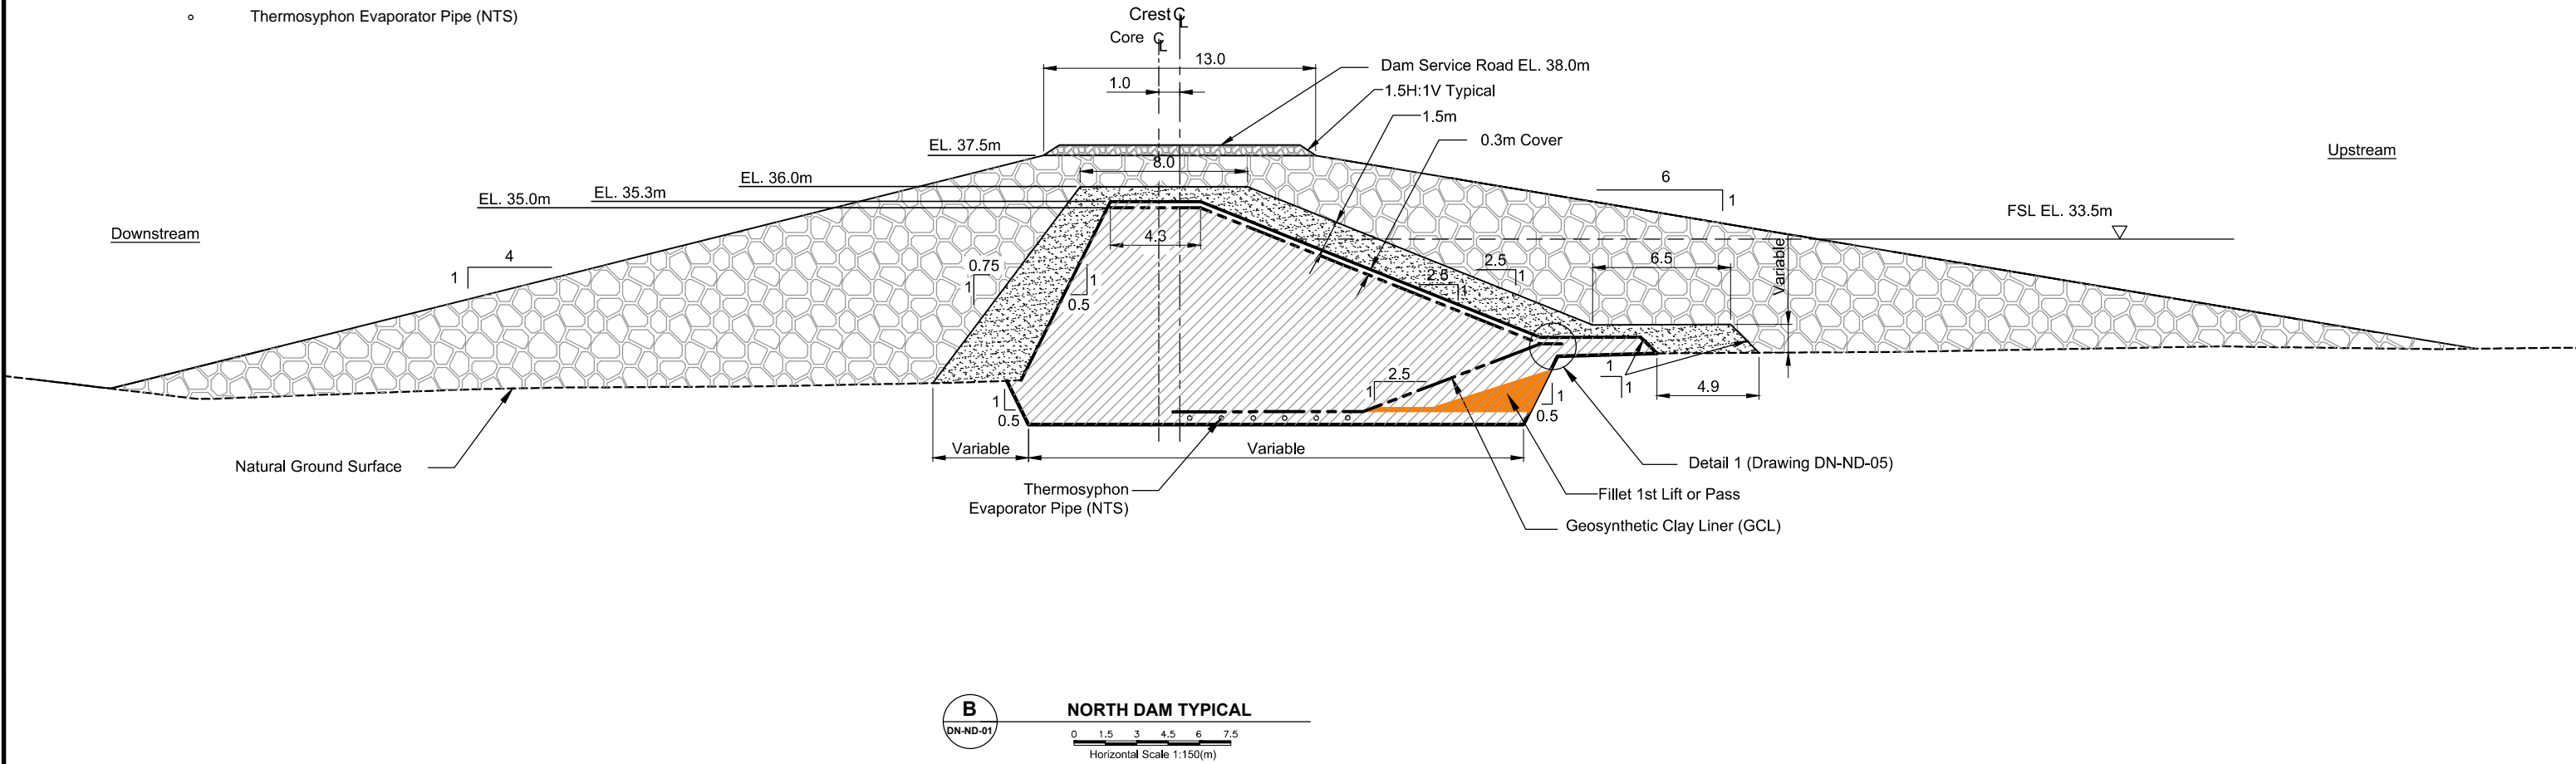
The “fillet” is the area of material below the up-stream liner and the base of the key trench. The technical specifications call for the construction of the “fillet” to be placed and compacted in thin horizontal lifts. This will be difficult due to limited space and narrow width of each lift which will become progressively narrower as the “fillet” reaches the top of the key trench. It has been proposed the fillet be constructed in a series of wedge shaped layers using moisture conditioned core material which is slightly drier than specified for constructing the core of the North Dam. This will allow the core material to be placed on an incline and not slump prior to freezing in-place. The core material will be place and compacted using an excavator bucket. The sequencing of the lifts are shown in the attached three figures.

- NOTES**
- North dam typical cross section taken from drawing, DN-ND-02 as SRK Engineering drawings for the North Dam, Doris North Project, Nunavut Canada. Drawing Issued for Construction, Revision 0, Project No. 1CH008.027, dated December 2010.

SRK does not have an issue with the proposed construction methodology. No changes to the IFC drawing will be required

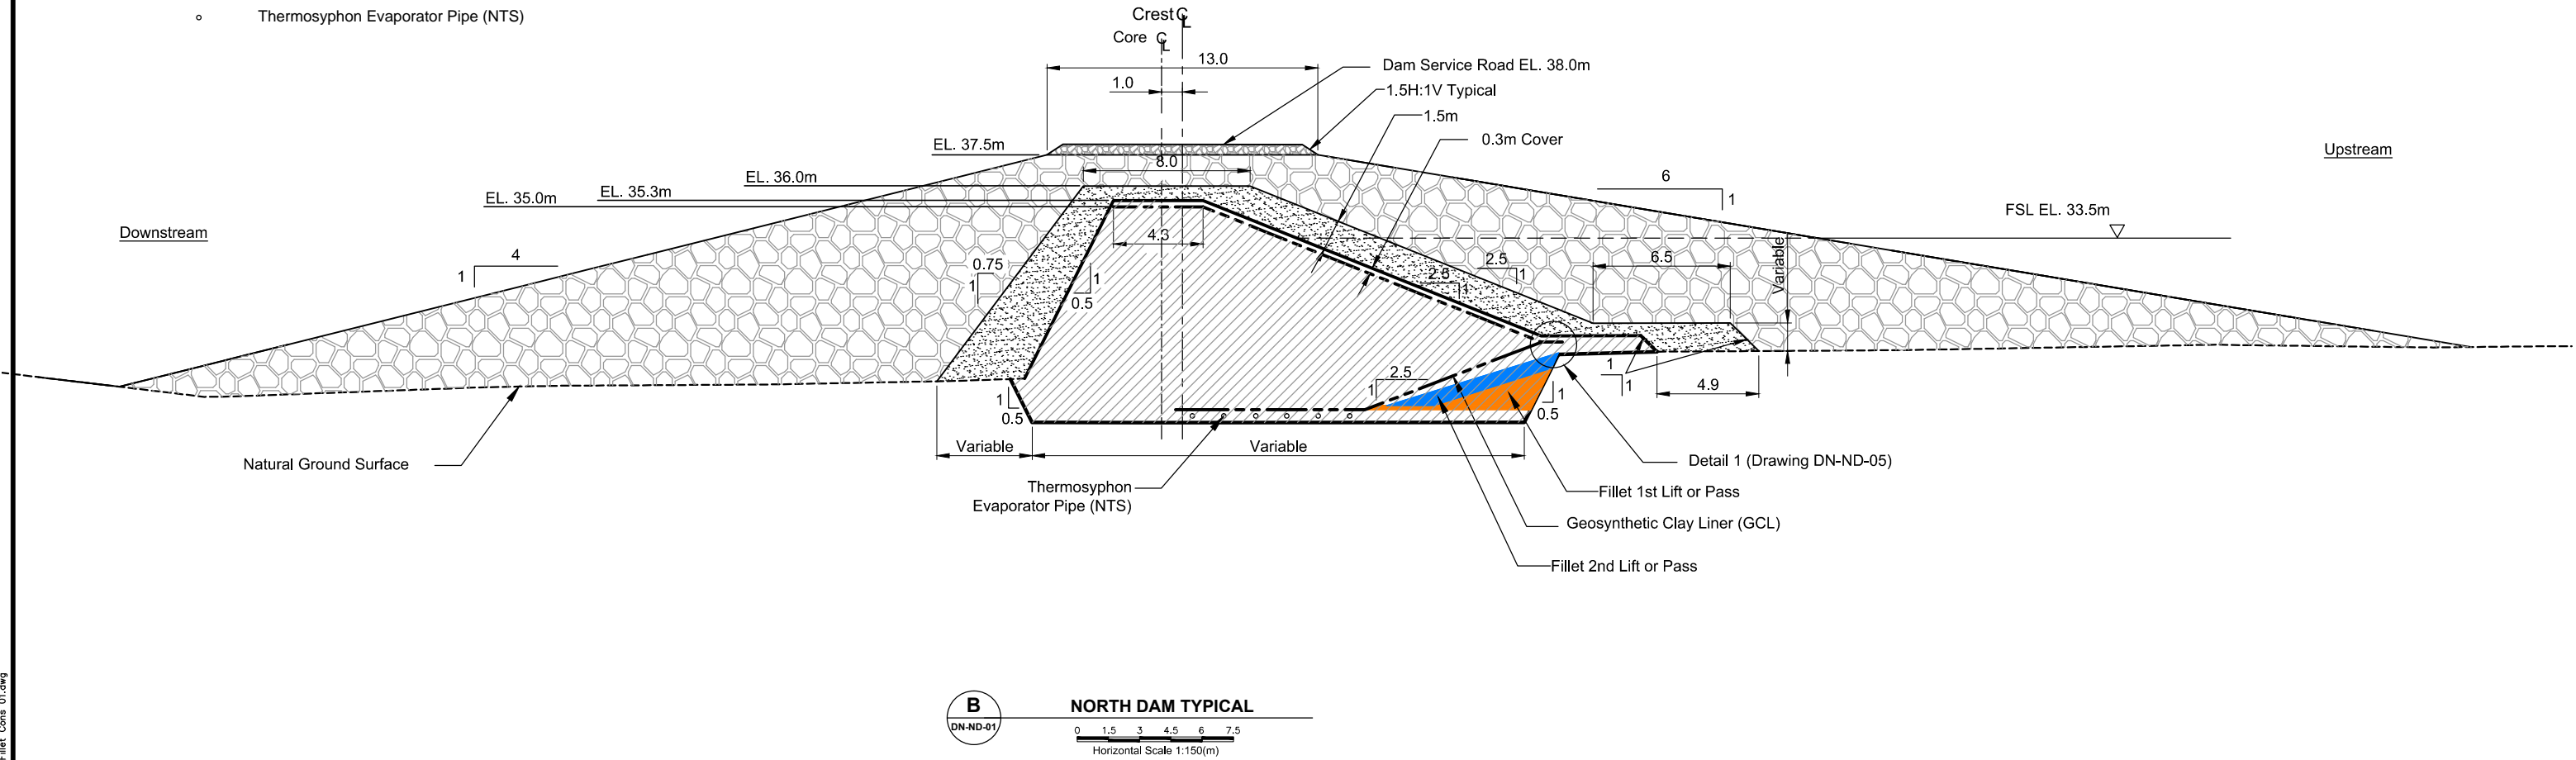
- North dam typical cross section taken from drawing, DN-ND-02 as SRK Engineering drawings for the North Dam, Doris North Project, Nunavut Canada. Drawing Issued for Construction, Revision 0, Project No. 1CH008.027, dated December 2010.

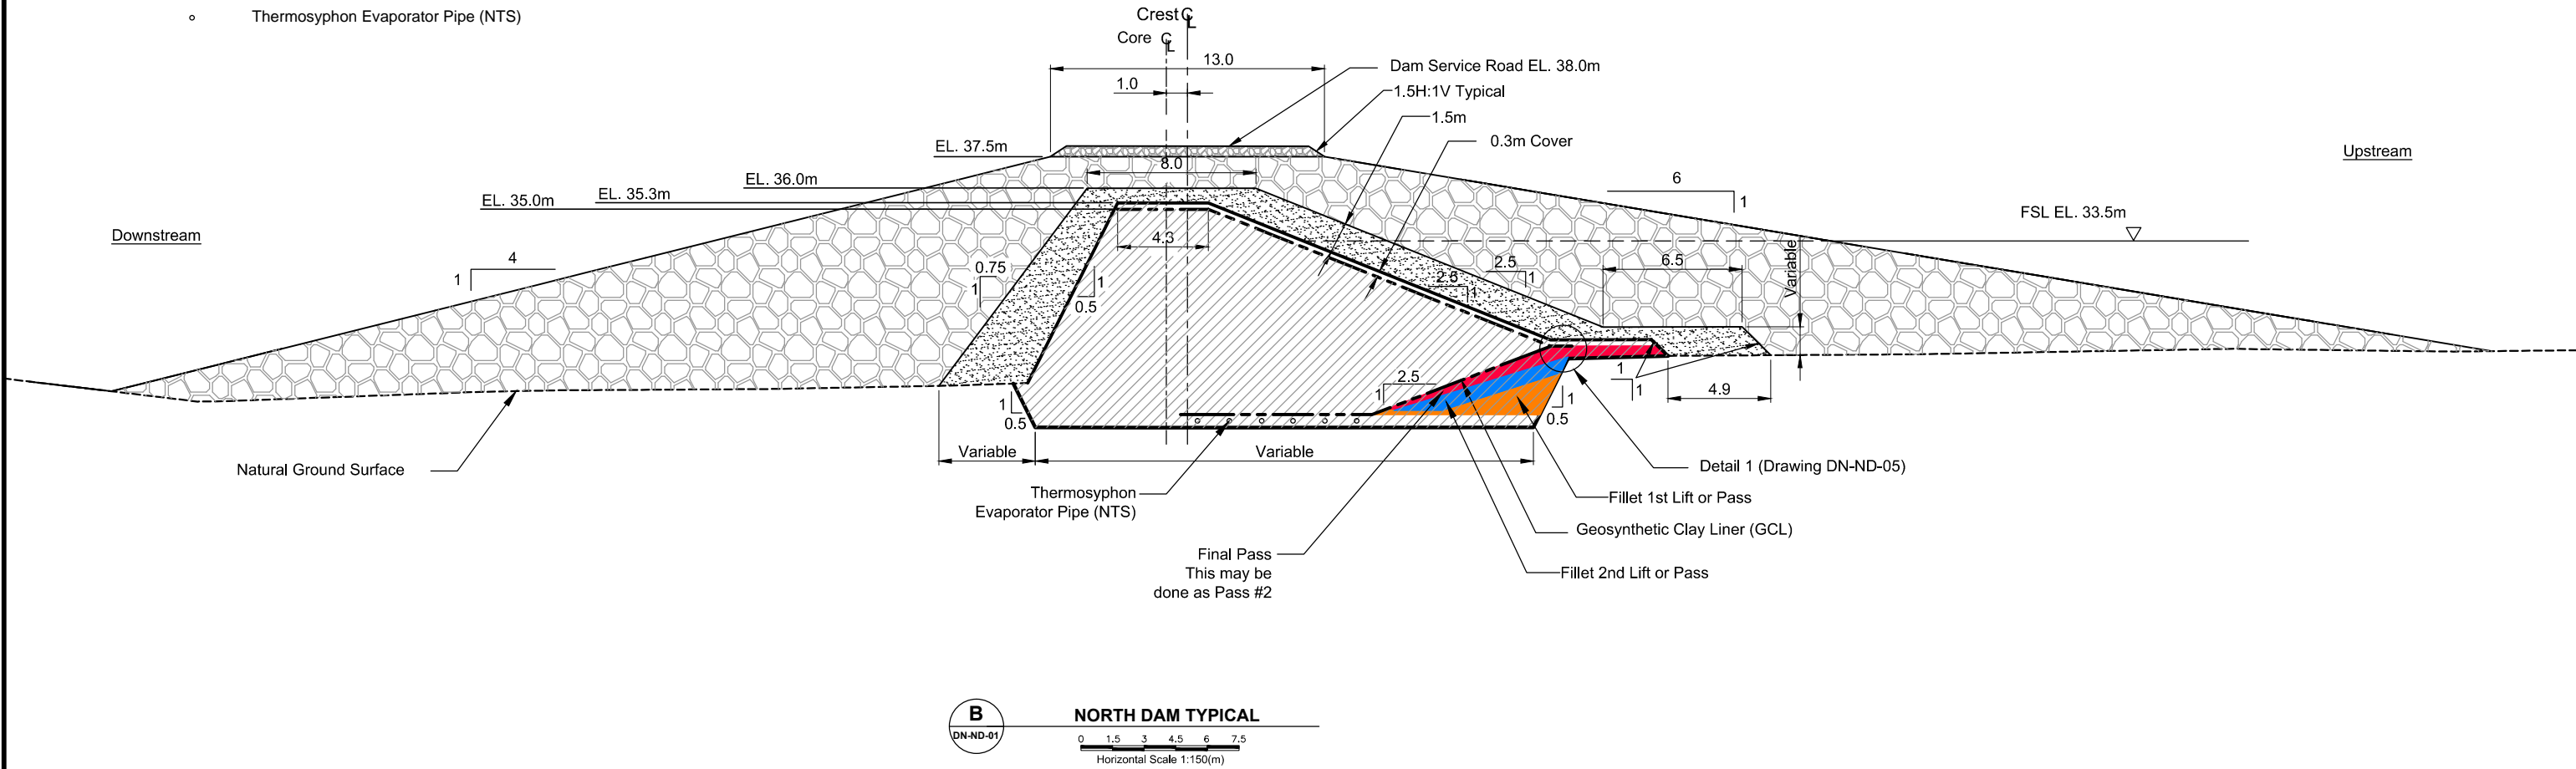
SRK Consulting Engineers and Scientists Vancouver B.C.	 NEWMONT NORTH AMERICA	Doris North Project		
		North Dam Fillet Construction		
SRK JOB NO.: 1CH008.027	HOPE BAY MINING LTD.	DATE:	APPROVED:	FIGURE:
FILE NAME: DN-ND-02_Fillet Cons 01.dwg		Jan. 2011	LW	3

North dam typical cross section taken from drawing, DN-ND-02 as SRK Engineering drawings for the North Dam, Doris North Project, Nunavut Canada. Drawing Issued for Construction, Revision 0, Project No. 1CH008.027, dated December 2010.

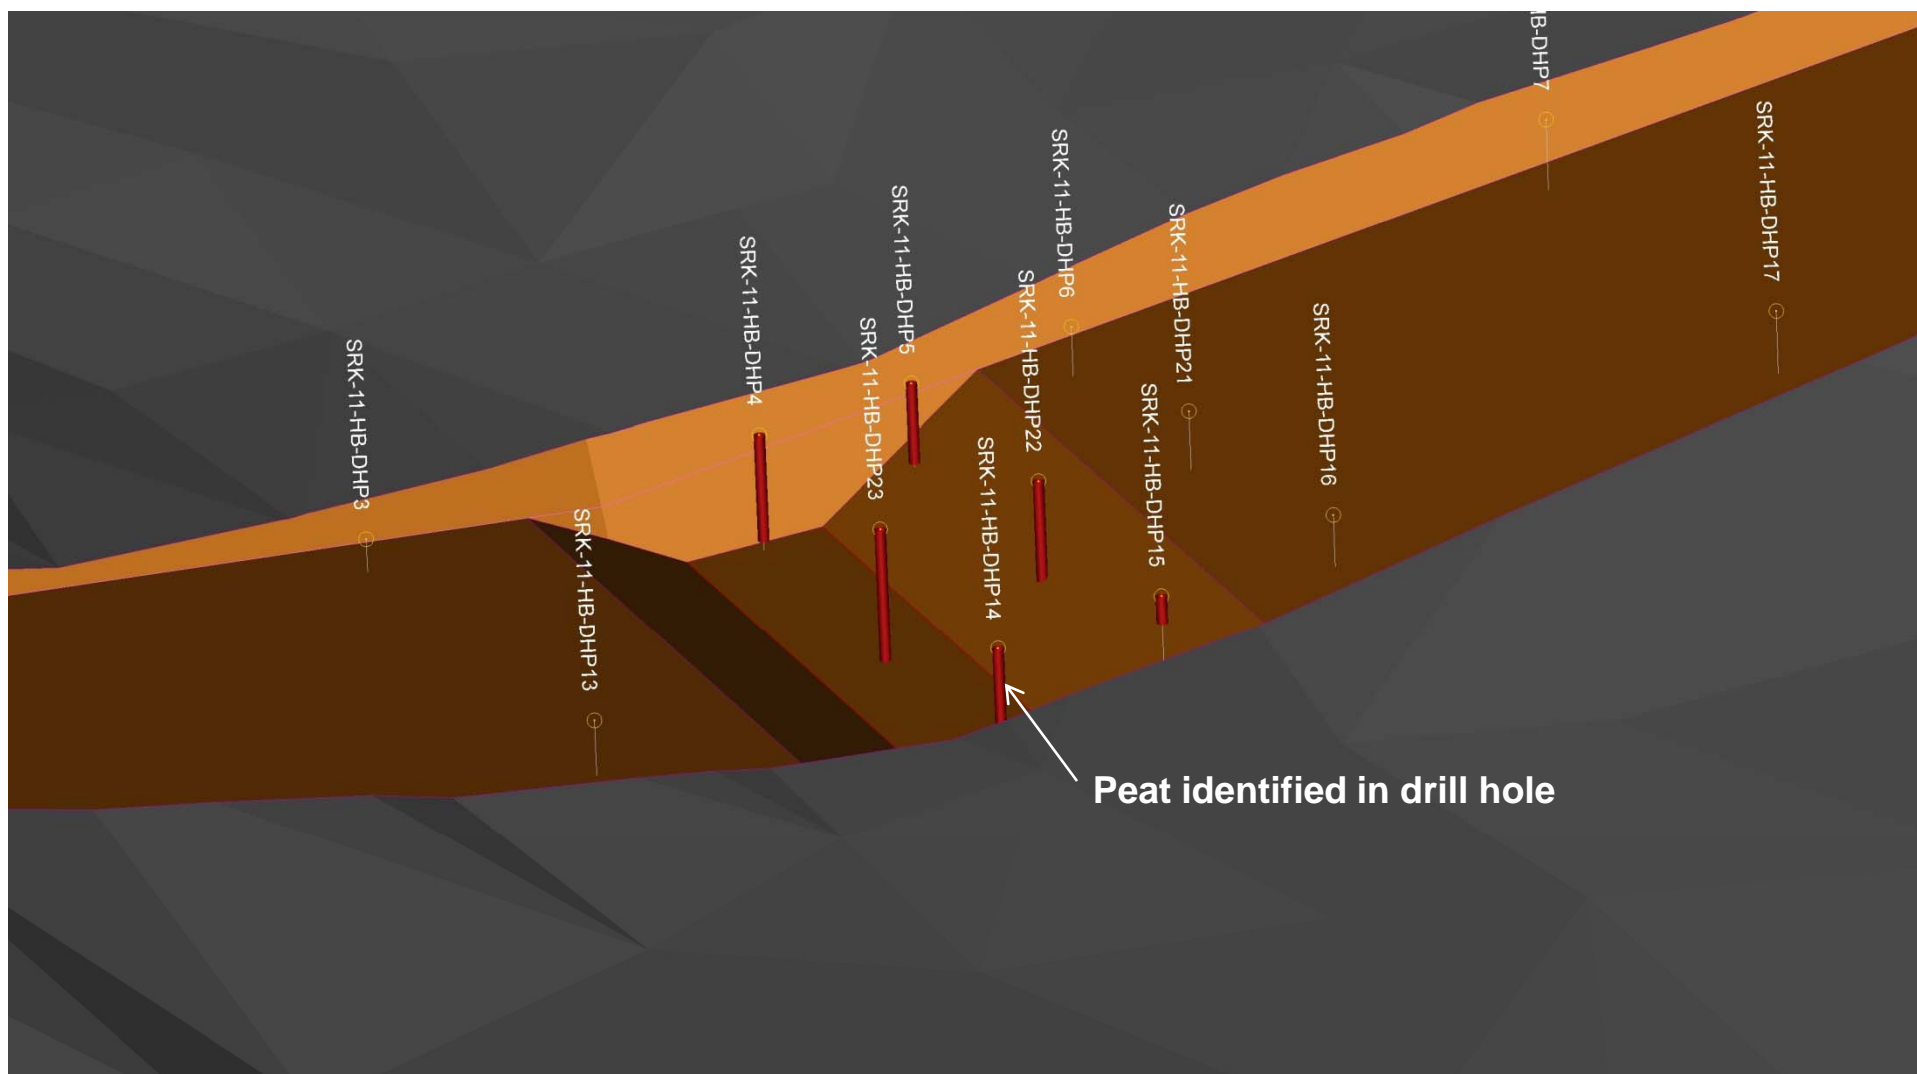
<p>NEWMONT NORTH AMERICA</p>	Doris North Project	
	<p>HOPE BAY MINING LTD.</p>	<p>North Dam Additional Key Trench Excavation 3D View</p>	
<p>Job No: 1CH008.033</p> <p>Filename: Figure 2_6_NorthDam_20110214.pptx</p>		<p>Date: February 2011</p>	<p>Approved: LW</p>
			<p>Figure: 2</p>

This peat and ice rich material must be completely removed, and replaced with saturated core material to ensure the integrity and performance of the dam. The additional excavation is about 625 m³ and consists of a trapezoidal cut with a horizontal 5 m base width at chainage 0+095, and 2H:1V slopes in the west and east directions intercepting the design key trench base at changes 0+82 and 0+99 respectively. The north and south sides of the additional excavation will be consistent with the existing key trench side slopes of 0.5H:1V. The additional excavation is variable in depth, with a maximum depth of about 5 m below original ground, or 2.6 m below the original key trench base design depth.

It should be noted that the north and south wall of the additional excavation will be near vertical high-walls in frozen ice rich material, and the Contractor must be instructed to take special precaution to ensure the safety of all workers when working in these areas.

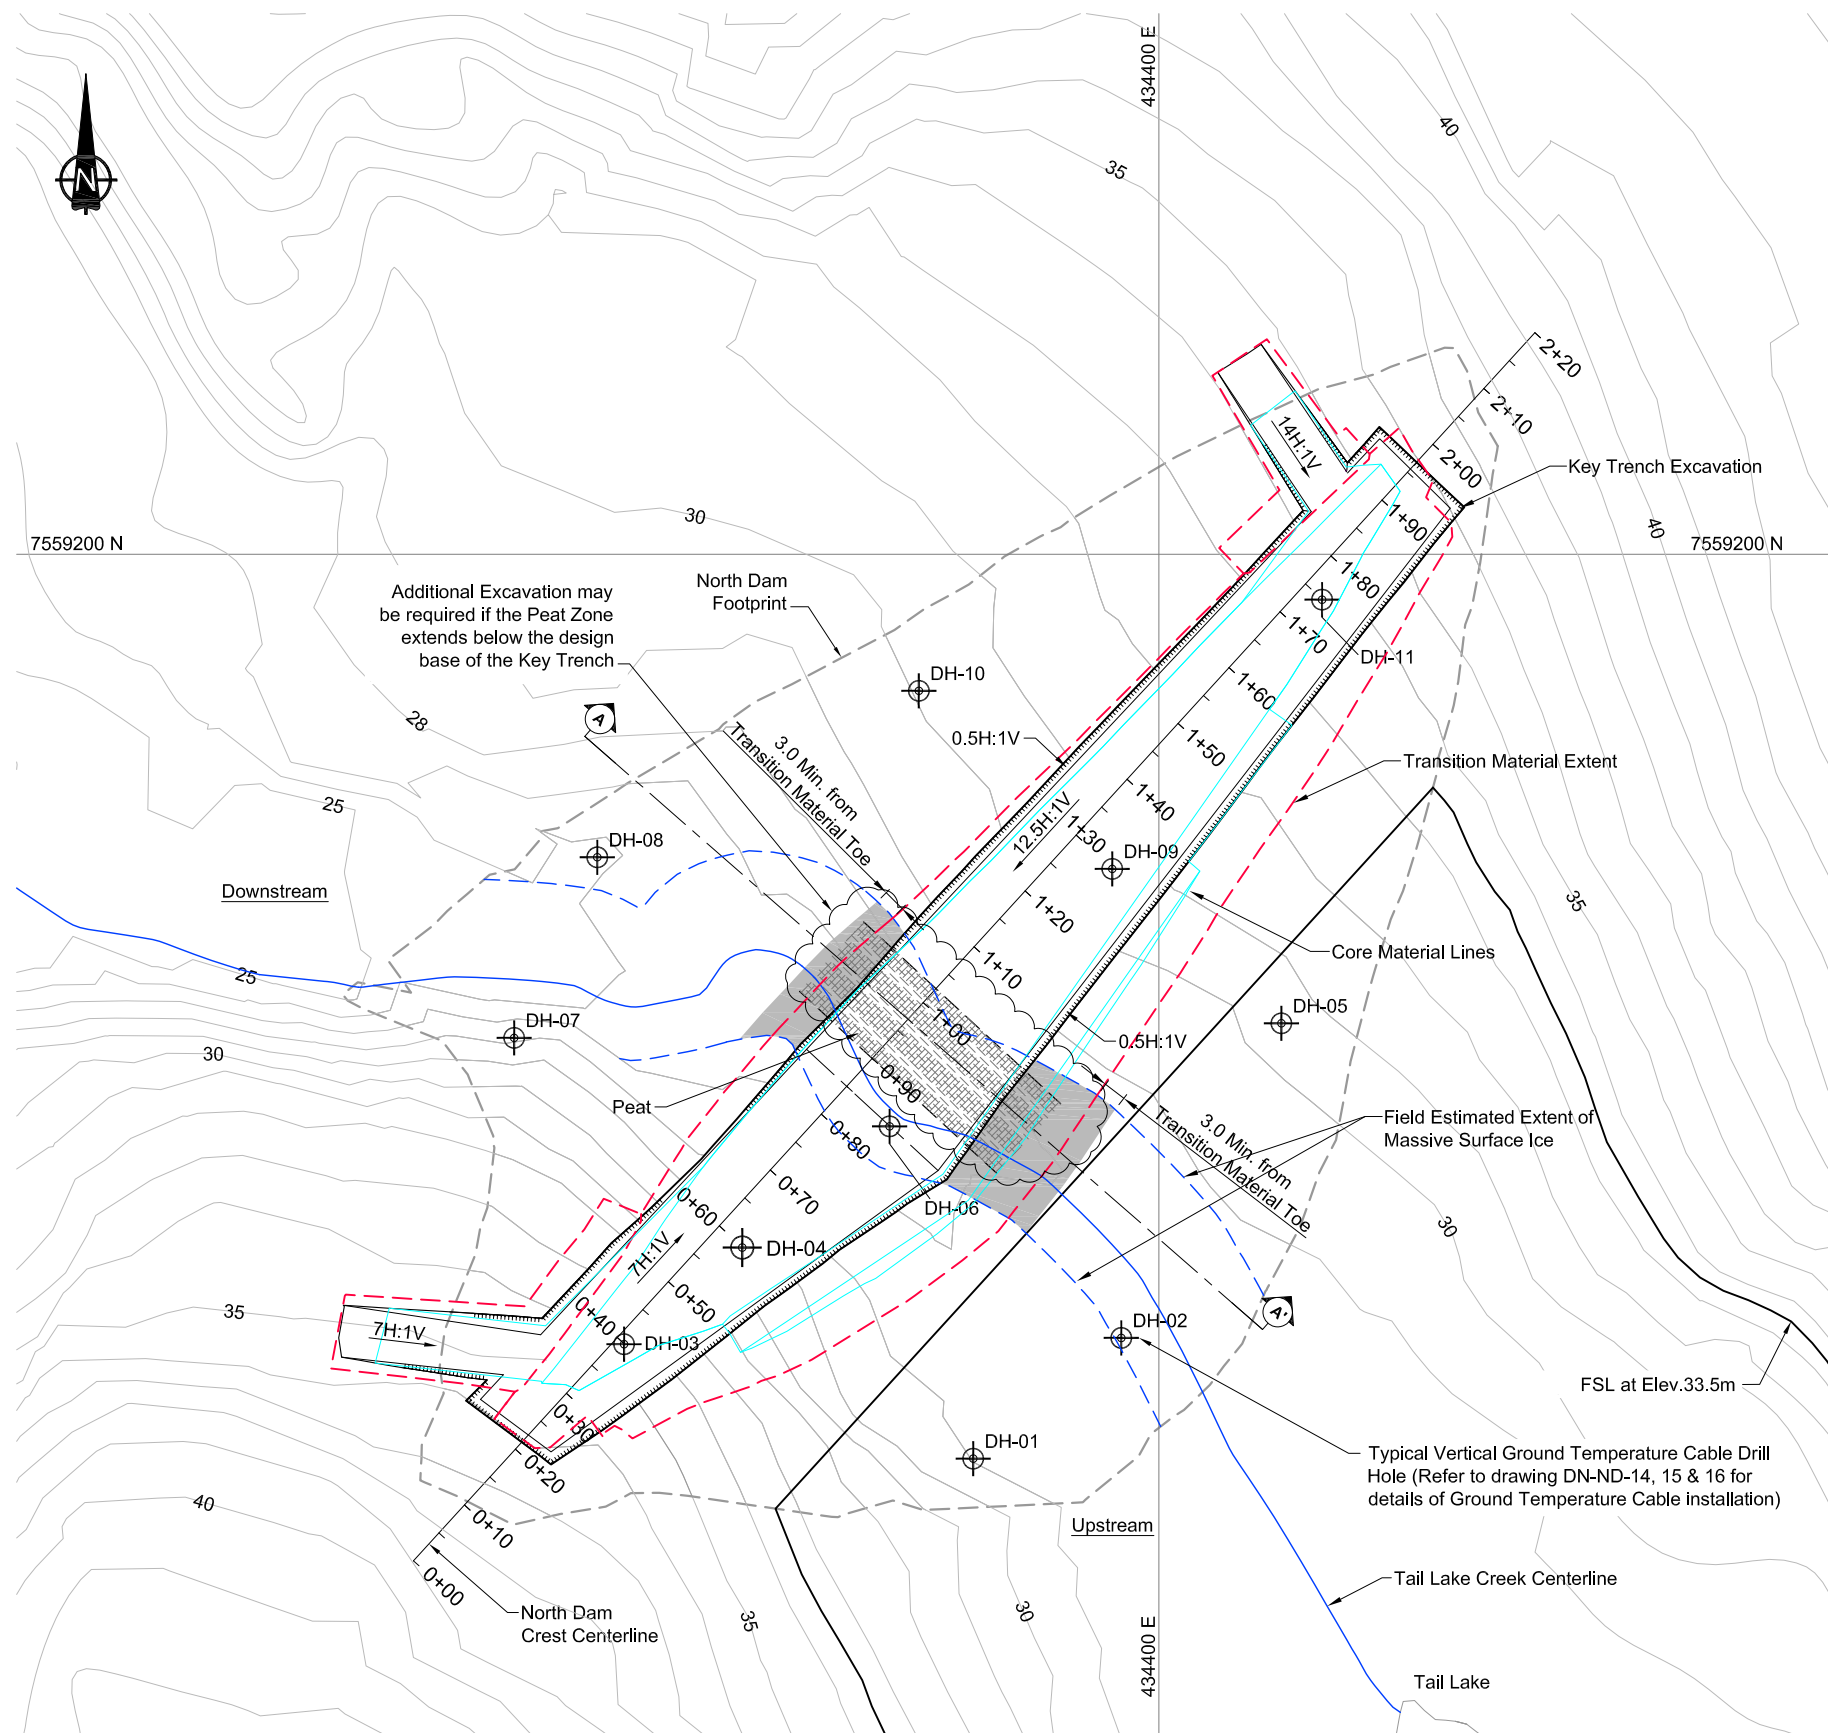
Visual inspection of the upstream and downstream slopes of the key trench at chainage 0+95 to 1+00 confirms the presence of a zone of massive surface ice, as much as 0.5 m thick and about 4 to 6 m in width. It has been noted in the field that thinner lenses of ice interlaced with layers of ice saturated alluvium extend to a depth of about 1.5 m below ground; this is above the invert level of the key trench. Reconnaissance inspection suggests that the surface ice follows along the Tail Lake Creek course, and therefore its presence is directly related to the normal flow of the Creek. Due to the direct correlation to the Creek it is estimated that this zone of surface ice should be approximately constrained around the vicinity of chainage 0+80 to 1+00. If this ice remains in place, and should it thaw, it could lead to local differential settlement of the transition and ROQ zones in this area.

To prevent this settlement from happening, the zones of massive ice needs to be removed and replaced with suitable fill. Rather than using mass excavation techniques, SRK recommends that the ice be visually chased at surface and only relevant section be ripped out. Dental cleaning is not required, with the intent being to remove massive ice rather than smaller lenses of ice less than 10 cm. It should be noted that this ice should be chased to at least 3 m beyond the interface point between the Transition and ROQ zones, both upstream and downstream. Details on the required minimum upstream and downstream extents of this massive surface ice excavation can be found in figure ND-IE1 and ND-IE2.

Core material or out of spec core material (i.e. core reject) is a suitable fill material for the areas where surface ice is encountered outside of the key trench footprint. This material does not have to be placed saturated and compacted. Further details of the required excavation backfilling can be found on figure ND-IE2.

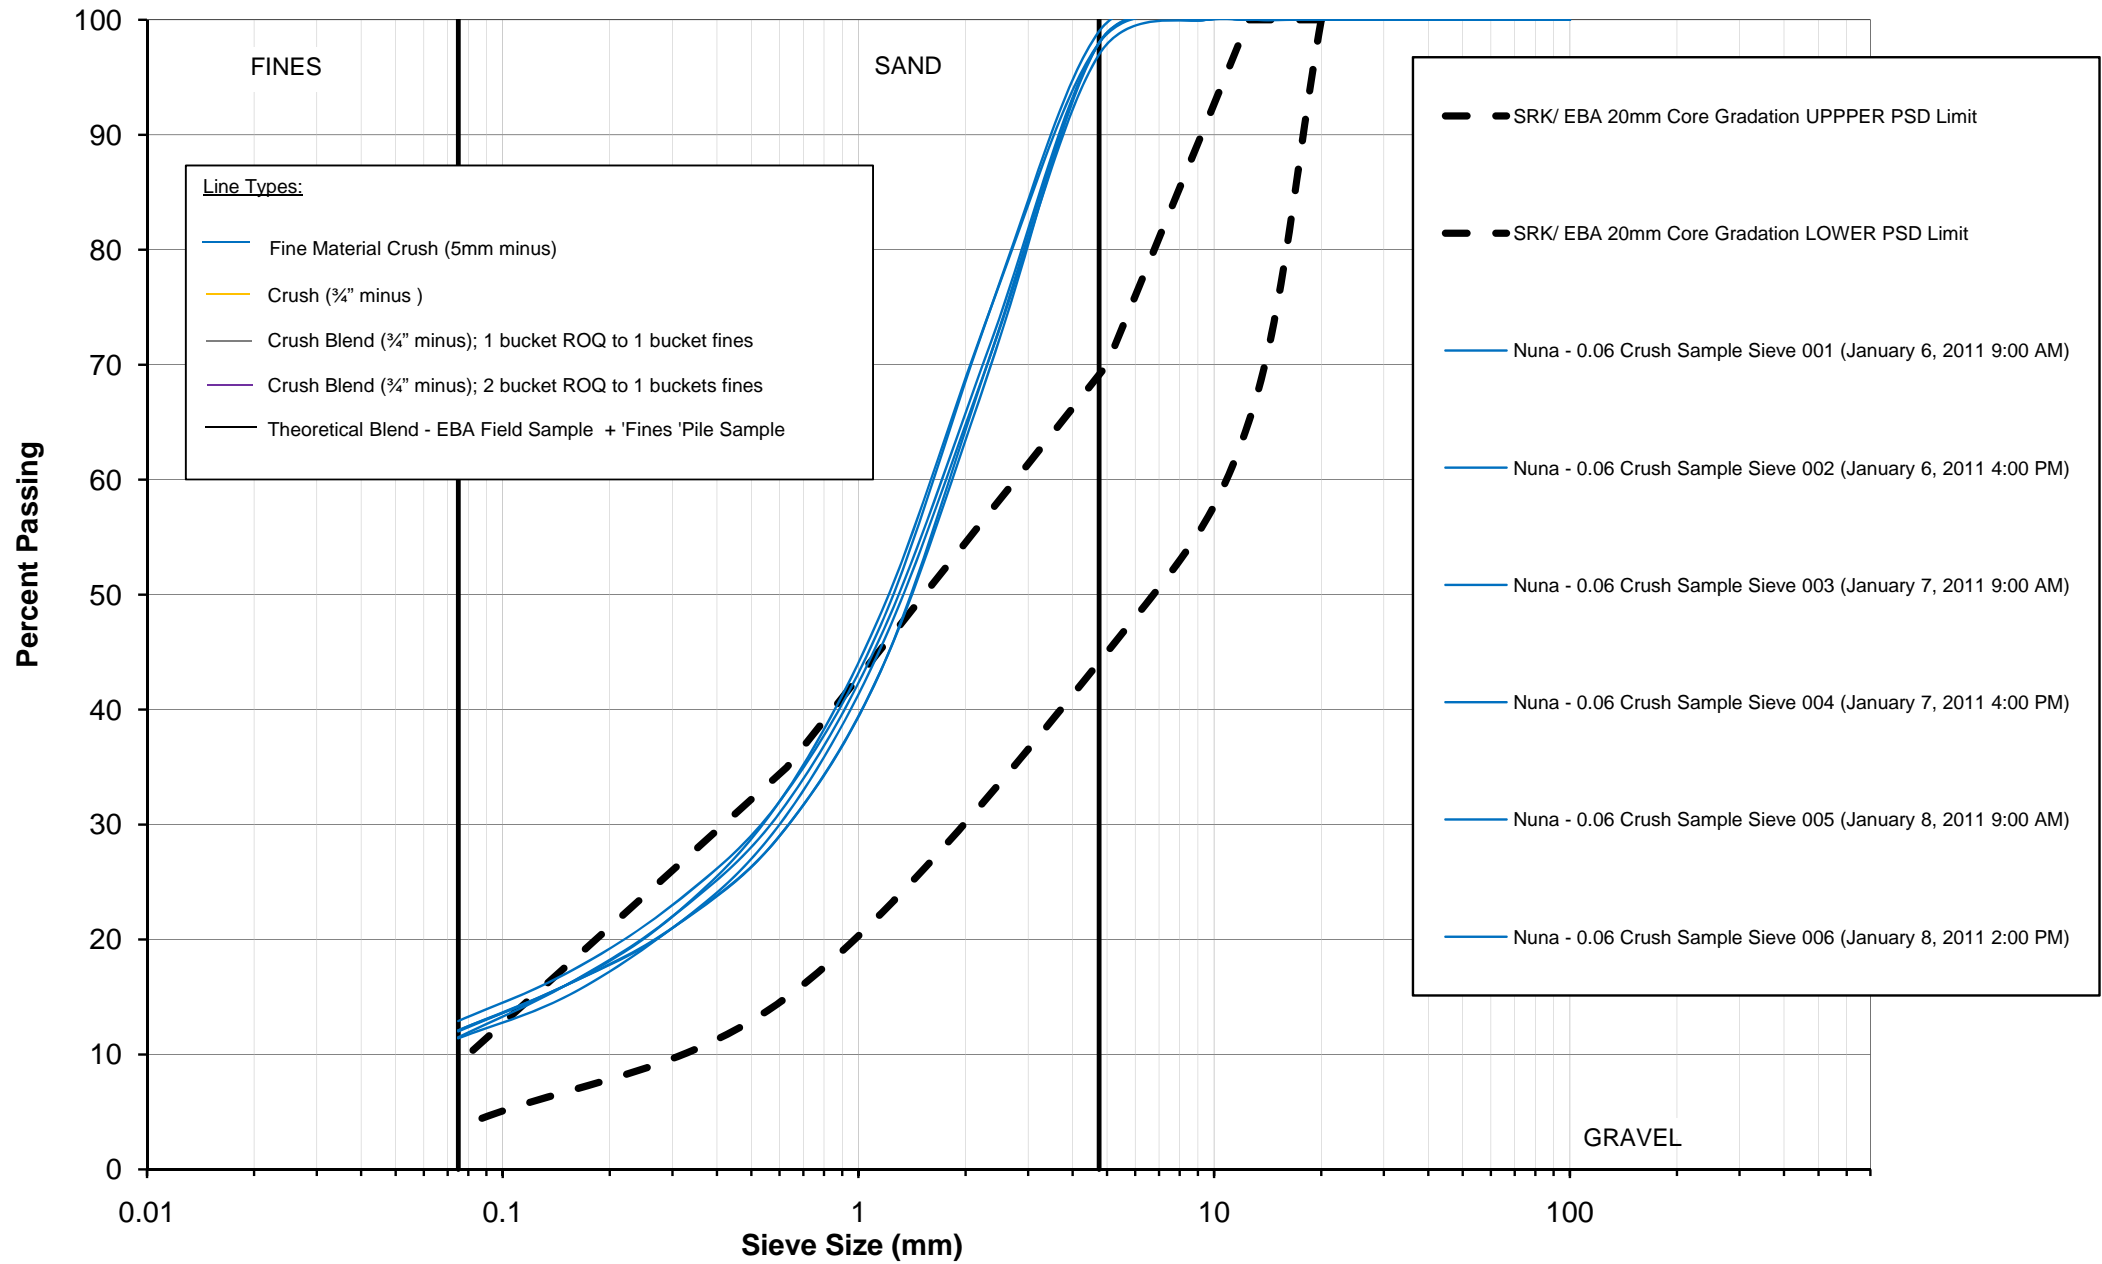
Note: This Figure has been plotted as an internal SRK tool to assist in visualizing the % passing data presented in the preliminary PSD testing results. EBA lab PSD sheets can be referenced for official results.

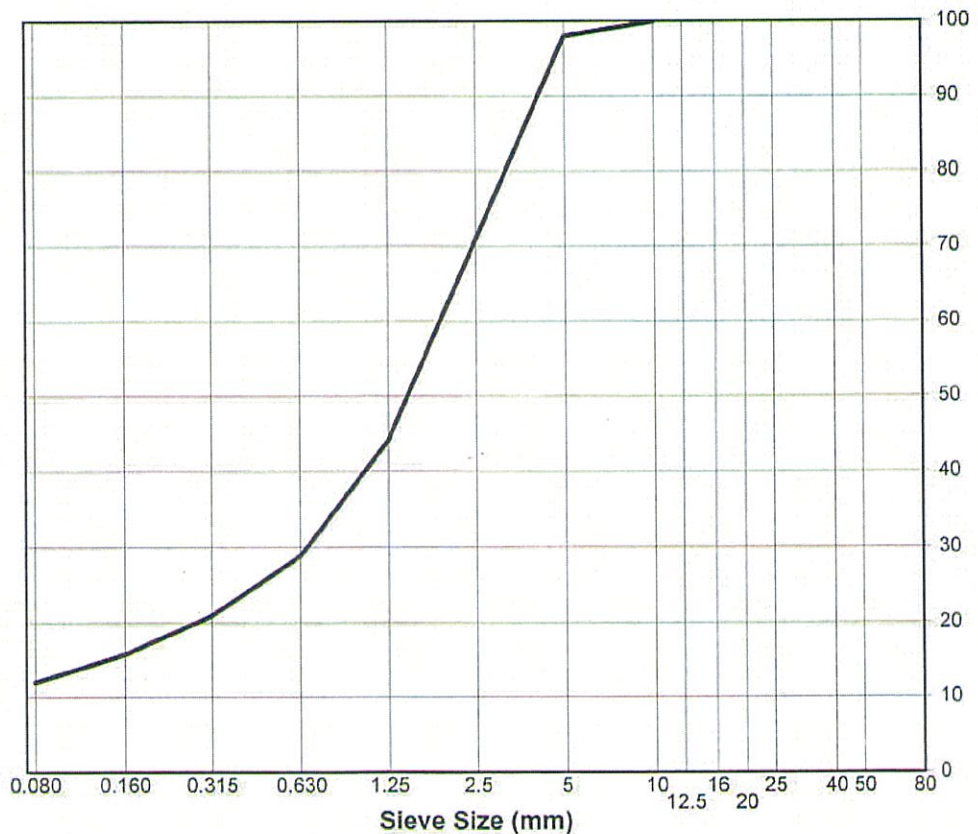
Sample No.: 1
Date Received: January 6, 2011
Sample Time: 9:00 AM
Sampled by: AJC
Date Tested: January 6, 2011
Tested by: AJC Office: Site
Moisture Content (as received): 6.4%
Screen(s) size: 5/8 " and 3/16 "
Cone Type: Standard Coarse

Sieve Size	Percent Passing
10	100
5	98
2.5	71
1.25	44
0.630	29
0.315	21
0.160	16
0.080	12.0

Remarks: January 2011 Crusher Run. Fine material crush. (5 mm minus)

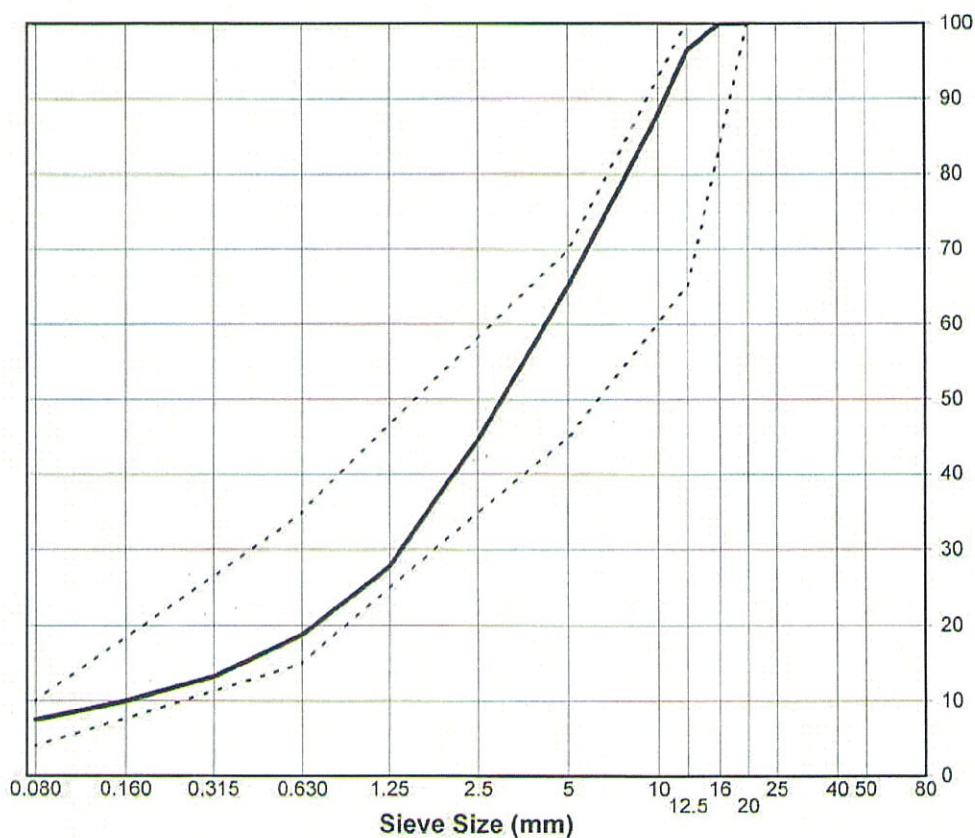
Sieve Size	Percent Passing
20	100
16	100
12.5	96
10	88
5	65
2.5	45
1.25	28
0.630	19
0.315	13
0.160	10
0.080	7.5

Remarks: January 2011 Crusher Run. Theoretical Blend of Jan 2011 Sample 1 and EBA Sample 5426. (60% 20 mm minus crush, 40 % 5 mm crush)

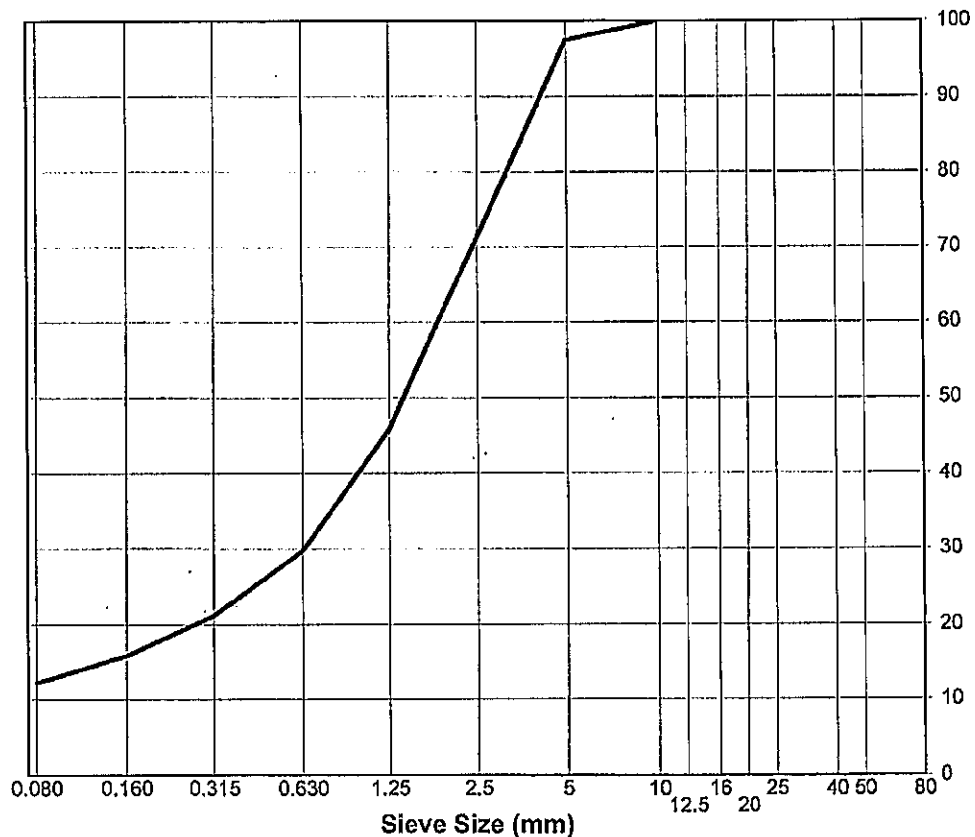
Sample No.: 6
Date Received: January 8, 2011
Sample Time: 2:00 PM
Sampled by: AJC
Date Tested: January 8, 2011
Tested by: AJC Office: Site
Moisture Content (as received): 7.4%
Screen(s) size: 5/8 "
Cone Type: Standard Coarse

Sieve Size	Percent Passing
10	100
5	97
2.5	71
1.25	46
0.630	30
0.315	21
0.160	16
0.080	12.3

Remarks: January 2011 Crusher Run. Fine material crush. (5 mm minus) Less airborne dust
at quarry from crushing, sample appears more moist than Sample 5 (possible cause of dust reduction).

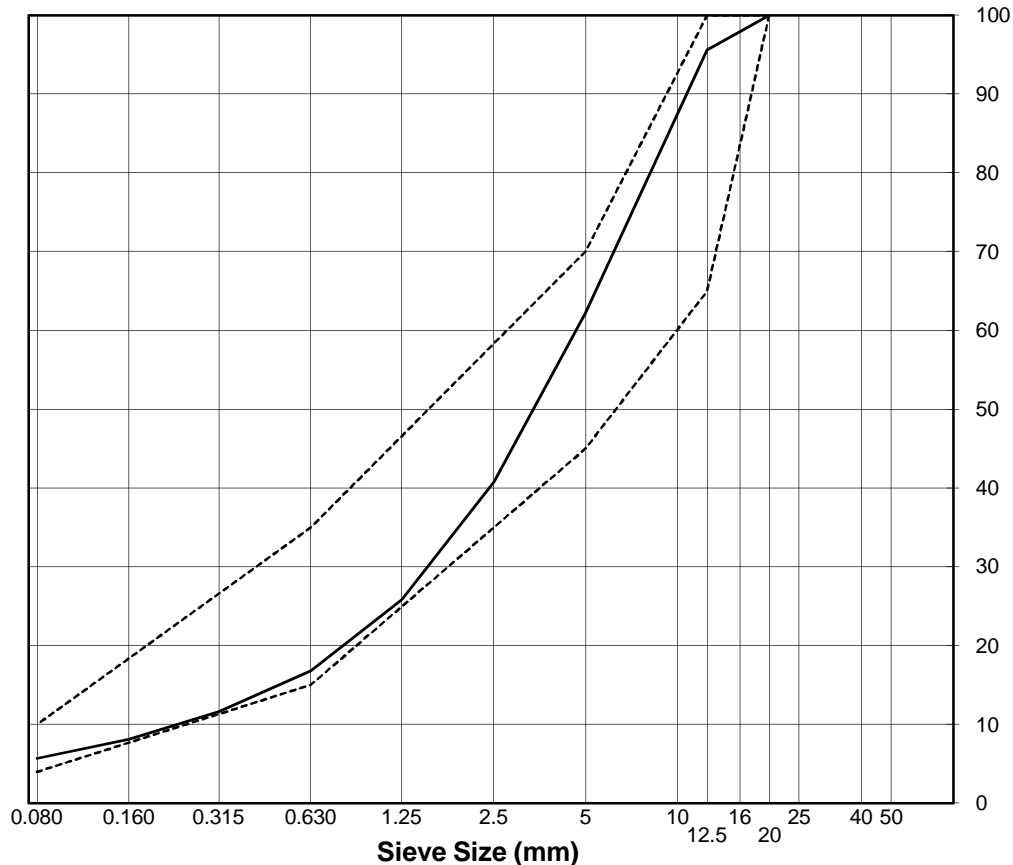
Sieve Size	Percent Passing
20	100
12.5	96
5	62
2.5	41
1.25	26
0.630	17
0.315	12
0.160	8
0.080	5.6

Remarks: This particle size analysis represents the Core blend, prior to saturation.

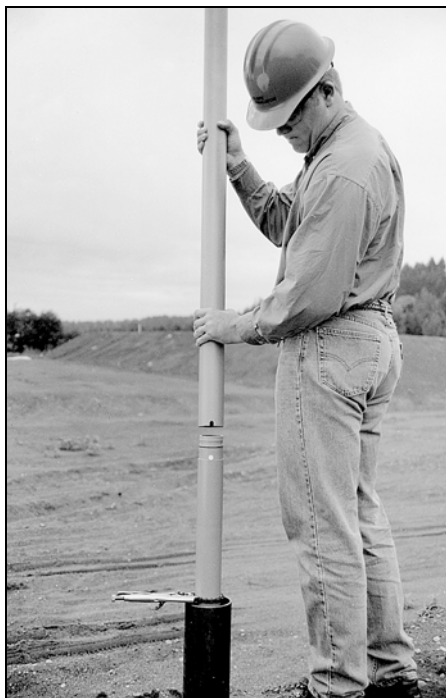
Inclinometer Casing

Inclinometer casing is a special purpose, grooved pipe used in inclinometer installations. It is typically installed in boreholes, but can also be embedded in fills, cast into concrete, or attached to structures.

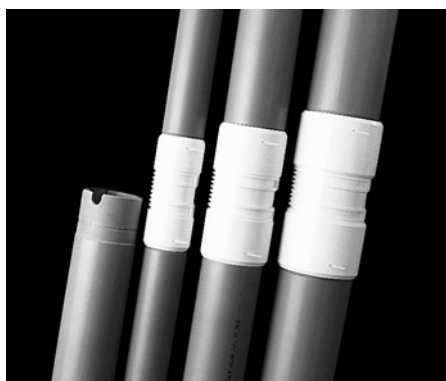
CPI CASING

CPI casing features quick assembly and disassembly and is available in 3 diameters.

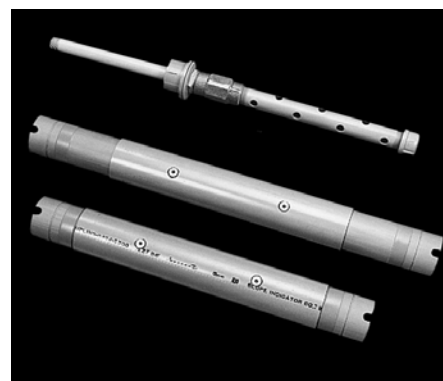
GROUT VALVES

Grout valves allow placement of grout backfill in boreholes that cannot accommodate an external grout pipe. The one-way valve is installed in the bottom section of casing. A grout pipe is lowered through the casing to mate with the grout valve and deliver the grout.

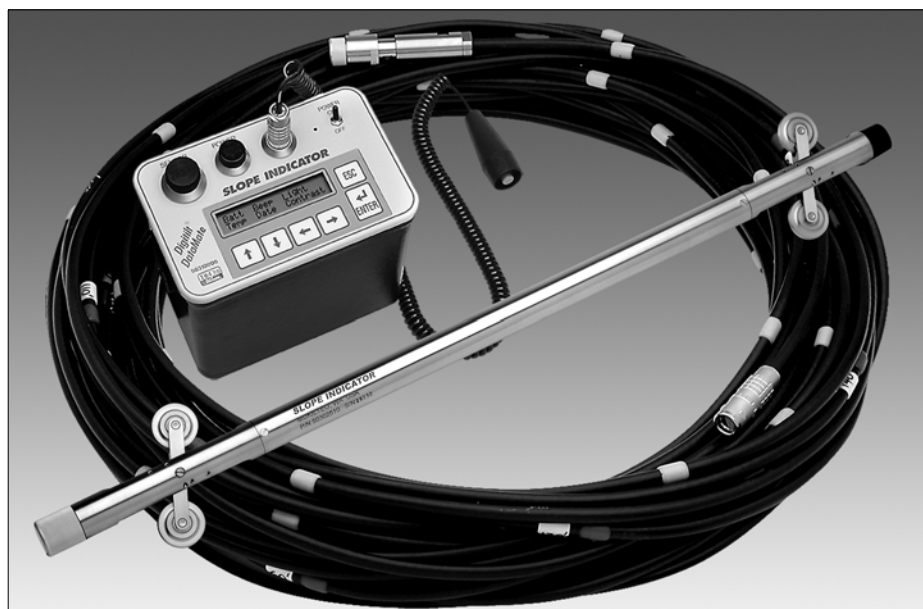
Digitilt Inclinometer Probe

Proven Performance: Digitilt inclinometer probes have earned a world-wide reputation for durability, high precision, and rapid response.

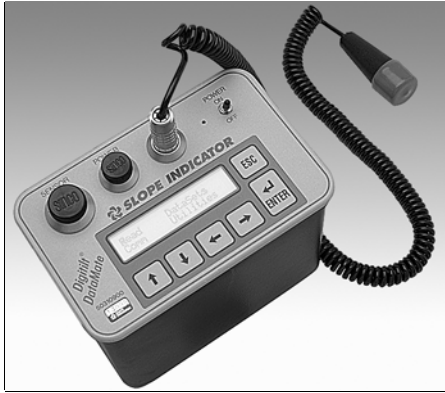
Simple to operate, the compact Digitilt DataMate runs 16 hours on one charge, stores up to 320 surveys, and transfers data to a PC for processing.
