Hope Bay Mining Ltd.

Hope Bay Project Quarry Monitoring

*Project Reference Number
SRK 1CH008.023*

November 2009

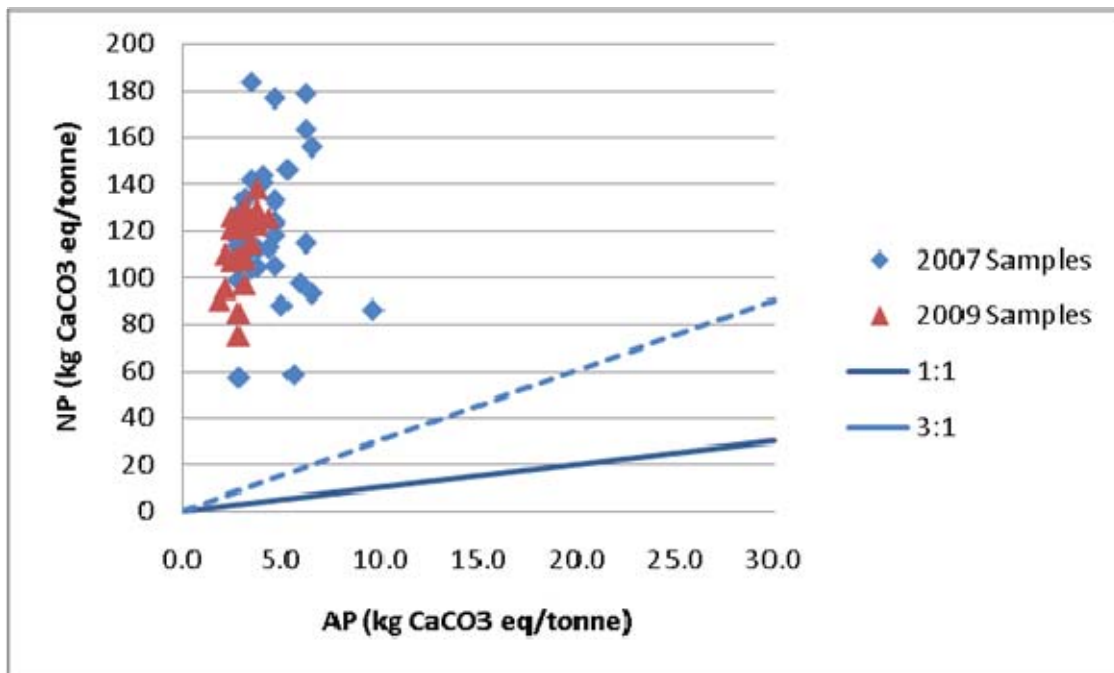
Figure 2: NP* versus AP (*Standard Sobek NP for 2007 samples, Modified Sobek NP for 2009 samples)

Acid base accounting results showed that all samples contained substantial amounts of neutralization potential. Conventional NP/AP ratios were all greater than 3 (Figure 2), indicating these samples are not potentially acid generating. Total inorganic carbon (TIC) expressed in units of CaCO₃ eq/tonne were generally lower than conventional NP, but ratios of carbonate NP/AP (Figure 3) were also all greater than 3 and therefore not potentially acid generating.

It should be noted that NP determination for 2007 samples was done using the standard Sobek method; however, other work at the site has shown that the standard Sobek method tends to overestimate NP. Therefore, NP determination for 2009 samples was done by Modified Sobek method. This is why 2009 samples typically have slightly lower NP than 2007 samples (Table 2, Figure 1).

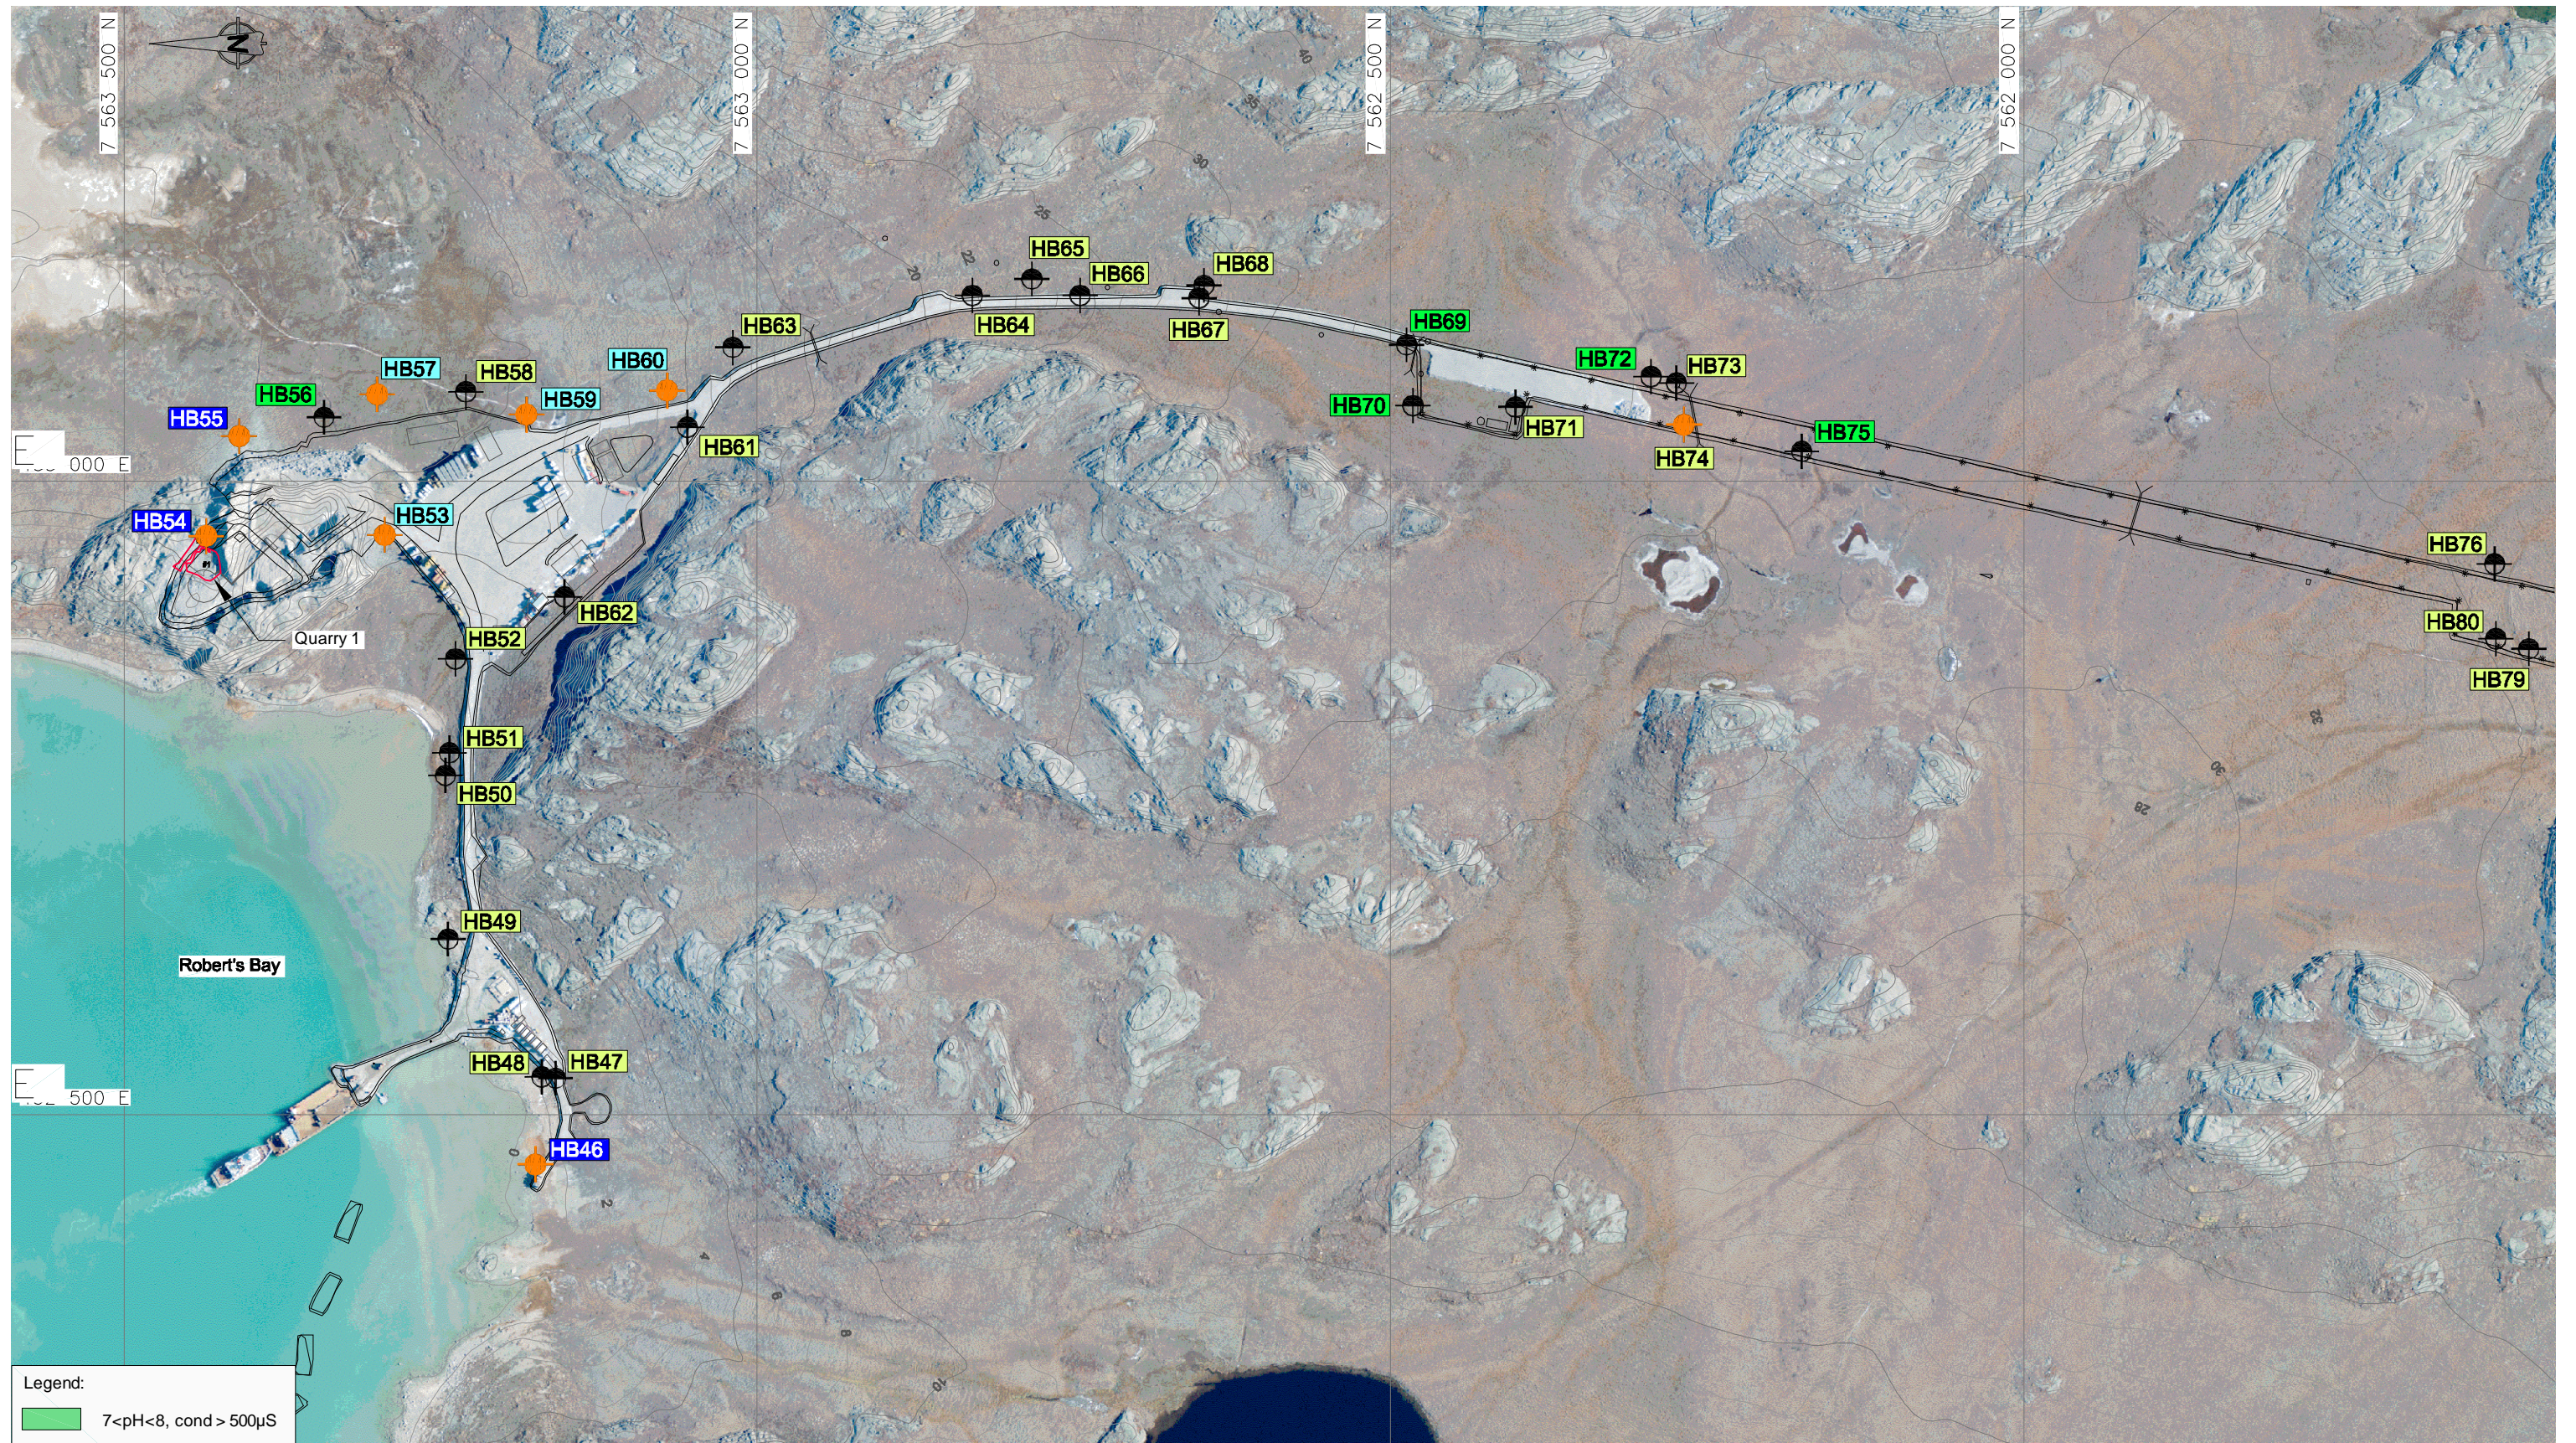
Legend:	
■	7<pH<8, cond > 500µS
■	7<pH<8, cond < 500µS
■	pH>8, cond > 500µS
■	pH>8, cond < 500µS
●	Sample Submitted for Chemical Analysis

SRK Consulting Engineers and Scientists Vancouver B.C.	HOPE BAY MINING LTD.		Quarry Rock Seepage Monitoring		
	Hope Bay Gold Project		Seep Survey Locations North		
SRK JOB NO.: 1CH008.023.0001 FILE NAME: Doris site-Layout.dwg			DATE: Sep. 2009	APPROVED: —	FIGURE: 1
