## 2010 Waste Rock and Quarry Monitoring Report

# **Hope Bay Project 2010 Waste Rock and Quarry Monitoring Report**

## **Hope Bay Mining Ltd.**

## **SRK Consulting (Canada) Inc.**

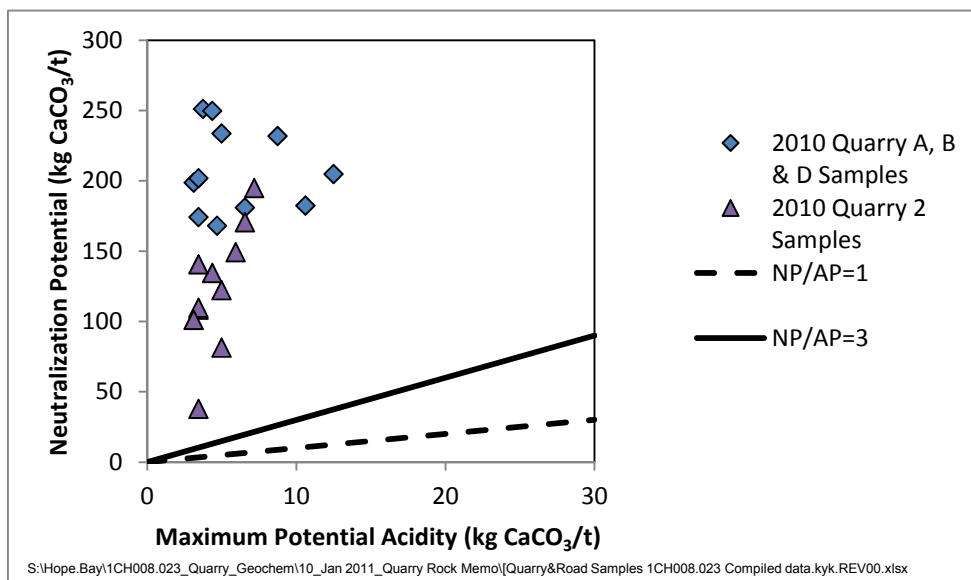
**Figure 1: Neutralization Potential versus Acid Potential for 2010 Quarry Samples with >0.1 wt. % Total Sulphur.**

Acid-base accounting results showed that all samples contained substantial amounts of neutralization potential, and that most of the neutralization potential was present as with carbonates. Conventional NP/AP ratios were all greater than 3 (Figure 1), indicating these samples are not potentially acid generating.

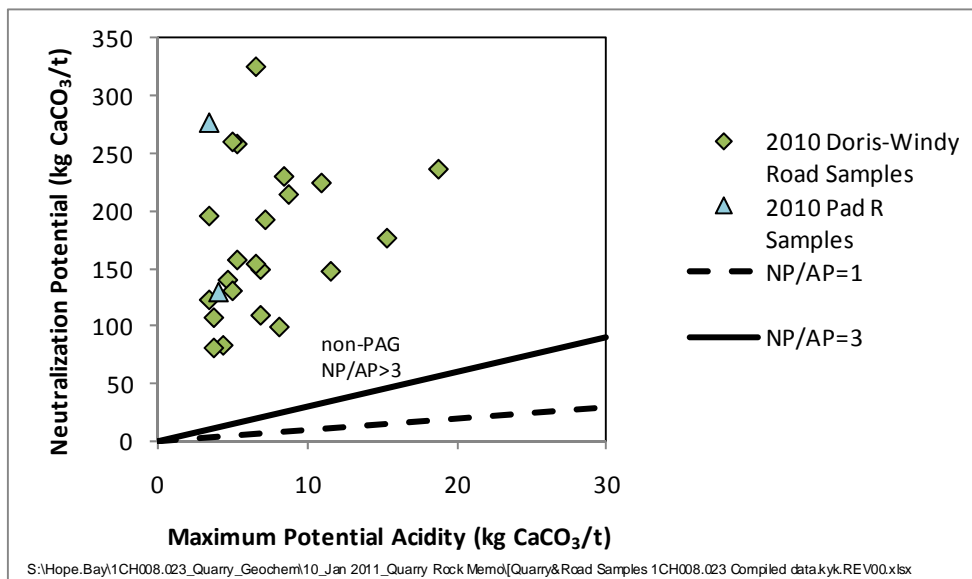
**Figure 3: Neutralization Potential versus Acid Potential for 2010 Infrastructure samples with >0.1 wt. % Total Sulphur.**

The ABA results show that the road samples all contain substantial amounts of neutralization potential with NP/AP ratios significantly greater than 3 (Figure 3), indicating that the samples are not potentially acid generating. Neutralization potential is well correlated with carbonate content (TIC) indicating that carbonates are the likely source of the neutralization potential (Figure 4).

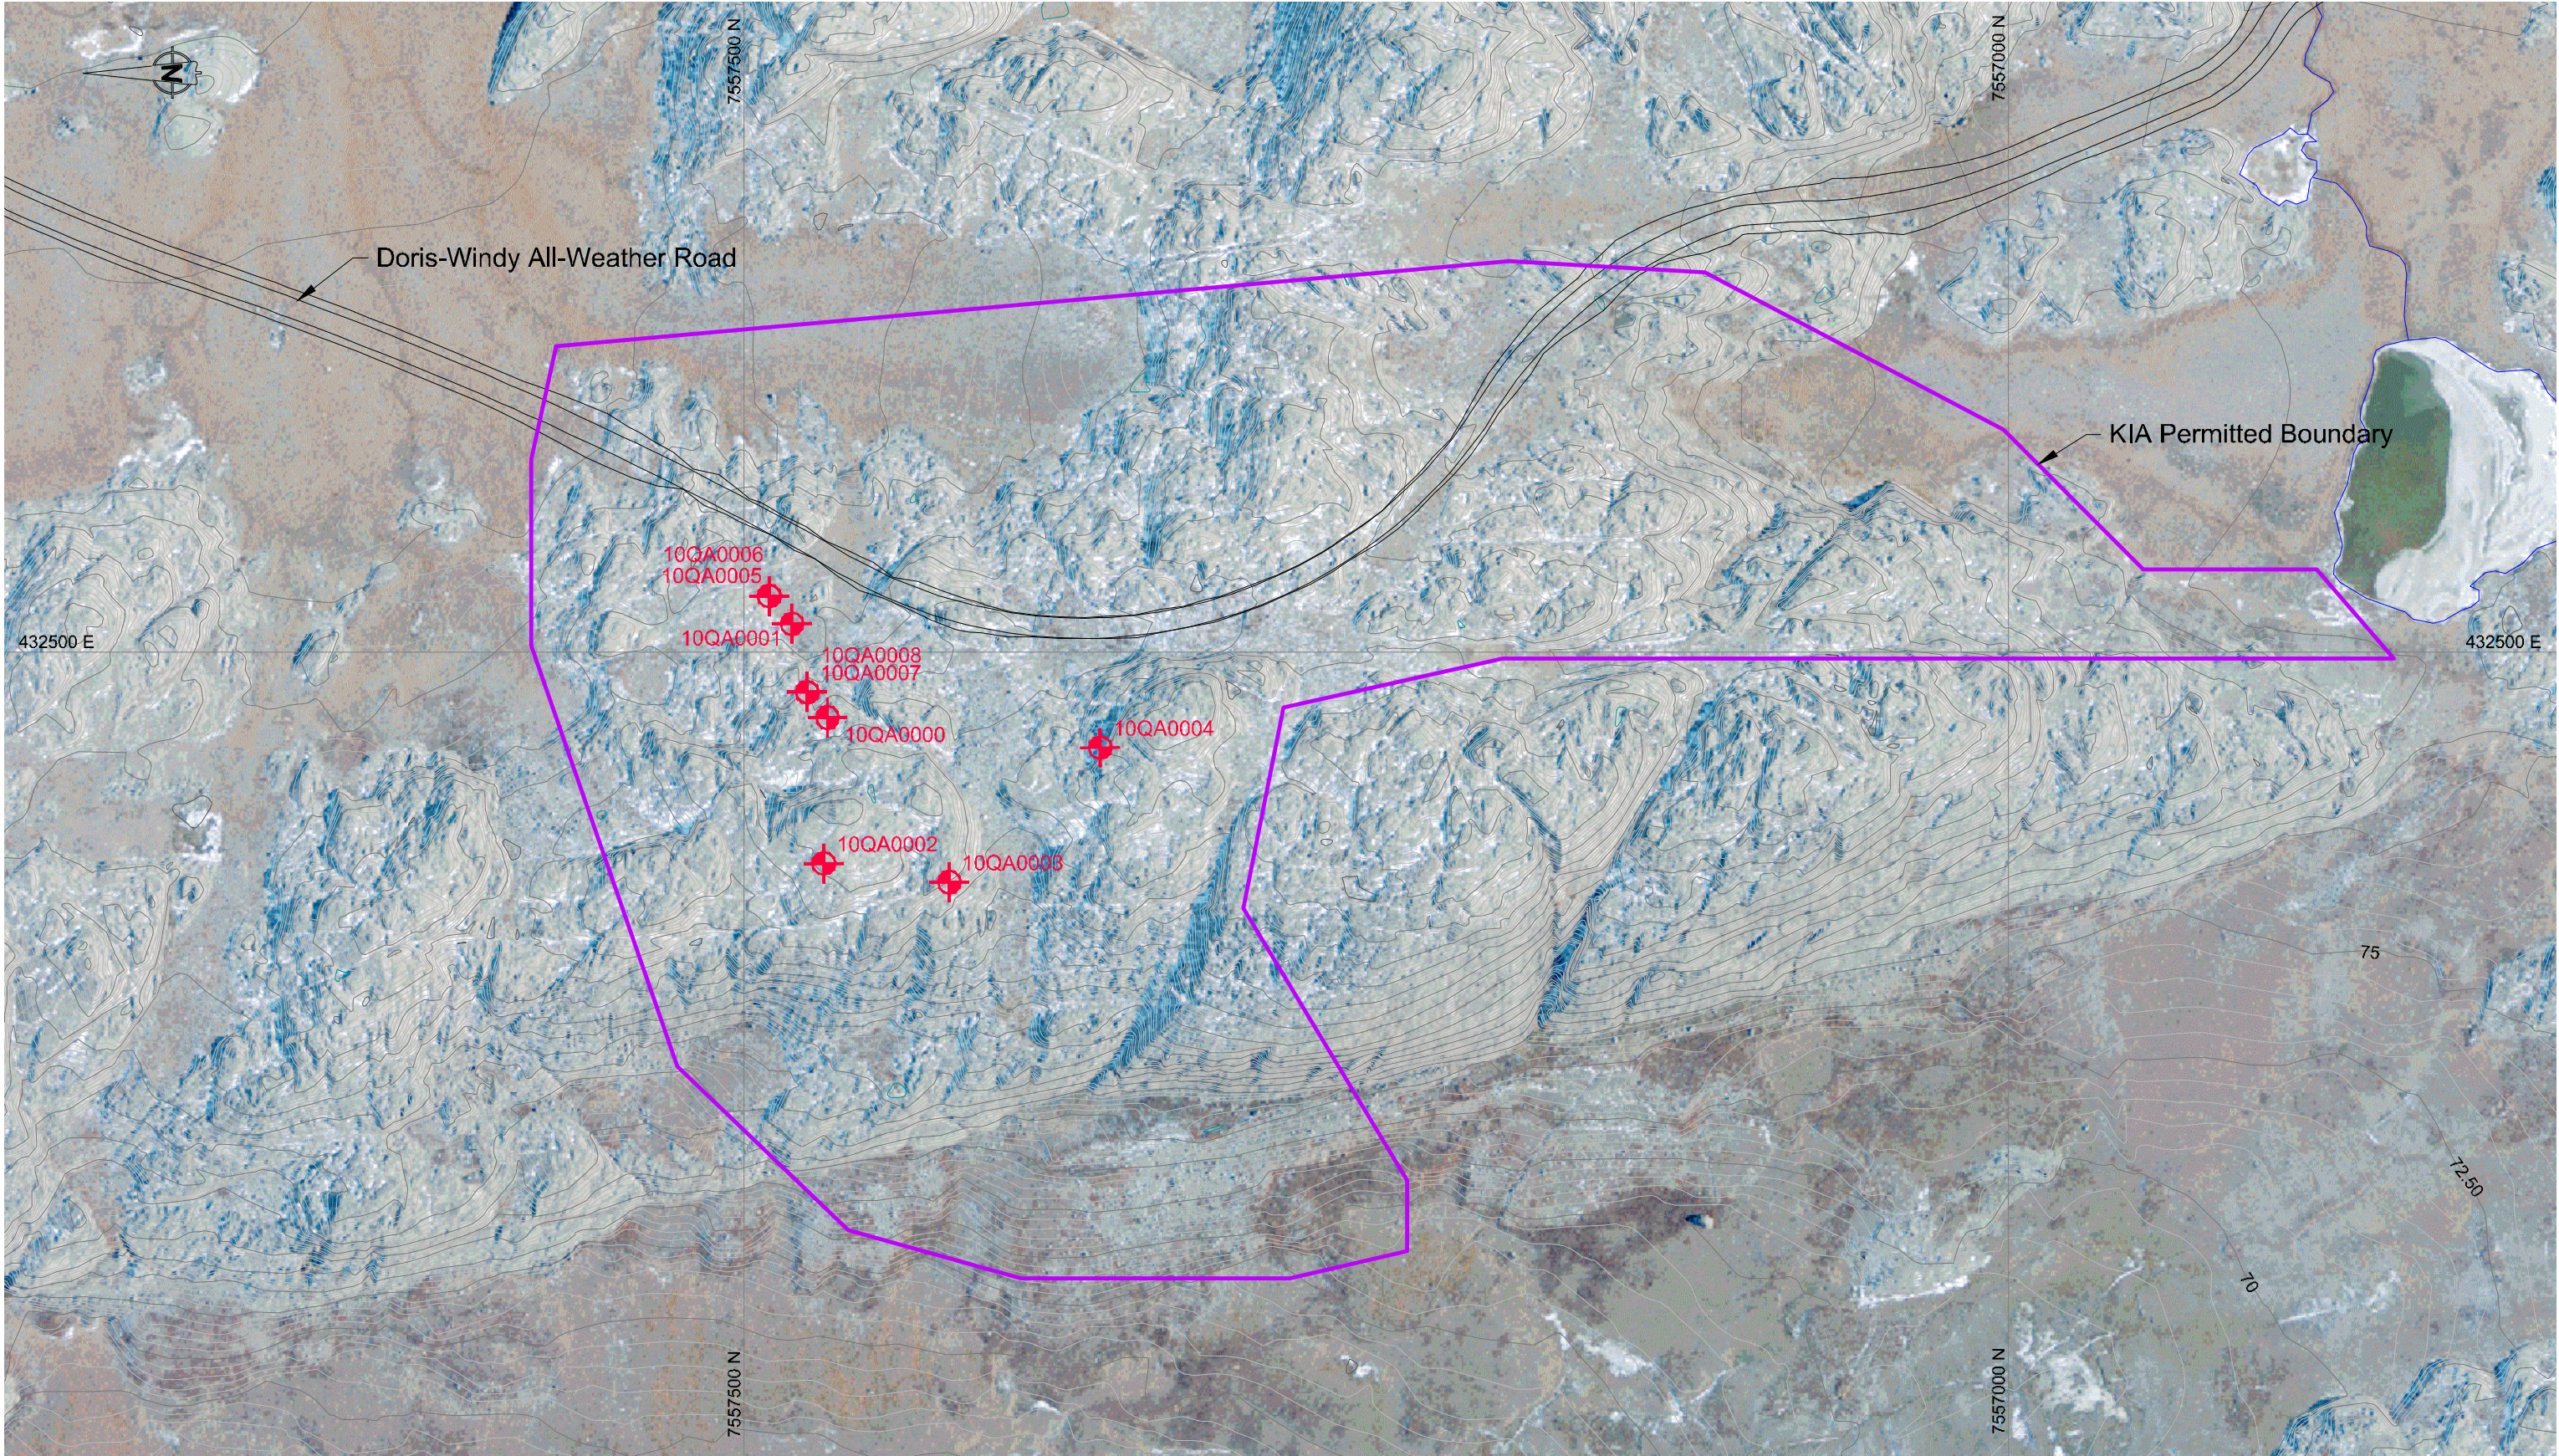
SRK Consulting Engineers and Scientists Vancouver B.C.	SRK JOB NO.: 1CH008.023.0001		NEWMONT NORTH AMERICA		Quarry Rock Sampling		
	FILE NAME: Quarry Sampling_w.As-built Lines.dwg		HOPE BAY MINING LTD.		Geochemistry Sample Locations Quarry A Area		
			DATE: March 2011	APPROVED: KK	FIGURE: 1

Visual observations are provided in Attachment 1. The majority of the rock inspected in the quarries was observed to be grey/green fine grained basalt with trace to 1% disseminated sulphides. Significant calcite veining was present at some locations. In parts of Quarry B, pyrite occurred as abundant euhedral cubes across fracture surfaces in basalt.

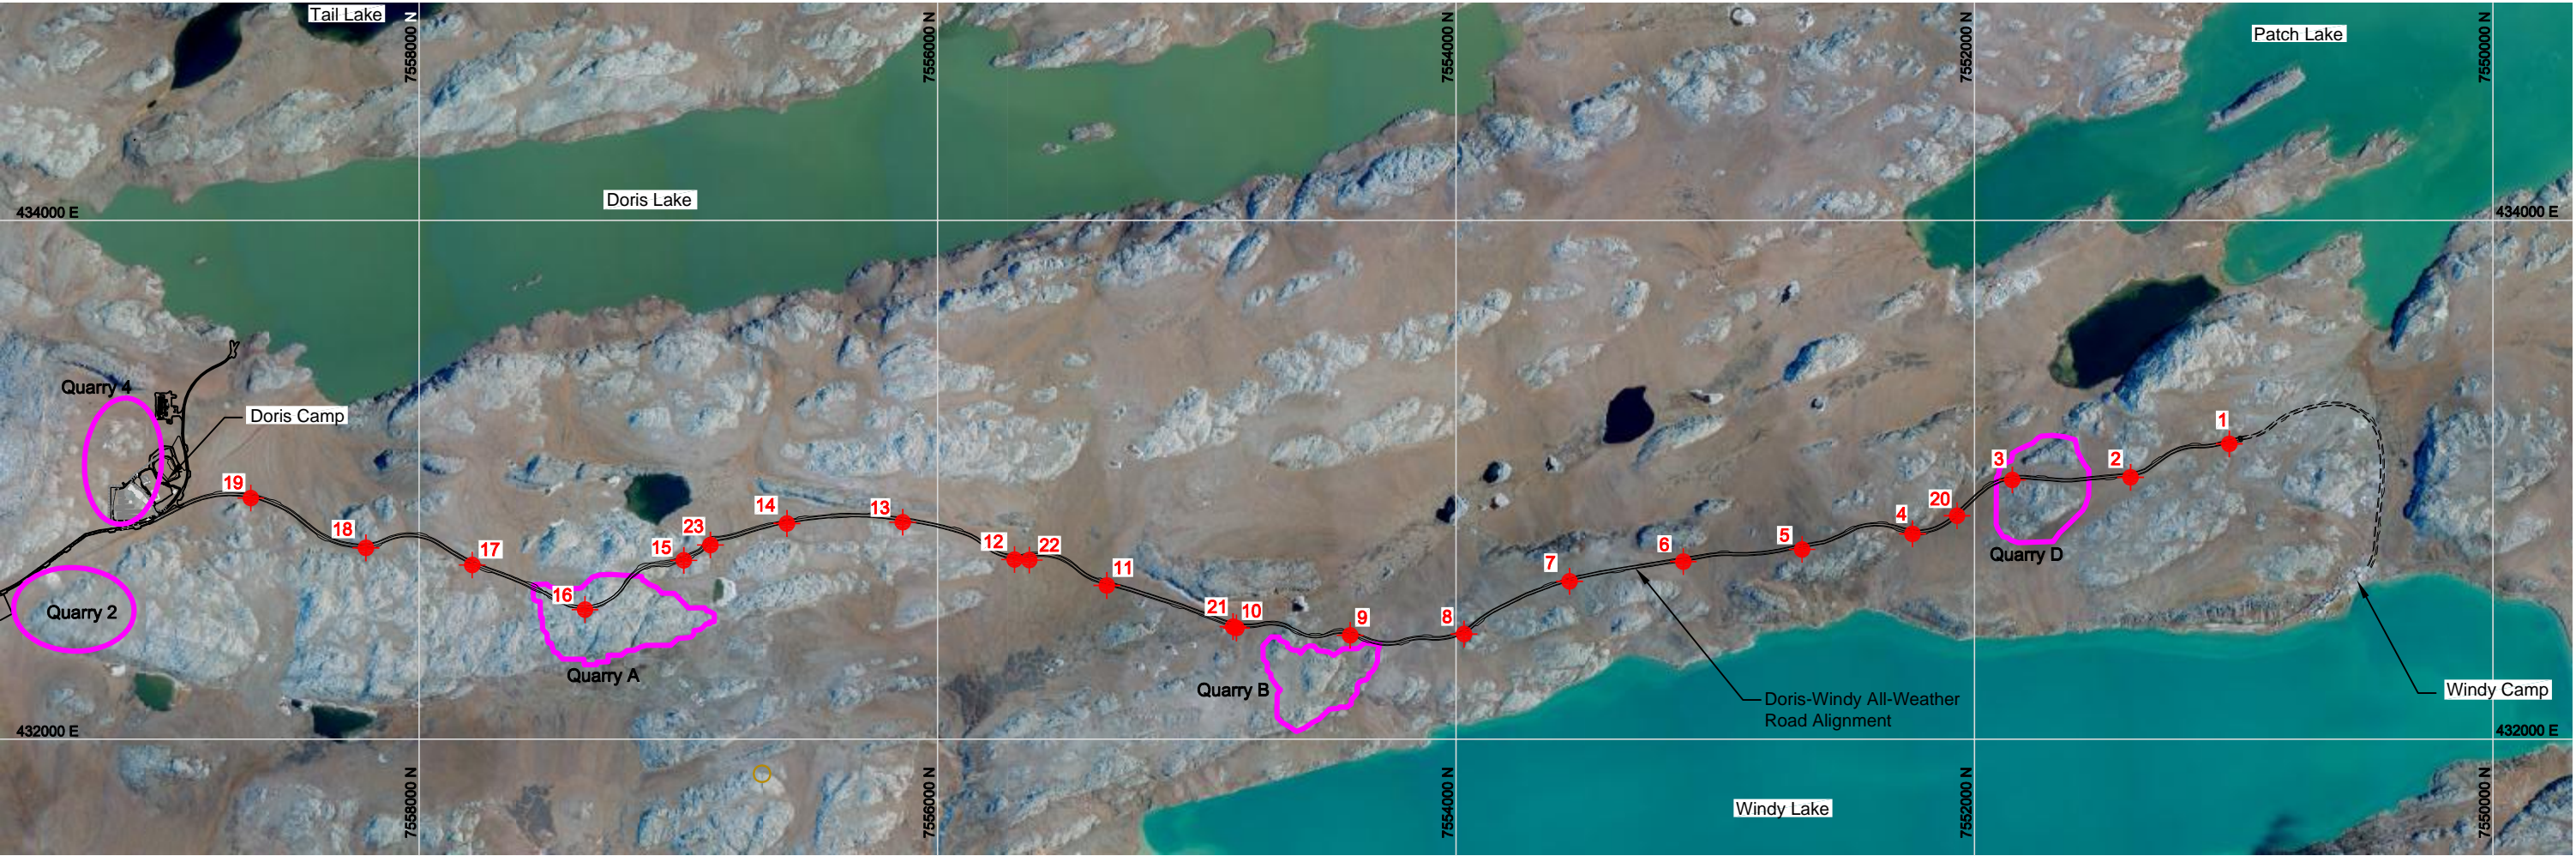
The road was visually inspected by walking along the base on the western side. Samples were collected from a total of 23 sites on September 29 (sites 1 to 9 and 20) and October 1, 2010 (sites 10 to 19 and 21 to 23). The locations of sites 1 to 19 were pre-determined, as per license requirements and were selected to be at approximately equidistant intervals along the length of the constructed road. Samples were collected from an additional four sites during the field inspection. The rationale for the extra sampling included collection of the fine fraction (site 20), which was not observed at most of the sites on September 29, and also additional sampling of material from Quarry A, B and D (sites 21 to 23) as it was learned during the inspection that the materials from sites 17 to 19 were sourced from Quarry 2.

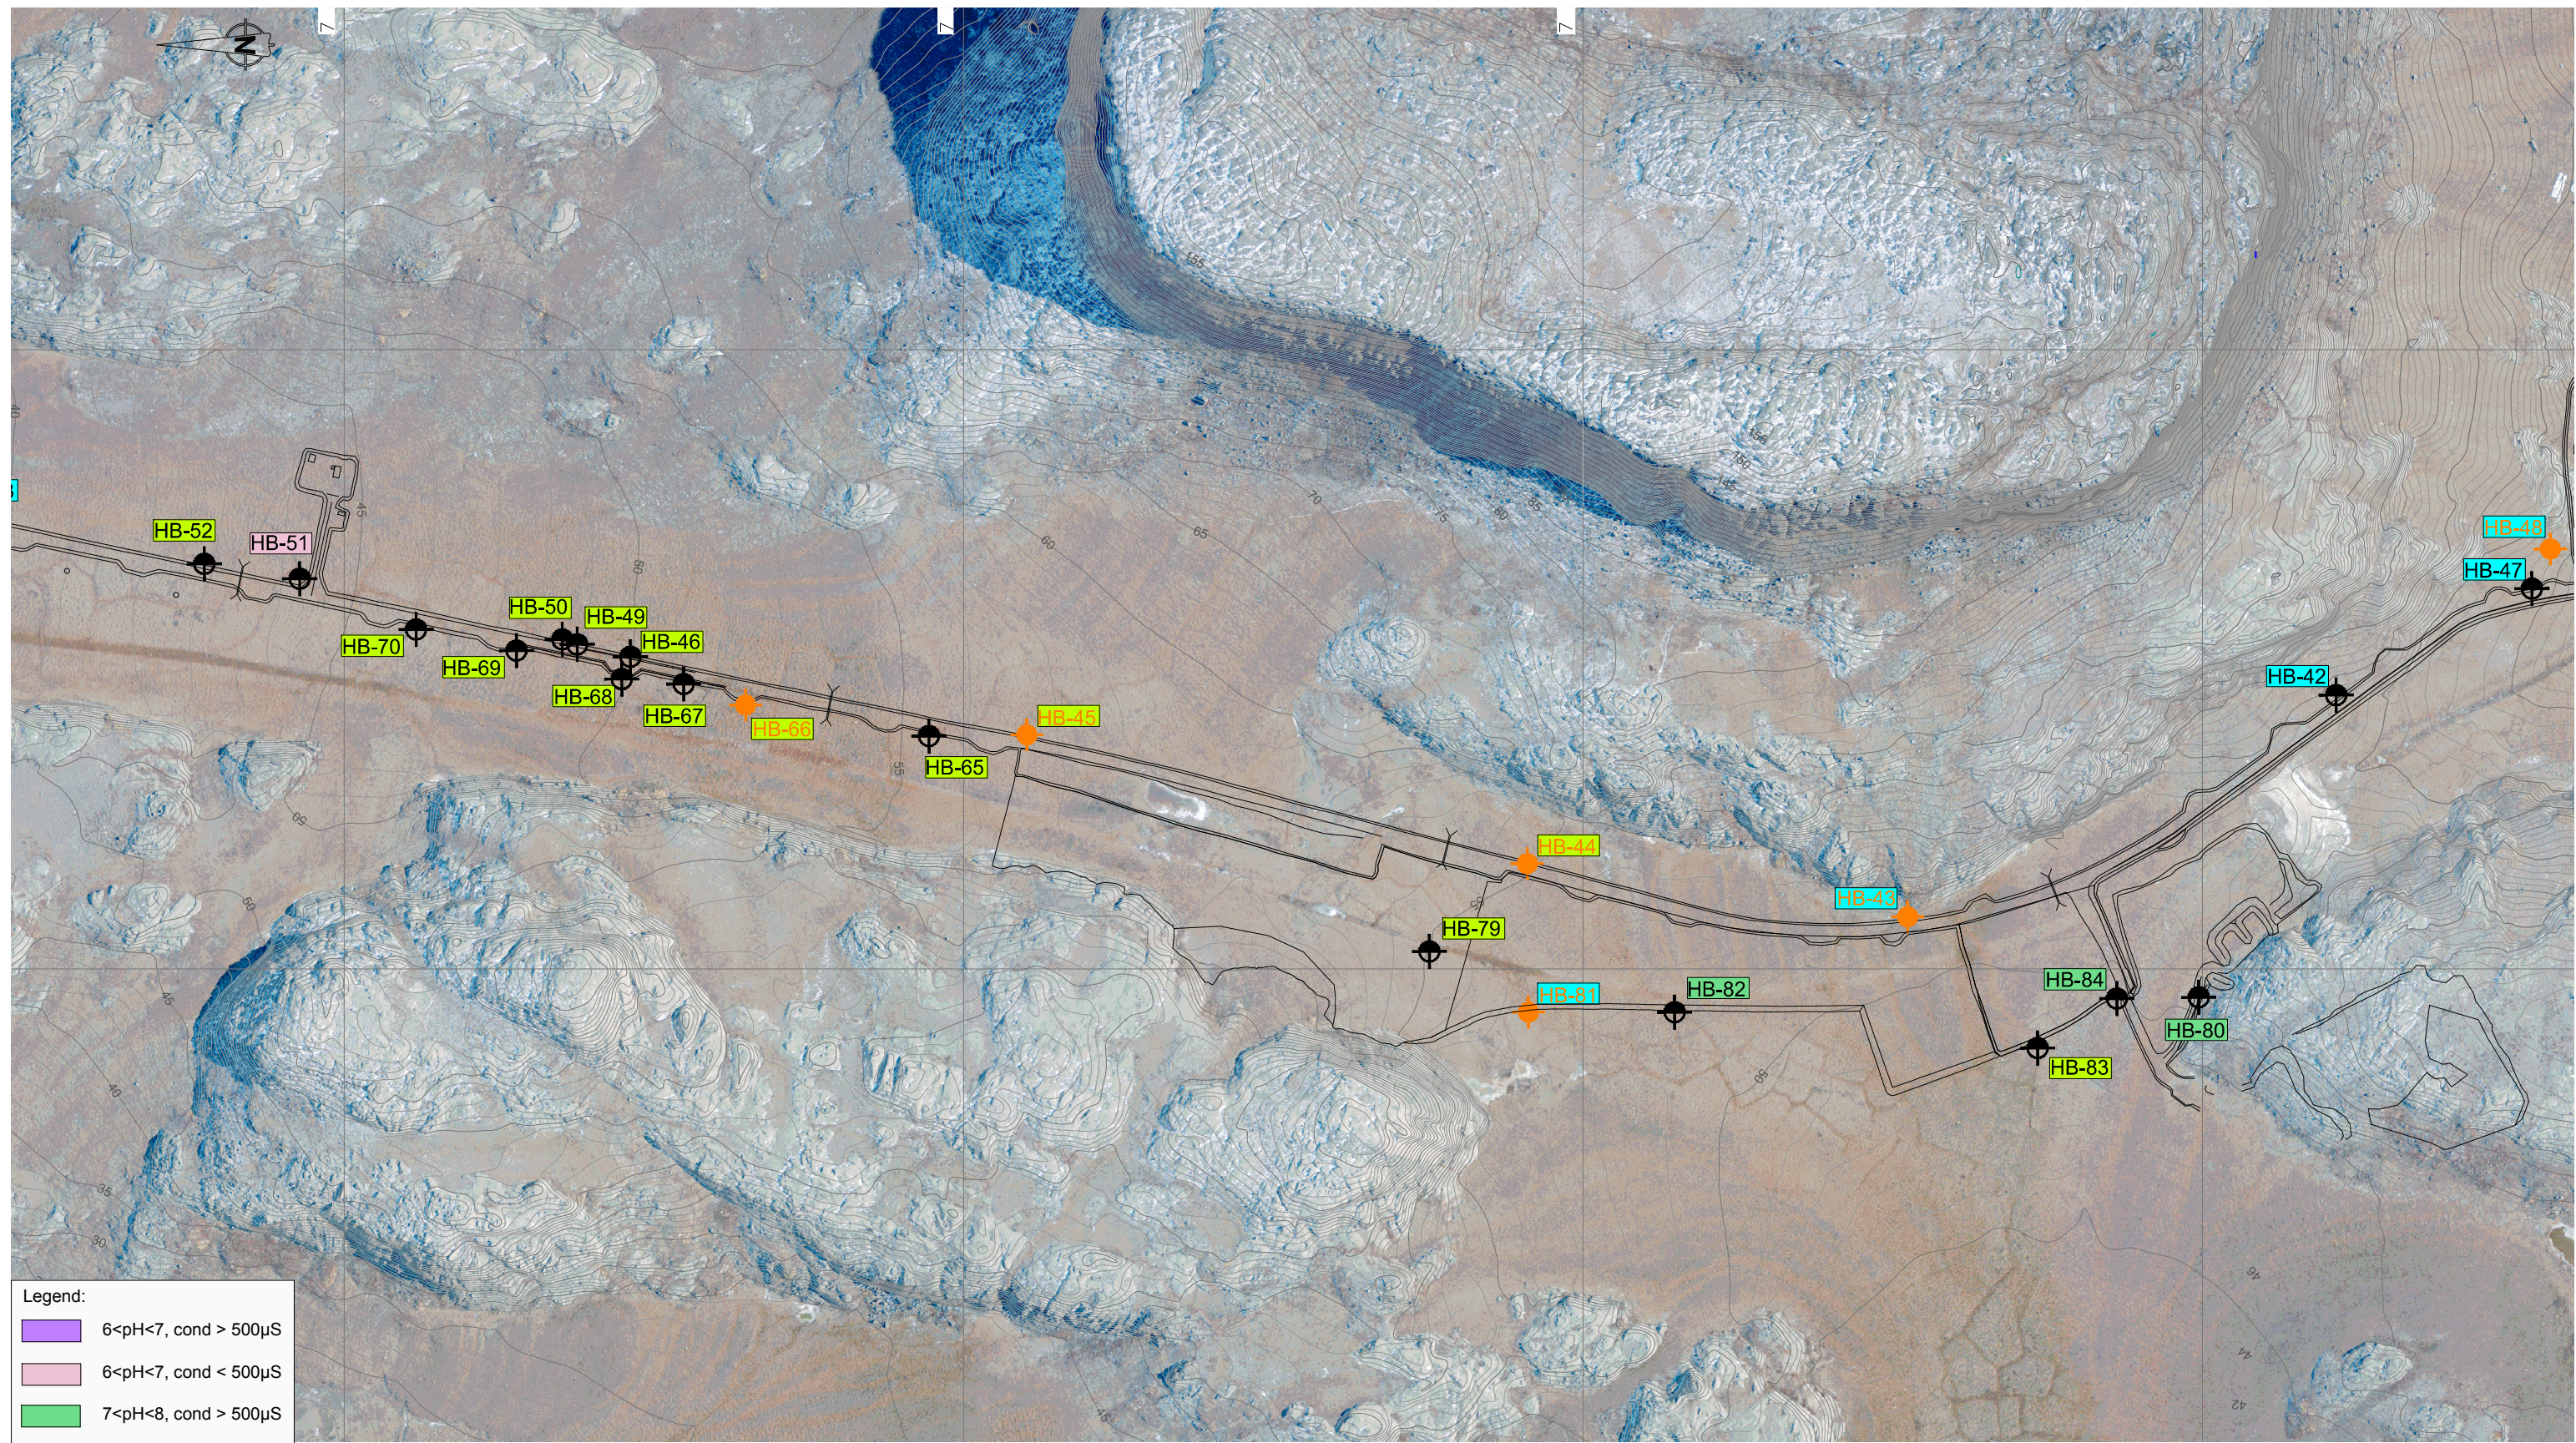
<b>SRK Consulting</b> Engineers and Scientists Vancouver B.C.	<b>HOPE BAY MINING LTD.</b>		Quarry Rock Seepage Monitoring	
	Hope Bay Gold Project		Seep Survey Locations Central	
SRK JOB NO.: 1CH008.023.0001 FILE NAME: Doris site-Layout LA.dwg	DATE: Jan. 2011	APPROVED: CJ	FIGURE: 2

Field measurements were taken at all locations where flow was observed flowing into or out of construction rock material. A total of 103 sites, including three reference points, were established and field pH and electrical conductivity measurements were taken.

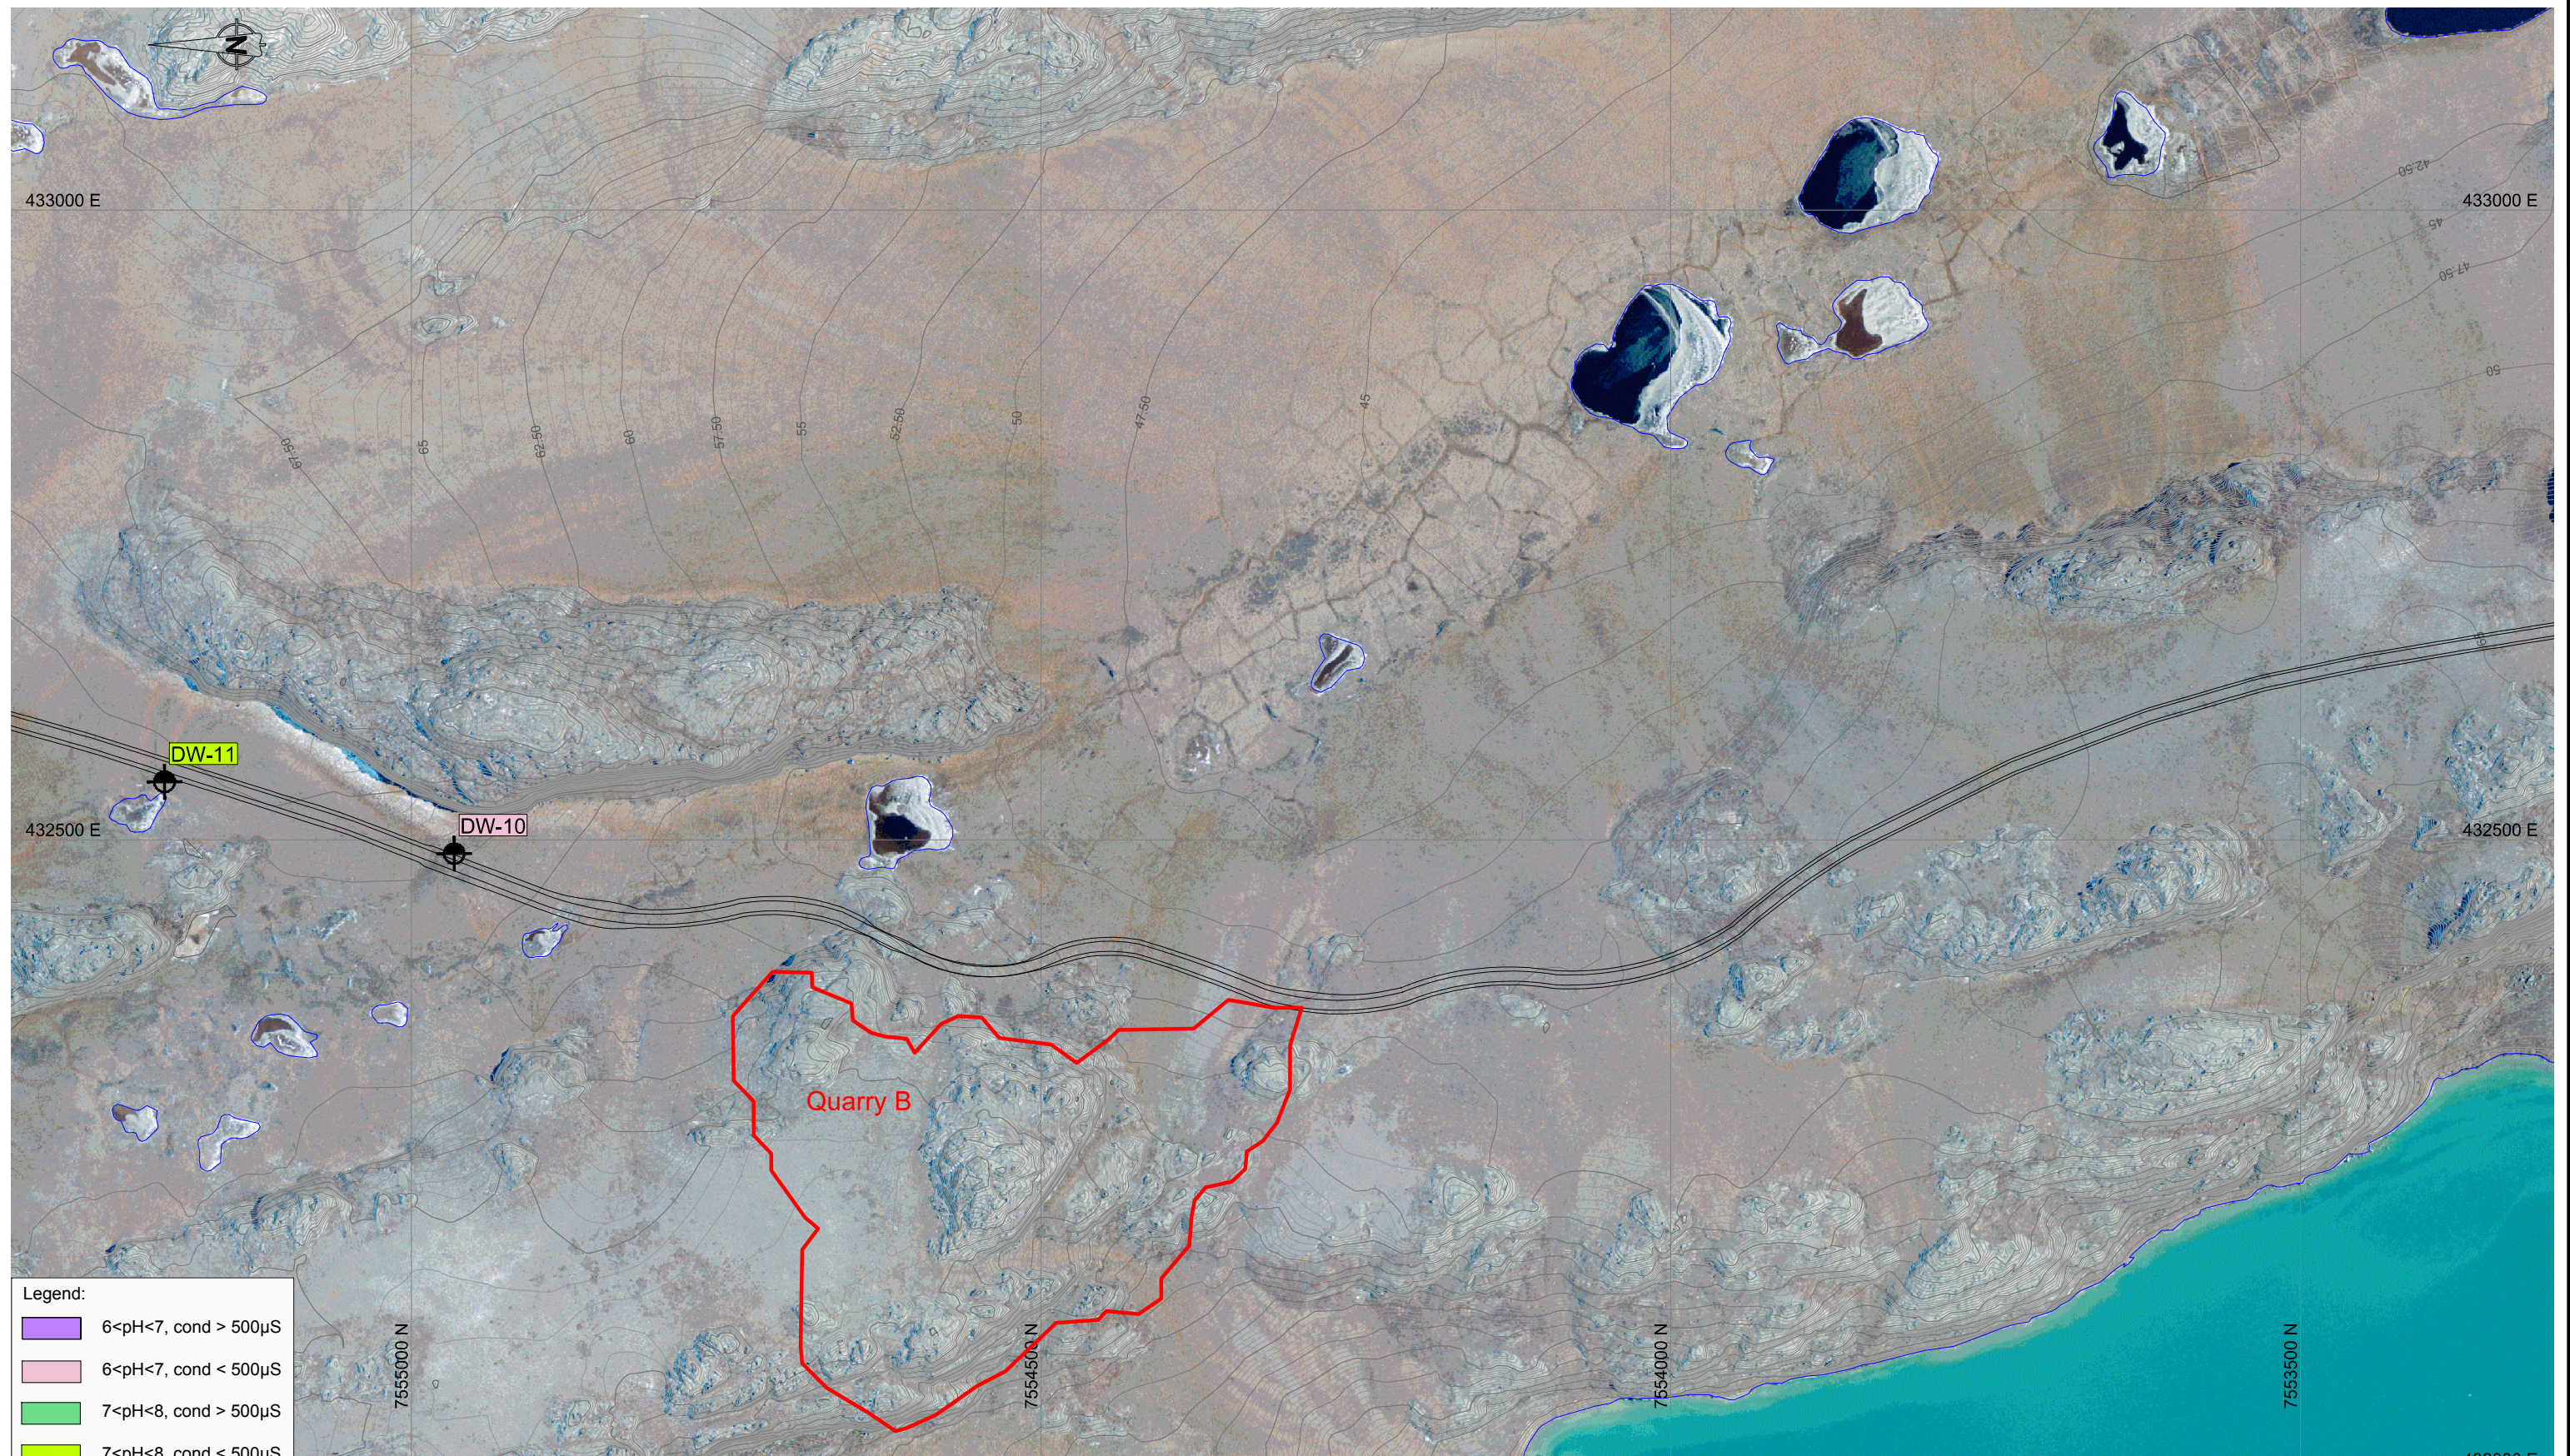
DATE: Jan. 2011	APPROVED: CJ	FIGURE: <b>5</b>
--------------------	-----------------	---------------------

U:\01\_SITES\Hope Bay\UACAD\2011 Drawings\DorisWindy Seeps LA.dwg

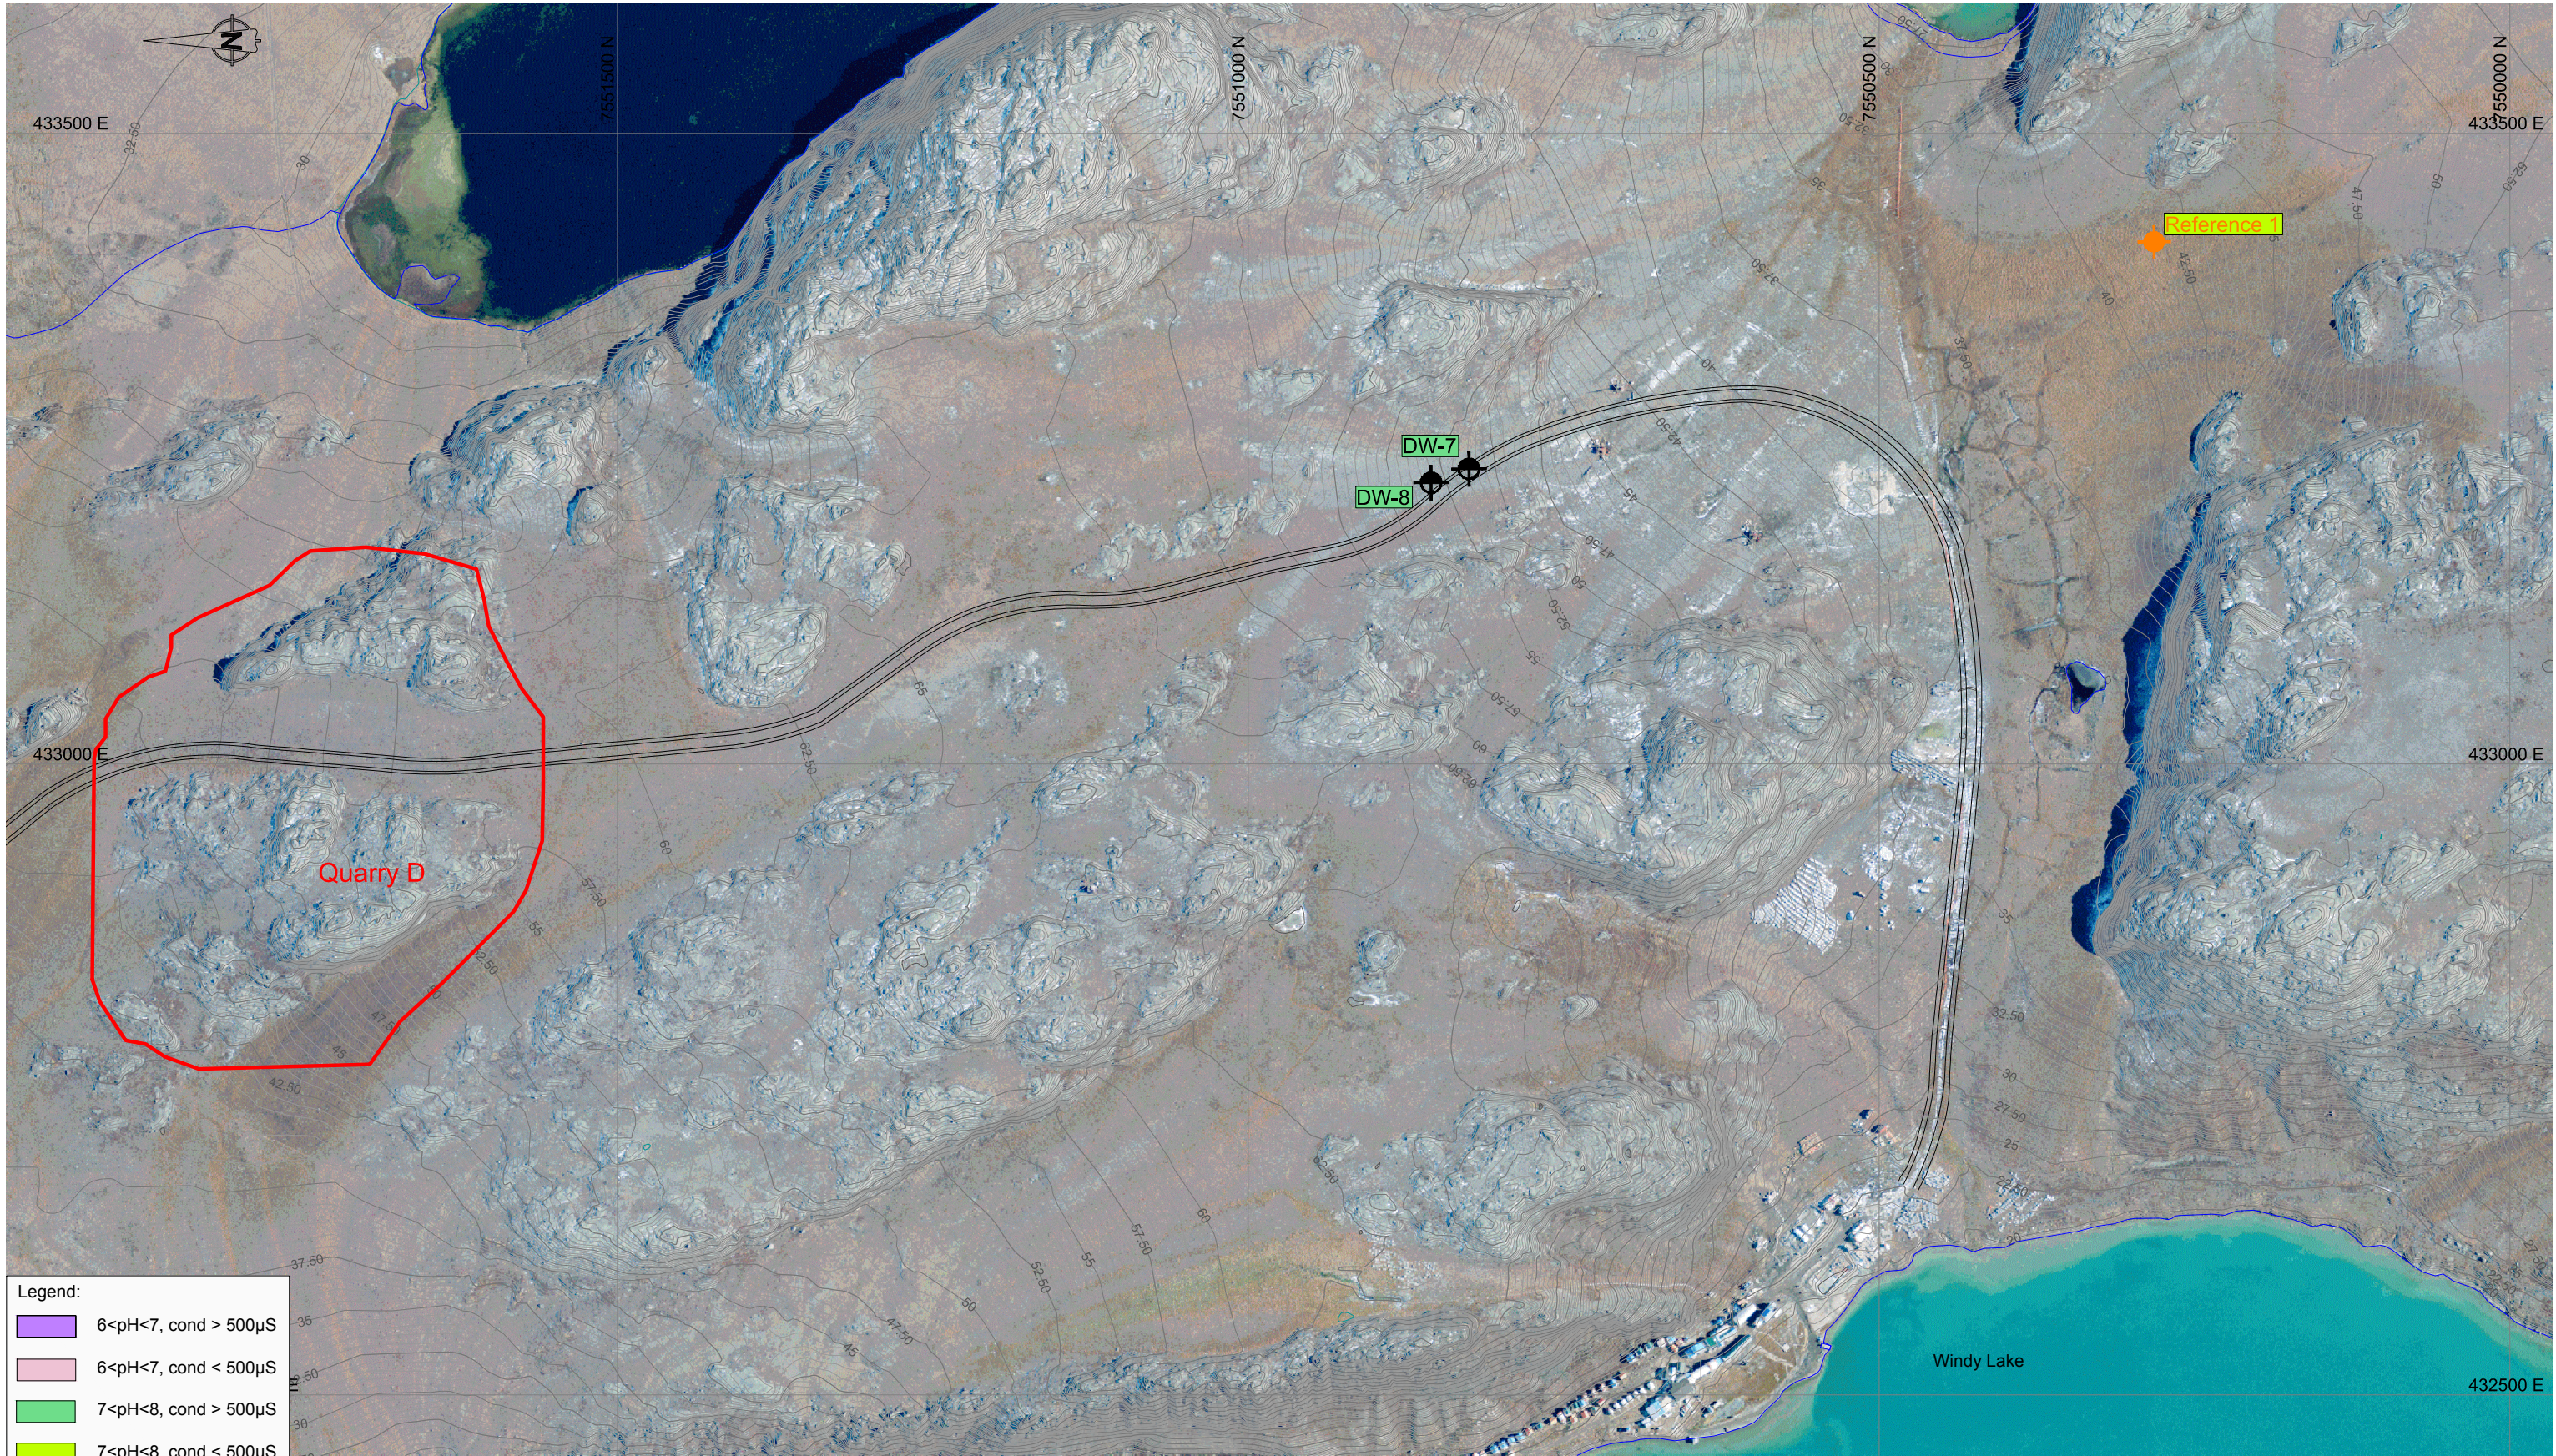
6<pH<7, cond > 500µS
	6<pH<7, cond < 500µS
	7<pH<8, cond > 500µS
	7<pH<8, cond < 500µS
	pH>8, cond > 500µS
	pH>8, cond < 500µS
	Sample Submitted for Chemical Analysis
