Doris North Portal Investigation

Hope Bay Mining Limited

SRK Project Number 2CH009.001

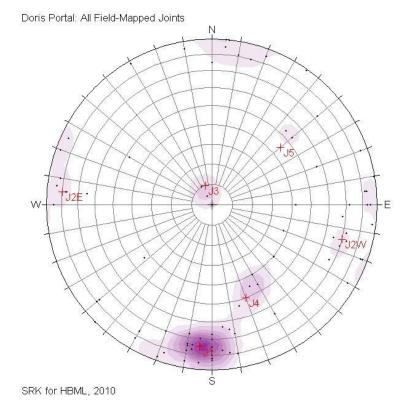
PROJECT:	DATE:	APPROVED:	FIGURE:
2CH009.000	June 2010	BM	A1

ID		Dip	/[Direction
1		75	1	005
2V	V	70	1	285
2E		80	1	095
3		10	1	160
4		50	1	340
5		45	1	230

Stereonet plot of all field-mapped joints along the diabase dyke ridge.

95 Joint measurements were taken from across the full length of accessible outcrop. The un-weighted (poles to the plane) stereonet plot for these field data are represented in Appendix A's Figure A1. In these data the dominant EW joint set J_1 (75/005°) is orthogonal to the cluster of J_{2W} (70/285°) and J_{2E} (80/095°) – while an isostatic unloading set is represented by J_3 (10/160°). The position of the NE-SW interpreted fault was visited, but no ground-evidence could be found for its existence – apart from a relatively shallow dipping (45/335° 21 m long, and 46/330° 13 m long) joint face – across which no off-set could be determined. – it would need further examination under better field conditions, or from longwall mapping of the decline. This, and other sub-parallel features are represented as J_4 (50/340°), while another very widely spaced set is represented by J_5 (45/230°). From the interpretation and mapping, a minor NE-SW fault (along the J_4 trend) has been inferred to the south-east of the portal. The intra-Belt NW-SE left-lateral fault trend does not appear to be represented in the joint sets within the portal area, other than possibly the few joints in J_5 (52/227°). There are contiguous joint-planes (53/225°, 9 m long, and 53/230°, 10 m long) on the J_5 trend, but no evidence of offsets or fault-induced damage-zones were found.

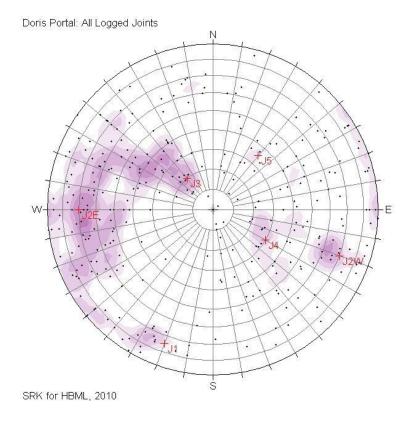
PROJECT:	DATE:	APPROVED:	FIGURE:
2CH009.000	June 2010	BM	A2

ID	Dip / Direction	
1	75 / 020	
2W	70 / 290	
2E	70 / 090	
3	20 / 140	
4	30 / 300	
5	35 / 220

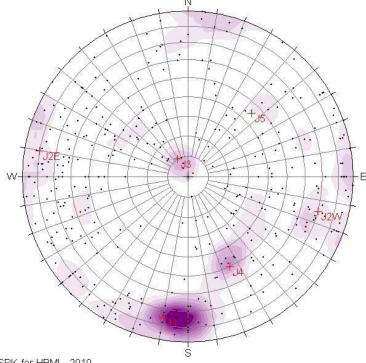
2CH009.000
 June 2010
 BM
 A3

Doris Portal: Joints (Terzhagi and length weighted)

ID	Dip / Direction
1	75 / 010
2W	70 / 285
2E	80 / 100
3	10 / 150
4	50 / 335
5	45 / 225

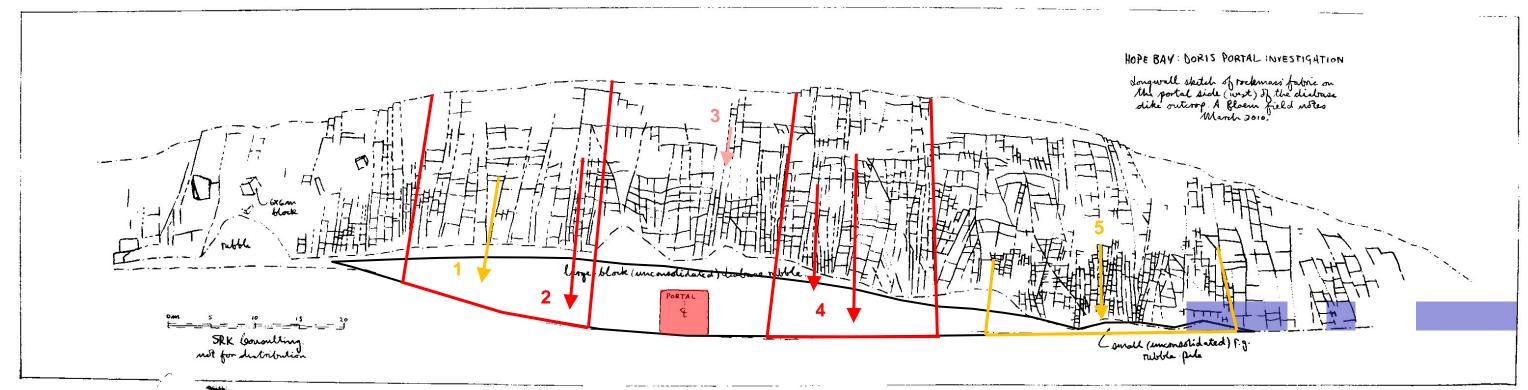
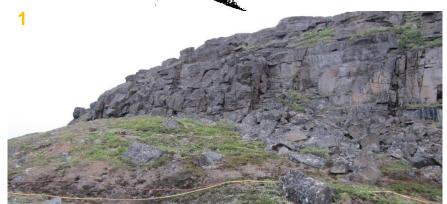
PROJECT: DATE: APPROVED: FIGURE::
2CH009.001 September 2010 BM A5

Toppling Risk (Current Status): Slope Stability Risk (On Excavation): Consequences: MODERATE LOW moderate LOW HIGH severe HIGH LOW high

Slope Risk Areas Along Portal Face, Front View

An on-site fall, bounce, and roll evaluation was conducted. The hazards are considered to be significant in both the northern and southern slopes adjacent to the portal face. There are overhangs on the southern slope, and both slopes have loose blocks in toppling mode. The overall slope angle is around 70° (0.3:1 gradient), and the effective height is 20 m, which has loose material in the *free-fall* to *bounce* categories. The risks of toppling, fall and roll, range from low to high for these slopes – all of which can be mitigated. These are illustrated in Figures A4 – A7 (Appendix A).

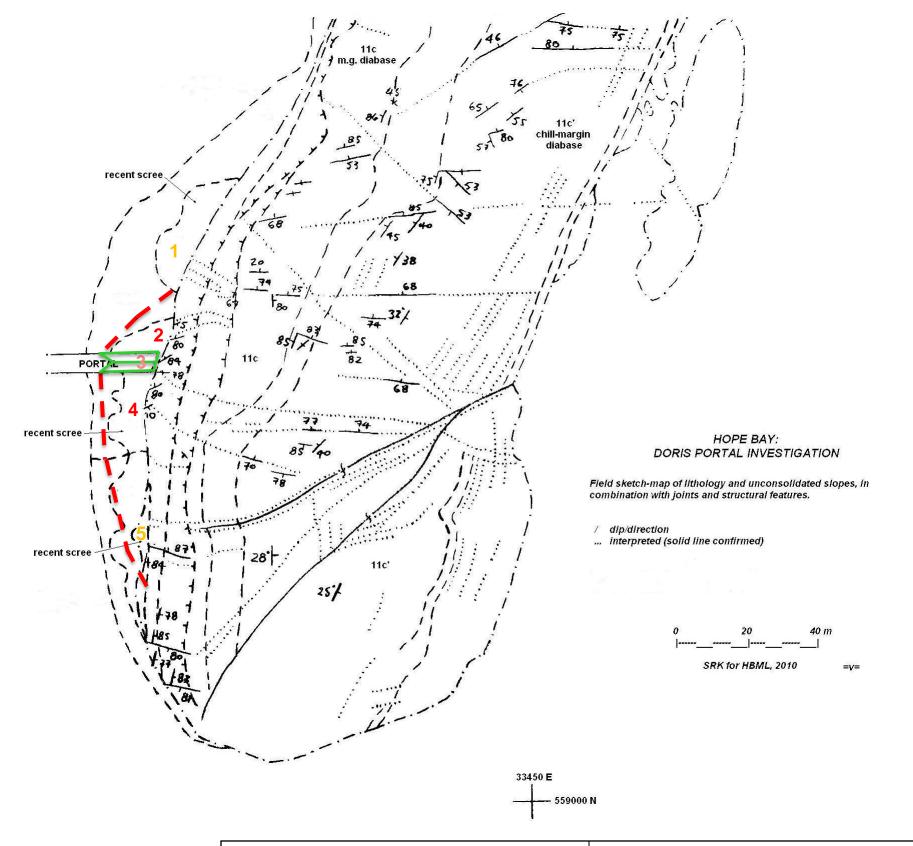
PROJECT:	DATE:	APPROVED:	FIGURE::
2CH009.001	September 2010	BM	A7

Mitigation Measures:

Far North 1 None required, out of activity zone

Slope Mitigation Measures along Portal Face, Plan View

The risks associated with the adjacent slopes' morphology and loose can be mitigated using draped mesh from an anchor-line above the portal face. A good position, in terms of a natural break in slope and rock mass condition, is the 68 m amsl level. An anchor-line, with a 20 m wide portal-brow protection fence, can support draped gabion mesh which would channel loose material to a 3 m wide catchment bounded by a 1.5 m high windrow. The design is illustrated in Appendix B's DN-P-01, DN-P-04 and DN-P-05 and the hardware requirements are included the table in Appendix B's Figure DN-P-06.

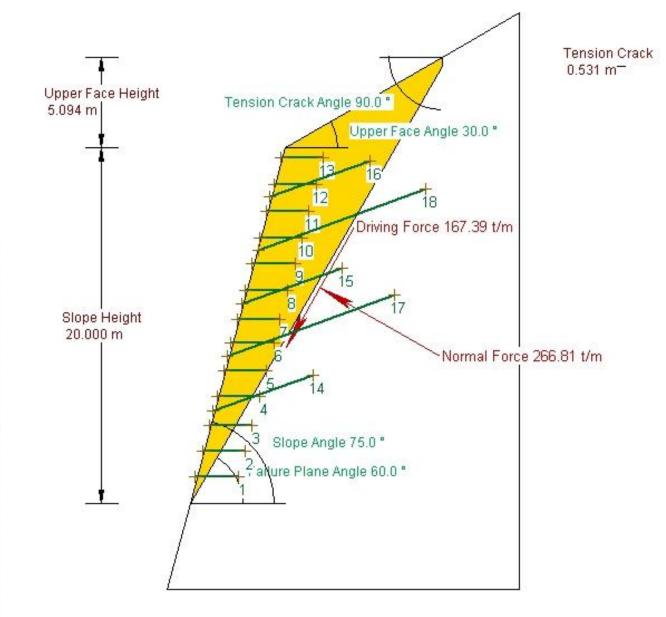
Factor of Safety	1.82
Driving Force	167.39t/m
Resisting Force	305.33t/m
Wedge Weight	236.58t/m
Wedge Volume	78.34m^3/m
Shear Strength	182.40t/m^2
Normal Force	266.81t/m
Plane Waviness	5.0°
Active Bolt Force	75.00t
Active Bolt Angle	0.0"
Passive Bolt Force	130.00t
Passive Bolt Angle	-20.0°

Filename: DP_J3TC90_BCC2.pln
Project Title: Doris Portal (J3 and Tension Crack) Planar Wedge Stability Analysis

#	Angle	Capacity	Length	AnchLength
1	0.0 °	15.00t/m	2.400 m	1.907 m
2	0.0 °	15.00t/m	2.400 m	1.458 m
3	0.0 °	15.00t/m	2.400 m	1.003 m
4	0.0 °	15.00t/m	2.400 m	0.502 m
5	0.0 °	15.00t/m	2.400 m	0.046 m
6	0.0 °	15.00t/m	2.400 m	0.000 m
7	0.0 "	15.00t/m	2.400 m	0.000 m
8	0.0 °	15.00t/m	2.400 m	0.000 m
9	0.0 °	15.00t/m	2.400 m	0.000 m
10	0.0 °	15.00t/m	2.400 m	0.000 m
11	0.0 °	15.00t/m	2.400 m	0.000 m
12	0.0 °	15.00t/m	2.400 m	0.000 m
13	0.0 °	13.00t/m	2.400 m	0.000 m
14	20.0 °	25.00t/m	6.000 m	3.670 m
15	20.0 °	25.00t/m	6.000 m	1.180 m
16	20.0 °	25.00t/m	6.000 m	0.000 m
17	20.0 °	40.00t/m	10.000 m	6.393 m
18	20.0°	40.00t/m	10.000 m	4.121 m

The wedge and planar sliding failure risks were evaluated using a J_{2W} at 60° and a J_3 combination, assuming a back-volume tension crack failure. (These are illustrated in Appendix A's Figure A9a and A9b.) The risk of the J_{2W} failure occurring is low to moderate (237 t/m wedge weight), while the tension-crack resting on a J_3 base scenario risk is high (629 t/m wedge weight). The J_{2W} sliding risk can be mitigated using appropriate pattern-bolting, while the J_3 tension crack scenario is relatively stable even with a 14 m deep full-face detachment.

The risks of failure of the portal face (from wedge and-or planar sliding) can be mitigated by pattern support in the form of rebar, cable-bolts, and mesh. To support the 237 t/m wedge weight with a factor of safety of around 1.8, the following is recommended: 15 t/m capacity (2.4 m long) fully grouted rebar at a 1.5 m spacing, 25 t/m capacity (6 m long) fully grouted cablebolts at a 3.0 m spacing, and 40 t/m capacity (10 m long) fully-grouted cablebolts at a 6.0 m spacing, with welded wire mesh. The design is illustrated in Appendix B's Figure DN-P-02 and the hardware requirements are included in the table in Appendix B's Figure DN-P-06.

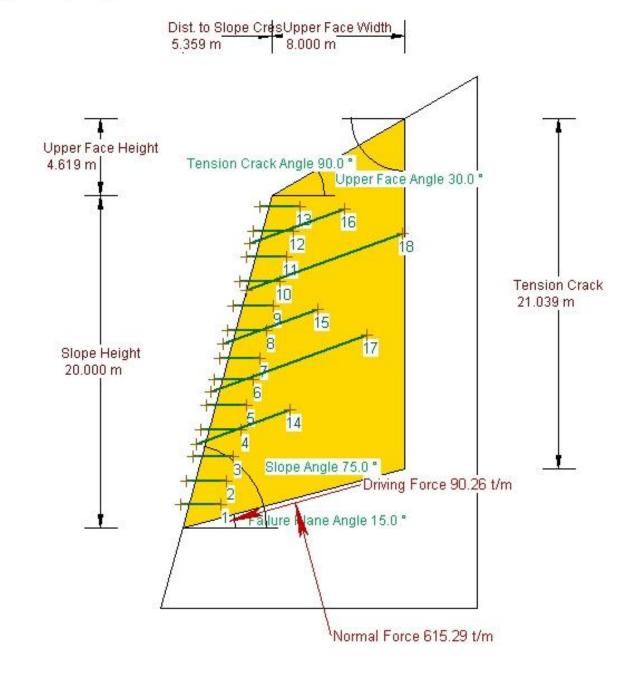
Factor of Safety	6.12
Driving Force	90.26t/m
Resisting Force	552.41t/m
Wedge Weight	628.63t/m
Wedge Volume	208.16m^3/m
Shear Strength	369.07t/m^2
Normal Force	615.29t/m
Plane Waviness	5.0°
Active Bolt Force	75.00t
Active Bolt Angle	0.0°
Passive Bolt Force	130.00t
Passive Bolt Angle	-20.0°

Planar Wedge Stability Analysis J3and Tension Crack

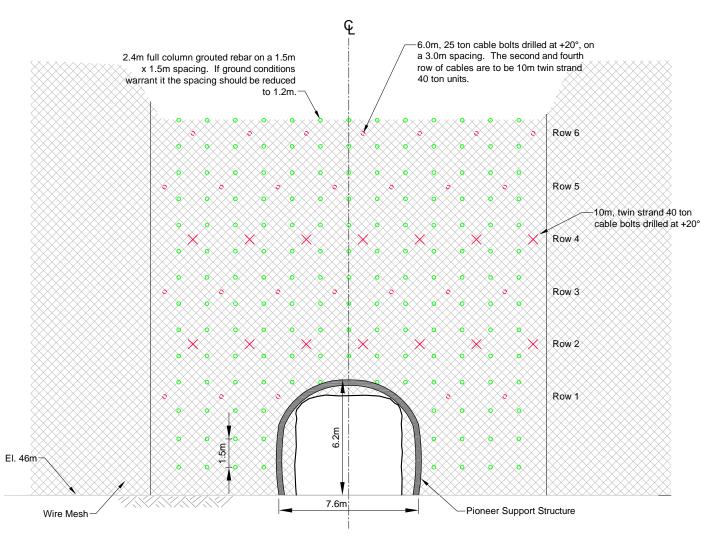
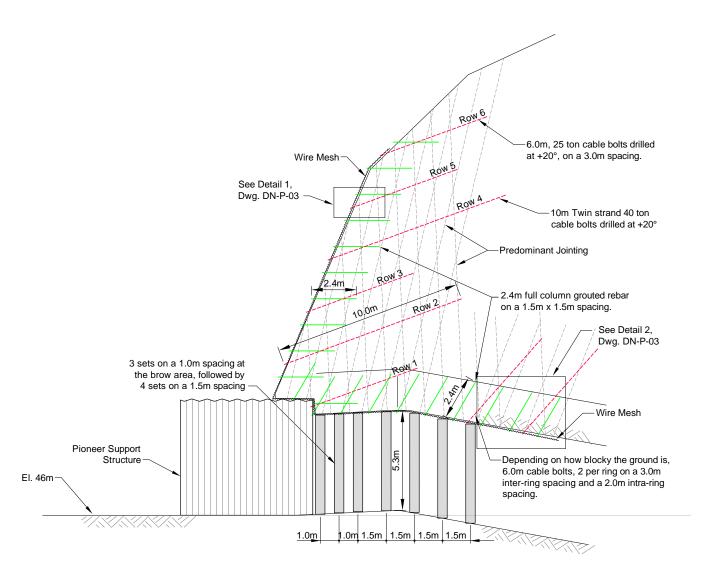
Portal Support Section

- If ground conditions warrant it, the spacing of the full column grouted rebar along the rock face should be reduced to 1.2m.
- 2. Steel set supports are to be horseshoe or modified horseshoe shape and designed to support a load of 0.3MPa at a depth of 15m.
- 3. Tie bars are required between steel set supports.
- 2.4m fully grouted rebar supporting the tunnel are to be oriented at 20° towards the advancing face.
- 5. Steel sets and Pioneer Support Structure are to be installed per the manufacturers instructions.

The main concern in the tunnel is gravity driven falling and sliding of blocks defined by the orthogonally intersecting discontinuity suite present in the rock mass, and potentially the unravelling of more fractured and inadequately supported material. As part of the initial (beyond the Pioneer Support Structure) tunnel's support for the decline's first 10 metres of tunnel, steel sets with a 330 kPa load capacity should be used at a 1 m spacing for the first 5 m (3 units), and then at 1.5 m spacing for the next 6.0 m (4 units). Within this part of the tunnel, 15 t/m capacity (2.4m long) fully grouted rebar at 1.5 m spacing (5 per ring, oriented 20° towards the advancing face) should be used on a 1.5 m ring-spacing with welded-wire mesh between all bolts for the roof. For the next 10 m of the decline the following is recommended: 15 t/m capacity (2.4m long) fully grouted rebar at 1.5 m spacing (with one at 2.5 m above grade in each sidewall, 7 per ring in total, oriented 20° towards the advance) should be used on a 1.5 m ring-spacing with welded-wire mesh between all bolts for the roof and sidewall – added to which are 15 t/m capacity (6.0 m long) fully grouted cablebolts at a 3.0 m spacing (2 per ring, 0.75 m off-section, oriented 30° towards the advance). The design is illustrated in Appendix B's Figures DN-P-02 and DN-P-03, and the hardware requirements are included in the table in Appendix B's Figure DN-P-06.
