**Re: September 2019 – Monthly Monitoring Report for Water Licence 2AM-DOH1335**

This report is comprised of the monitoring requirements set out in Part I and Schedule I of water licence 2AM-DOH1335 Amendment 2 (the licence), and additional requirements from CIRNAC.

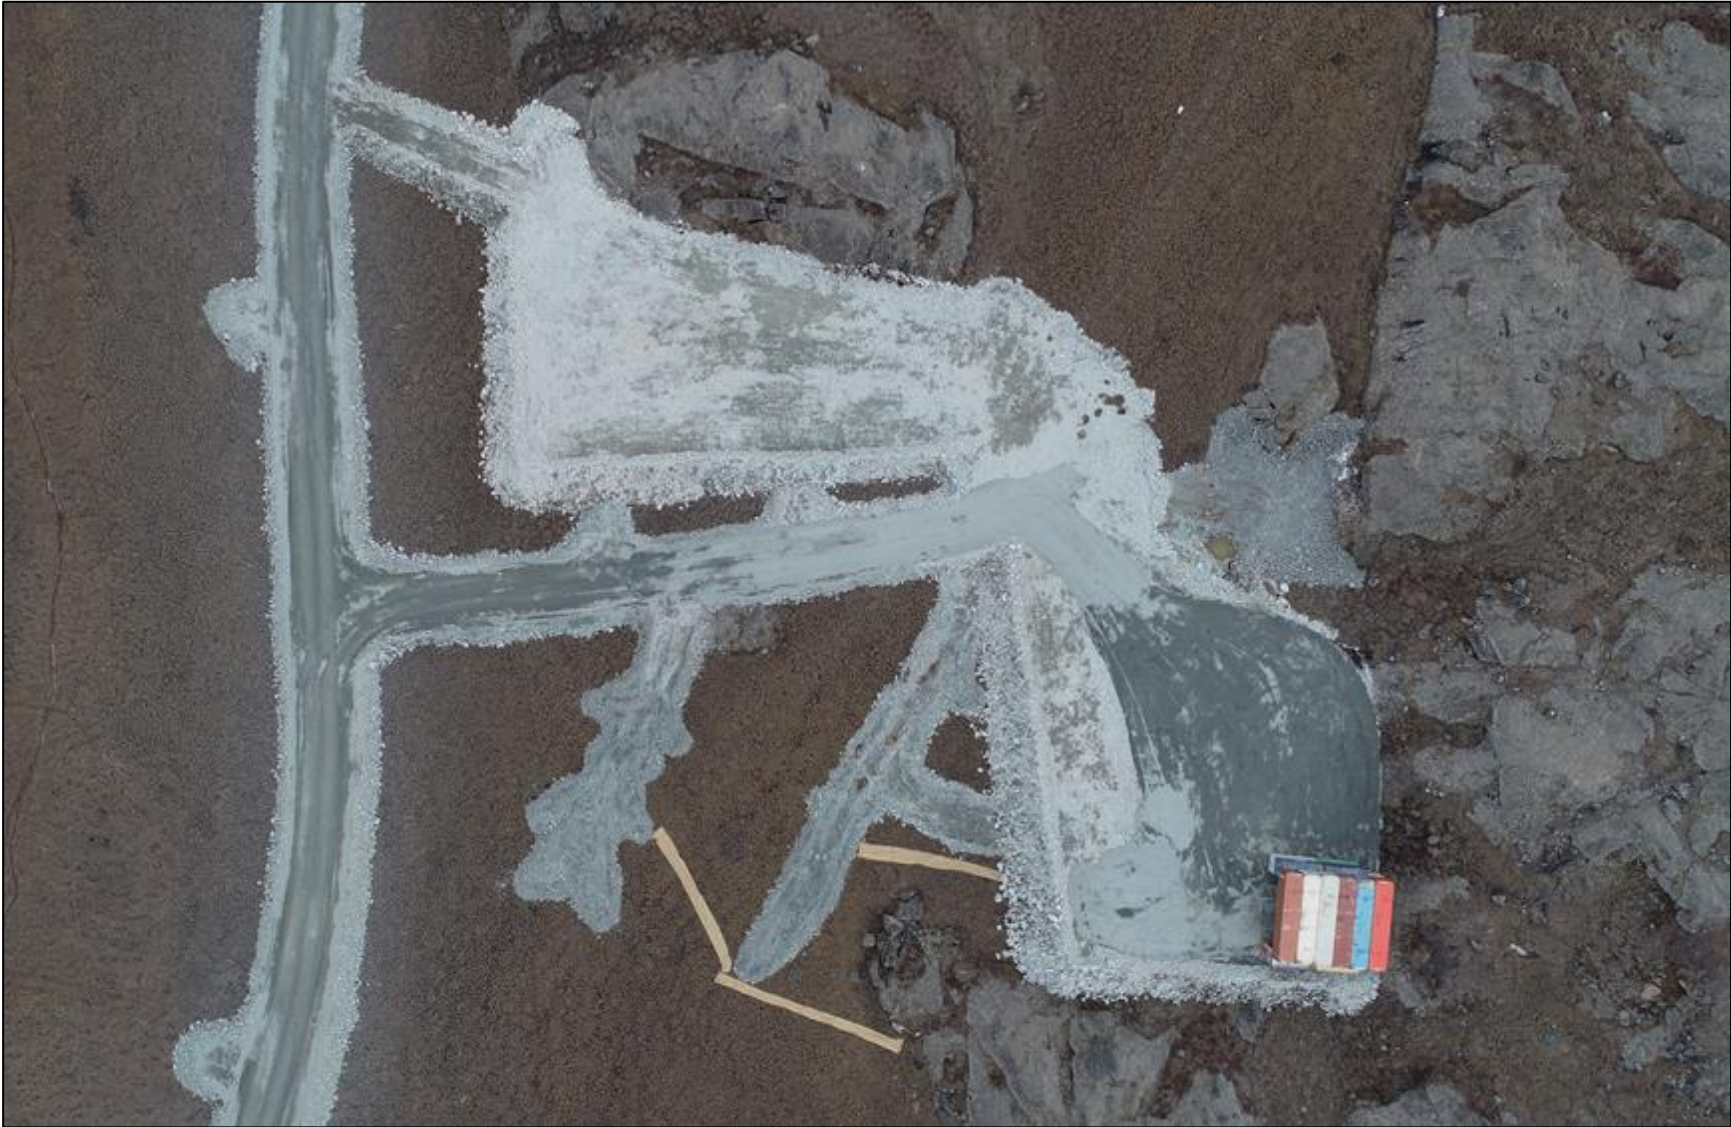
**Figure 1. Madrid North Portal Laydowns, September 2019**

Construction of the Madrid North Portal laydowns started in September and construction of the Waste Rock Pad continued. Overburden stripping and blast activities continued in the Naartok East Crown Pillar Recovery Trench under this licence for the month. Figure 1 shows construction activities at the Madrid North portal laydowns. Figure 2 shows progress of overburden stripping and mining activities at the Naartok East Crown Pillar Recovery Trench.

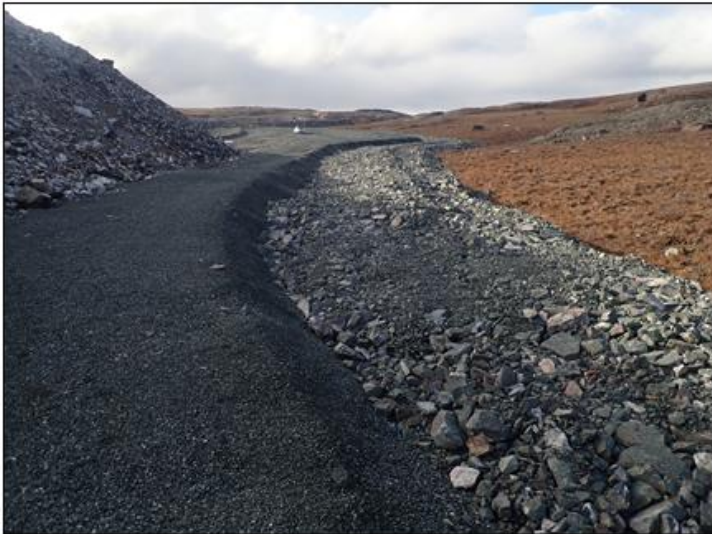
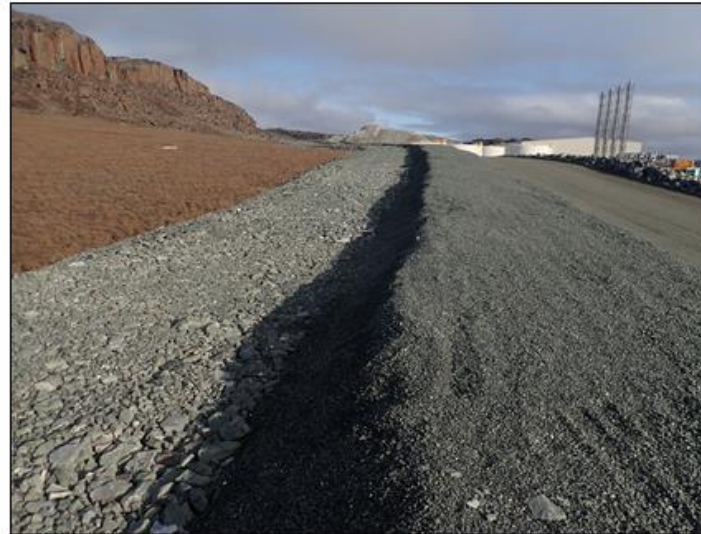
**Figure 5. Diversion berm dry during September (left) towards culverts (right)**

The Diversion Berm and associated check dam were observed to be functioning as designed and diverting non-contact water around the Doris site infrastructure. Photos of this infrastructure are provided in Figures 5 and 6 below.

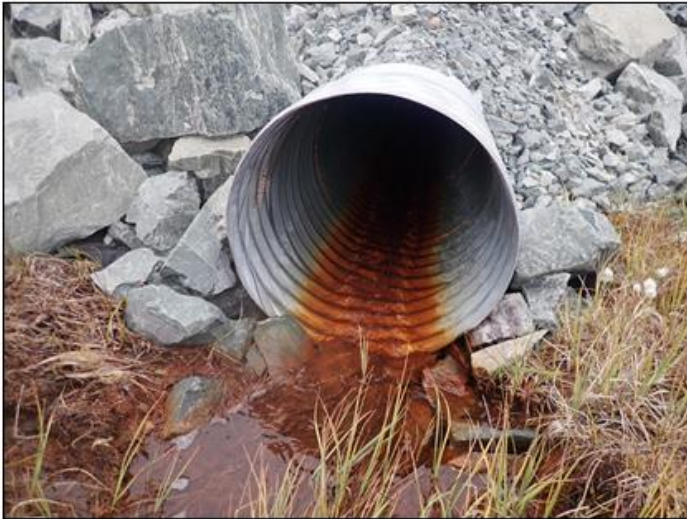
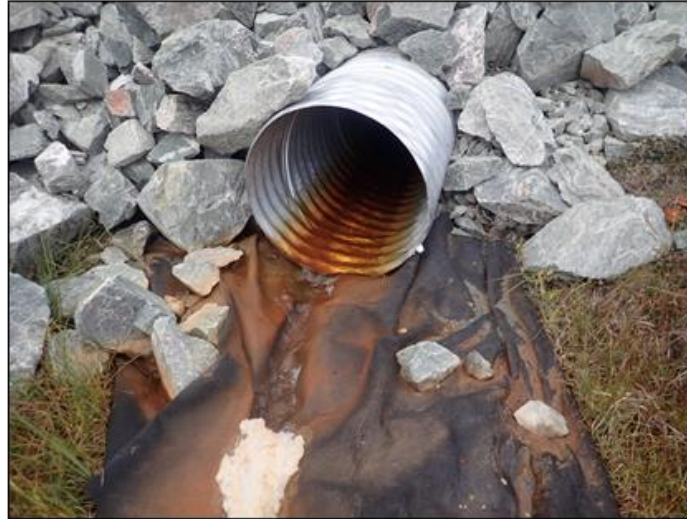
**Figure 7. Culvert at Doris Connector Vent Raise access road upstream (left) and downstream (right)**

Inspections were completed of site culverts throughout the month of September. No issues were identified with these water management structures. Figure 7 and 8 below shows the upstream and downstream conditions of culverts located at the Doris Connector Vent Raise access road and the Marine Outfall access road at Robert's Bay.
