Re: October 2020 – Monthly Monitoring Report for Water Licence 2AM-DOH1335

This report is comprised of the monitoring requirements set out in Part I and Schedule I of water licence 2AM-DOH1335 Amendment 2 (the licence), and additional requirements from CIRNAC.

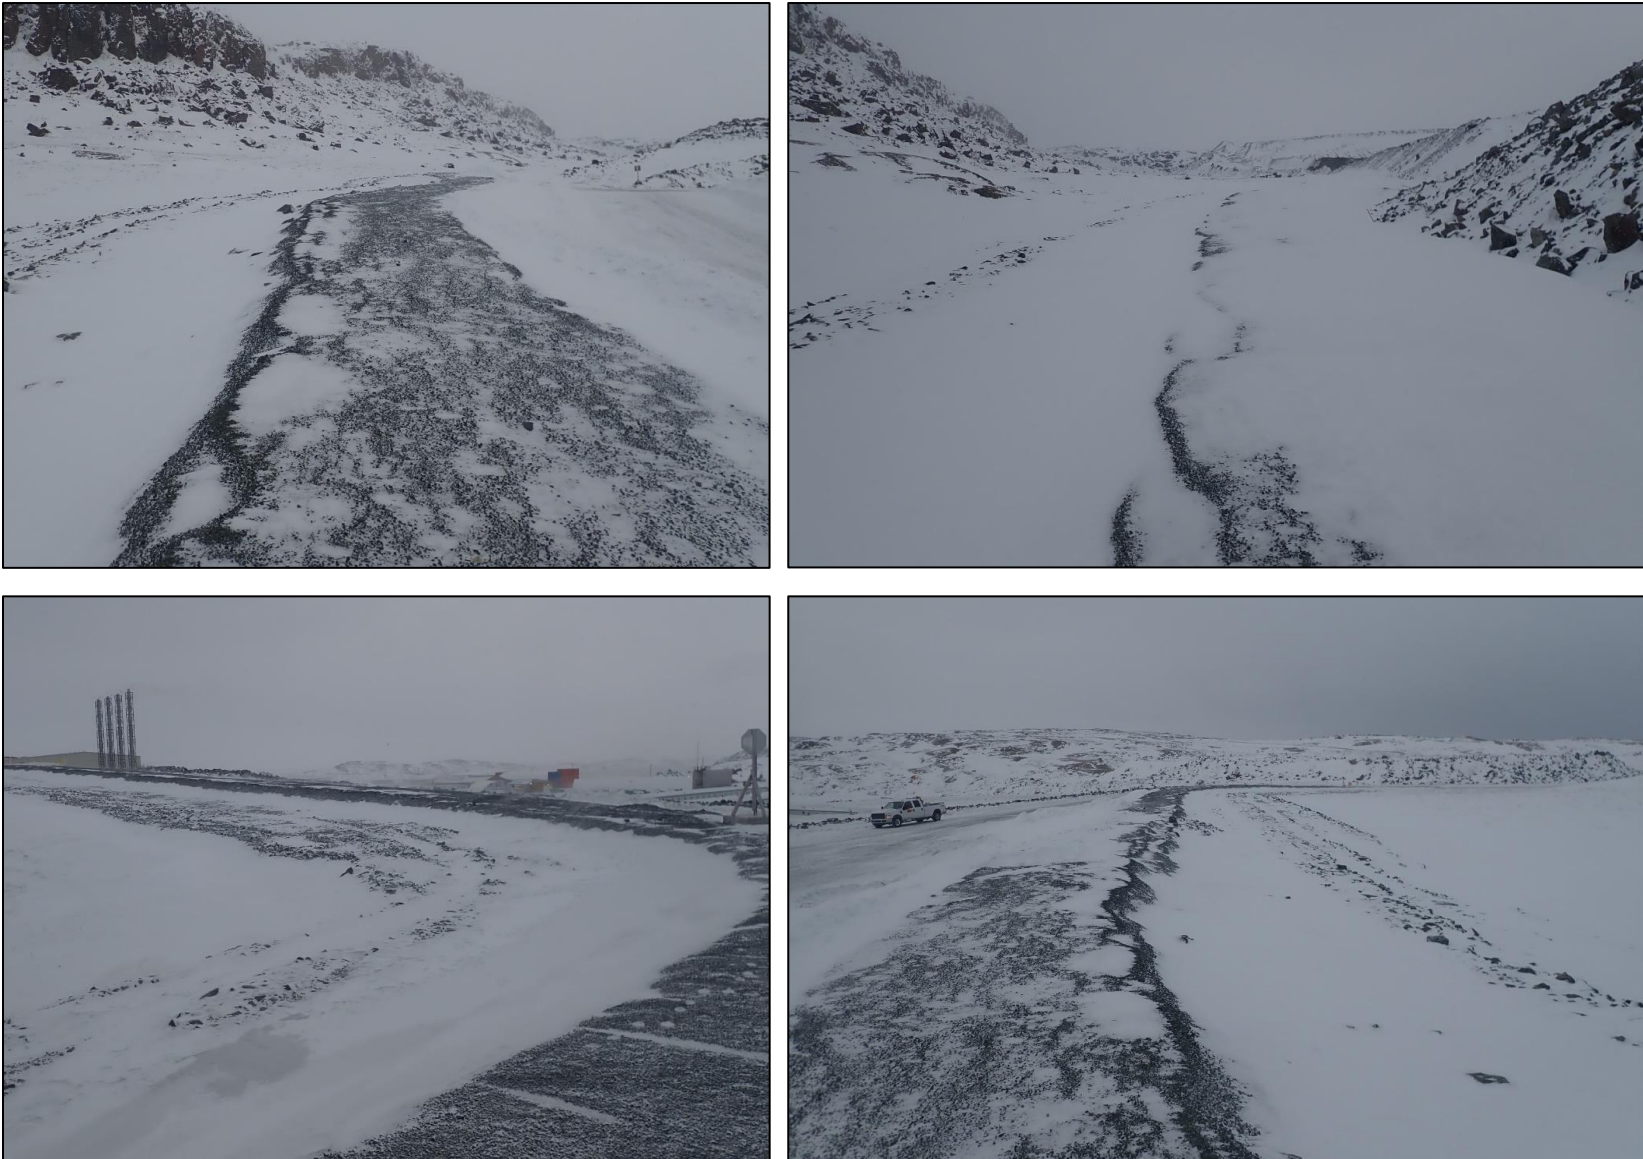
No issues were identified at the Diversion Berm and associated check dam as surface water was observed to be frozen during the month of October. Photos of this infrastructure are provided in Figure 3 below.

Figure 3. Diversion berm during October 2020
