Re: January 2021 – Monthly Monitoring Report for Water Licence 2AM-DOH1335

This report is comprised of the monitoring requirements set out in Part I and Schedule I of water licence 2AM-DOH1335 Amendment 2 (the licence), and additional requirements from CIRNAC.

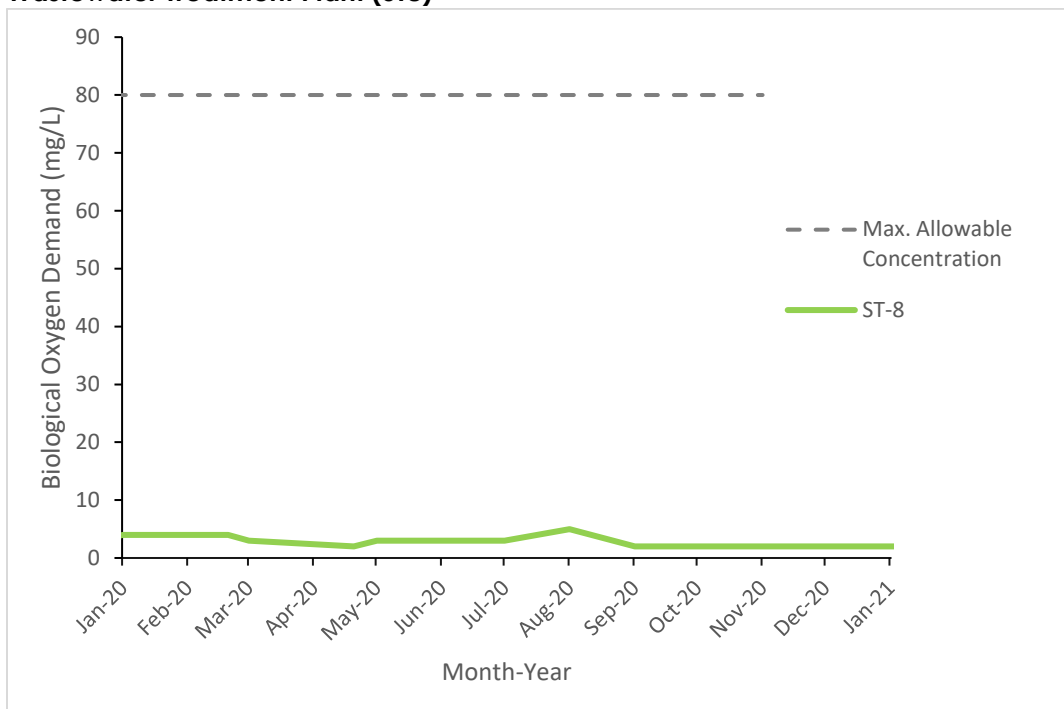
Figure 1. Biological Oxygen Demand Results Consistently Below Discharge Criteria for Wastewater Treatment Plant (ST8)

Note: Maximum Average Concentration as per Part F Item 4(b).

Figure 1 and 2 illustrates effluent quality characteristics for parameters of interest at select monitoring stations.

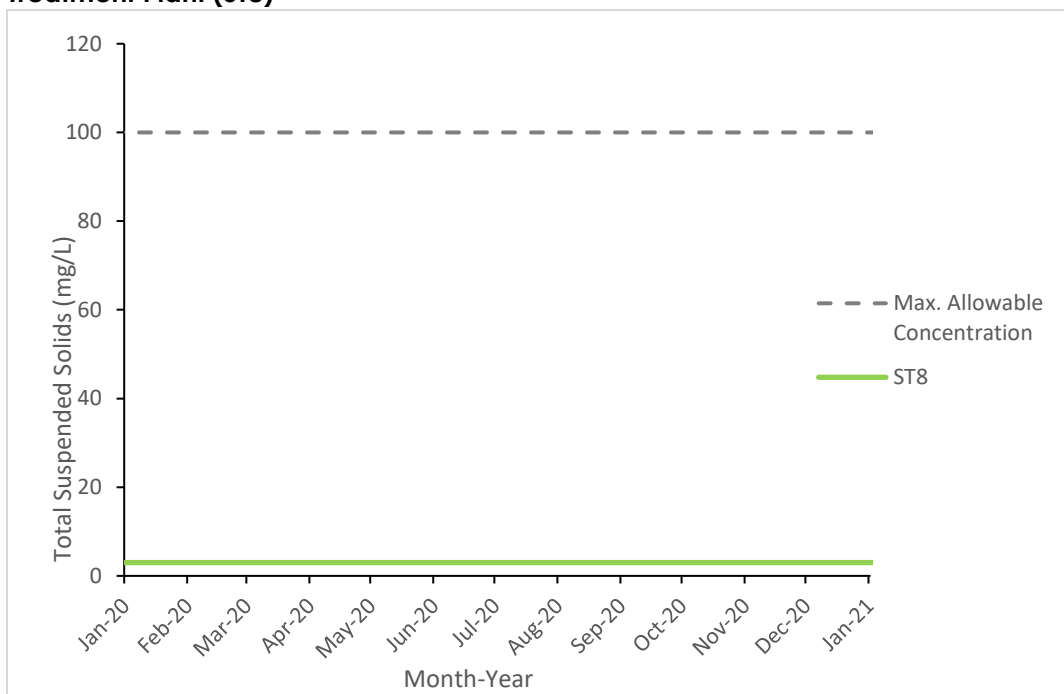
Figure 2. Total Suspended Solids Results Consistently Below Discharge Criteria for Wastewater Treatment Plant (ST8)

Note: Maximum Average Concentration as per Part F Item 4(b).

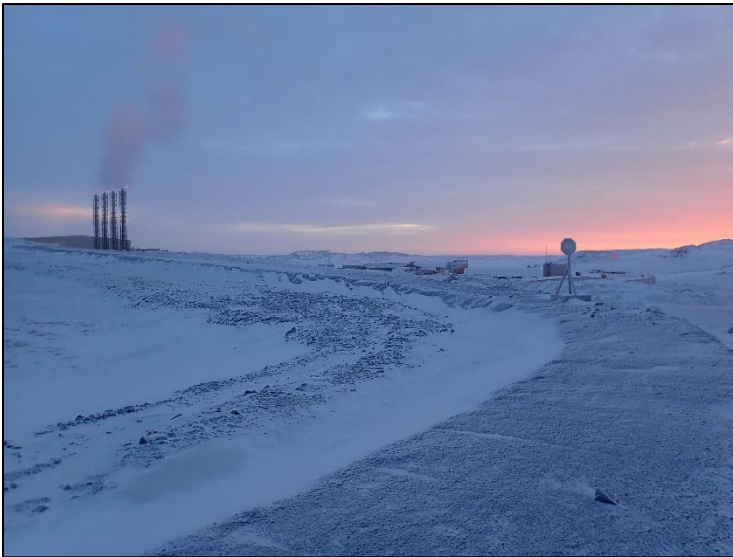
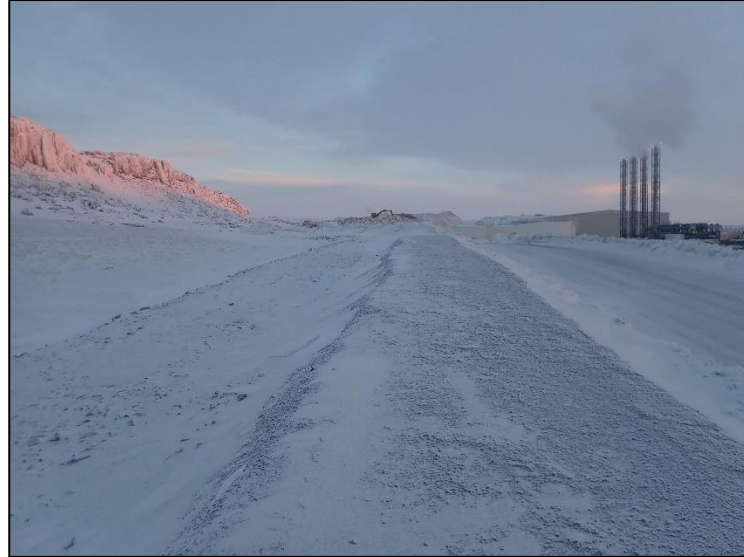
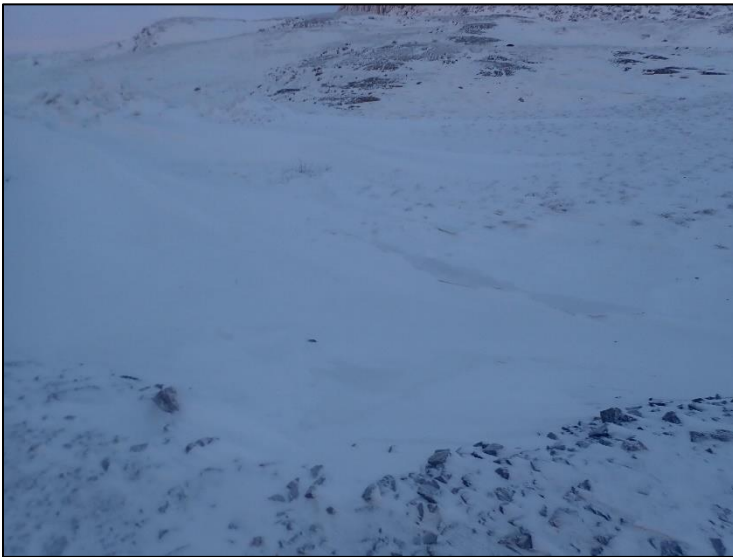
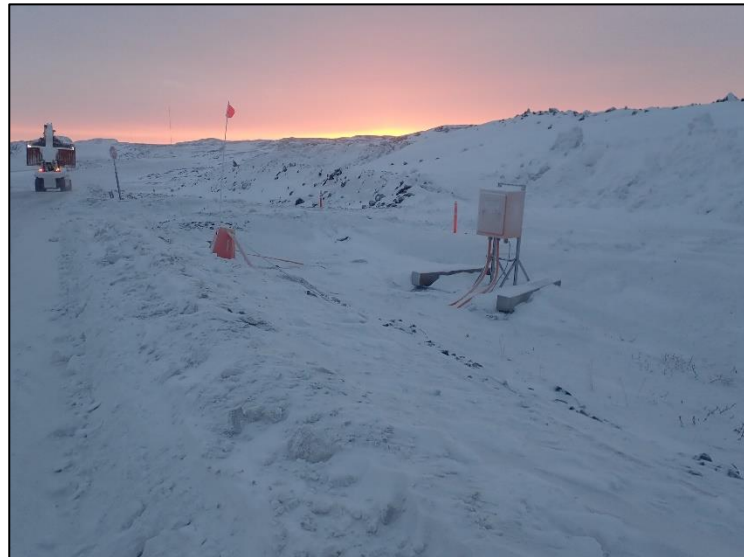
Visual monitoring was conducted at the Diversion Berm this month. All other water management structures (e.g. culverts) were frozen.

No issues were identified at the Diversion Berm and associated check dam in January. Photos of this infrastructure are provided in Figure 3 below.

Figure 3. Diversion berm during January 2021

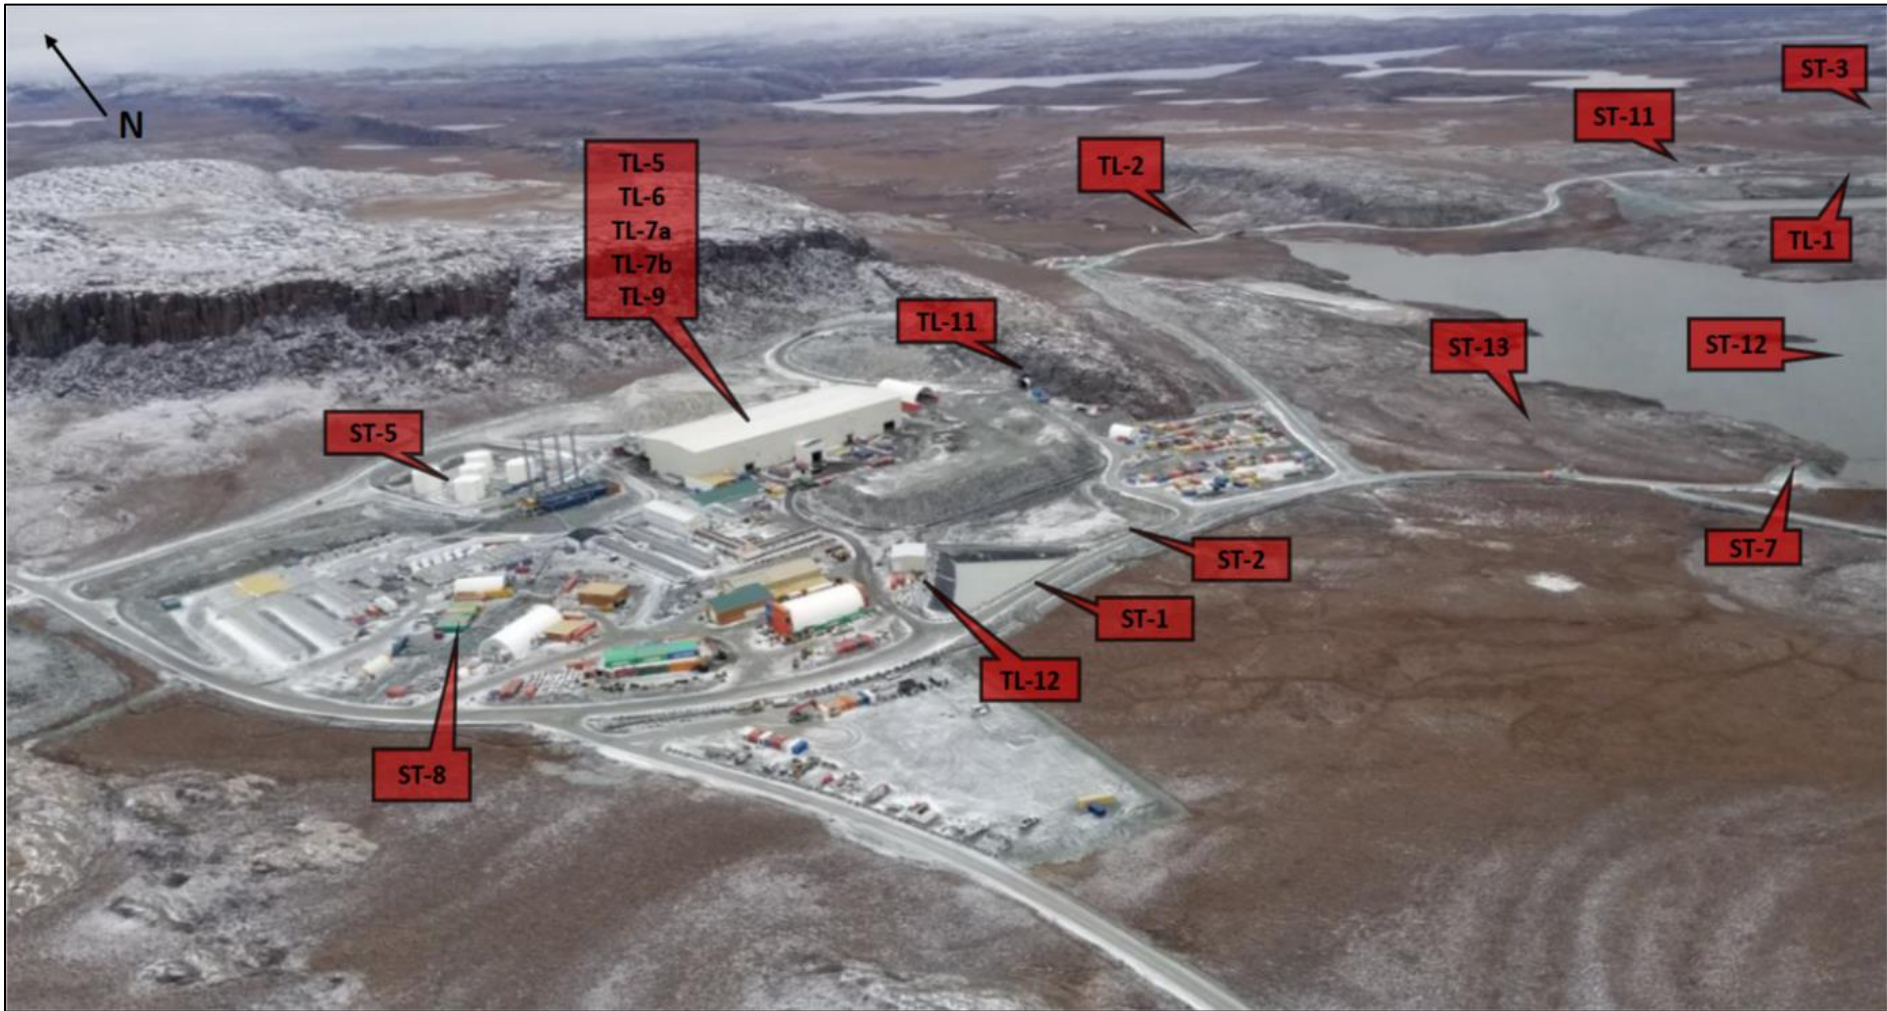
Figure 4. 2AM-DOH1335 SNP Monitoring Locations

Sampling locations monitored under this licence (seasonally or when facilities are operational) are provided in Figure 4 through Figure 6 at the end of this report.

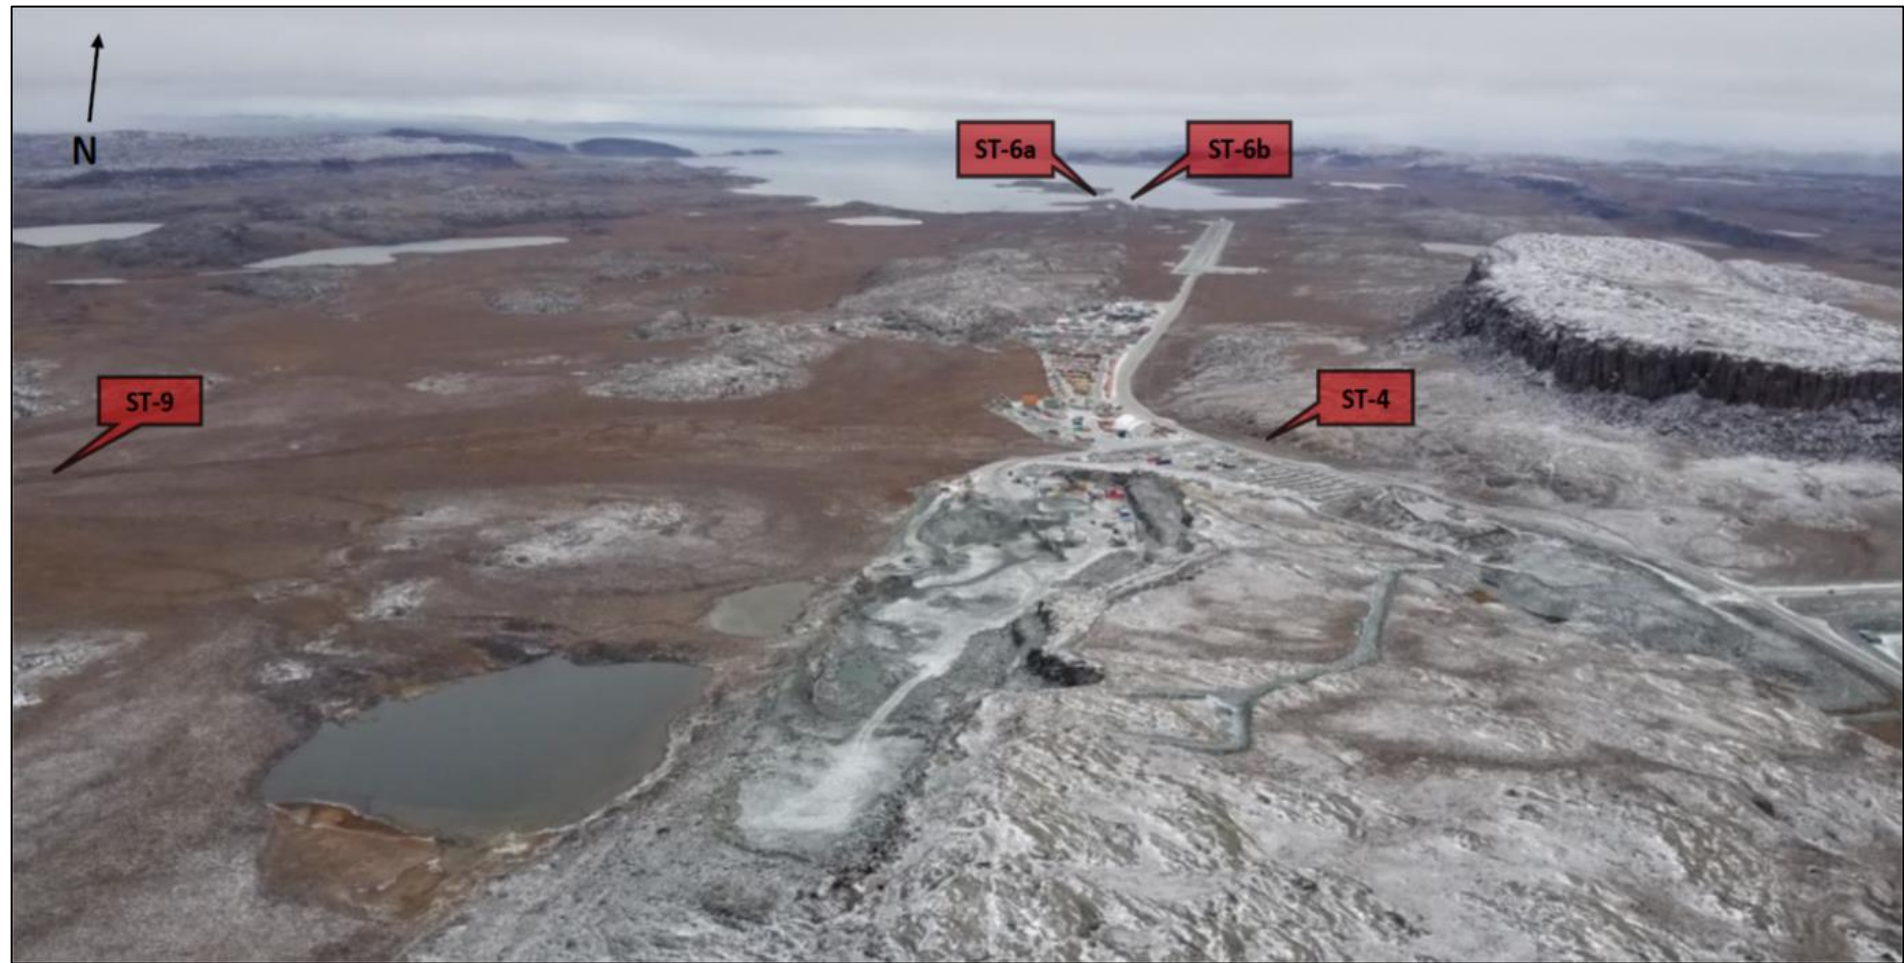
Figure 5. 2AM-DOH1335 SNP Monitoring Locations

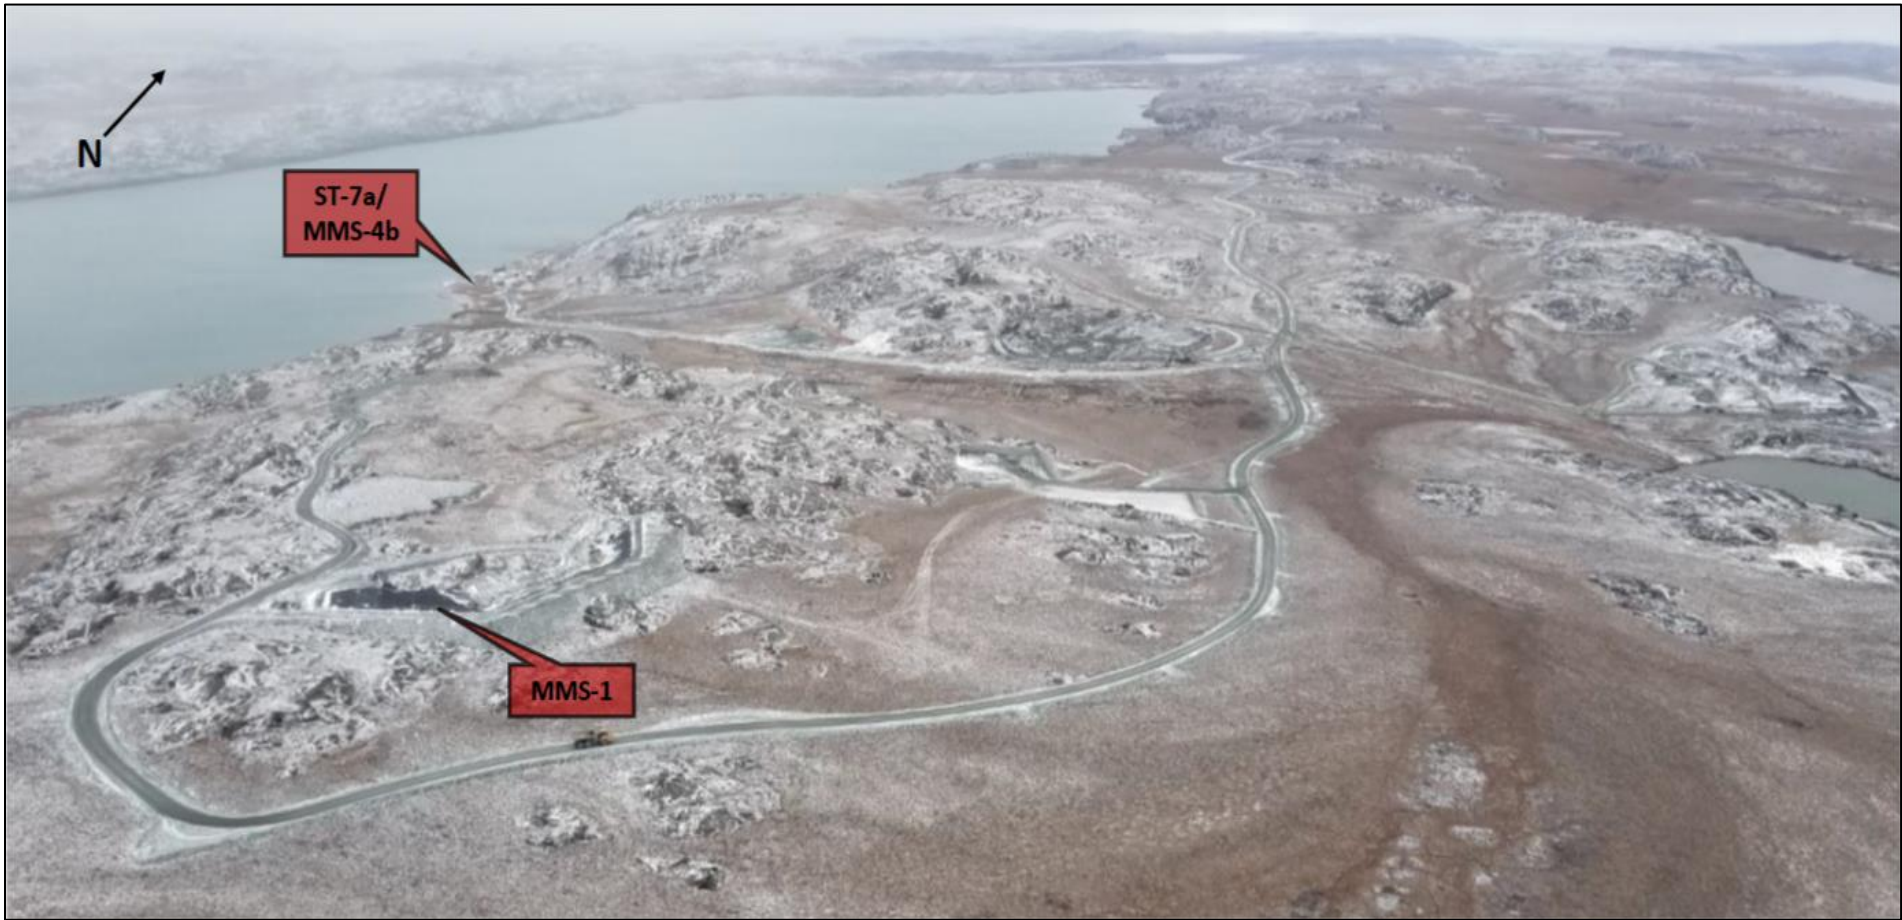
Figure 6. 2AM-DOH1335 SNP Monitoring Locations
