**Re: March 2021 – Monthly Monitoring Report for Water Licence 2AM-DOH1335**

This report is comprised of the monitoring requirements set out in Part I and Schedule I of water licence 2AM-DOH1335 Amendment 2 (the licence), and additional requirements from CIRNAC.

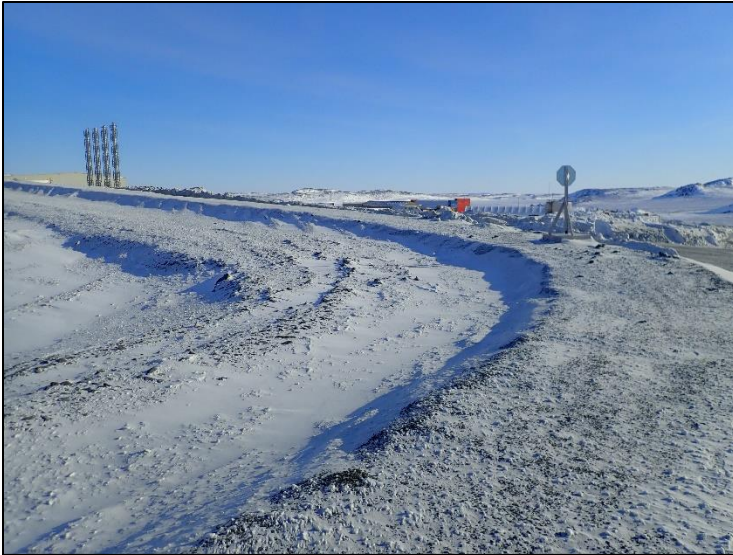
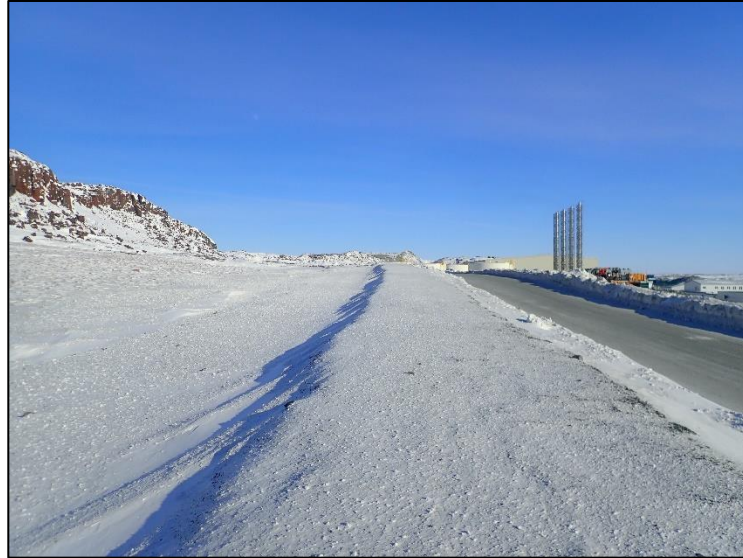
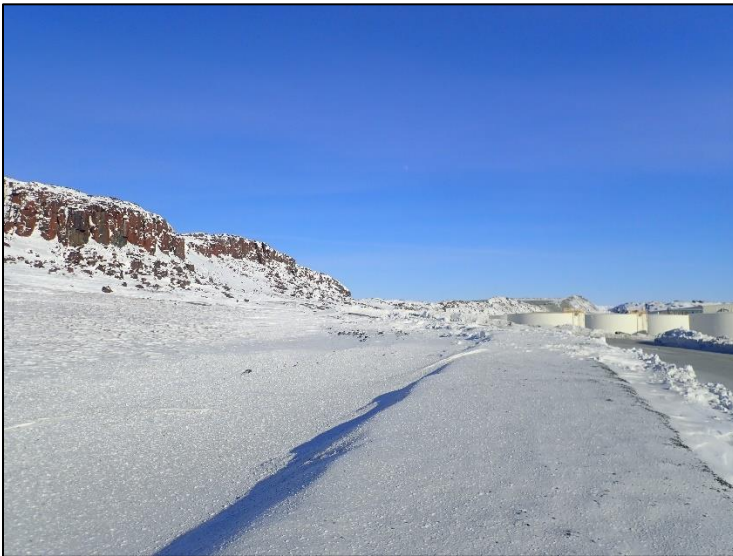
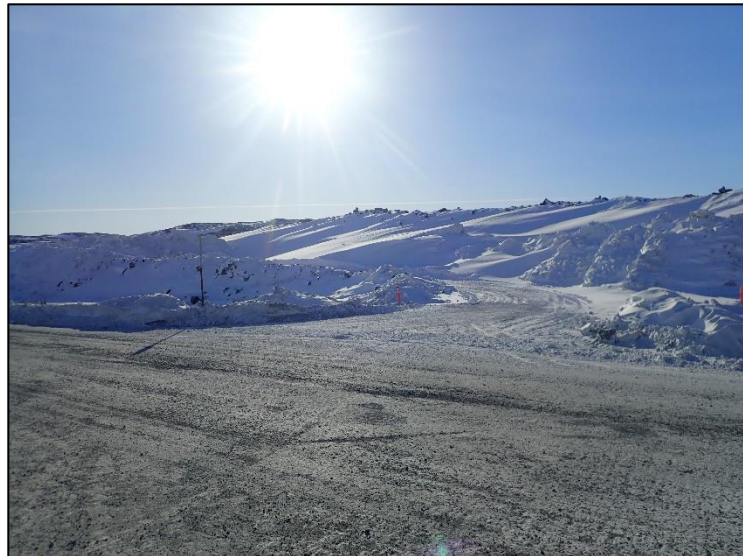
Visual monitoring was conducted at the Diversion Berm this month. All other water management structures (e.g. culverts) were frozen.

No issues were identified at the Diversion Berm and associated check dam in March. Photos of this infrastructure are provided in Figure 3 below.

**Figure 3. Diversion berm during March 2021**

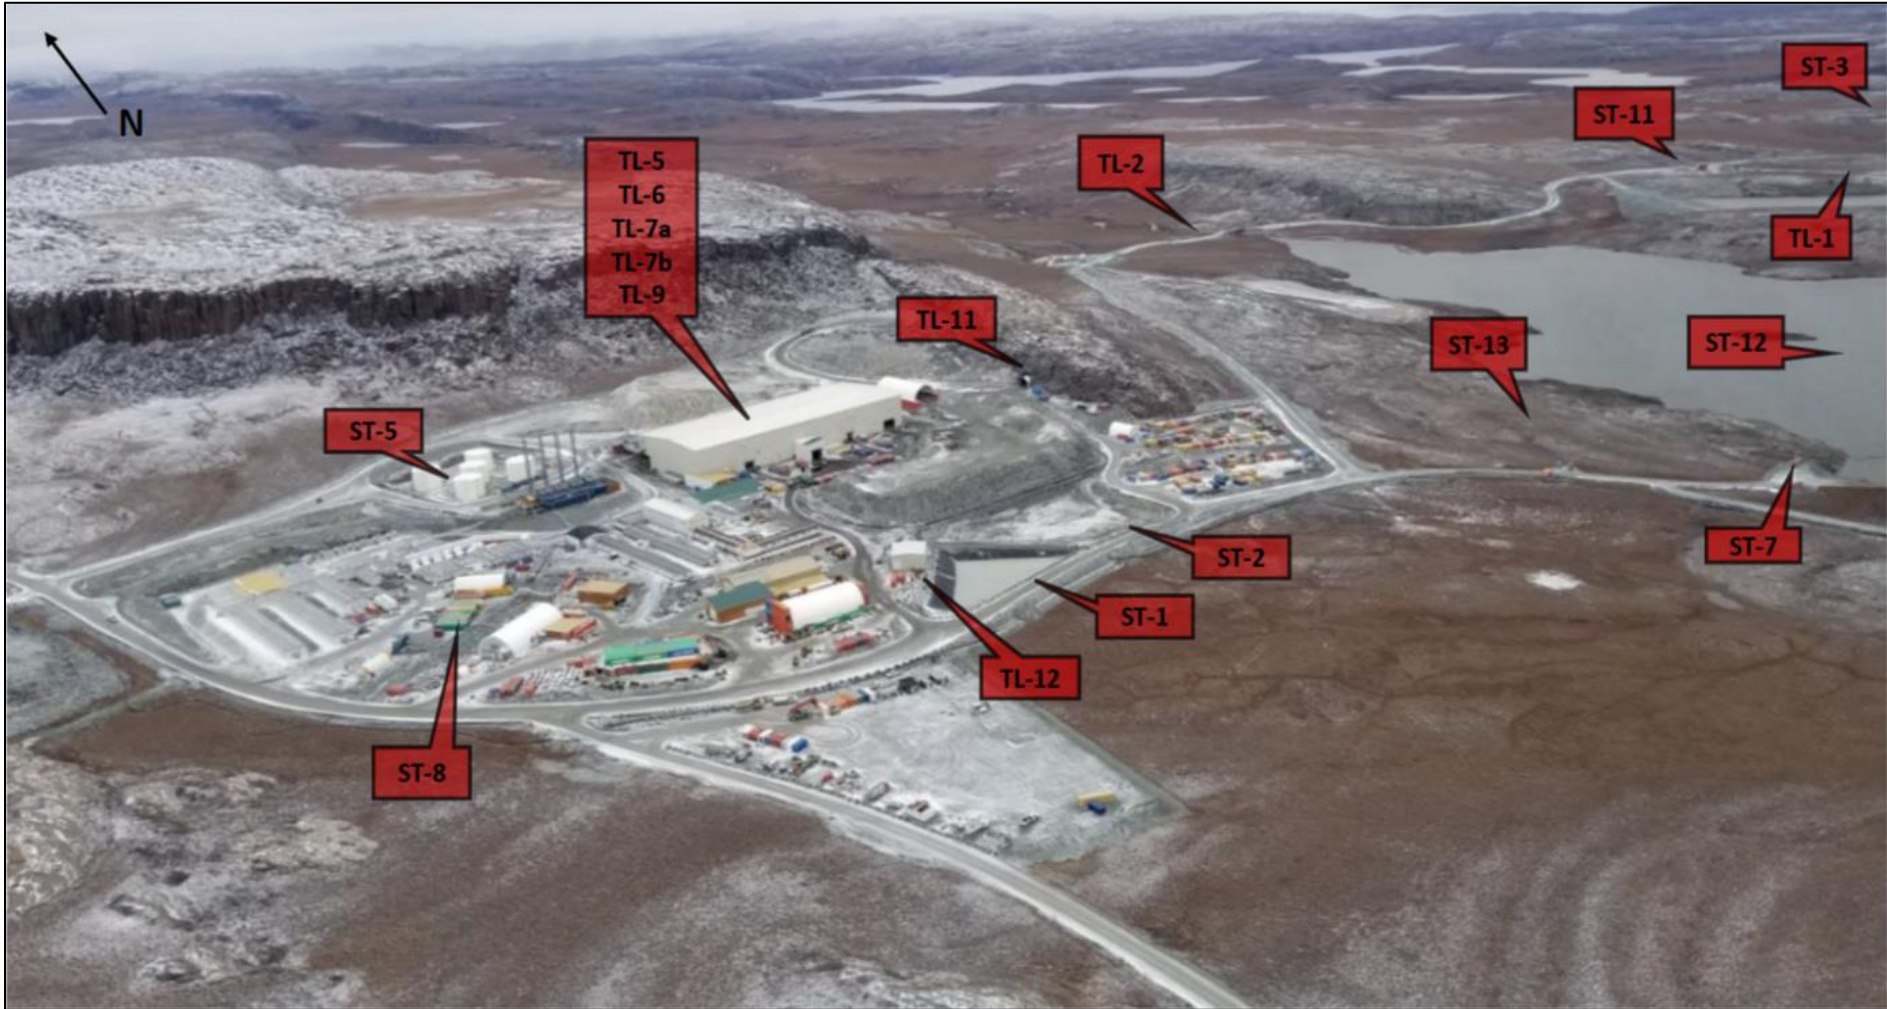
Figure 4. 2AM-DOH1335 SNP Monitoring Locations

Sampling locations monitored under this licence (seasonally or when facilities are operational) are provided in Figure 4 through Figure 6 at the end of this report.
