Re: April 2021 - Monthly Monitoring Report for Water Licence 2AM-DOH1335

This report is comprised of the monitoring requirements set out in Part I and Schedule I of water licence 2AM-DOH1335 Amendment 2 (the licence), and additional requirements from CIRNAC.

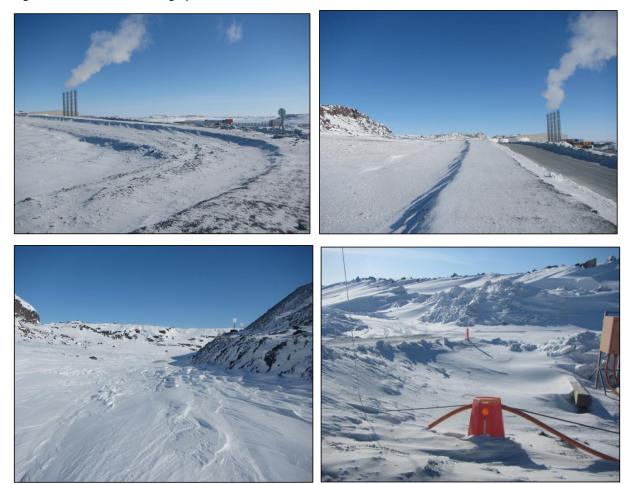
Visual monitoring was conducted at the Diversion Berm this month. All other water management structures (e.g. culverts) were frozen.

No issues were identified at the Diversion Berm and associated check dam in April. Photos of this infrastructure are provided in Figure 3 below.

Figure 3. Diversion berm during April 2021

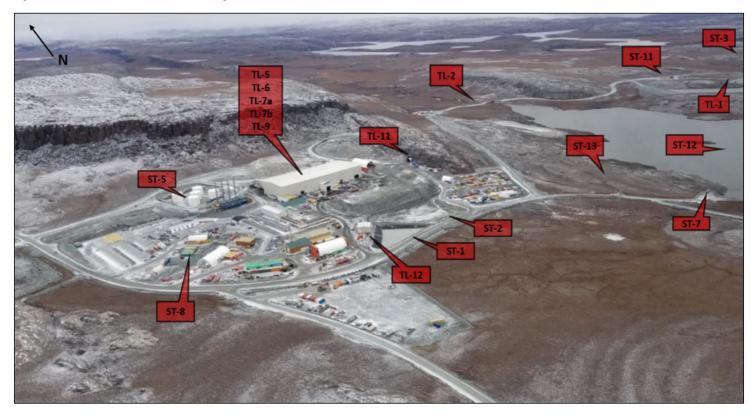
Figure 4. 2AM-DOH1335 SNP Monitoring Locations

Sampling locations monitored under this licence (seasonally or when facilities are operational) are provided in Figure 4 through Figure 6 at the end of this report.

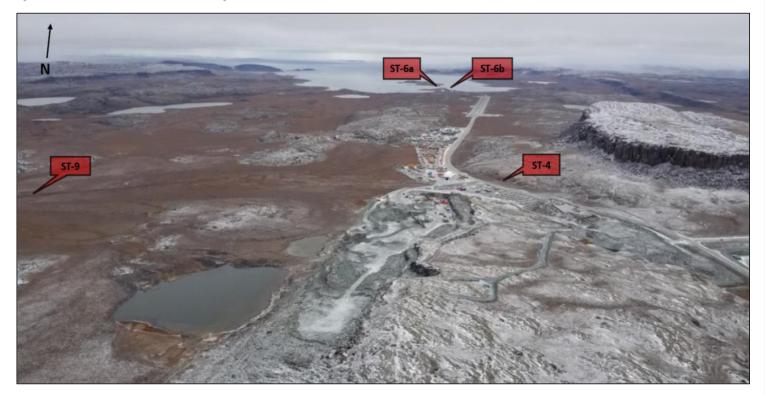
Figure 5. 2AM-DOH1335 SNP Monitoring Locations

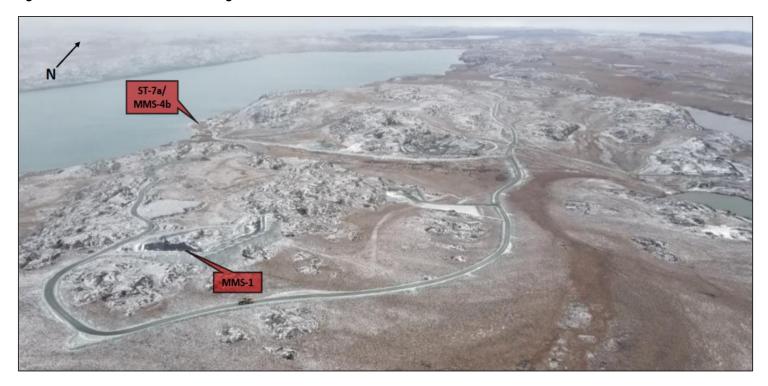
Figure 6. 2AM-DOH1335 SNP Monitoring Locations
