Re: May 2021 – Monthly Monitoring Report for Water Licence 2AM-DOH1335

This report is comprised of the monitoring requirements set out in Part I and Schedule I of water licence 2AM-DOH1335 Amendment 2 (the licence), and additional requirements from CIRNAC.

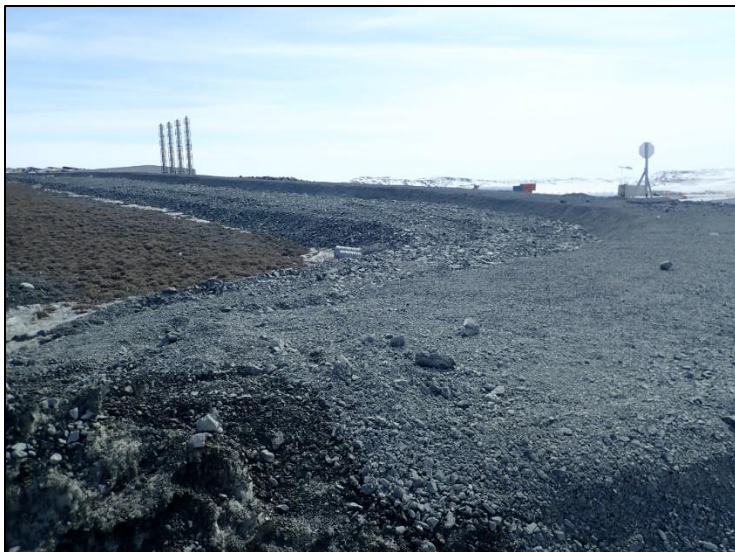
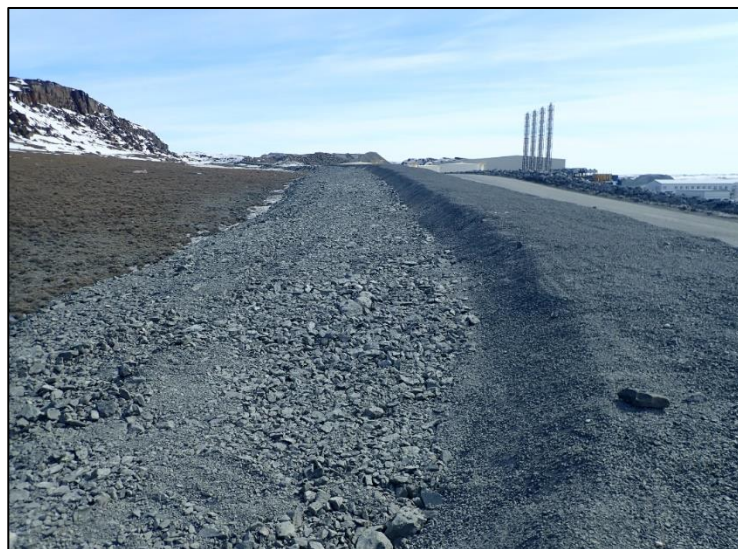
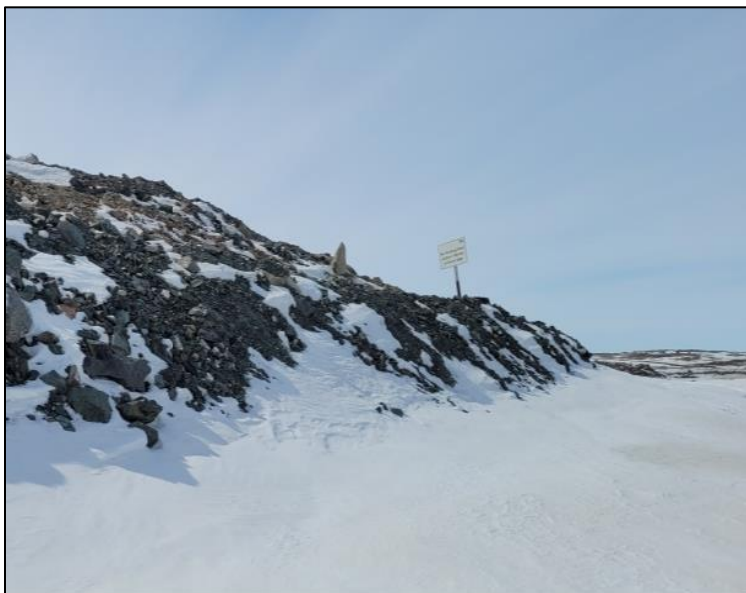
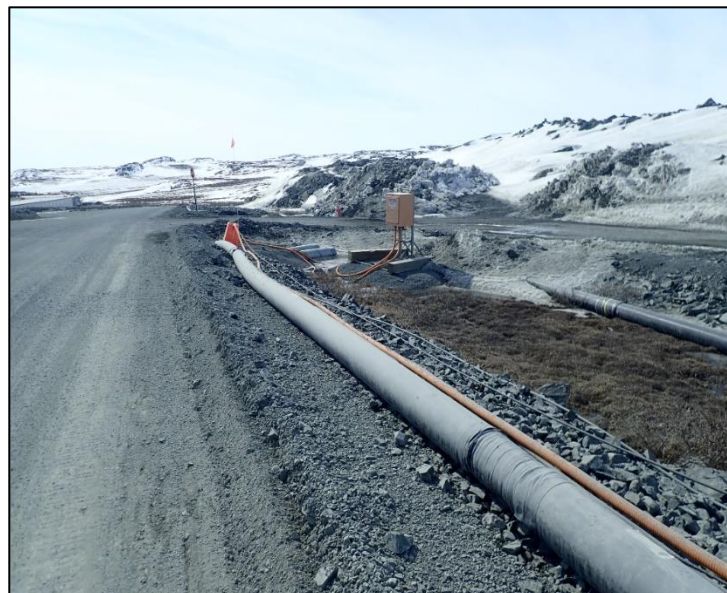
Visual monitoring was conducted at the Diversion Berm this month. All other water management structures (e.g. culverts) were frozen. No issues were identified at the Diversion Berm and associated check dam in May. Photos of this infrastructure are provided in Figure 3 below.

Figure 3. Diversion berm during May 2021

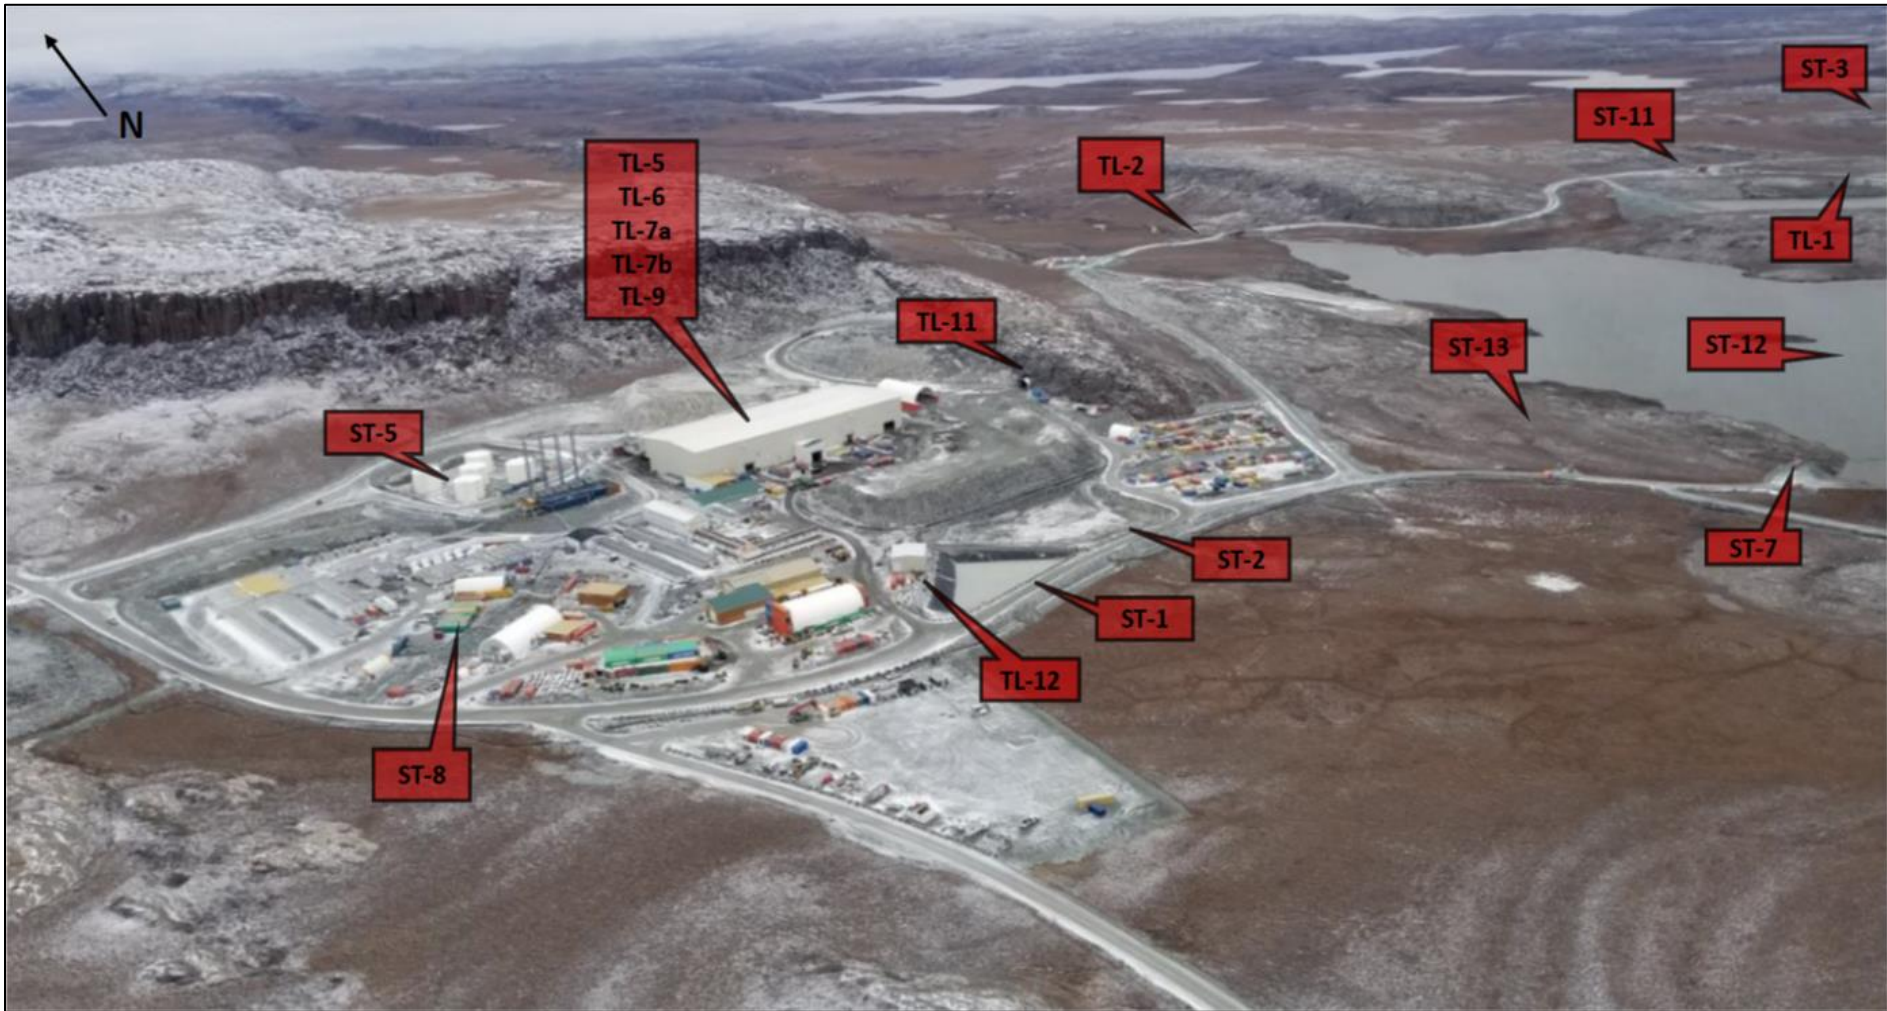
Figure 4. 2AM-DOH1335 SNP Monitoring Locations

Sampling locations monitored under this licence (seasonally or when facilities are operational) are provided in Figure 4 through Figure 6 at the end of this report.
