**Re: August 2021 – Monthly Monitoring Report for Water Licence 2AM-DOH1335**

This report is comprised of the monitoring requirements set out in Part I and Schedule I of water licence 2AM-DOH1335 Amendment 2 (the licence), and additional requirements from CIRNAC.

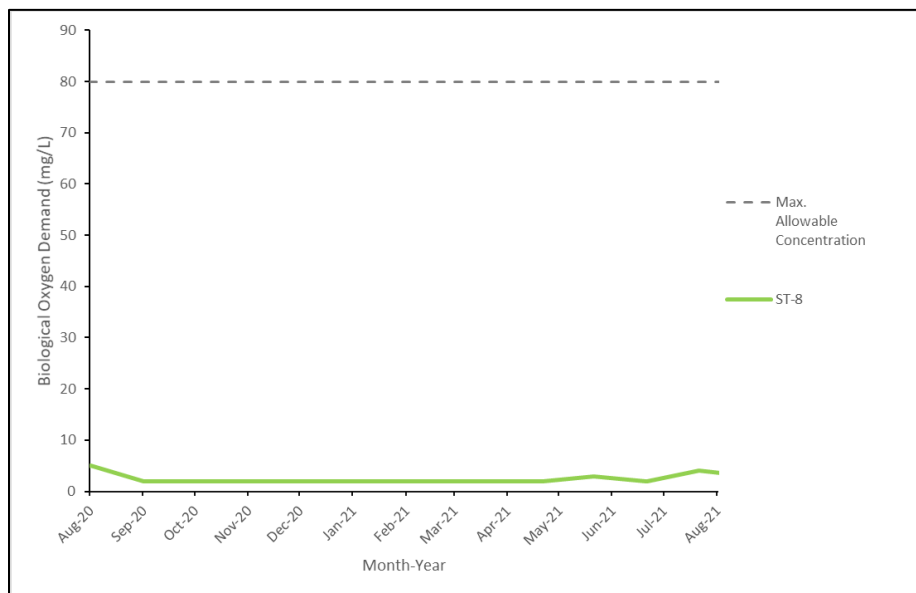
**Figure 1. Biological Oxygen Demand Results Consistently Below Discharge Criteria for Wastewater Treatment Plant (ST8)**

Note: Maximum Average Concentration as per Part F Item 4(b).

Figure 1 and 2 illustrates effluent quality characteristics for parameters of interest at select monitoring stations.

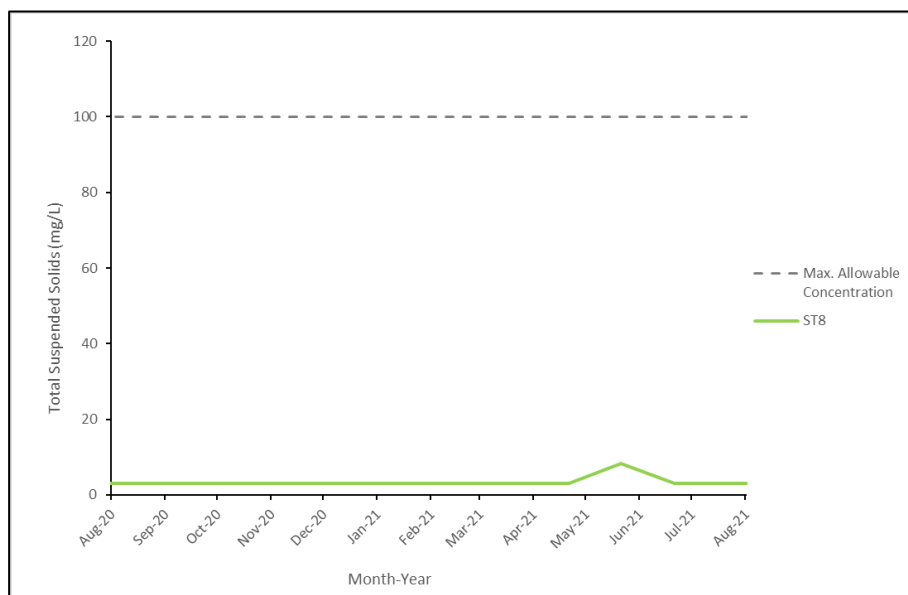
**Figure 2. Total Suspended Solids Results Consistently Below Discharge Criteria for Wastewater Treatment Plant (ST8)**

Note: Maximum Average Concentration as per Part F Item 4(b).

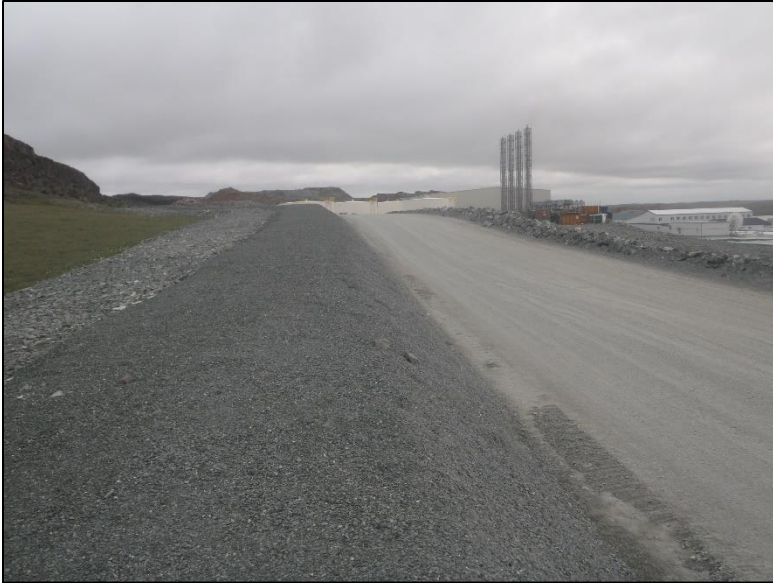
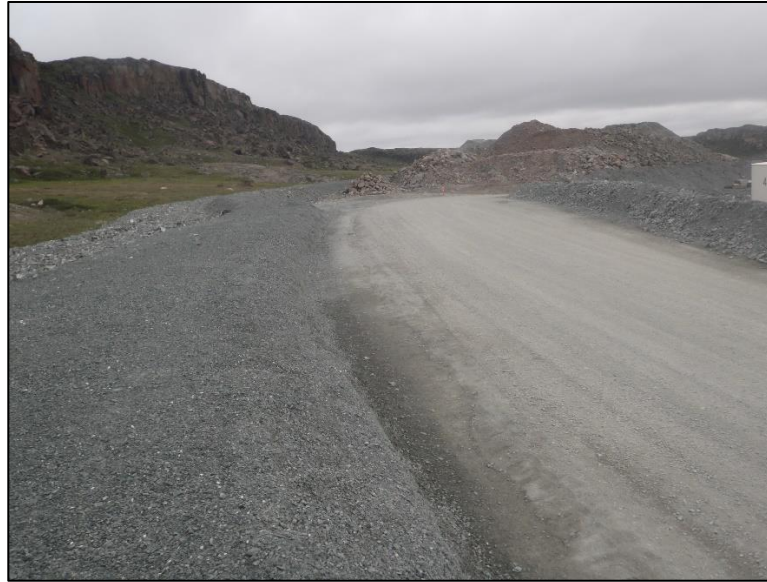
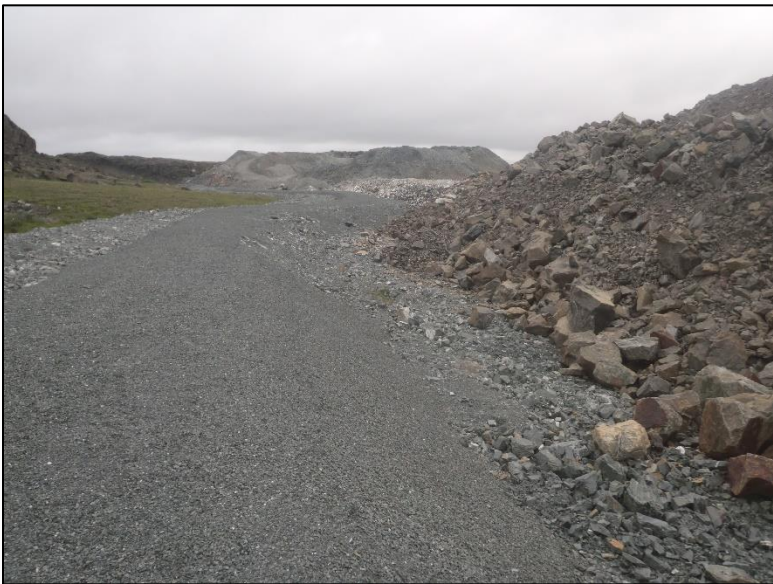
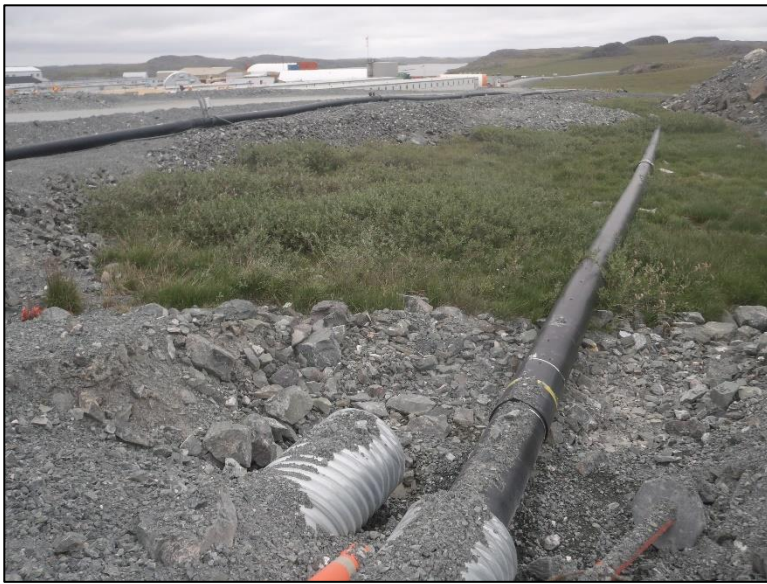
Visual monitoring was conducted at the Diversion Berm this month. No issues were identified at the Diversion Berm and associated check dam in August. Photos of this infrastructure are provided in Figure 3 below.

**Figure 3. Diversion berm during August 2021**

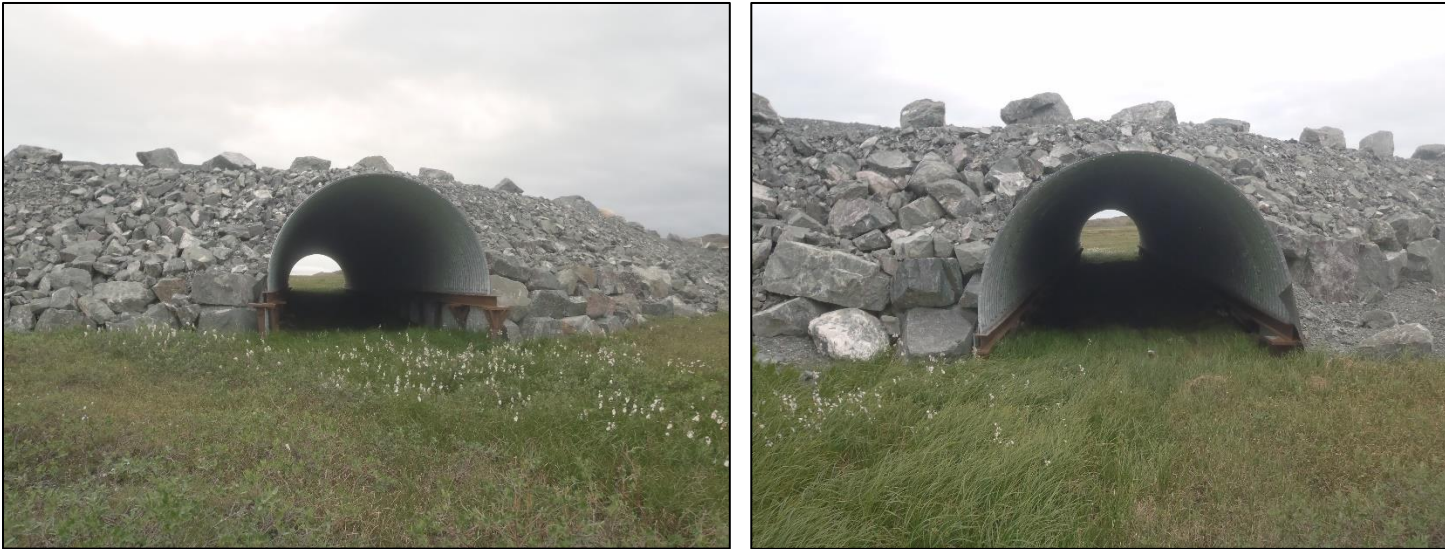
Inspections were completed of site culverts throughout the month of August. No issues were identified with these water management structures. Figure 4 and 5 below shows the upstream and downstream conditions of culverts located at both extremities of the Madrid All-Weather Road.

**Figure 4. Culvert at km 2 on Madrid camp access road upstream (left) and downstream (right) August 2021**

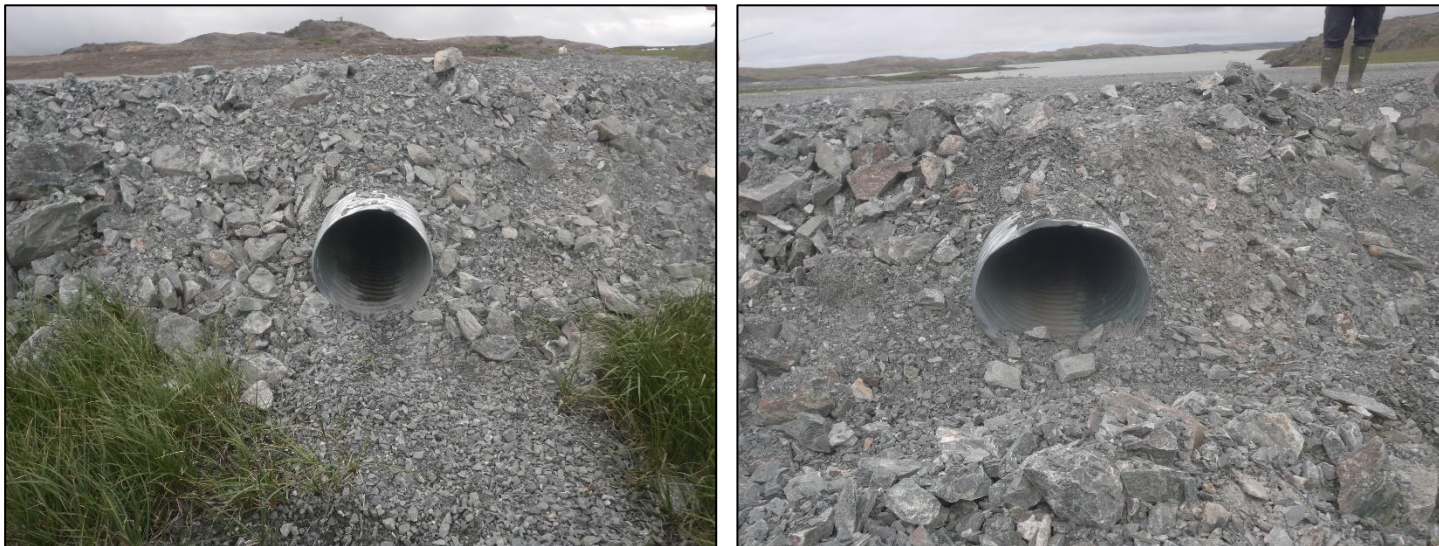
**Figure 5. Culvert at Madrid All-Weather Road at Naartok intersection upstream (right) and downstream (left) August 2021**

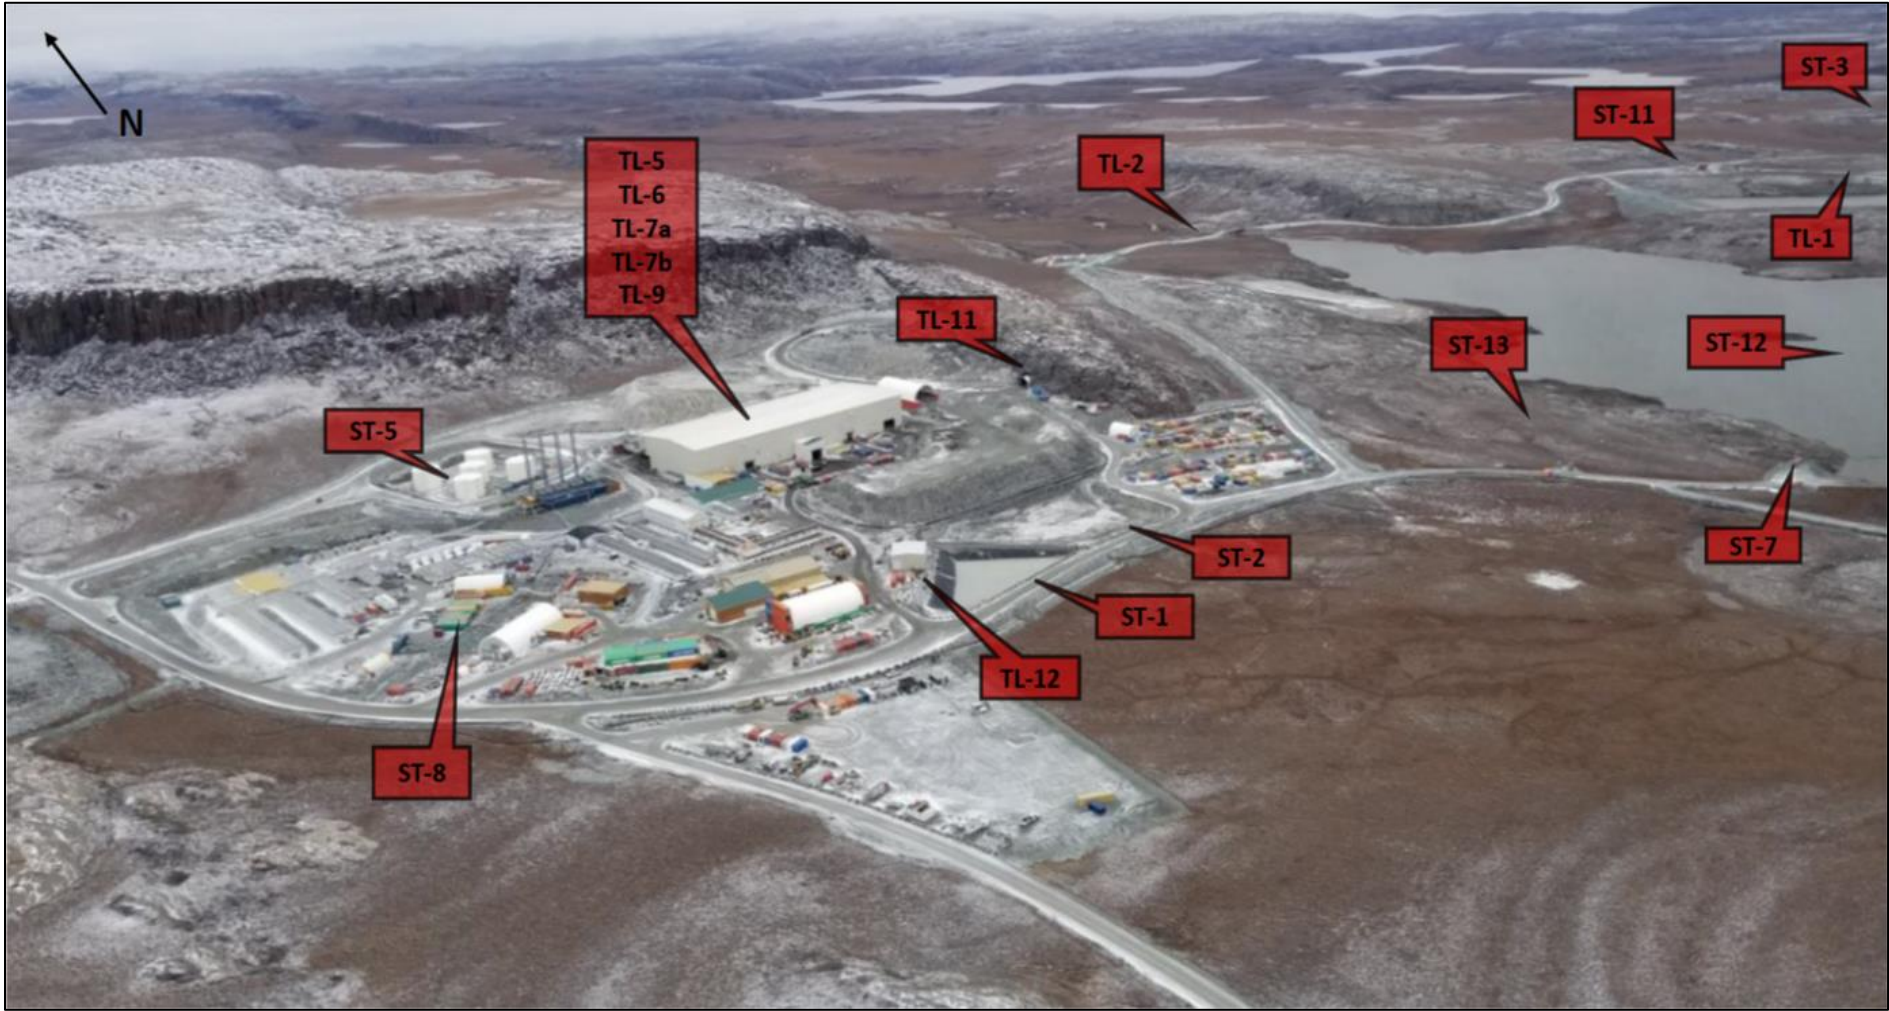
Sampling locations monitored under this licence (seasonally or when facilities are operational) are provided in Figure 6 through Figure 8 at the end of this report.

Figure 6. 2AM-DOH1335 SNP Monitoring Locations

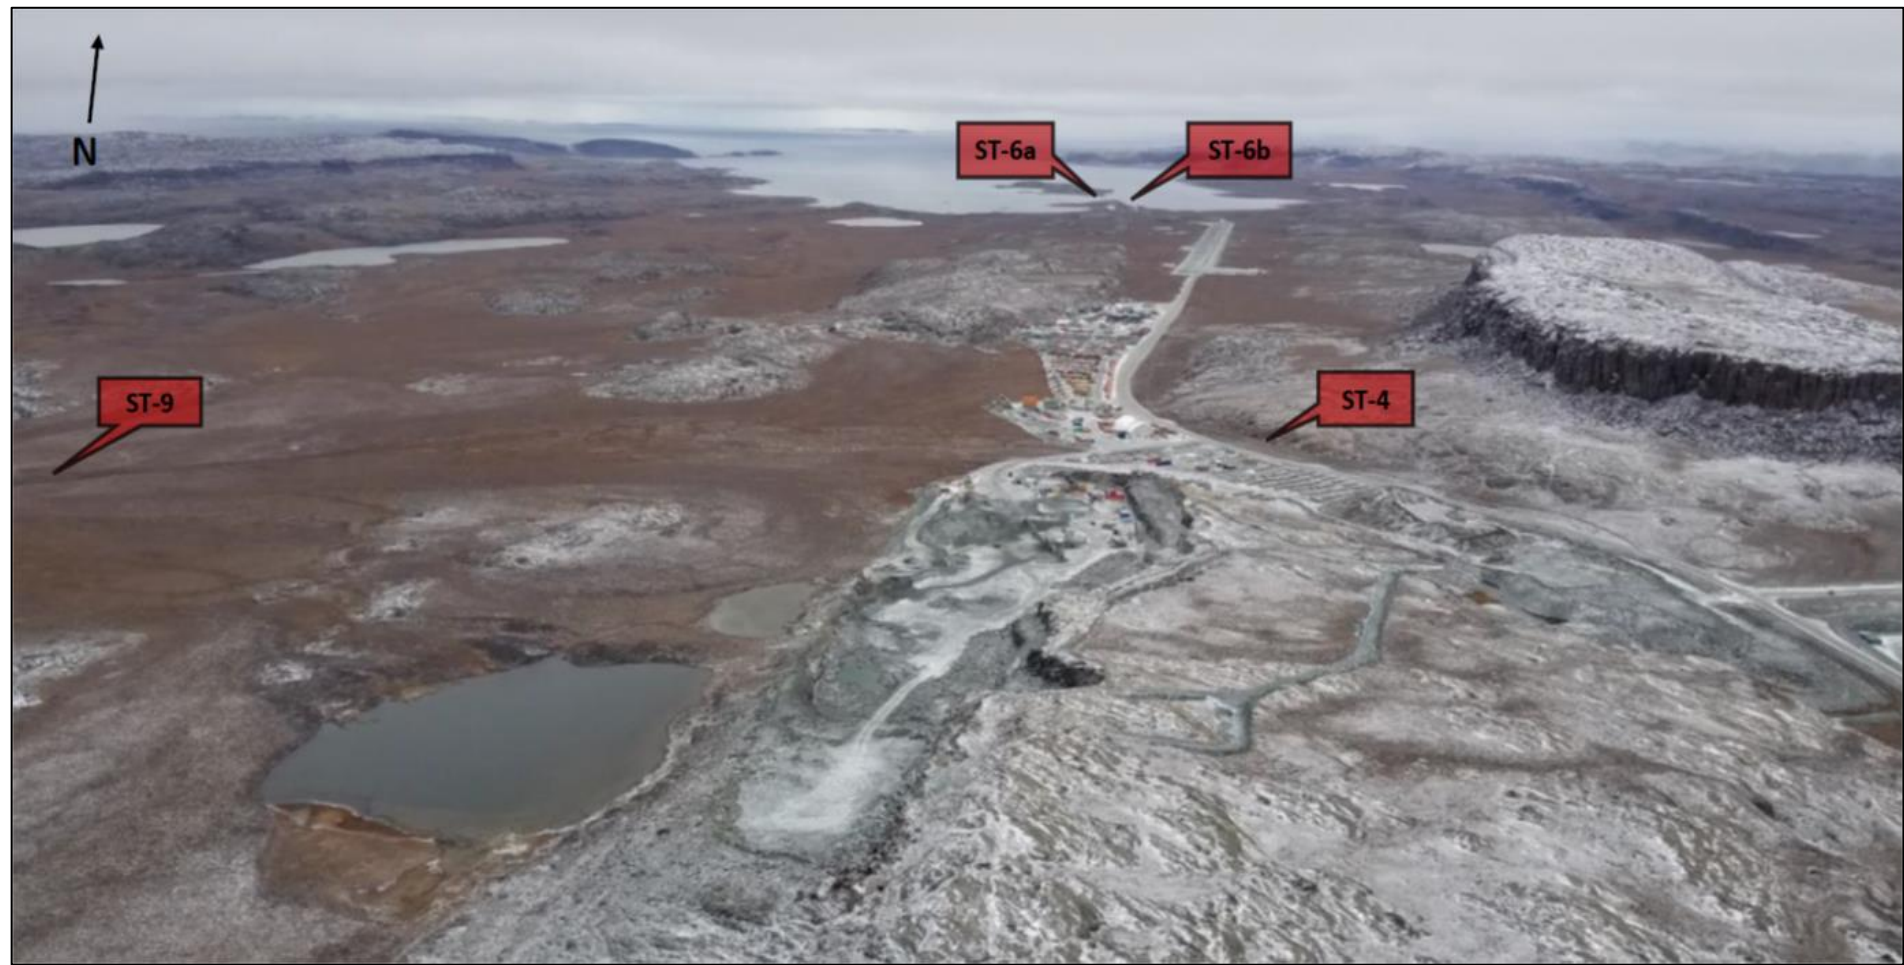
Figure 7. 2AM-DOH1335 SNP Monitoring Locations

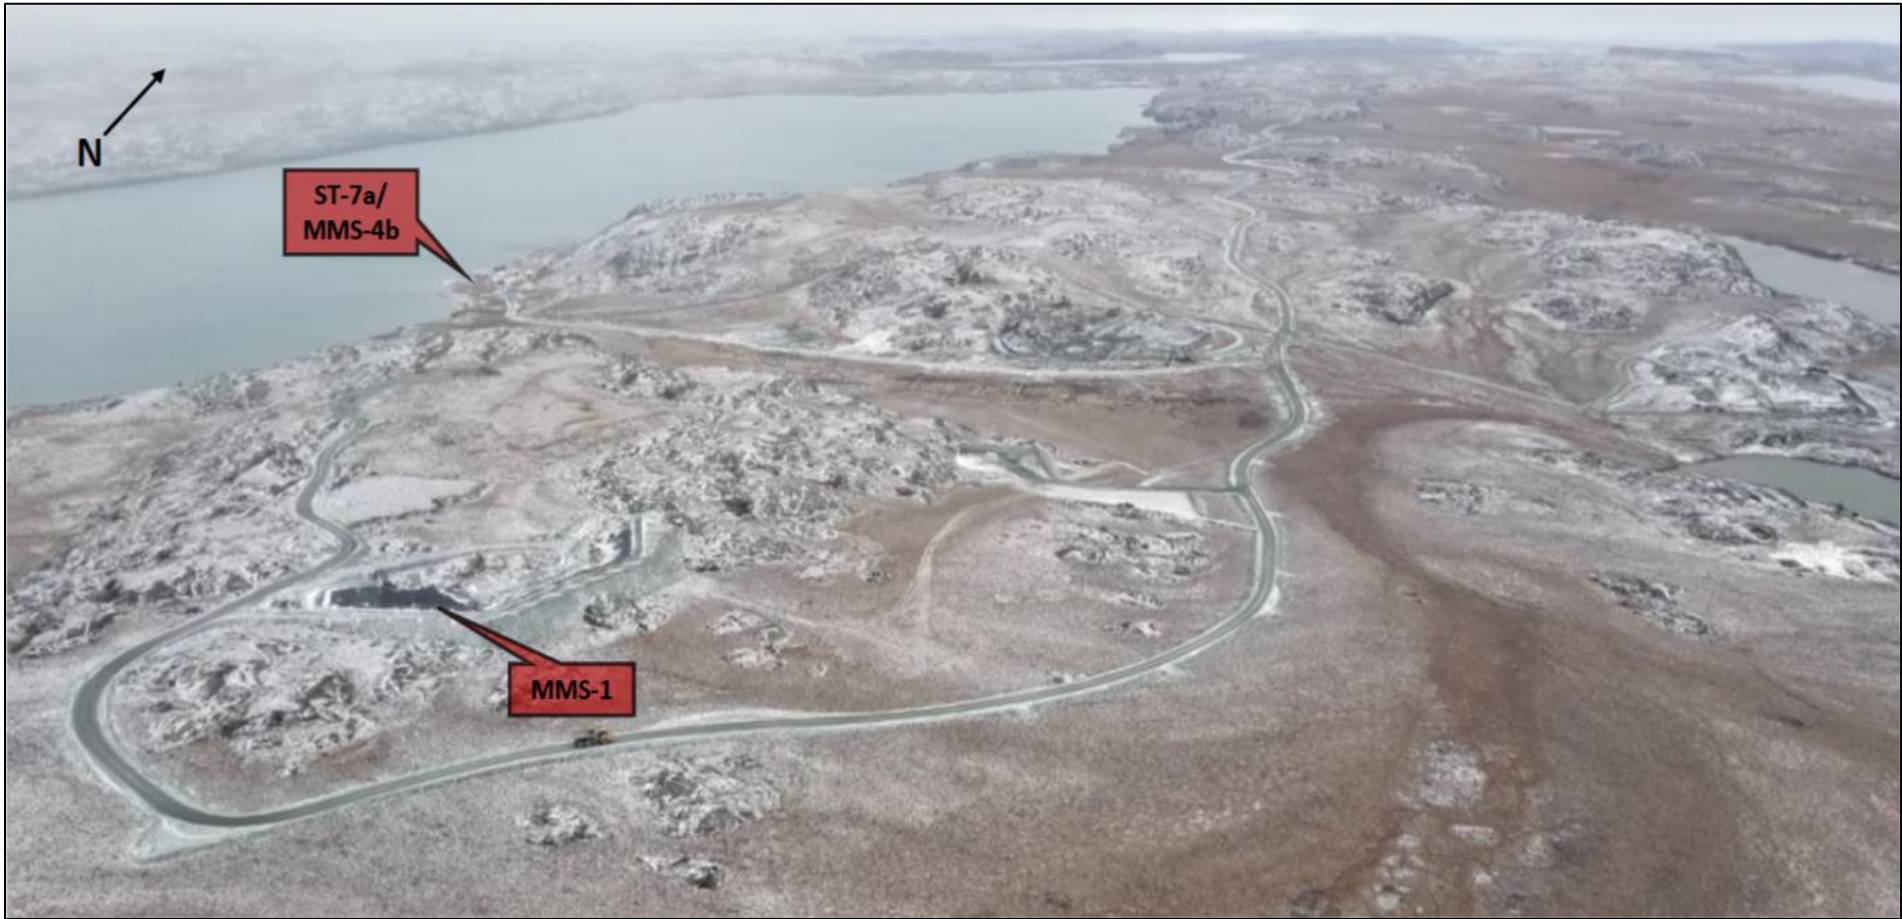
Figure 8. 2AM-DOH1335 SNP Monitoring Locations
