**Re: December 2021 – Monthly Monitoring Report for Water Licence 2AM-DOH1335**

This report is comprised of the monitoring requirements set out in Part I and Schedule I of water licence 2AM-DOH1335 Amendment 2 (the licence), and additional requirements from CIRNAC.

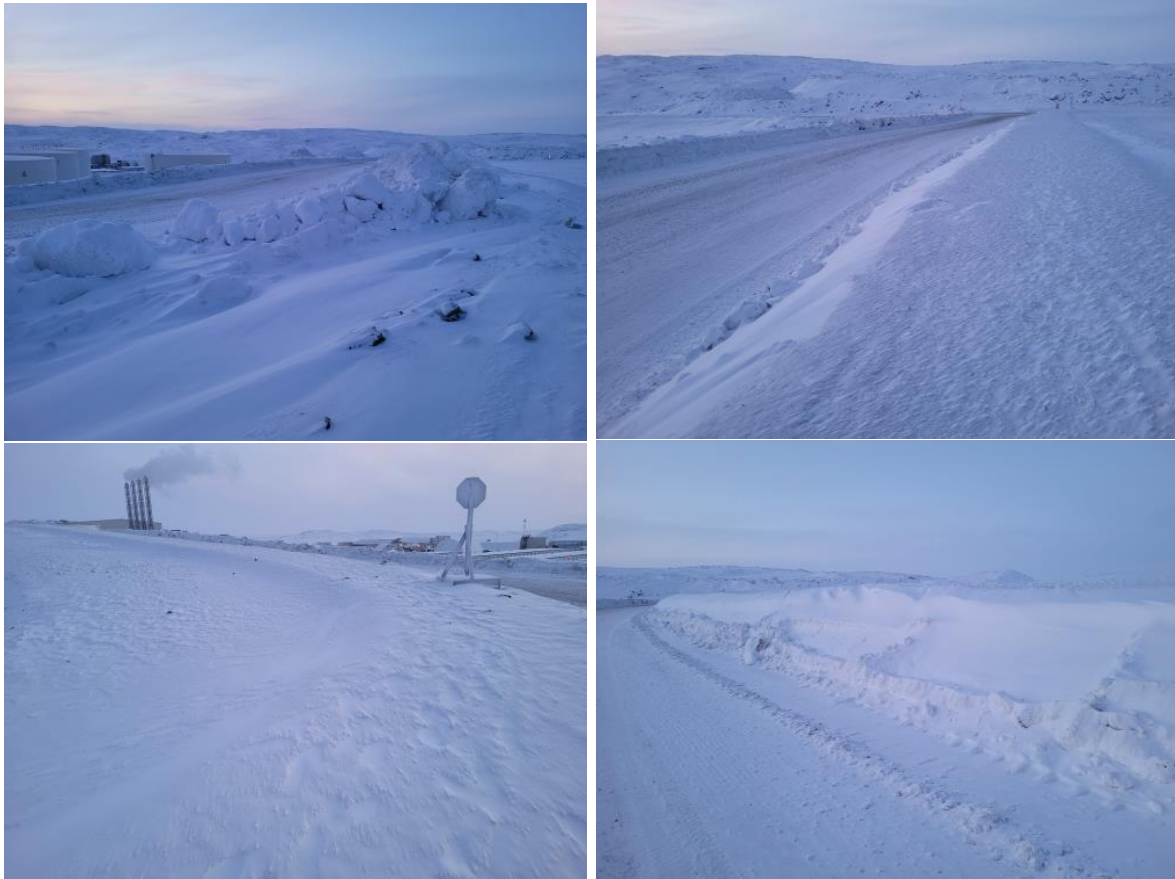
Visual monitoring was conducted at the Diversion Berm this month. No issues were identified at the Diversion Berm and associated check dam in December. Photos of this infrastructure are provided in Figure 3 below.

**Figure 3. Diversion berm during December 2021**

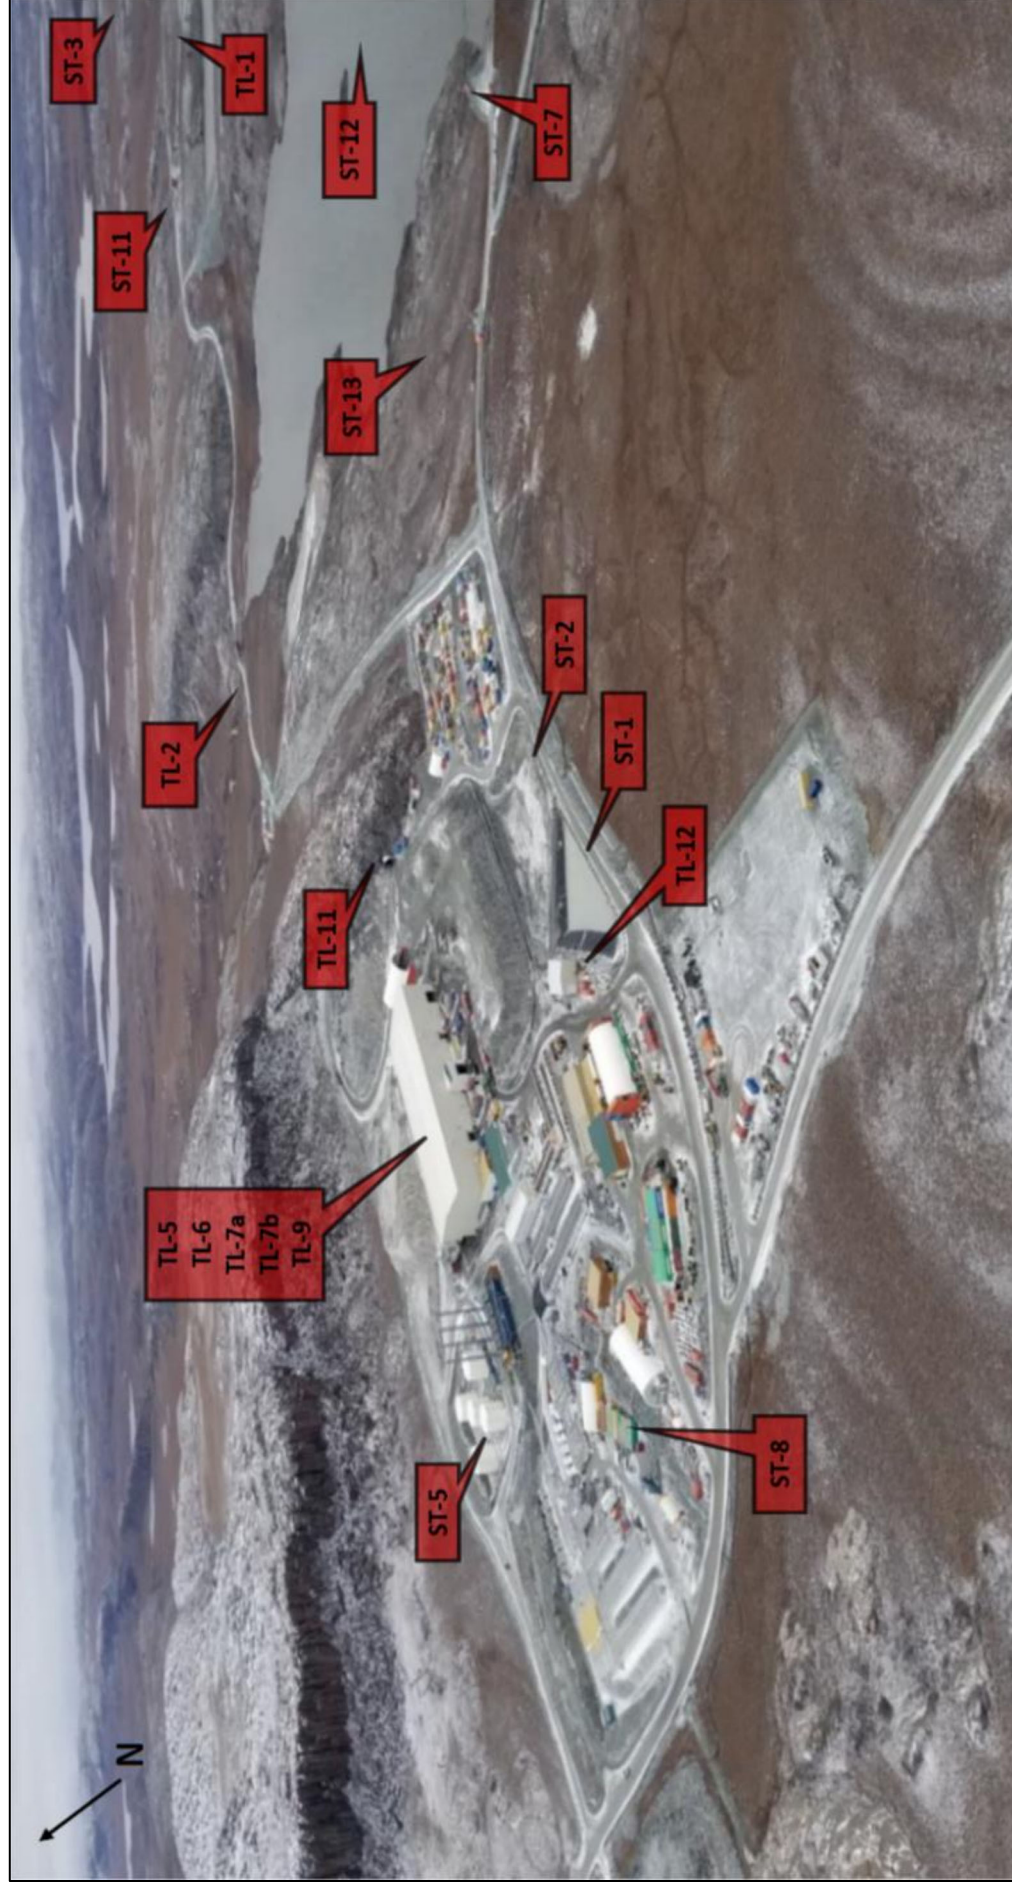
Sampling locations monitored under this licence (seasonally or when facilities are operational) are provided in Figure 6 through Figure 8 at the end of this report.

Figure 6. 2AM-DOH1335 SNP Monitoring Locations

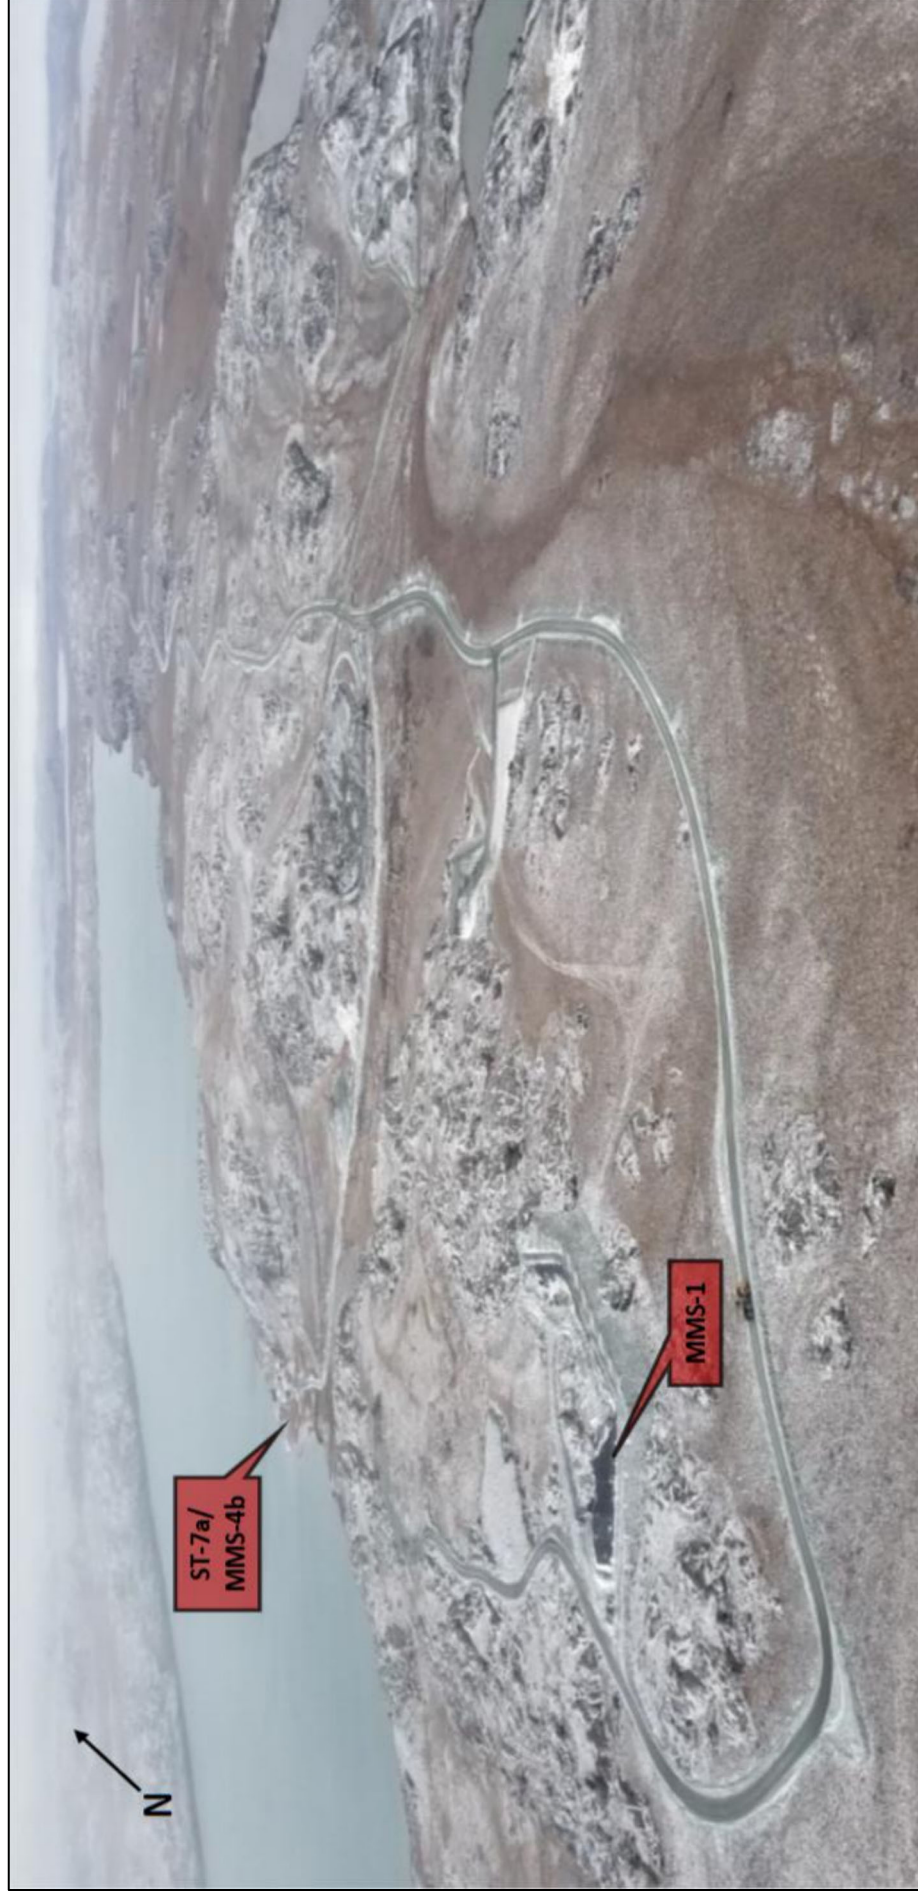
**Figure 8. 2AM-DOH1335 SNP Monitoring Locations**
