Re: February 2022 – Monthly Monitoring Report for Water Licence 2AM-DOH1335

This report is comprised of the monitoring requirements set out in Part I and Schedule I of water licence 2AM-DOH1335 Amendment 2 (the licence), and additional requirements from CIRNAC.

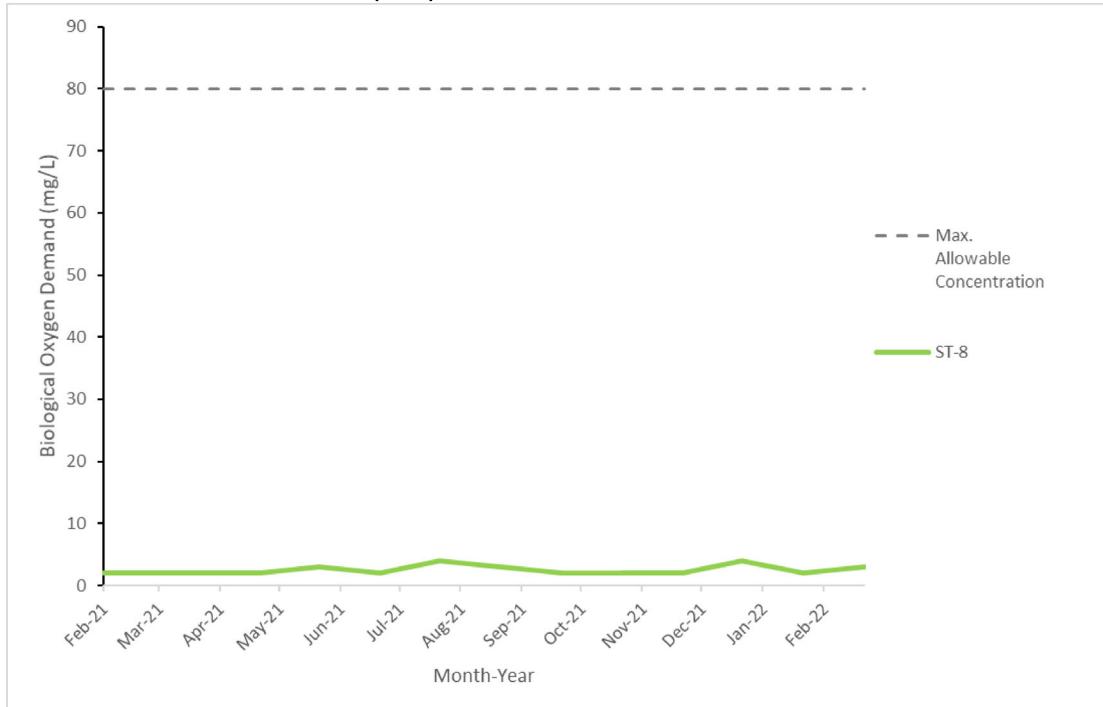
Figure 1. Biological Oxygen Demand Results Consistently Below Discharge Criteria for Wastewater Treatment Plant (ST8)

Note: Maximum Average Concentration as per Part F Item 4(b).

Figure 1 and 2 illustrates effluent quality characteristics for parameters of interest at select monitoring stations.

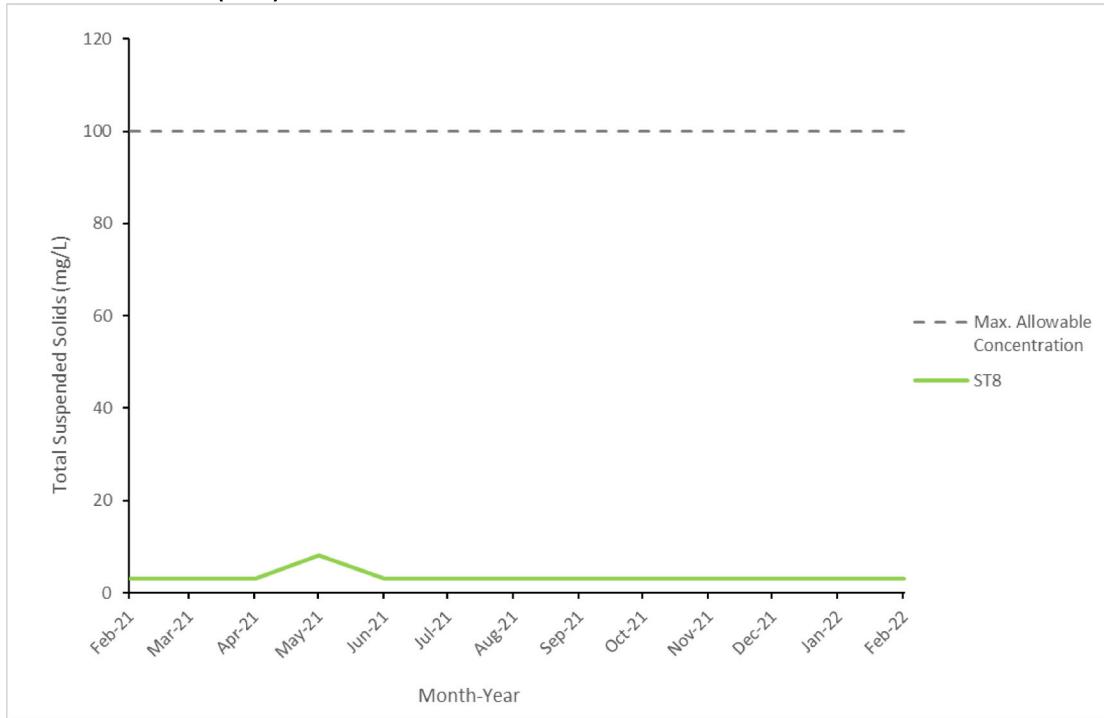
Figure 2. Total Suspended Solids Results Consistently Below Discharge Criteria for Wastewater Treatment Plant (ST8)

Note: Maximum Average Concentration as per Part F Item 4(b).

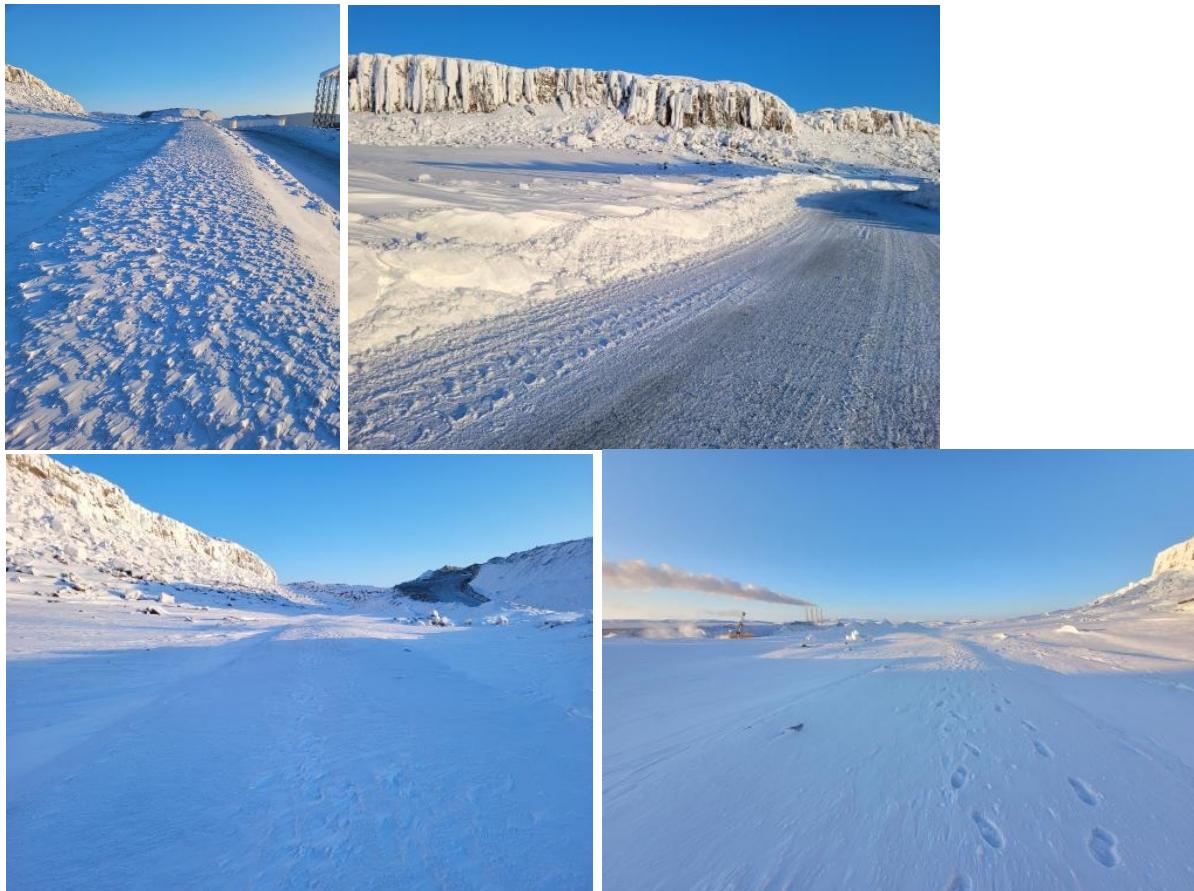
Visual monitoring was conducted at the Diversion Berm this month. No issues were identified at the Diversion Berm and associated check dam in February. Photos of this infrastructure are provided in Figure 3 below.

Figure 3. Diversion berm during February 2022
