Re: March 2022 – Monthly Monitoring Report for Water Licence 2AM-DOH1335

This report is comprised of the monitoring requirements set out in Part I and Schedule I of water licence 2AM-DOH1335 Amendment 2 (the licence), and additional requirements from CIRNAC.

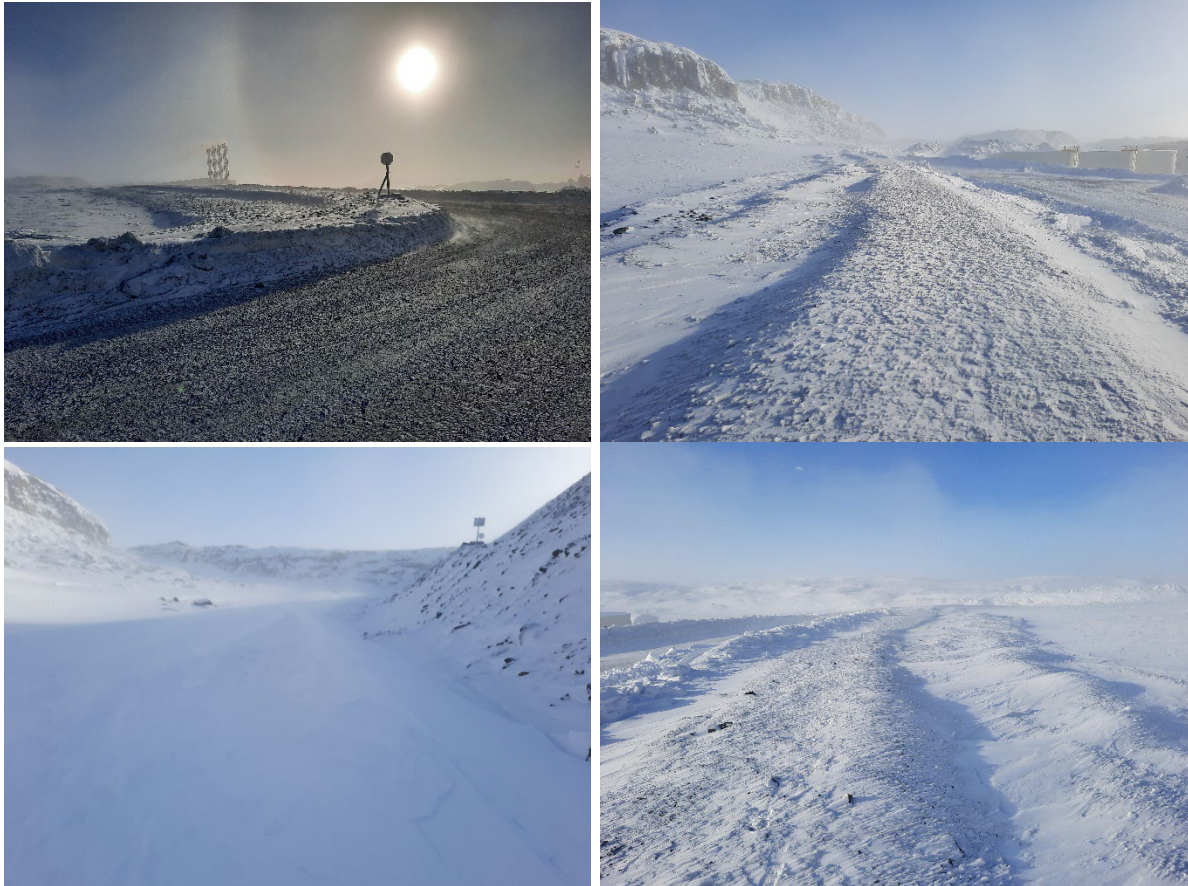
Visual monitoring was conducted at the Diversion Berm this month. No issues were identified at the Diversion Berm and associated check dam in March. Photos of this infrastructure are provided in Figure 3 below.

Figure 3. Diversion berm during March 2022
