**Re: April 2022 – Monthly Monitoring Report for Water Licence 2AM-DOH1335**

This report is comprised of the monitoring requirements set out in Part I and Schedule I of water licence 2AM-DOH1335 Amendment 2 (the licence), and additional requirements from CIRNAC.

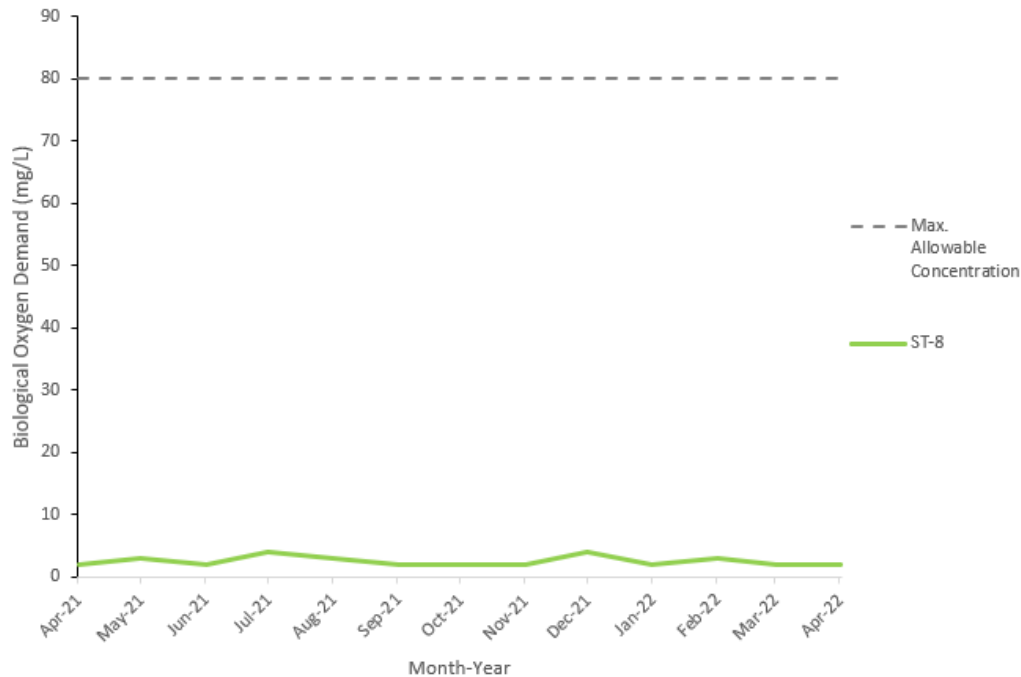
**Figure 1. Biological Oxygen Demand Results Consistently Below Discharge Criteria for Wastewater Treatment Plant (ST8)**

Note: Maximum Average Concentration as per Part F Item 4(b).

Figure 1 and 2 illustrates effluent quality characteristics for parameters of interest at select monitoring stations.

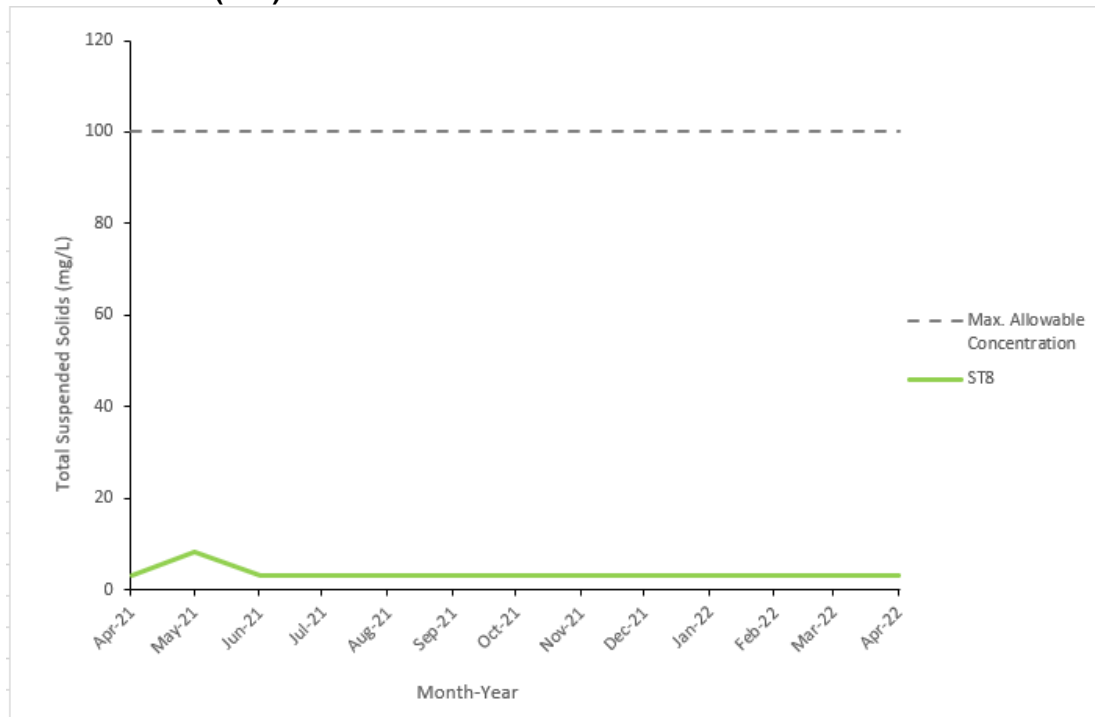
**Figure 2. Total Suspended Solids Results Consistently Below Discharge Criteria for Wastewater Treatment Plant (ST8)**

Note: Maximum Average Concentration as per Part F Item 4(b).

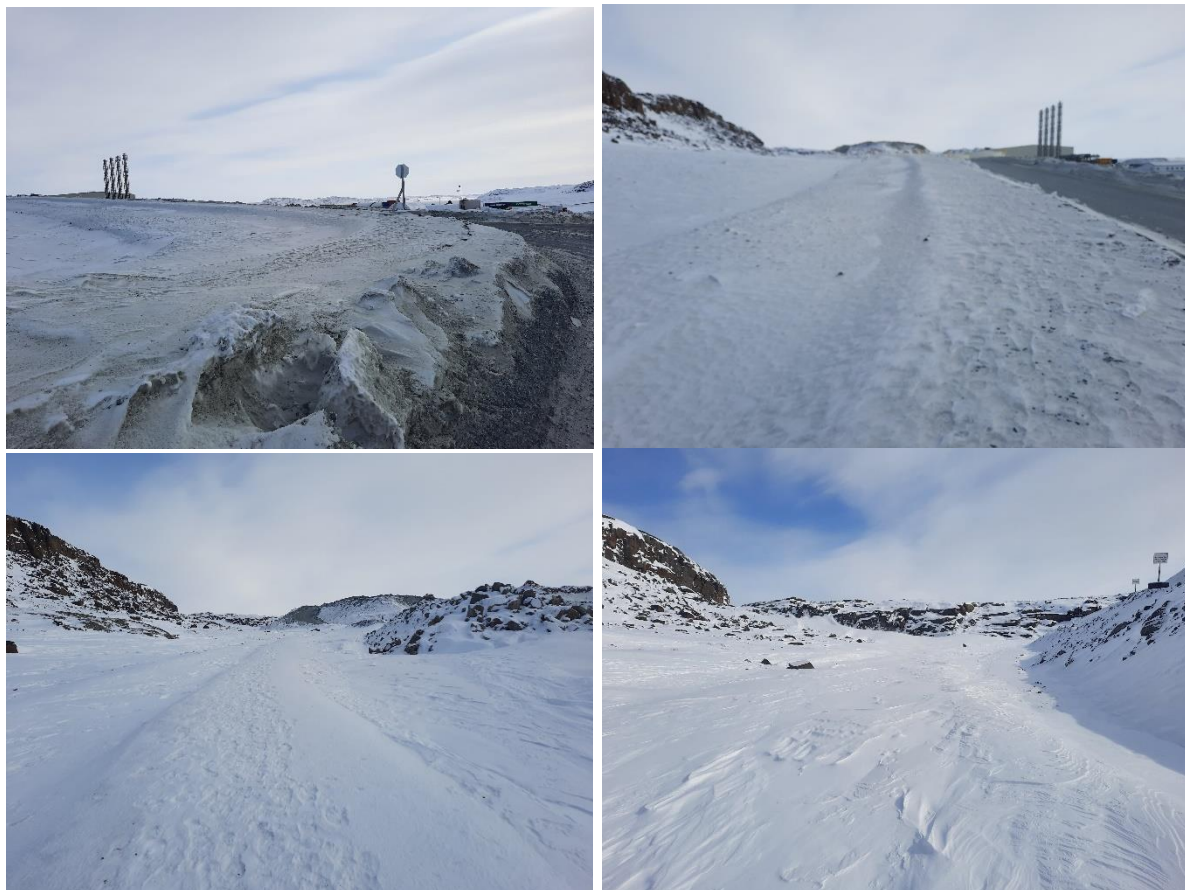
Visual monitoring was conducted at the Diversion Berm this month. No issues were identified at the Diversion Berm and associated check dam in April. Photos of this infrastructure are provided in Figure 3 below.

**Figure 3. Diversion berm during April 2022**
