Re: September 2023 – Monthly Monitoring Report for Water License 2AM-DOH1335

This report is comprised of the monitoring requirements set out in Part I and Schedule I of water licence 2AM-DOH1335 Amendment 2 (the license), and additional requirements from CIRNAC.

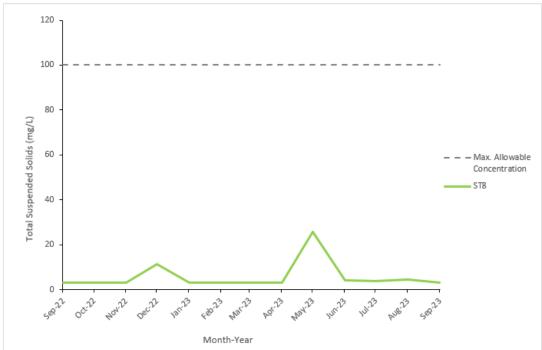
Figure 2. Total Suspended Solids Results Consistently Below Discharge Criteria for Wastewater Treatment Plant (ST8)

Note: Maximum Average Concentration as per Part F Item 4(b).

Figure 1 and 2 illustrates effluent quality characteristics for parameters of interest at select monitoring stations.

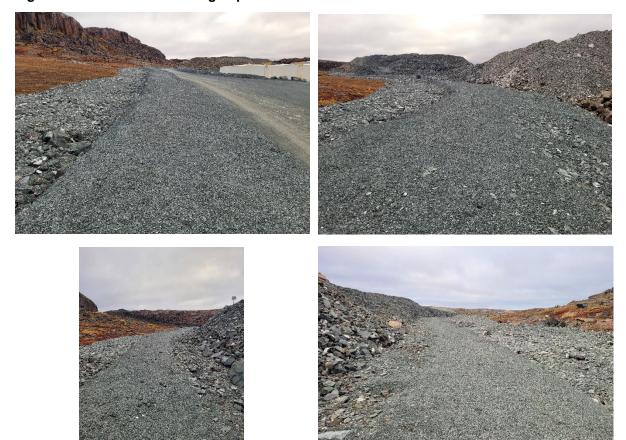
Visual monitoring was conducted at the Diversion Berm this month. No issues were identified at the Diversion Berm and associated check dam. Photos of this infrastructure are provided in Figure 3 below. Inspections of site culverts throughout the month of September were continued.

Figure 3. Diversion berm during September 2023

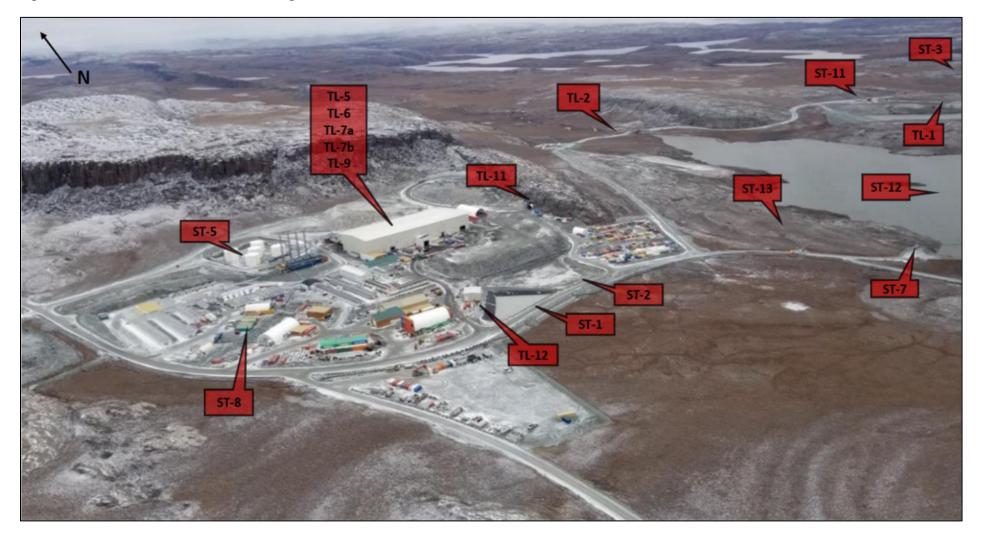
Figure 6. 2AM-DOH1335 SNP Monitoring Locations

Sampling locations monitored under this licence (seasonally or when facilities are operational) are provided in Figure 6 through Figure 8 at the end of this report.

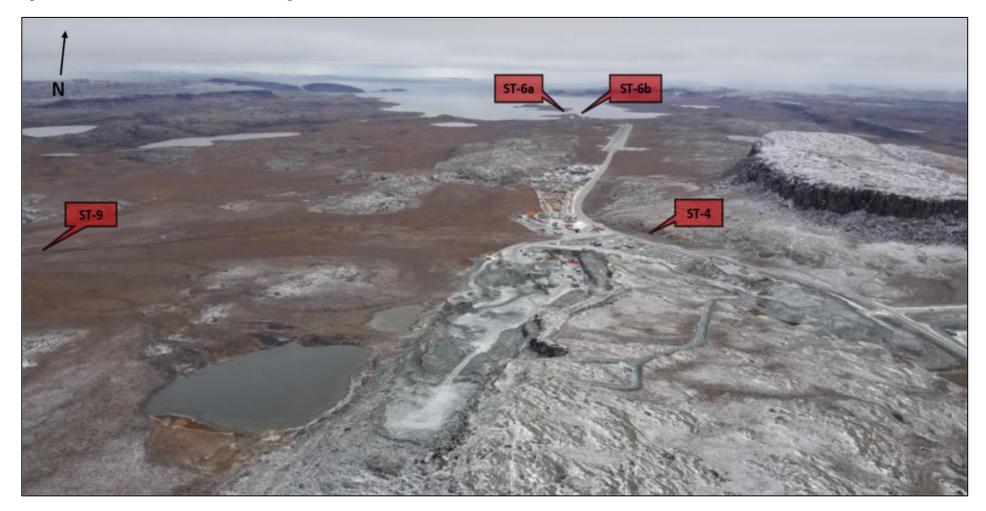
Figure 7. 2AM-DOH1335 SNP Monitoring Locations

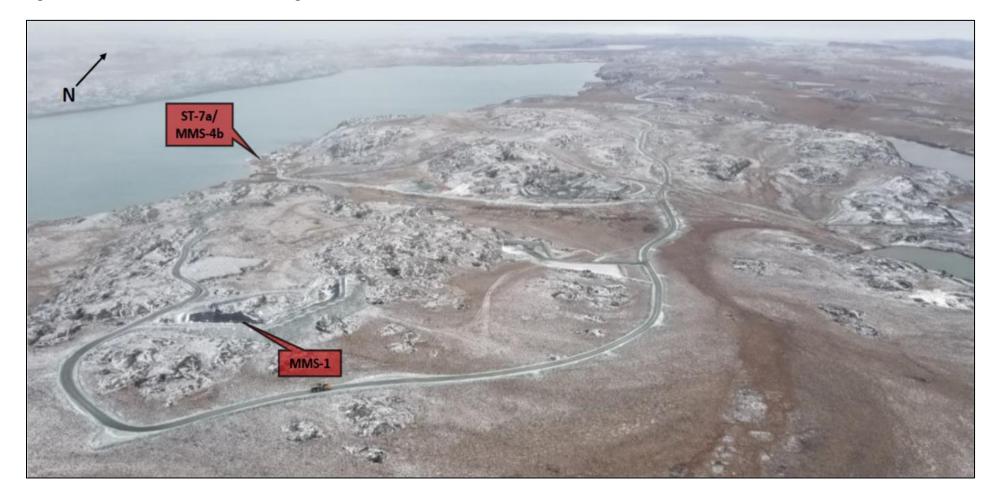
Figure 8. 2AM-DOH1335 SNP Monitoring Locations
