2015 North Dam Geotechnical Inspection		
		Depression Tracking D18		
Job No: 1CT022.002 Filename: Ndam_DepressionTracking.pptx	HOPE BAY MINING LTD.	Date: Oct. 2015	Approved: PDL	Figure: H.27

2015 North Dam Geotechnical Inspection		
		Depression Tracking D19		
Job No: 1CT022.002 Filename: Ndam_DepressionTracking.pptx	HOPE BAY MINING LTD.	Date: Oct. 2015	Approved: PDL	Figure: H.28

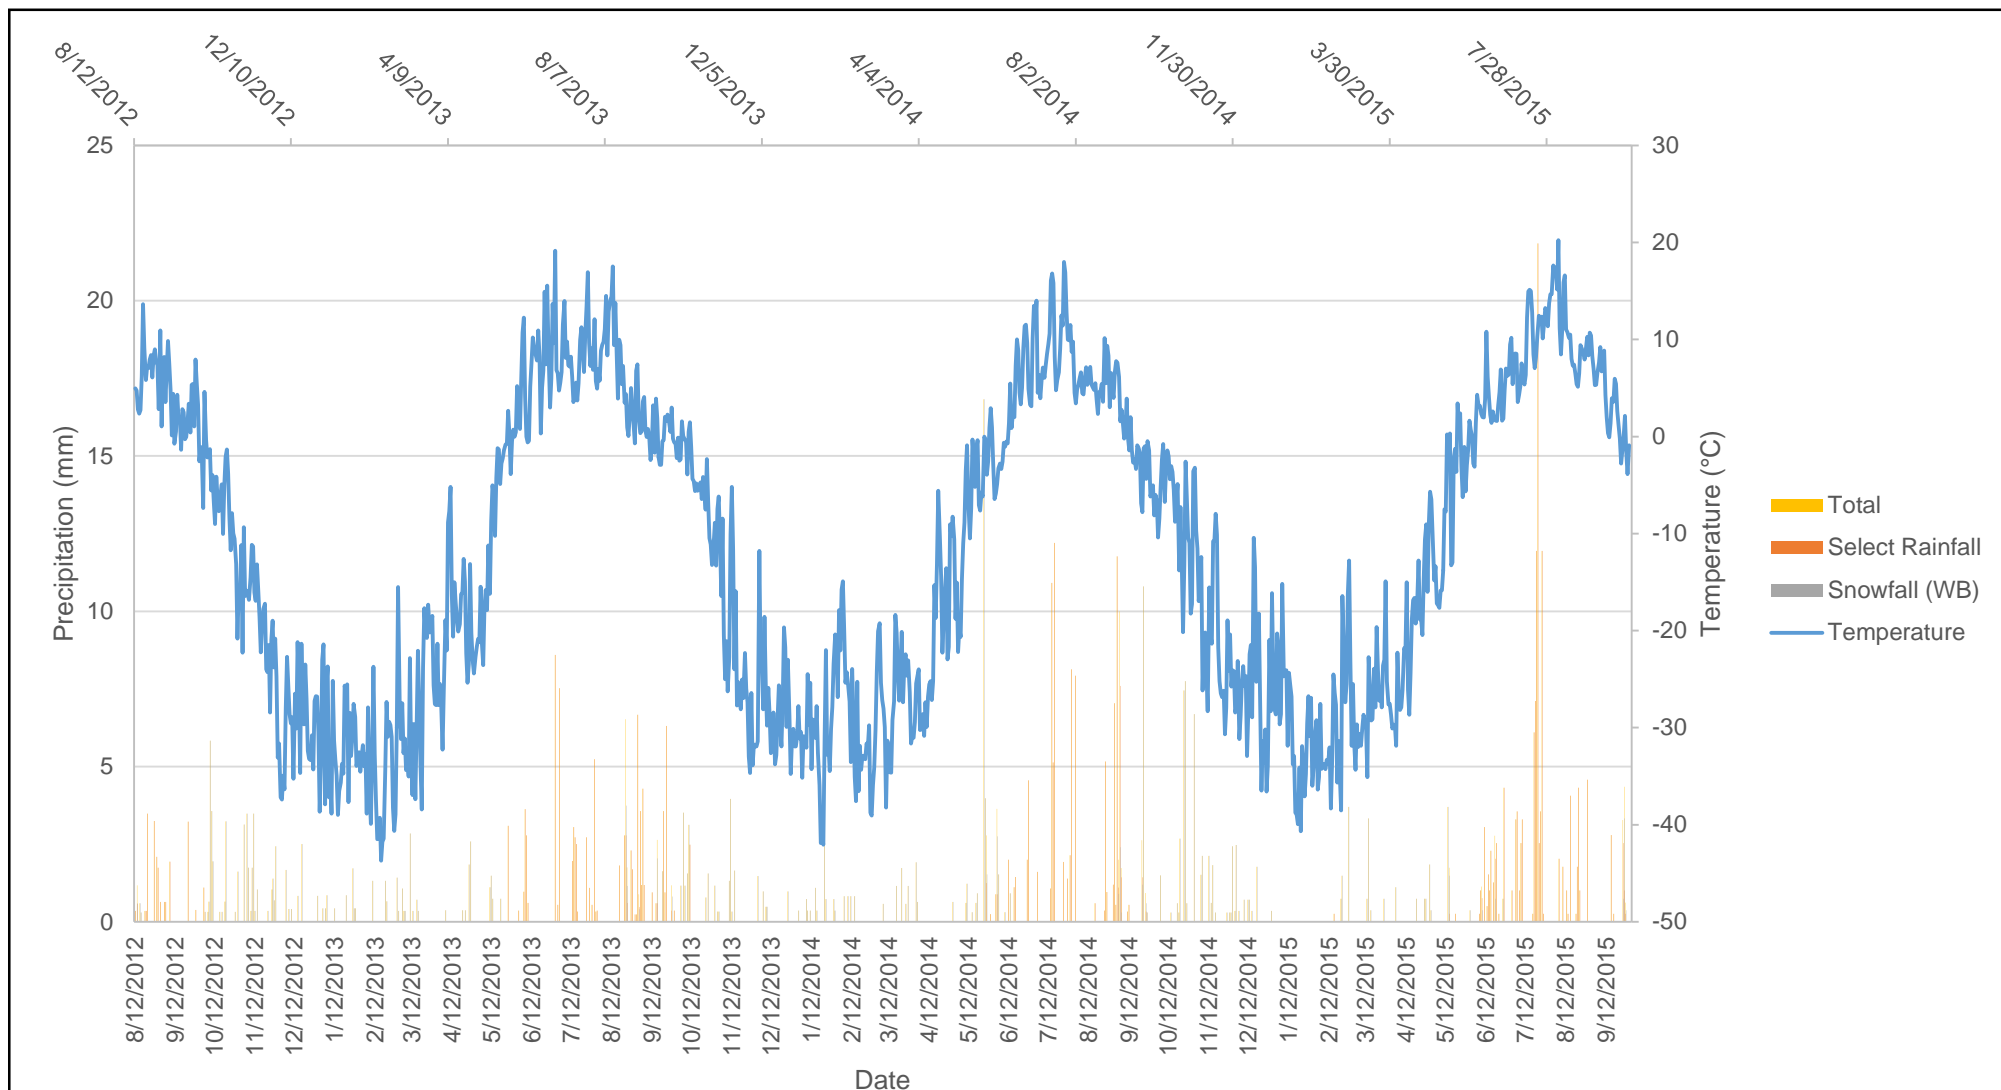
Rainfall was selected from site data where available, otherwise data from the water balance model was used.

2015 Geotechnical Inspection		
		<b>Climate Data</b>		
Job No: 1CT022.002 Filename: AppendixI_ClimateData.pptx	HOPE BAY MINING LTD.	Date: Oct. 2015	Approved: PDL	Figure: <b>I.1</b>
