| | | 2015 North Dam Geotechnical Inspection | | |
| | | Depression Tracking<br>D3 | | |

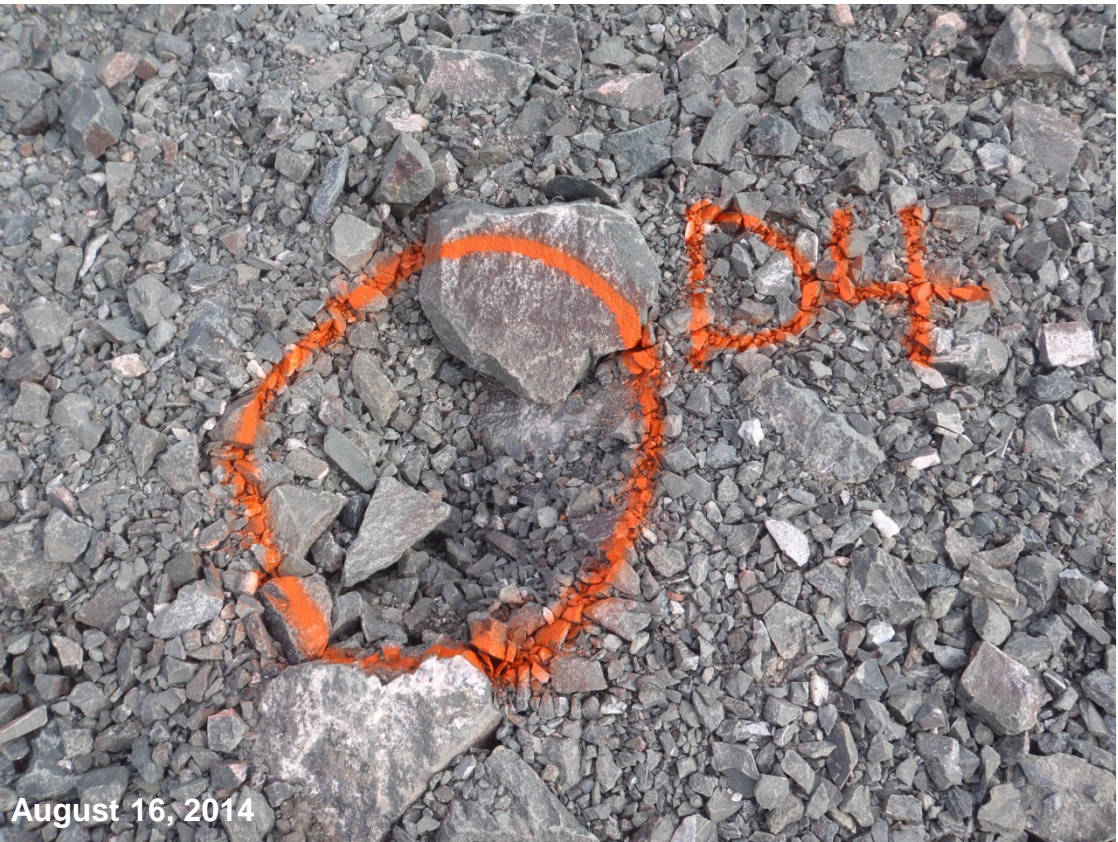
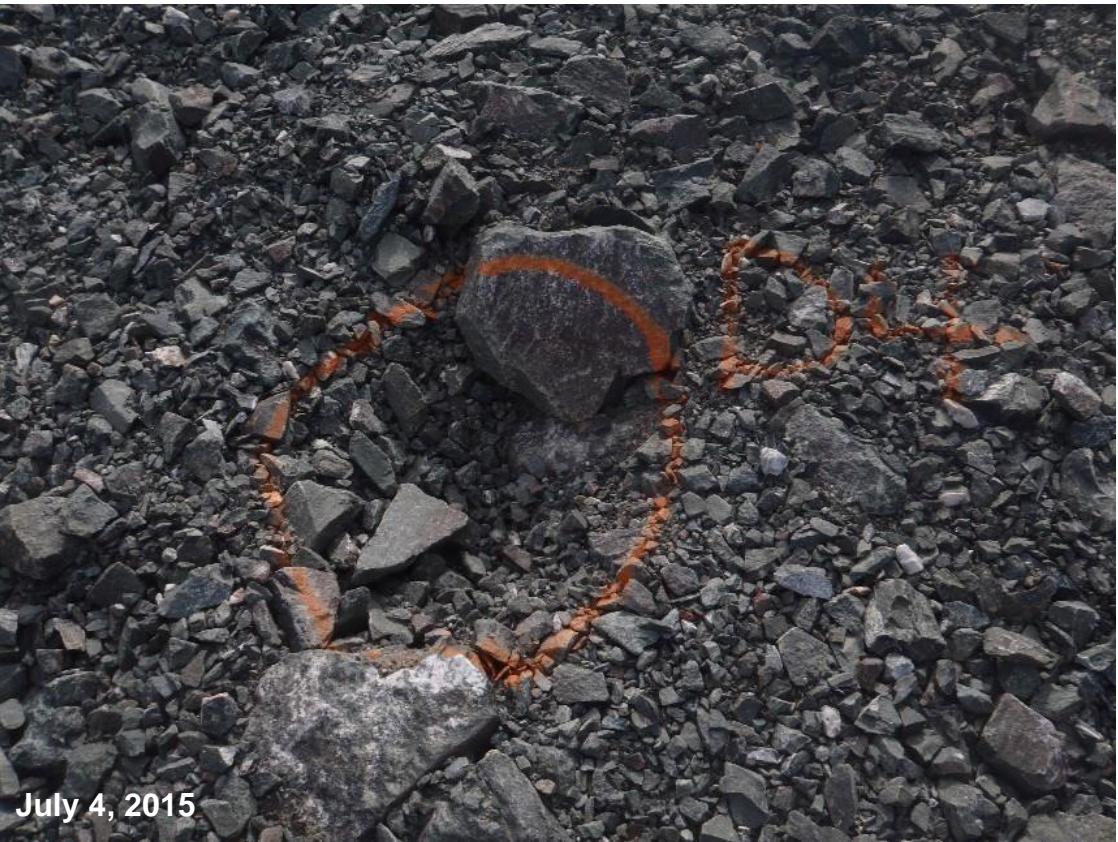
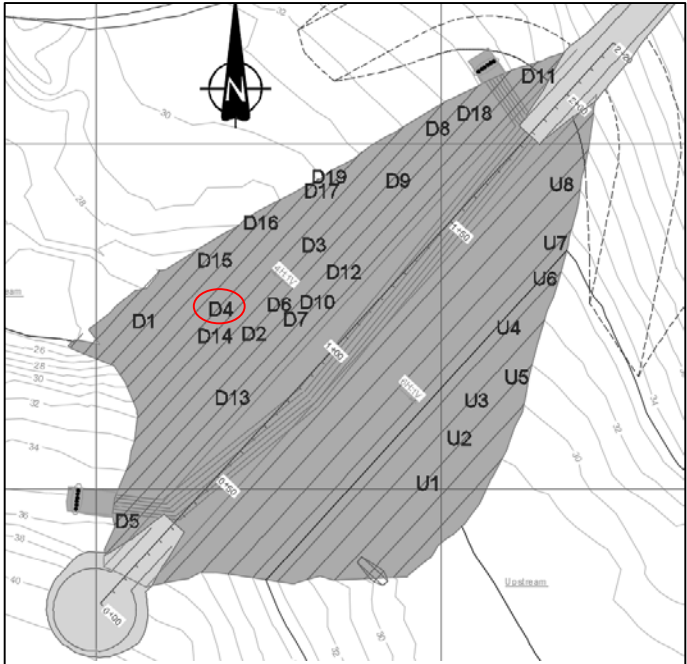
| Job No: 1CT022.002<br>Filename: Ndam_DepressionTracking.pptx | HOPE BAY MINING LTD. | Date: Oct. 2015 | Approved: PDL | Figure: H.13 |

| | | Depression Tracking<br>D4 | | |

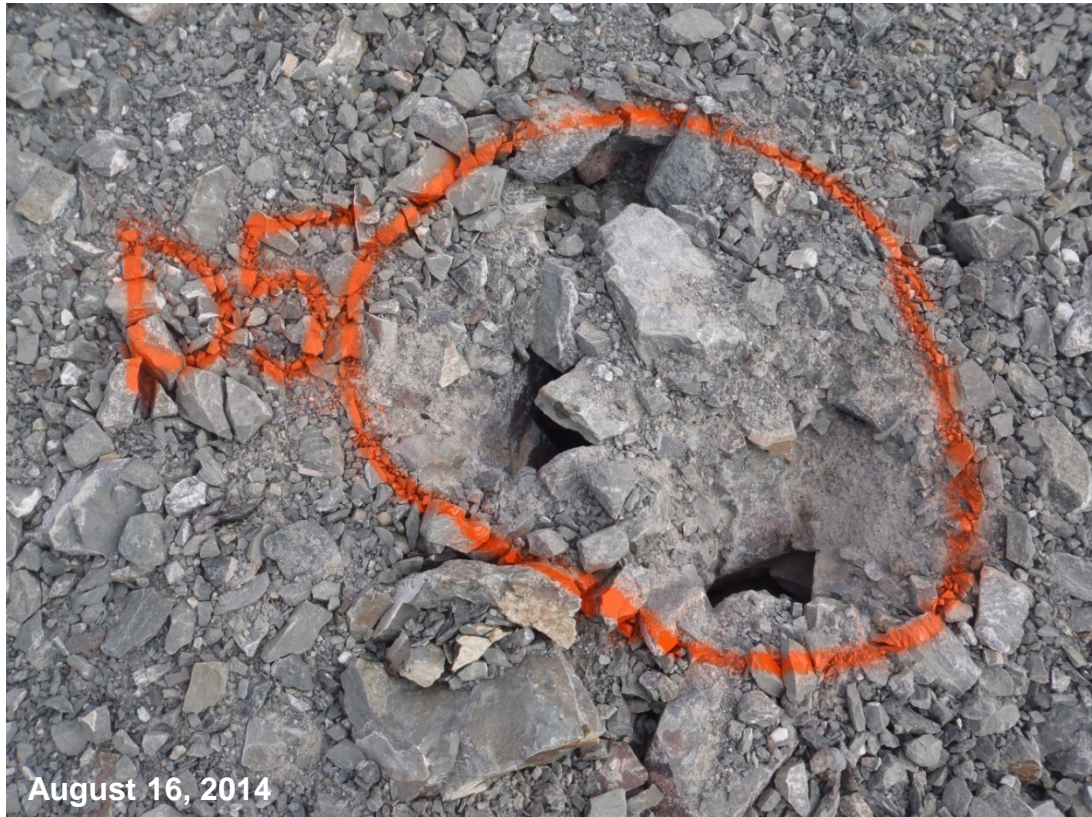
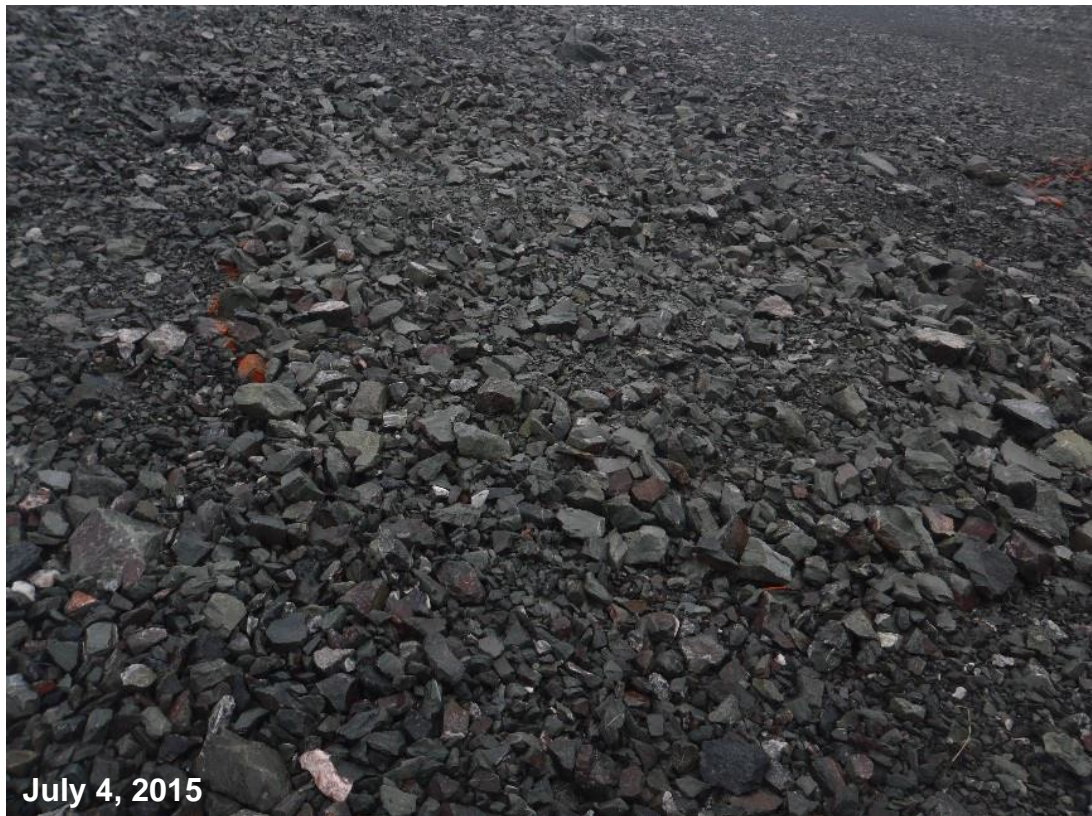
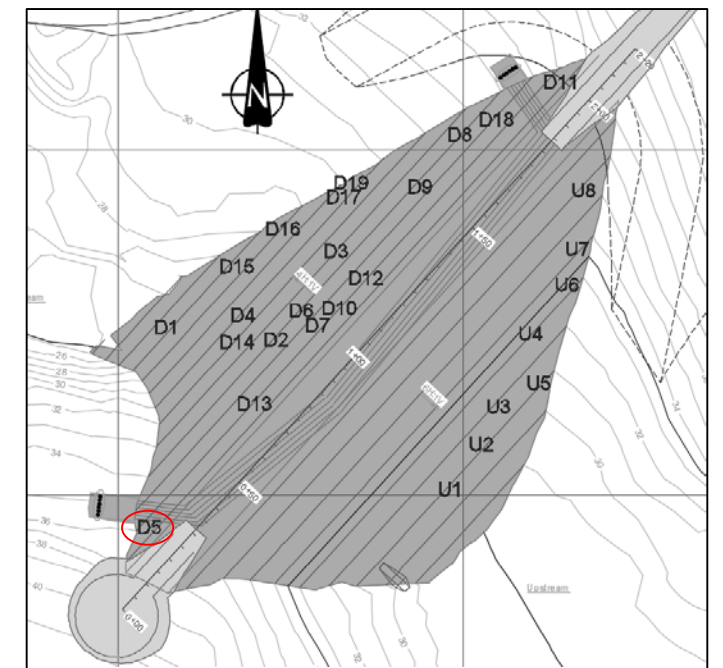
| Job No: 1CT022.002<br>Filename: Ndam_DepressionTracking.pptx | HOPE BAY MINING LTD. | Date: Oct. 2015 | Approved: PDL | Figure: <b>H.14</b> |

1. Depression locations are based on hand held GPS measurements, accuracy is at best +/- 4 m.
2. Most photos courtesy of TMAC site personnel
3. **D5 was Backfilled this year**

| | | Depression Tracking<br>D5 | | |
