Jericho Diamond Mine Project

Title: The Nunavut Impact Review Board 2008 – 2009 Monitoring Report for the Jericho Diamond Mine Project

Monitoring Period: January 2008 to September 2009

Title: 2009 NIRB's Monitoring Officer Site Visit Report for the Jericho Diamond Mine Project

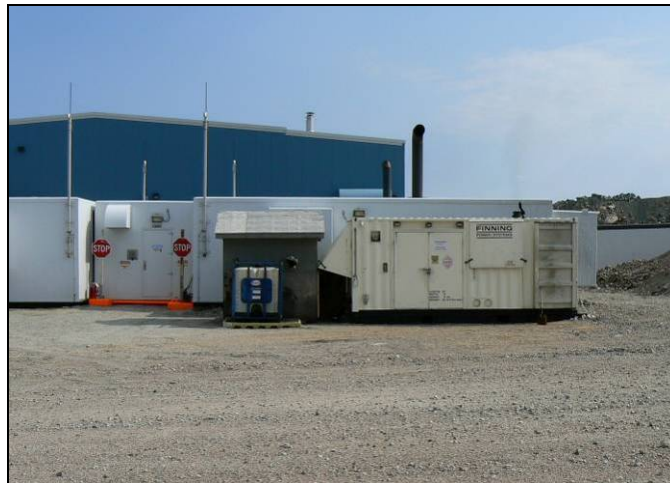
Currently this condition is not applicable – the Jericho site is in the Care and Maintenance phase with no blasting occurring and with approximately 5 – 10 people on site at one time. The only noticeable source of noise was from the vehicles driving around site and the camp generator (see Photo # 2).

Photo # 2: Camp generator

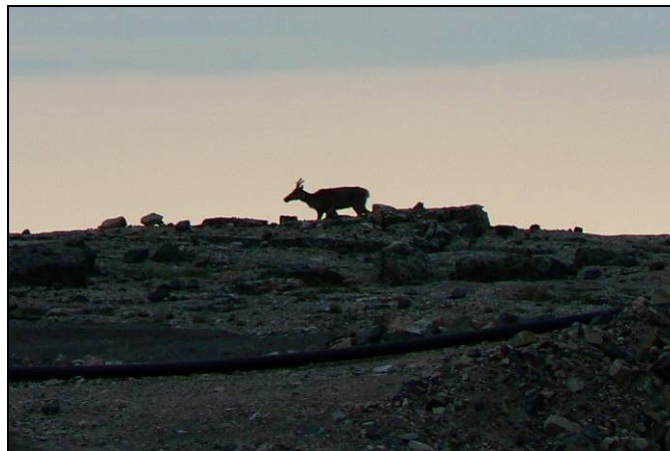
During the site visit, caribou were observed on different occasions and at various different locations (see Photo # 3 through Photo # 5).

Photo # 3: Caribou sighting near PKCA

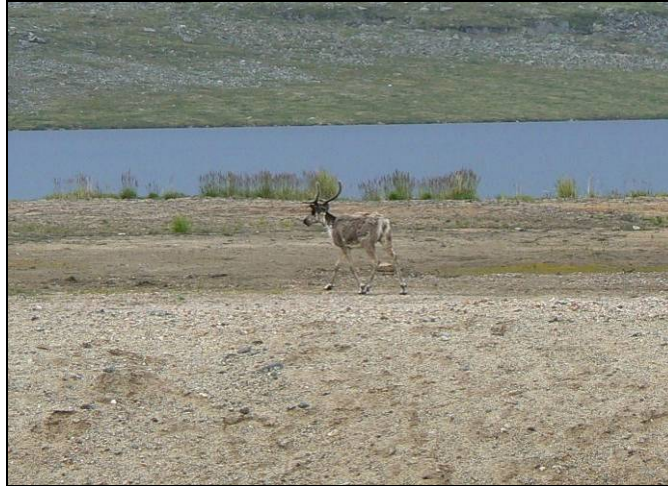
Photo # 4: Caribou sighting near waste transfer containment area

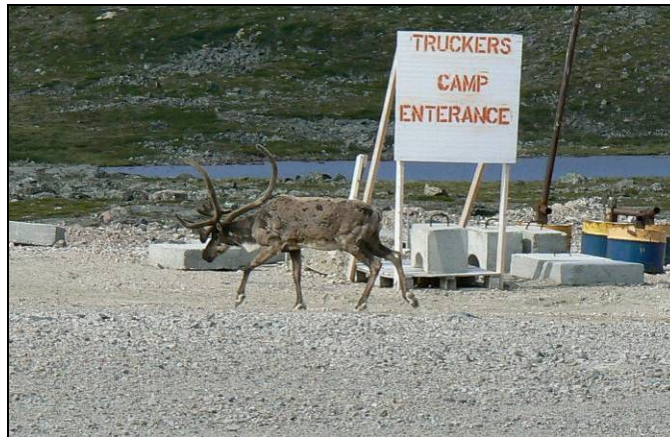
Photo # 5: Caribou sighting near fuel tank farm

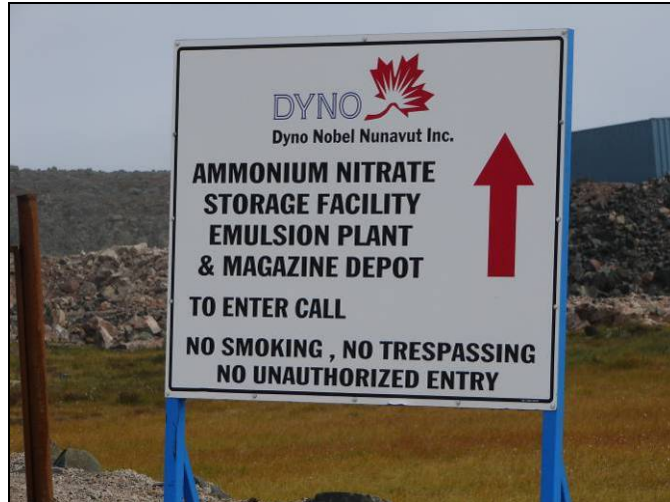
Photo # 6: Example of signage posted at the entrance to the ammonium nitrate storage and magazine compound (picture taken in 2008)

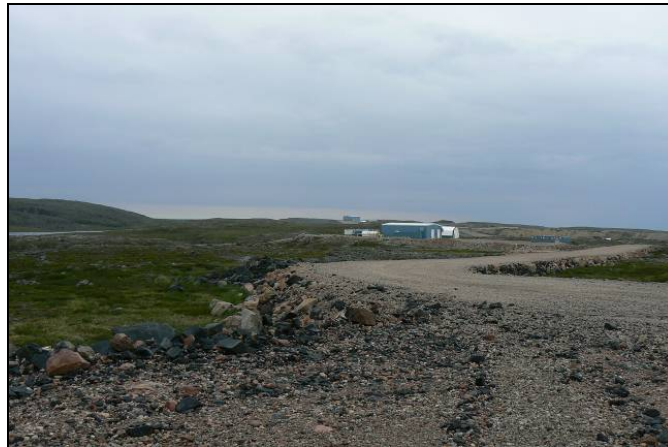
Photo # 7: Emulsion Plant from Ammonia Nitrate Storage Pad

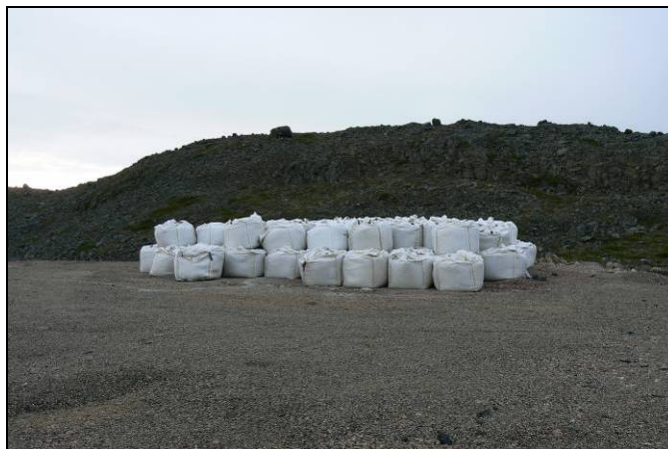
No blasting is being conducted on site while in Care and Maintenance and no blasting agents/blasting constituents are being stored on site. During the site visit, the only items stored at the Ammonia Nitrate Storage Pad were bags containing cement mix (see Photo # 8).

Photo # 8: Bags of cement mix at the Ammonia Nitrate Storage Pad

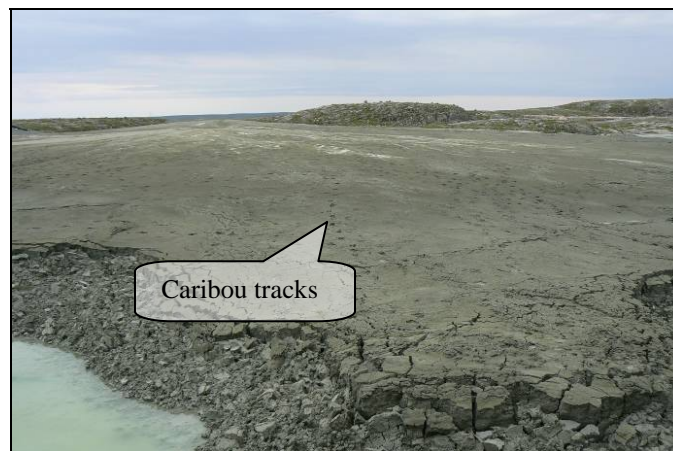
Tahera has not incorporated ramps or caribou crossings in the design of its camp roads. This was based on previous studies that have shown that caribou generally do not have a problem crossing roads unless their line of site is compromised, which should not be the case at the Jericho site^{4,5}. During the site visit in July, the caribou around the camp site appeared to have no difficulty climbing very steep piles of rock or tailings (see Photo # 3 and Photo # 9), although they tend to prefer the roads.

Photo # 9: Caribou tracks on tailings pile

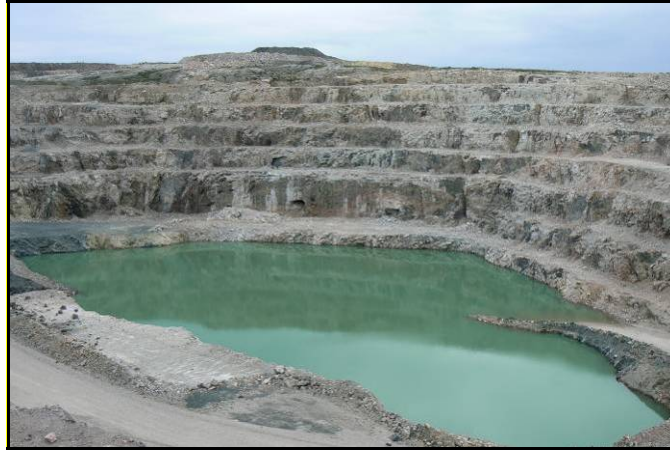
During the site visit, no fencing was visible around the pit area. The open pit does have a large berm constructed around the perimeter of the pit, approximately 4 to 5 feet in height in most places. Currently, the pit is deemed unsafe and no access is permitted down into the pit (a berm was placed across the access road to prevent any vehicles from entering the pit and to act as a deterrent). Water has begun to fill the bottom of the pit as can be seen in Photo # 10 and Photo # 11.

Photo # 10: Open pit at Jericho

The Mine Manager (Lee Staples) mentioned that when the Mine Inspector came to Jericho for his annual inspection, it was suggested to put big boulders around the pit area as a deterrent for people who might be travelling in the area, especially during the winter periods.

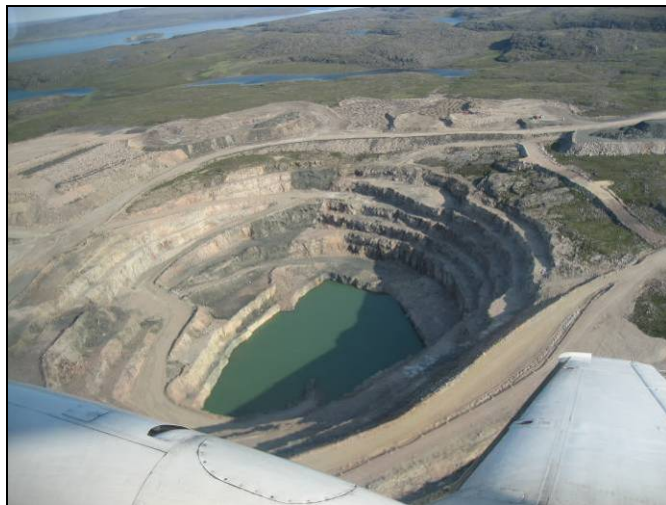
Photo # 11: Aerial view of open pit at Jericho

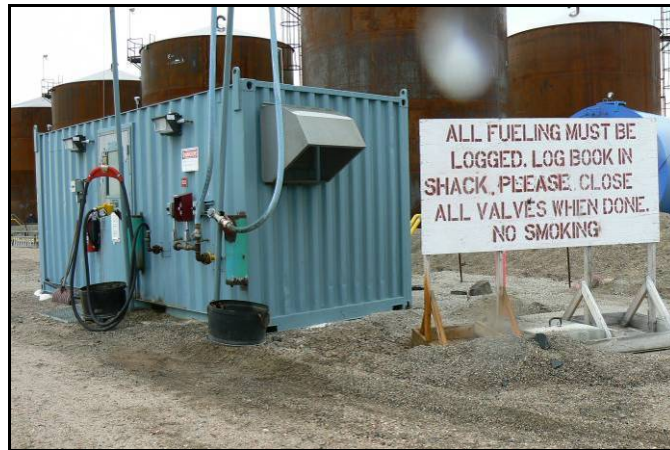
Photo # 12: Fuelling station at the camp's fuel tank farm

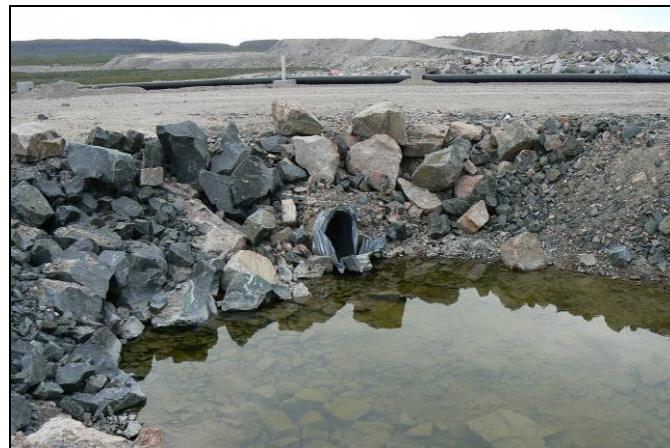
Roads around the mine site are maintained as required and some culverts have been upgraded and/or installed to prevent sedimentation into the stream or river crossings (see Photo # 13).

Photo # 13: Culvert at C1 Diversion

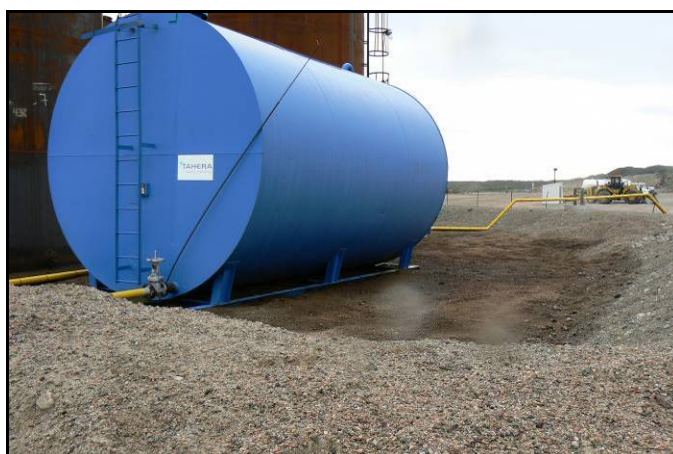
While all the fuel tank areas were well bermed, fuel contamination and soil staining are evident at several locations, including the main fuel tank area at the camp, generator day tank, emulsion plant fuel tank, airstrip jet fuel tanks, fuel transfer station and the waste transfer area. Some fuel tank areas also contain pooling of water (standing water) within the bermed areas (see Photo # 15 to Photo # 20). Hydrocarbon odours were notable at the waste transfer area, generator day tank and the emulsion plant fuel tank. During the 2008 site visit, similar observations were made for the fuel storage areas and the NIRB recommended that Tahera comply with Condition #34 and ensure that the fuel storage areas meet regulatory requirements.

Photo # 15: Contaminated soil within bermed area at Main Fuel Tank

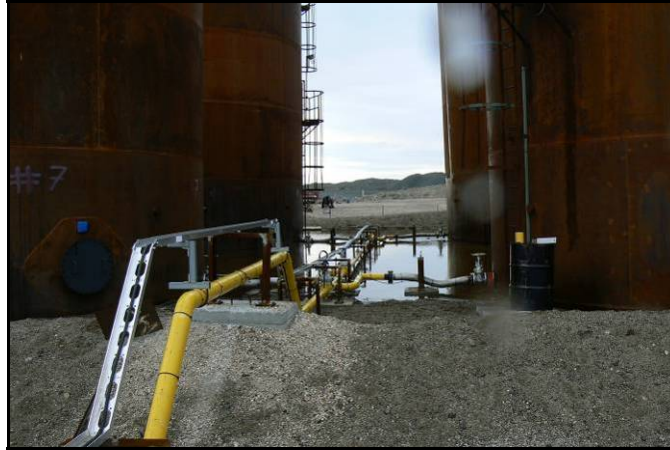
Photo # 16: Standing water within bermed area at Main Fuel Tank Farm

A visible hydrocarbon sheen was noticed on the water at both the main fuel tank area and at the airstrip. The berm at the airport showed evidence of contamination from a previous spill and it appeared that the contaminated soil was not removed from the bermed area. At this location, a spill of approximately 30,000 litres was previously reported from one of the tanks due to a faulty valve line.

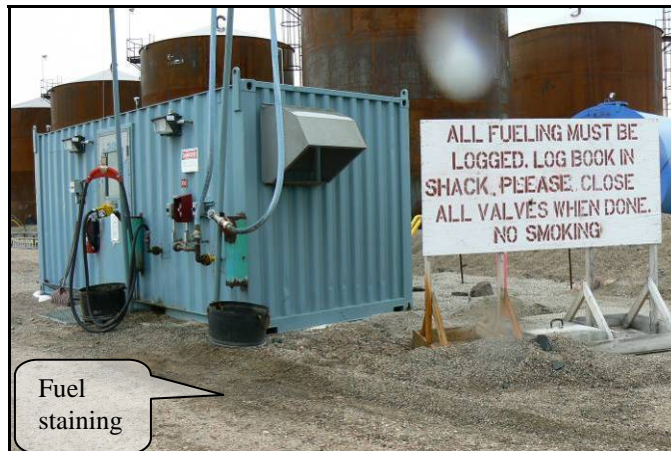
Photo # 17: Fuel Transfer Station

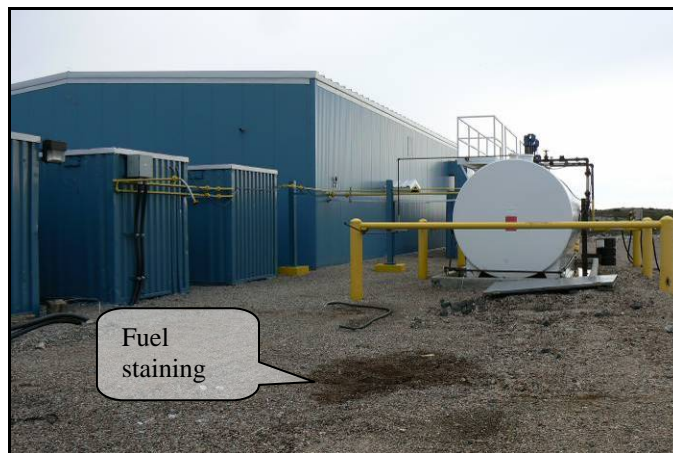
Photo # 18: Emulsion Plant Fuel Tank

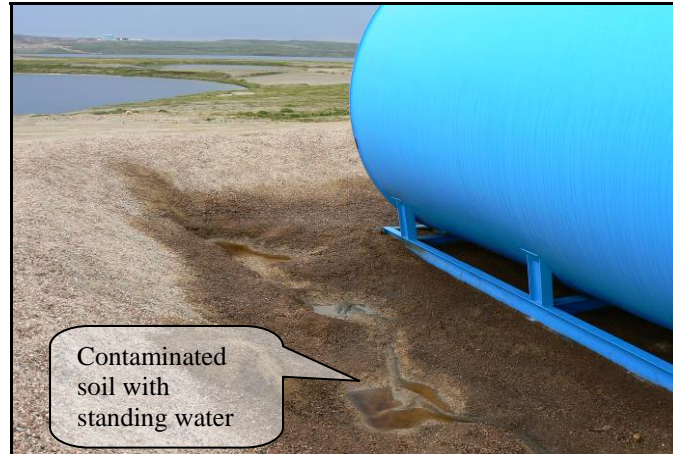
Photo # 19: Airstrip Fuel Tanks

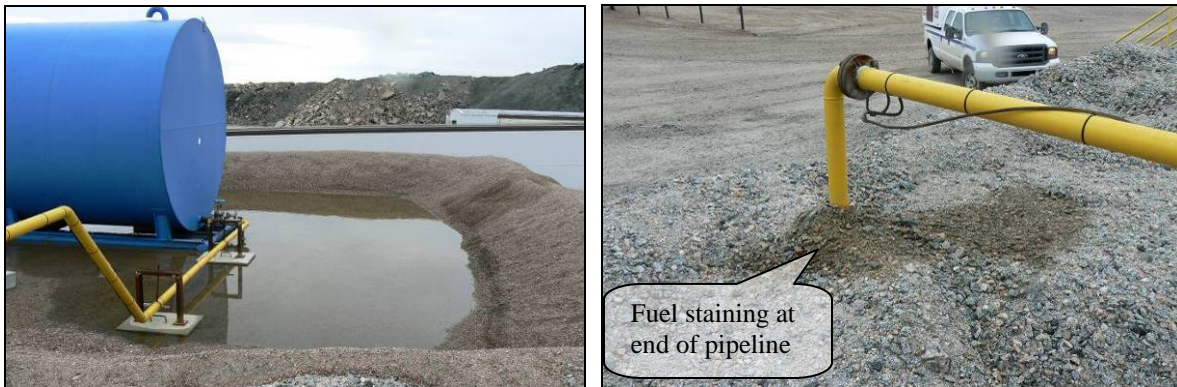
Photo # 20: Generator Day Tank

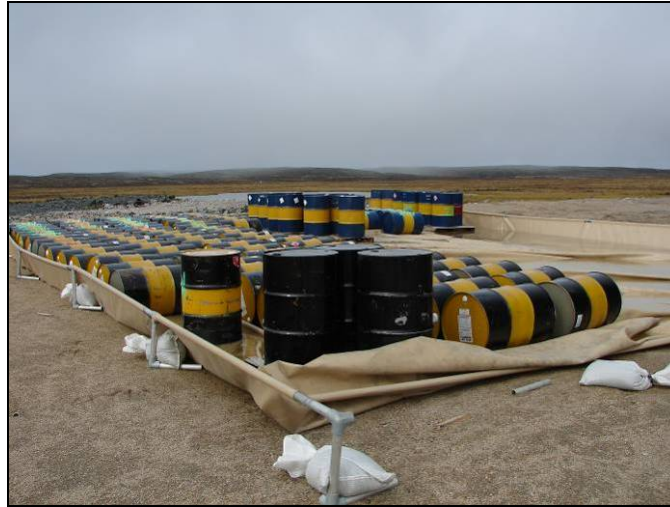
Photo # 21: Fuel storage containment unit at airport in 2008

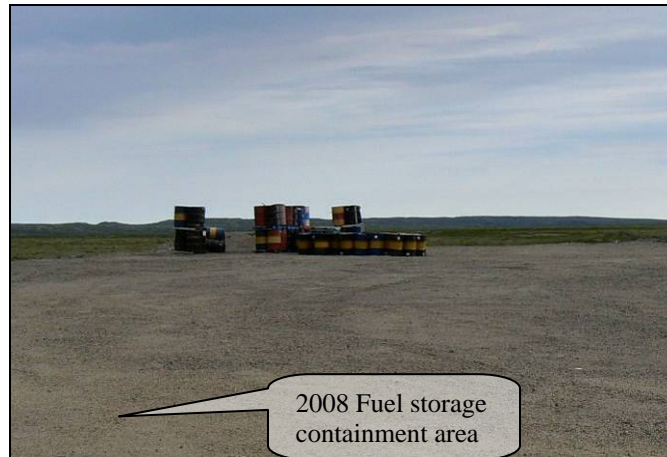
Fuel barrels were stored at the airport and were not within a contained facility (see Photo # 22). Mr. Kameemalik mentioned that they were waiting to remove these barrels from site.

Photo # 22: Fuel barrels stored at the airport

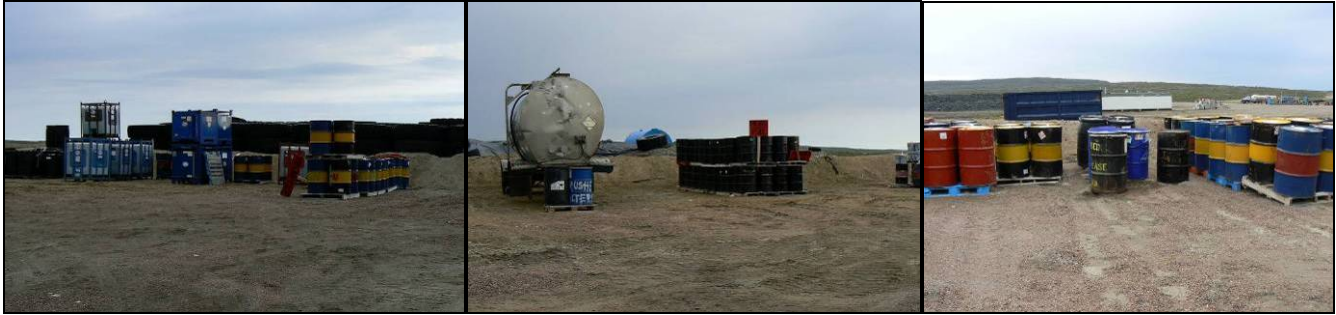
There are two waste transfer containment areas (two cells) located near the airport. These containment areas are bermed and lined, but are not completely enclosed as each cell has an access ramp located on its southeast corner. The eastern cell contains bulk waste containers, waste oil, waste fuel in drums and cubes, and drummed diesel fuel (see Photo # 23).

Photo # 23: Waste Transfer Containment Area – East Cell

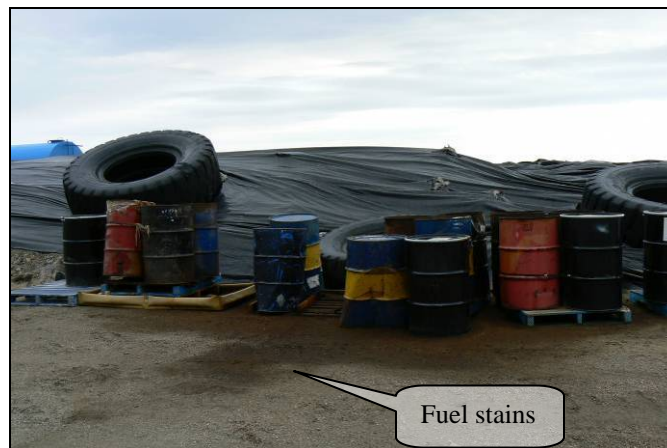
The western cell is being used for storage and/or isolation of petroleum contaminated soil (see Photo # 24), which is stored in heaped piles of numerous drums and bags. As there is no landfarm plan in place at Jericho, the contaminated soil has not been remediated on site, nor has it been taken off site for remediation. The majority of the contaminated soil located in the western cell is associated with the DC-4 Spill that occurred in December 2006 at the airport, along with the remainders of some minor spills that occurred around site since Tahera began construction. The piles of contaminated material have been covered by tarps, but holes have developed in the tarps and the piles are exposed to the environment. The bulk of the contaminated soil is currently being infiltrated by water and there is potential that hydrocarbons could be leaching out of the pile into the secondary containment (see Photo # 24). No pooling of water was noted at the time of the site visit; however, a visible stain was noted on the south side of the western cell at the base of the contaminated soil pile (see Photo # 24).

**Photo # 24: Waste Transfer Containment Area – West Cell
– Bulk and drummed hydrocarbon contaminated soil**

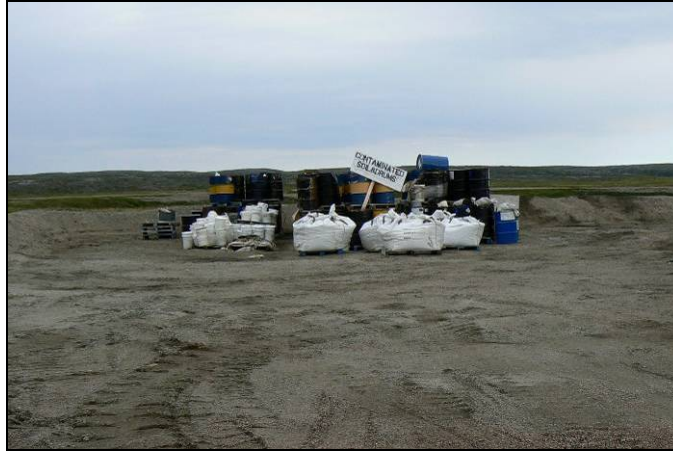
The drummed and bagged contaminated soil materials had been brought to Jericho from Hood River and MuskoX exploration camps where smaller spills had occurred. The soil is contaminated with diesel fuel or Jet fuel (see Photo # 25).

**Photo # 25: Waste Transfer Containment Area – West Cell
– Drummed and bagged hydrocarbon contaminated soil**

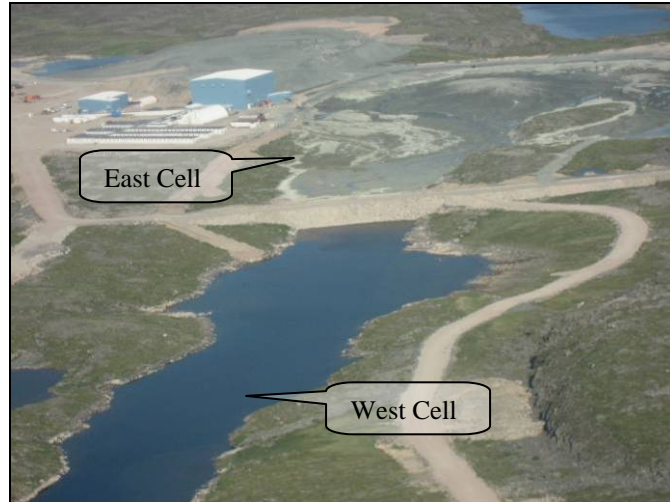
Photo # 26: Aerial view of PKCA

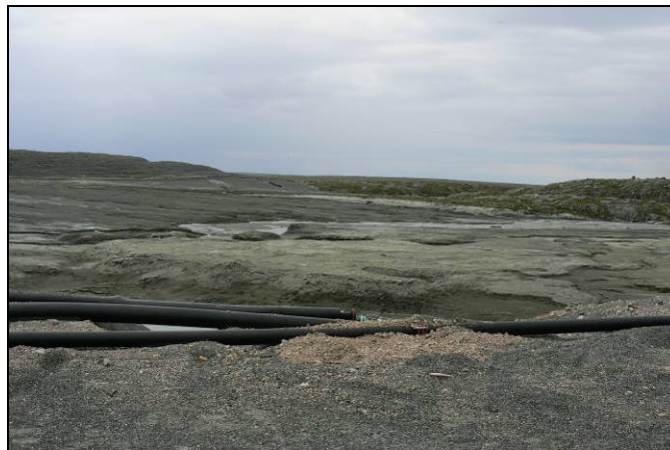
Photo # 27: East Containment Cell

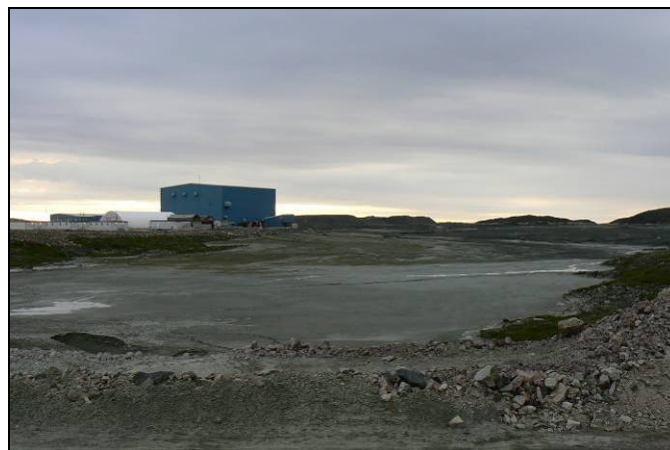
Photo # 28: View of East Containment Cell from top of permeable barrier that separates East and West Cells (processing plant in background)

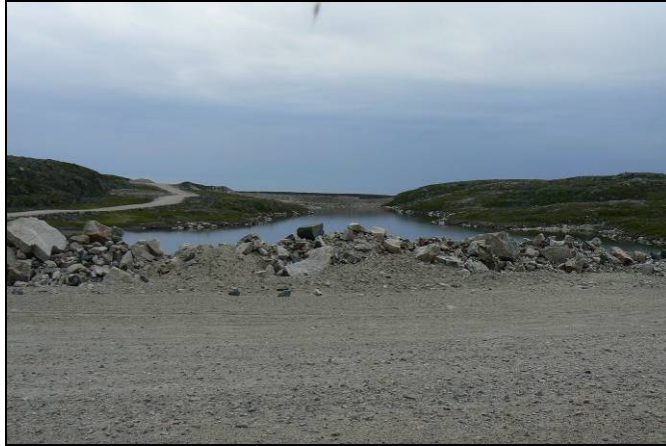
Currently, there is a permeable barrier in the Processed Kimberlite Containment Area (PKCA), dividing it into two containment cells; an East Cell and a West Cell, with only the East Containment Cell having been used for depositing tailings (see Photo # 27Photo # 26 through Photo # 28). During the site visit last year in August 2008, the NIRB technical advisor was informed that seepage beneath the permeable barrier occurred resulting in increased sedimentation within the West Containment Cell. The permeable barrier was reinforced with tailings to reduce the seepage into the West Cell and it appeared to have worked. During the current site visit, no sedimentation was observed within the West Containment Cell (see Photo # 29 and Photo # 30).

Photo # 29: View of West Containment Cell from top of permeable barrier that separates East and West Cells

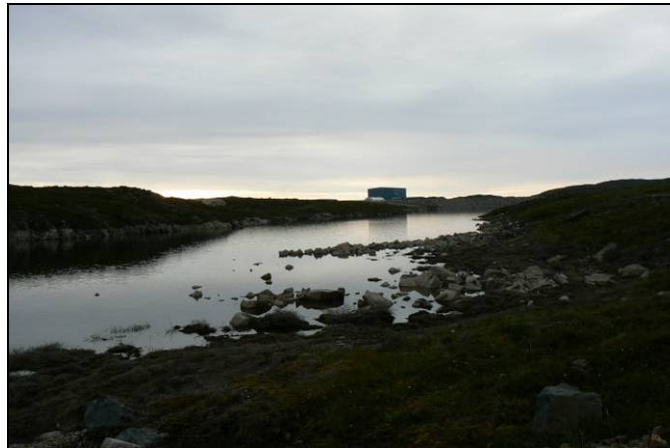
Photo # 30: West Containment Cell

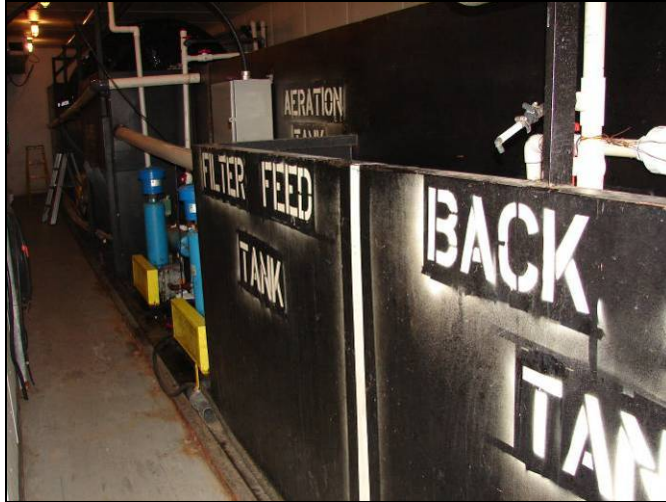
Camp sewage is limited owing to a small amount of staff operating the site while Jericho is in the Care and Maintenance phase. Ammonia and phosphorus levels are well recorded and are available upon request from Tahera (see Photo # 31 and Photo # 32).

Photo # 31: Inside the sewage treatment plant (picture taken in 2008)

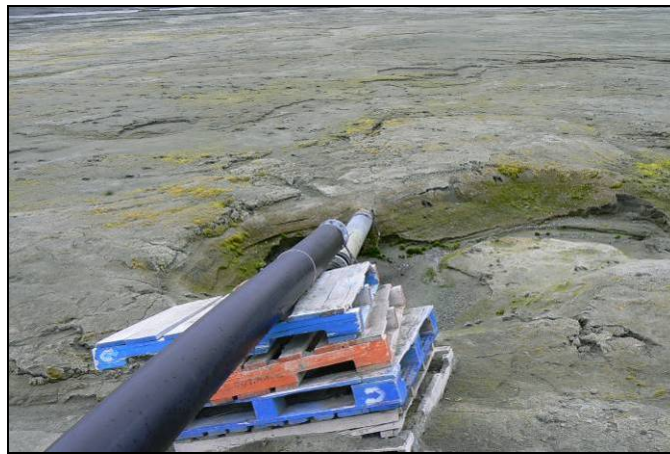
Photo # 32: Effluent discharge point into the East Containment Cell

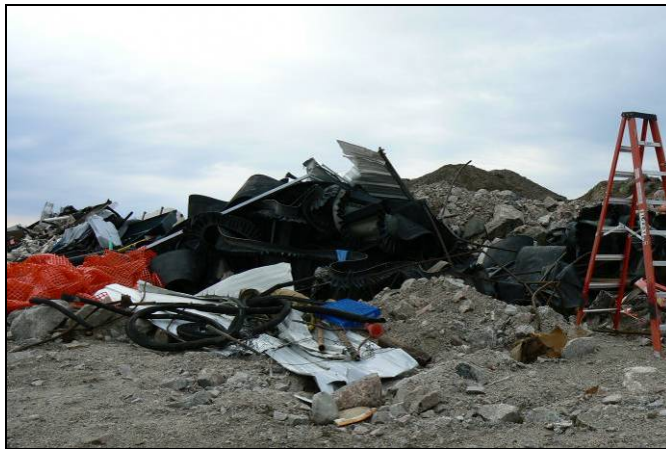
The landfill area was not fenced off and no other deterrents were apparent during the site visit (see Photo # 33). Wolverines have previously been attracted to this area during the winter months, which has resulted in an accidental killing by an employee in a truck. Another incident was previously reported in which a worker inside the seacan housing the incinerator was confronted by a wolverine barring the exit. The wolverine entered the incinerator stack despite attempts to scare it away. The wolverine left later on its own without incident. Improper incineration techniques were blamed for the attraction and both incidents prompted a review and revision of the techniques.

Photo # 33: Metal waste dump at Jericho Mine Site

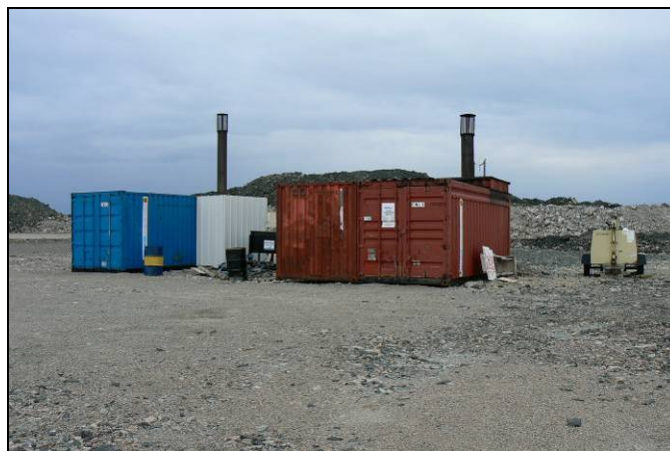
During the site visit, no garbage was seen in or around the camp site. All camp garbage is being incinerated every three to four days (Photo # 34).

Photo # 34: Incinerator at Jericho Mine Site

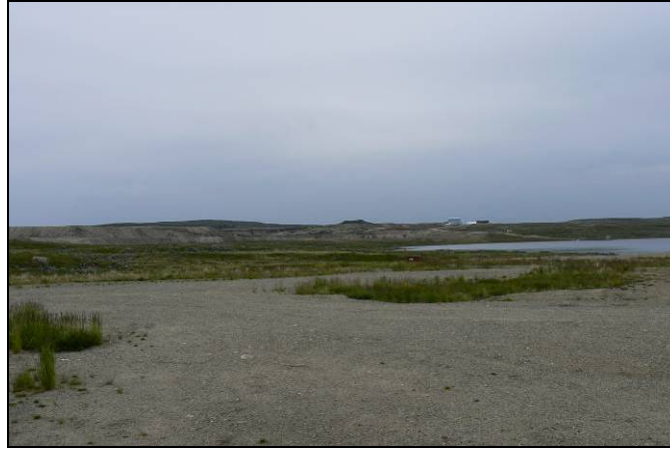
All infrastructure and garbage has been removed, and vegetation is beginning to establish itself. Structures (floating dock and tie-down structure for helicopters) that were on site last year were also removed (see Photo # 35).

Photo # 35: Old camp site on the edge of Carat Lake
