Nunavut Impact Review Board 2013 Site Visit Report for the Jericho Diamond Mine Project

NIRB File No. 00MN059

Project: Jericho Diamond Mine
Project Location: Kitikmeot Region, Nunavut

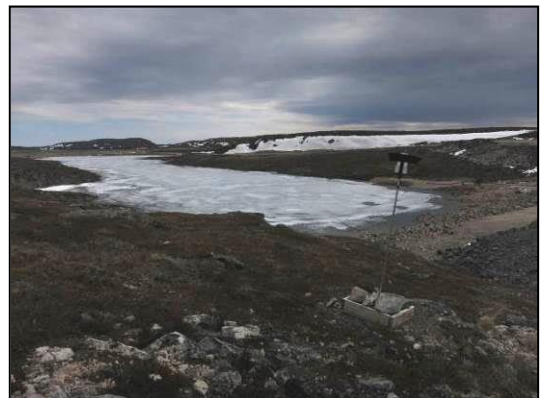
Photo 1: Dust fall monitoring station at west dam, on side opposite road, looking toward cell B/C

As the site was unmanned and not powered at the time of the 2013 site visit, the NIRB Monitoring Officer could not verify if the meteorological station was functioning. Dustfall stations remained in the same locations as previously observed around the site, through it is unclear if they are being monitored.

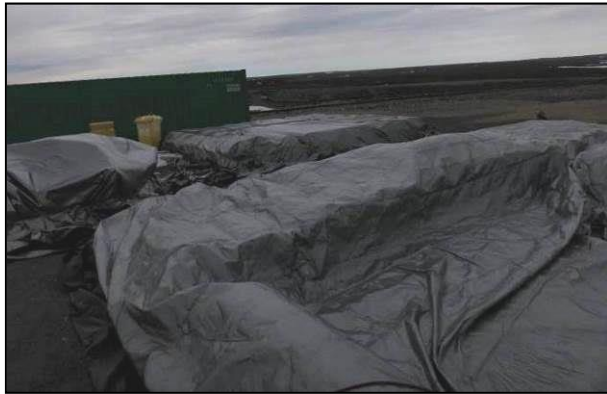
Photo 2: Barreled fuel found in cache by helipad and spill kits

The main fuel tank farm was enclosed in a completed berm as well as some of the caches of barreled fuel (see **Photo 2**), but other caches like the barrels at the airstrip (see **Photo 3**) were not. The berms that were incomplete as a result of upgrades taking place during the NIRB 2012 site visit were re-established and observed to be completely enclosing the bulk fuel storage areas during the NIRB 2013 site visit.

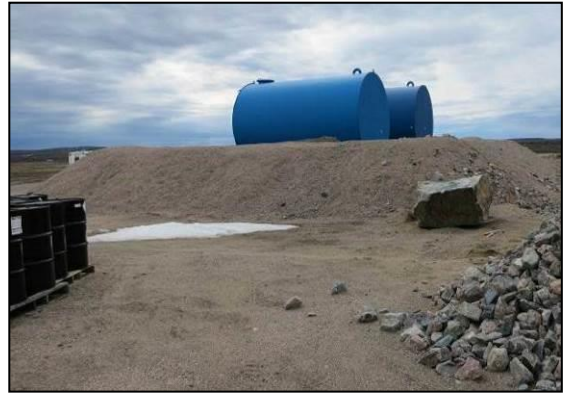
Photo 3: Fuel stores at airstrip

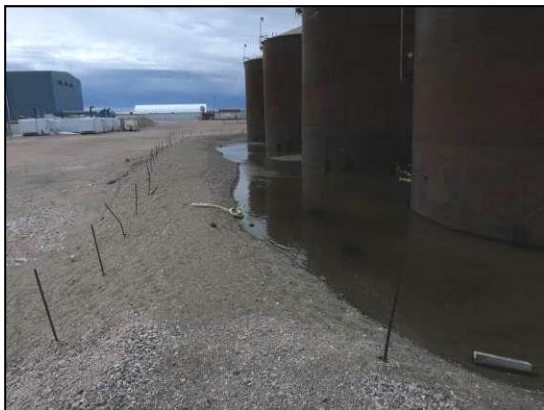
Photo 4: Melt water puddle in bermed area of main fuel tank farm

Areas previously suspected of fuel contamination during the 2009, 2011, and 2012 NIRB site visits remained within bermed areas; however, the bermed areas also contained puddles of sitting water (see **Photo 4**) as well as groups of open drums filled with mixed wastes (see **Photo 5**).

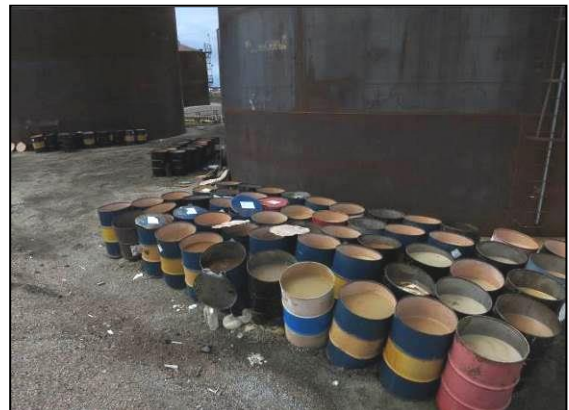
Photo 5: Barrels of waste material found within bermed area of main fuel tank farm

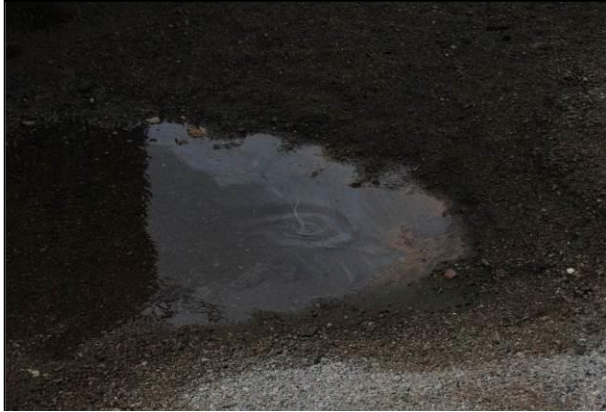
Photo 6: Hydrocarbon sheen on puddle within berm of Main Fuel Tank Farm

Areas affected by fuel spills at the main fuel tank farm and waste storage areas which had been noted during previous site visits remained untreated during the 2013 site visit.

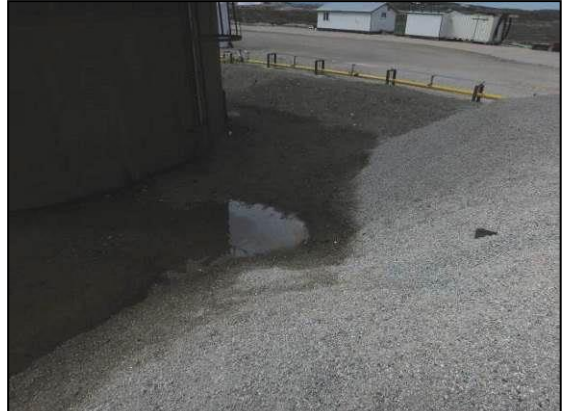
Photo 7: Soil staining within berm of Main Fuel Tank Farm

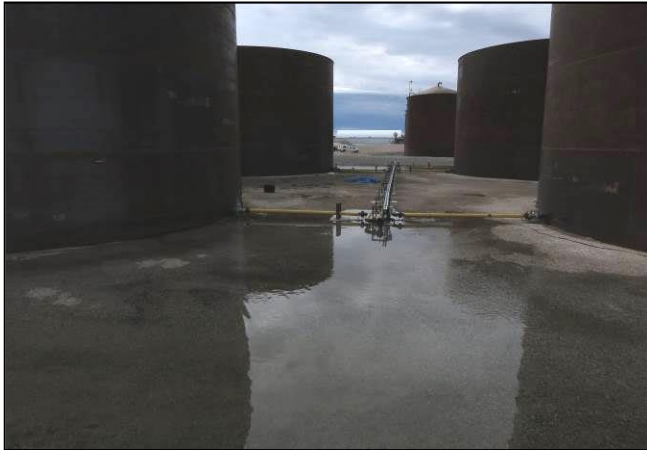
Photo 8: Meltwater in Main Fuel Tank Farm

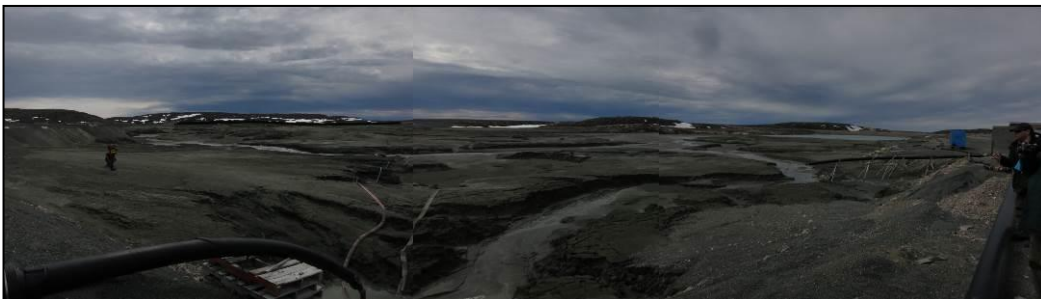
Photo 10: Processed Kimberlite Containment Area panorama

At the time of the 2013 site visit, any steps that Shear had previously undertaken to monitor or contain the fine processed kimberlite in the PKCA ceased (see **Photo 10**). The NIRB Monitoring Officer also observed that the surface of the PKCA was dry and in certain places, developing cracks (see **Photo 11**). The dust fall monitoring stations previously installed around the PKCA were still present (see **Photo 1**), but due to the site's temporary closure, it was unclear whether these stations would continue to be maintained and monitored.

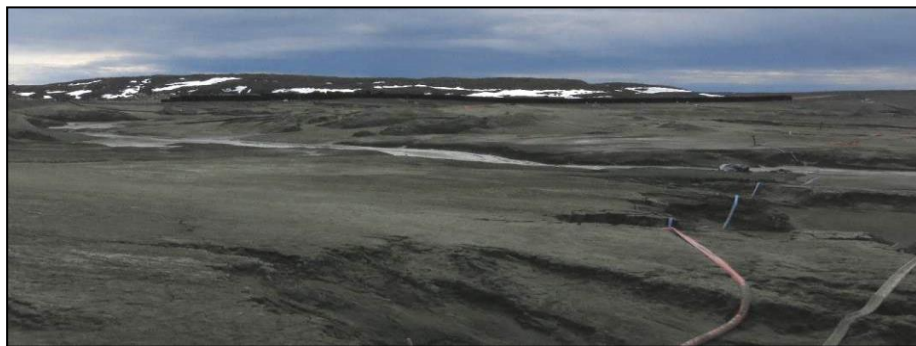
Photo 11: PKCA after spring freshet, top dry, slumping, and developing cracks

As evident in the photos of cell A of the PKCA, the majority of the surface of this area appeared to be dry, and therefore no short term need for water discharge from this cell (see **Photo 11**).

No use of spray irrigation was apparent during the 2013 site visit, and cracks appeared to be forming on the surface of the PKCA which looked to be dry.

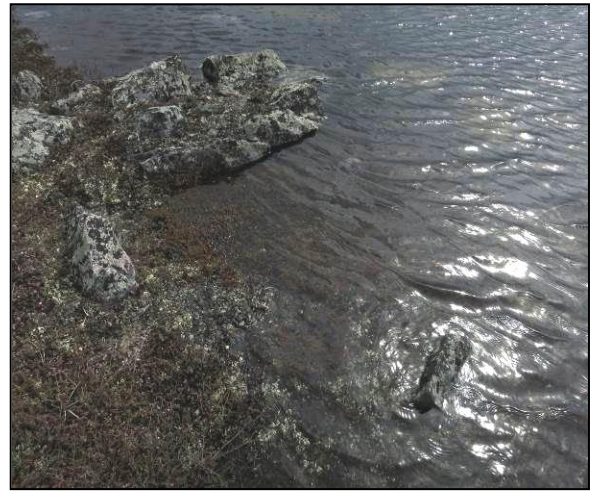
fish populations in areas surrounding project activities. During the 2013 site visit, the water level of cell B/C was observed to be at or above levels observed during previous site visits (see **Photo 13**) as evidenced by the amount of surface vegetation under water.

Photo 13: Cell B/C showing flooded vegetation

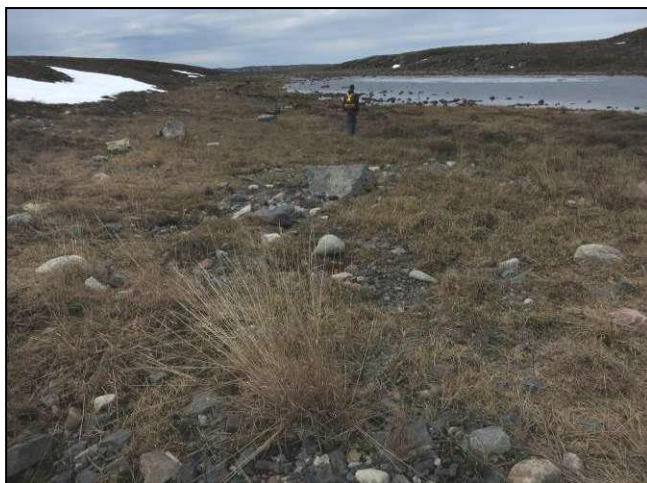
Due to the discontinuance of water discharge by Shear, the discharge area and outflow diffuser could be more thoroughly inspected (see **Photo 14** and **Photo 15**). The outflow diffuser consisted of a plate welded to the end of the hose on the metal fitting. Some evidence of surface erosion was present around the discharge area, but due to regrowth of vegetation in the area, the erosion was most likely not caused by discharge that occurred during the last growing season.

Photo 14: Discharge area from cell B/C

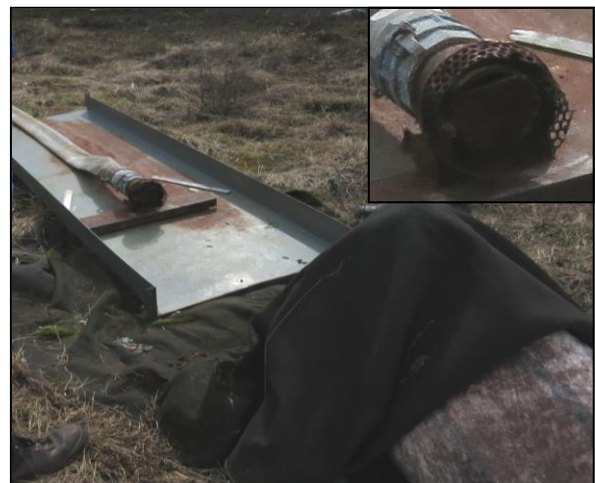
Photo 15: Outflow diffuser and impact area

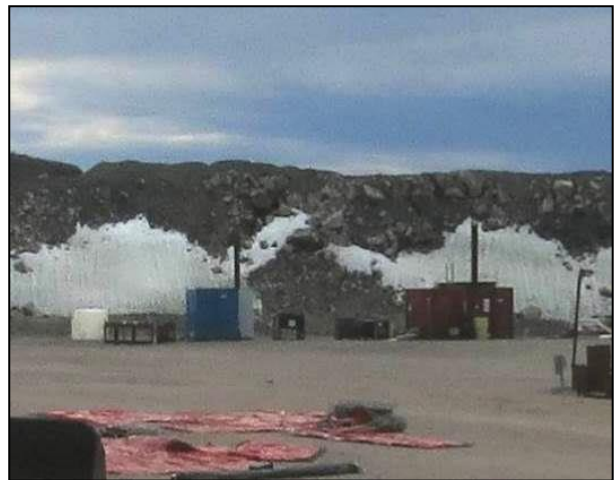
During the 2013 site visit it was noted that the incinerator seacan remained closed and locked (see **Photo 17**). Waste materials such as food items as well as wood, plastic, and metal debris were found in open-top, uncovered metal waste bins located by the machine shop and office buildings (see **Photo 18**).

Photo 17: Incinerator seacan area

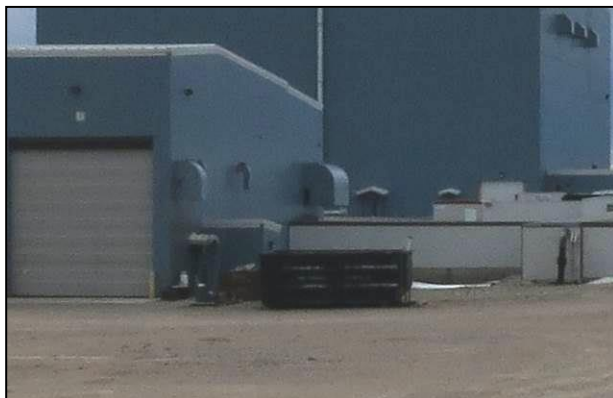
Photo 18: Waste bins at main camp
