2012-2013 Annual Monitoring Report

*For Shear Diamonds (Nunavut) Corporation's
Jericho Diamond Mine Project*

Report Title: The Nunavut Impact Review Board's 2012 – 2013 Annual Monitoring Report for the Jericho Diamond Mine Project (NIRB File No. 00MN059)

Report Title: Nunavut Impact Review Board 2013 Site Visit Report for the Jericho Diamond Mine Project

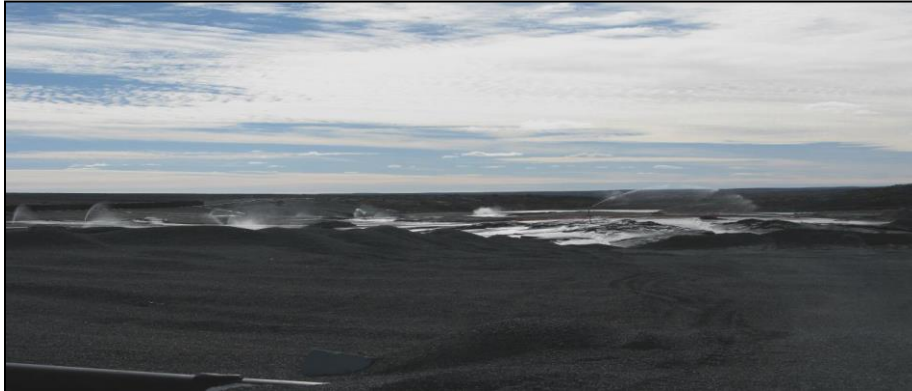
During the 2012 site visit, the NIRB had observed activities that Shear had undertaken to contain the dispersion of fine processed kimberlite from the processed kimberlite containment area (PKCA), in order to reduce further particle movement, and to monitor areas around the PKCA using dust fall monitoring stations. Specifically, Shear had begun re-wetting the fine processed kimberlite by pumping water from cell B/C back into cell A of the PKCA and dispersing the water using spray irrigation (see **Photo 1**).

Photo 1: Sprinklers wetting PKCA (2012)

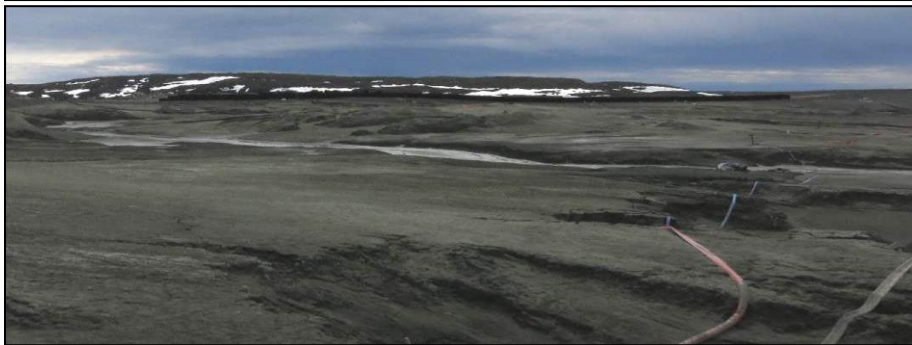
Photo 2: PKCA after spring freshet, top dry, slumping, and developing cracks (2013)

Shear had identified the PKCA as a site risk which required ongoing management as outlined in its Temporary Shut Down Plan. During the NIRB's 2013 site visit, the spray irrigation system was not in use and the PKCA exhibited signs of having dried out; including a lack of surface water and the presence of visible cracks as well as areas of slumping. The NIRB has not received any indication from Shear that the proposed management practices have been implemented, and the observations at site would indicate that Shear had not been conducting activities to manage risks at the PKCA. AANDC indicated that it has taken steps to manage risks at the PKCA site.

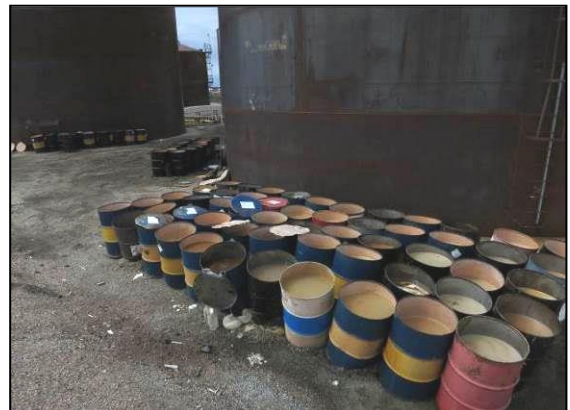
Areas previously suspected of fuel contamination during the 2009, 2011, and 2012 NIRB site visits remained within bermed areas; however, the bermed areas also contained puddles of sitting water (see **Photo 4**) as well as groups of open drums filled with mixed wastes (see **Photo 5**).

Photo 5: Barrels of waste material found within bermed area of main fuel tank farm

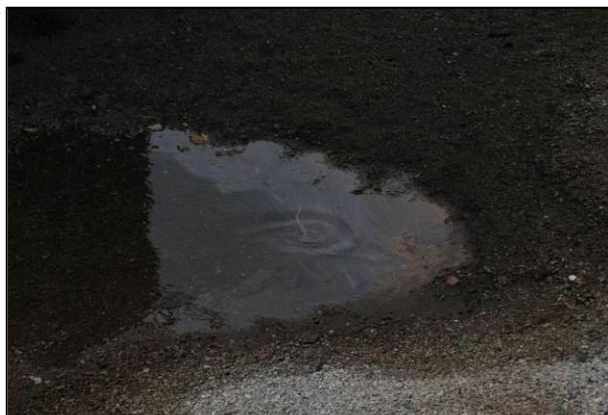
Photo 6: Hydrocarbon sheen on puddle within berm of Main Fuel Tank Farm

Areas affected by fuel spills at the main fuel tank farm and waste storage areas which had been noted during previous site visits remained untreated during the 2013 site visit.

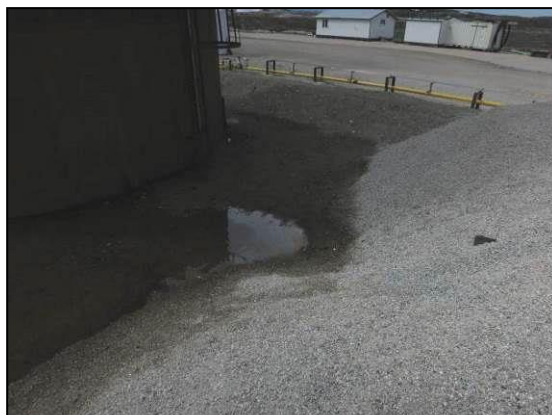
Photo 7: Soil staining within berm of Main Fuel Tank Farm

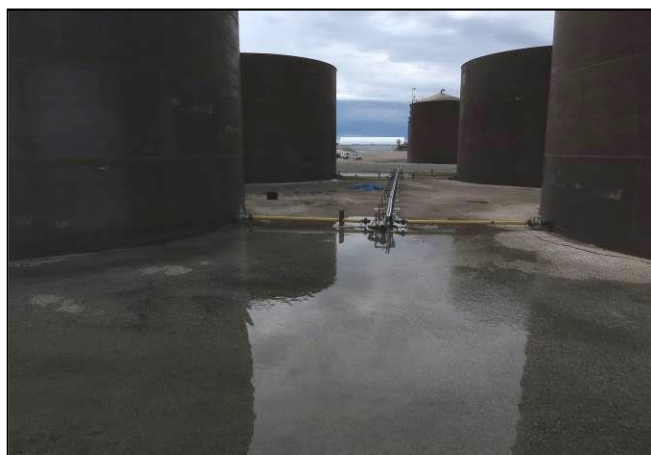
Photo 8: Meltwater in Main Fuel Tank Farm

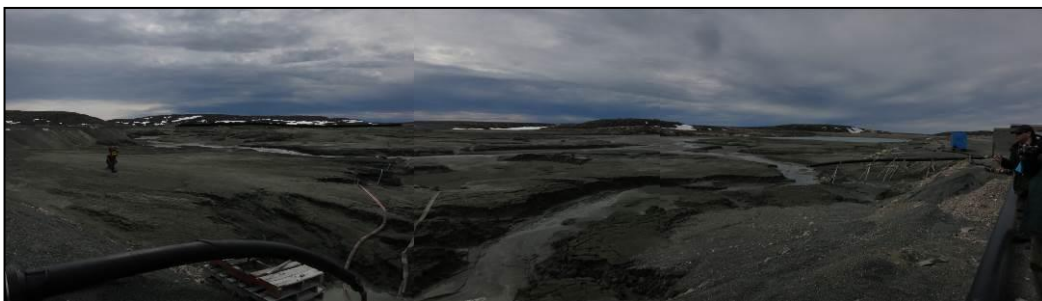
Photo 10: Processed Kimberlite Containment Area panorama

At the time of the 2013 site visit, any steps that Shear had previously undertaken to monitor or contain the fine processed kimberlite in the PKCA ceased (see **Photo 10**). The NIRB Monitoring Officer also observed that the surface of the PKCA was dry and in certain places, developing cracks (see **Photo 11**). The dust fall monitoring stations previously installed around the PKCA were still present (see **Photo 1**), but due to the site's temporary closure, it was unclear whether these stations would continue to be maintained and monitored.

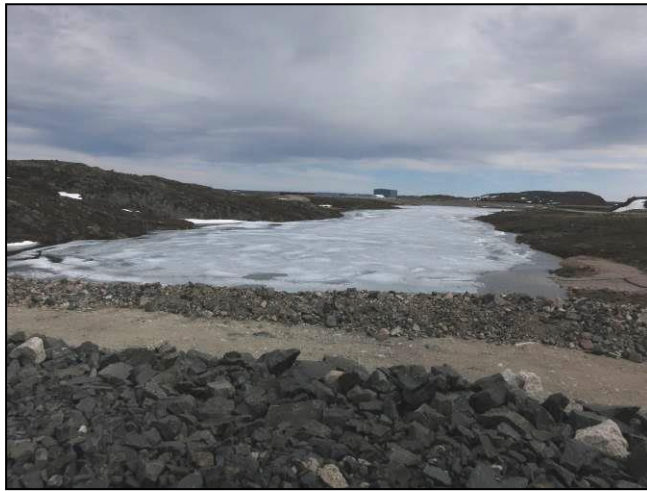
fish populations in areas surrounding project activities. During the 2013 site visit, the water level of cell B/C was observed to be at or above levels observed during previous site visits (see **Photo 13**) as evidenced by the amount of surface vegetation under water.

Photo 12: View of cell B/C from west dam

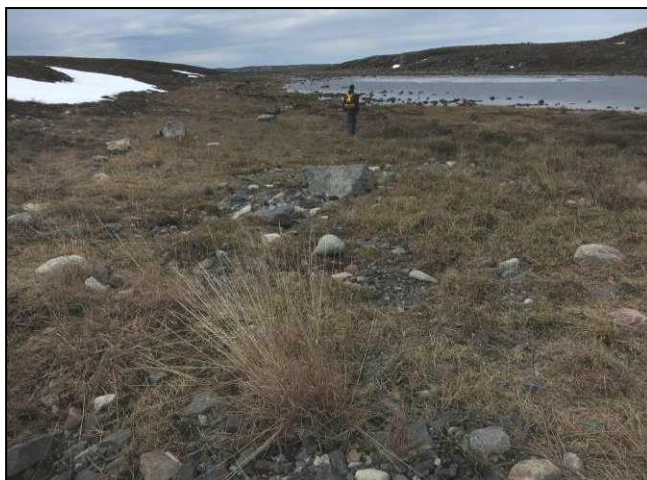
Due to the discontinuance of water discharge by Shear, the discharge area and outflow diffuser could be more thoroughly inspected (see **Photo 14** and **Photo 15**). The outflow diffuser consisted of a plate welded to the end of the hose on the metal fitting. Some evidence of surface erosion was present around the discharge area, but due to regrowth of vegetation in the area, the erosion was most likely not caused by discharge that occurred during the last growing season.

Photo 14: Discharge area from cell B/C

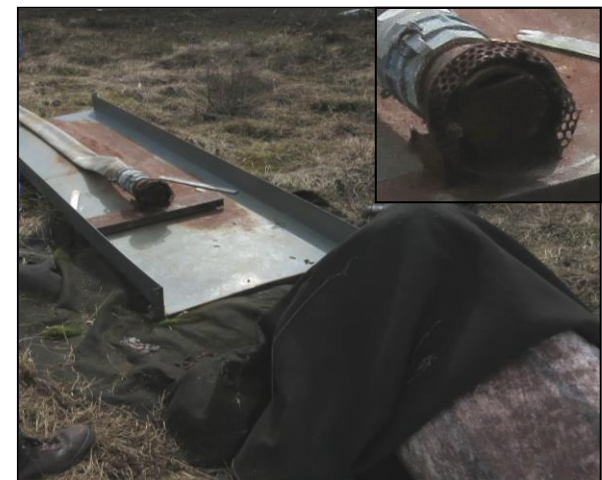
Photo 15: Outflow diffuser and impact area
