2016-2017 Monitoring Report for the Jericho Diamond Mine Project

Report Title: The Nunavut Impact Review Board's 2016 – 2017 Annual Monitoring Report for the Jericho Diamond Mine Project (NIRB File No. 00MN059)

2017 SITE VISIT REPORT

Jericho Diamond Mine Project

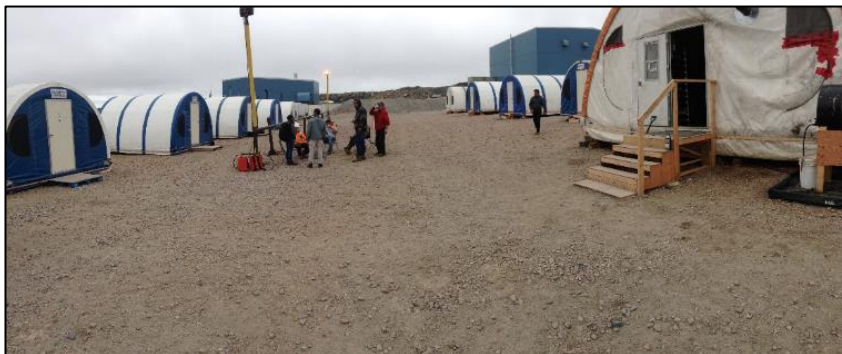
Photo 1: Contractor soft camp located adjacent to the former Jericho camp

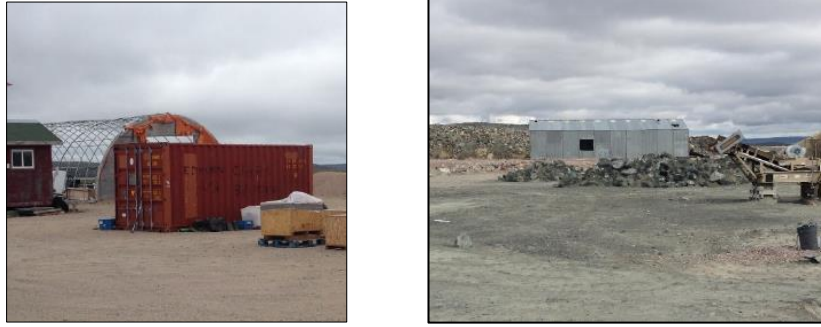
The Monitoring Officer noted that although the Jericho Mine site was occupied by a small contractor camp undertaking stabilization activities, site debris and garbage was generally contained within waste receptacles or in specific zones. As the contractor on-site was actively managing areas of fuel and/or chemical contamination through removal and storage, several areas of concern identified in the past appeared to be undergoing remediation and stabilization. For additional information related to fuel storage refer to [Section 4.2.6](#) of this report. As noted in 2016, the Monitoring Officer observed during the site visit that select structures were beginning to show signs of weathering due to seasonal environmental effects and that without intervention, the structures could continue to deteriorate and potentially contribute to contamination in the respective areas.

Photo 2: Deteriorating structures located at the airstrip (left) and near the main site (right)

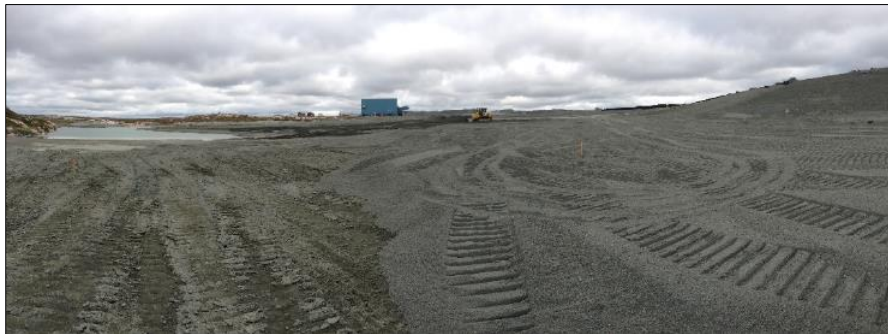
Photo 5: Coarse aggregate (material on right) being applied over processed kimberlite tailings (material on left)

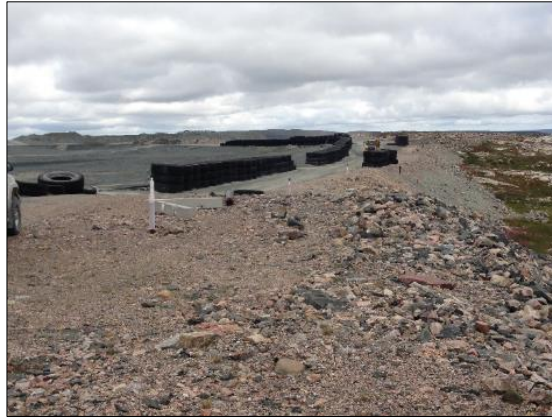
Photo 6: Tire berm adjacent to Cell A of the PKCA

The Monitoring Officer noted that the coarse cover material placed in Cell A of the PKCA appeared to encapsulate the PKCA effectively as compared to past methods of containment. However, trace fine materials were observed in the coarse cover material which may require further observation to ensure short- and long-term effectiveness. As noted in the past, the Monitoring Officer observed that the silt curtain deployed in the southeast pond was still installed.

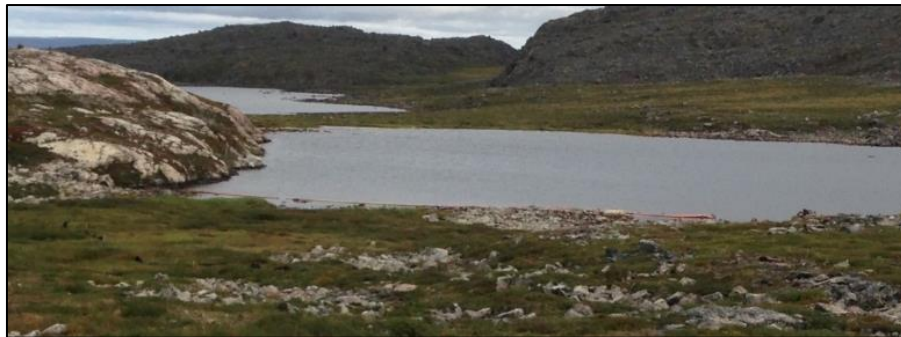
Photo 7: Silt curtain in the southeast pond

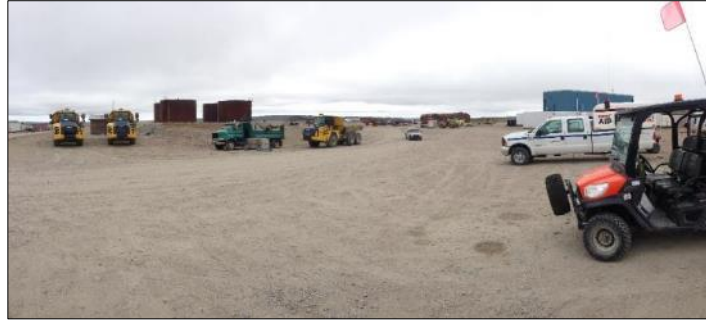
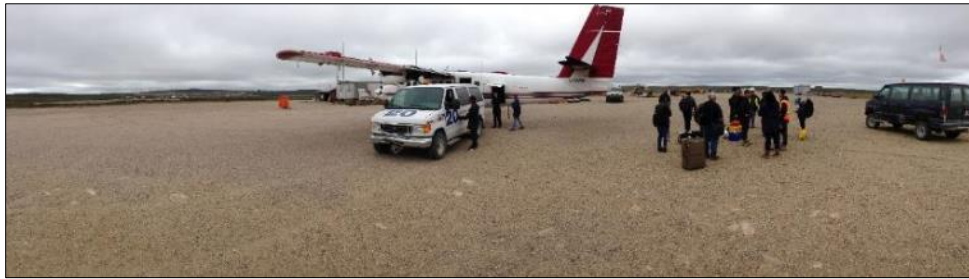
As the site is non-operational, there were no observed noise monitoring or mitigation activities being undertaken related to mining-specific activities. Noise was, however, observed from select stabilization-related operations including vehicle, heavy machinery, and equipment use, power generation, personnel movement, and aircraft transport.

Photo 8: Vehicles and heavy machinery being used for remediation and stabilization operations (above); aircraft used for site transport and contractor crew changes (below)

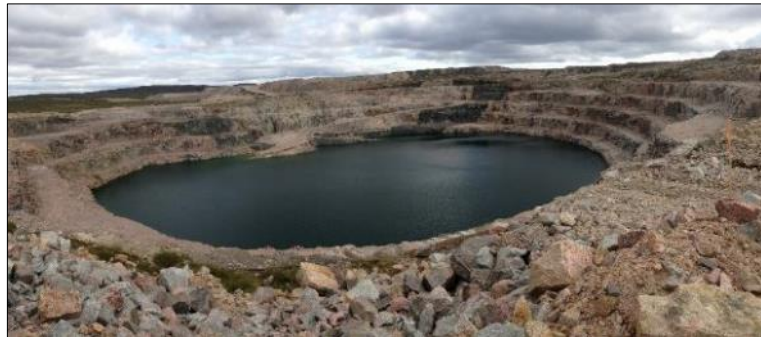
No caribou were observed during the site visit. Although the alteration of site features could alter the navigable landscape through the area, the modifications being undertaken did not appear to significantly deviate from existing potential movement corridors. Neither the Proponent nor INAC identified any constraint to movement related to site infrastructure. The berm surrounding the pit appeared to be intact, except for berm disturbances in areas where water management features were being rerouted during stabilization activities, and there were no visible traces of wildlife in the vicinity of the pit during observation.

Photo 9: View of the berm surrounding the open pit as seen during the 2017 site visit

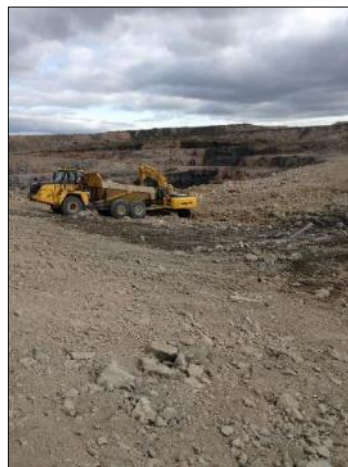
Photo 10: Heavy machinery undertaking earthworks near the open pit to reroute the C1 diversion

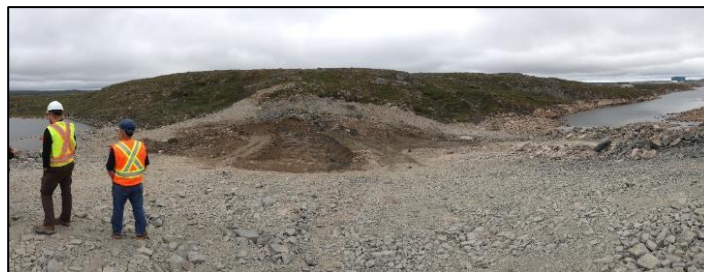
Mining-related blasting activities are not currently being undertaken on-site, although explosives were used prior to the site visit as part of the supplemental activities approved for the “Jericho Mine Site Stabilization Project” (NIRB File No. 16UN058) to loosen the core of the previously installed West Dam (see [Photo 12](#)). INAC confirmed that all blasting had been completed prior to the site visit and that it was not storing any blasting materials on-site. Due to time constraints

Photo 12: Breached segment of the West Dam where blasting occurred as part of stabilization operations

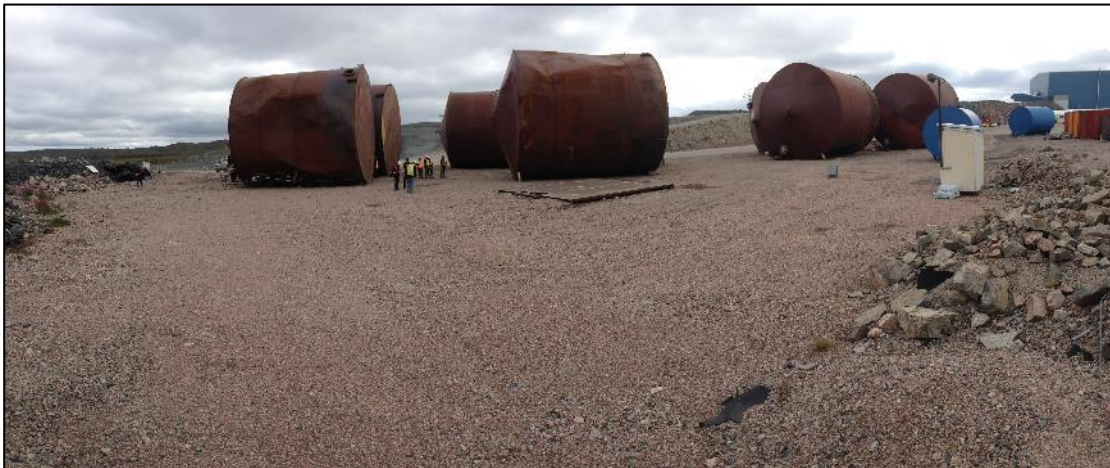
As part of the stabilization activities being undertaken by INAC under NIRB File No. 16UN058, contractors on-site were conducting substantial works related to fuel storage areas during the 2017 site visit. Fuel tanks within Phase 1 of the main fuel tank farm had been purged, cleaned, removed, and stored on-site prior to the visit to allow room for the consolidation and storage of contaminated soils (see [Photo 13](#) and [Photo 14](#)). INAC indicated that the contaminated soils, identified through past and ongoing testing at various locations on-site, would be collected, covered with a liner, and capped with coarse processed kimberlite within the Phase 1 berm for long-term storage. Based on the amended scope of remediation works being undertaken, following the cleaning and removal/storage of fuel tanks on-site, and collection of contaminated soils, INAC indicated that the majority of the berms (except for the former Phase 1 tank farm berm) would be breached to avoid seasonal water accumulation.

Photo 13: Remediated bulk fuel tanks storage location adjacent to the truck shop

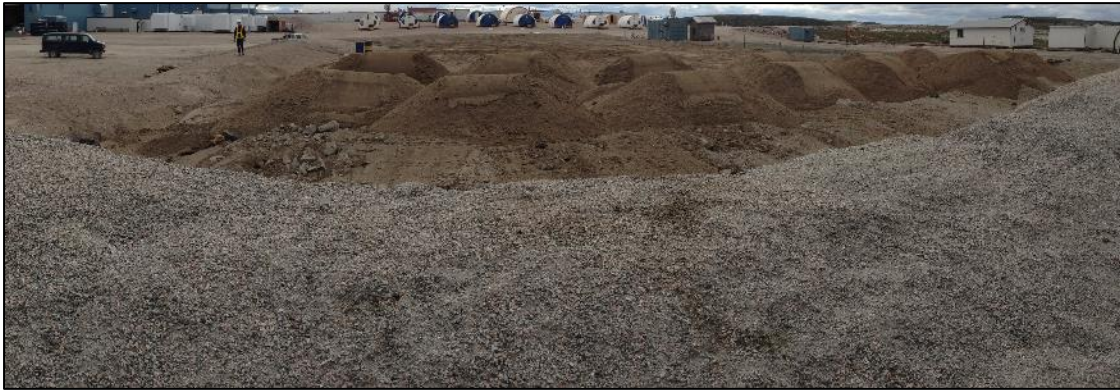
Photo 14: Contaminated soils stored in former Phase 1 tank farm berm to be capped and covered for long-term storage

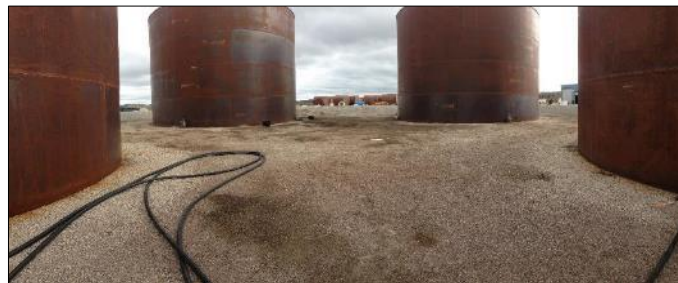
Remaining fuel from one (1) of the four (4) tanks within Phase 2 of the main fuel tank farm was being utilized for remediation operations. INAC indicated that the bulk fuel tanks within the Phase 2 main fuel tank farm would be purged of their remaining fuel following operations, cleaned, and would remain in-place within the breached berm area due to their size (see [Photos 15 through 18](#)). Prior to completion of the stabilization program, INAC indicated that all remaining fuel on-site would be purged and burned off using an on-site incinerator, except for four (4) drums of diesel fuel and the airstrip camp tank. INAC added that due to encountering additional fuel on-site and technical difficulties with the on-site incinerator, additional incineration may be required during the summer of 2018 to complete the disposal of fuel.

Photo 15: Bulk fuel tanks to remain in-place within Phase 2 of the main fuel tank farm

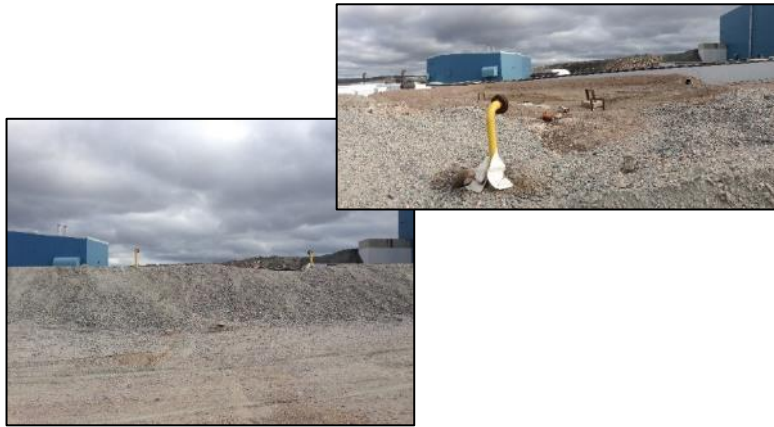
Photo 17: Former bulk fuel tank storage area near generators.

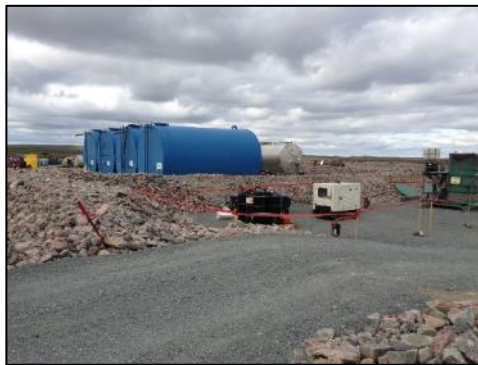
Photo 18: Incinerator (green stack) being used for burning remaining fuel and liquids (right in photo) and bulk fuel storage tanks (left in photo)

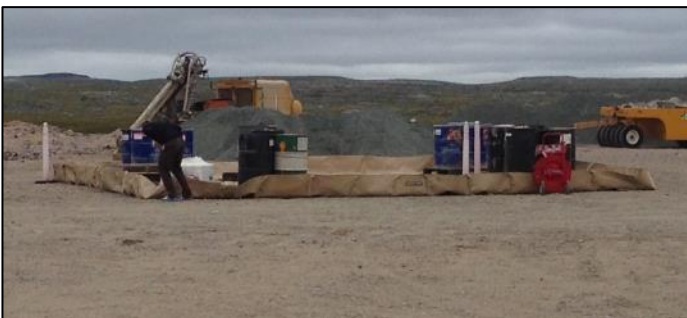
The Monitoring Officer observed several locations during the 2017 site visit where fuel was stored in appropriate temporary containment berms to support site activities. The temporary berms appeared to be well maintained and monitored, as barrels and materials contained within seemed to be well arranged, upright, and effectively covered to limit any potential transport of materials or release of contents into the berms and/or surrounding environment. During the site visit, INAC confirmed that the remaining electrical generators from the Jericho Project would be decommissioned to ensure environmental stability, and stored on-site.

Photo 19: Temporary berm containing fuel barrels near the airstrip

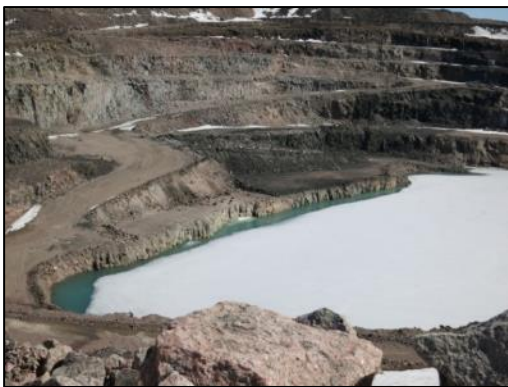
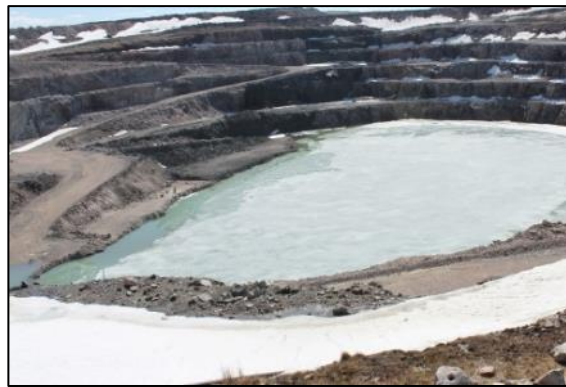
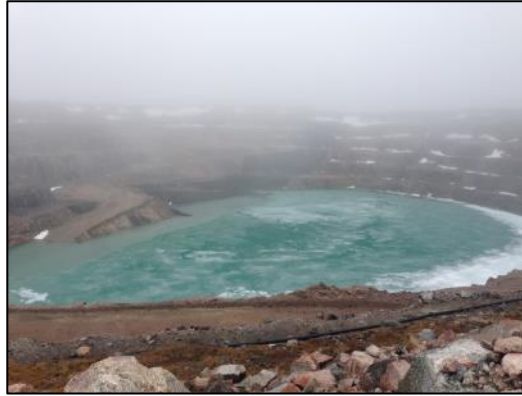
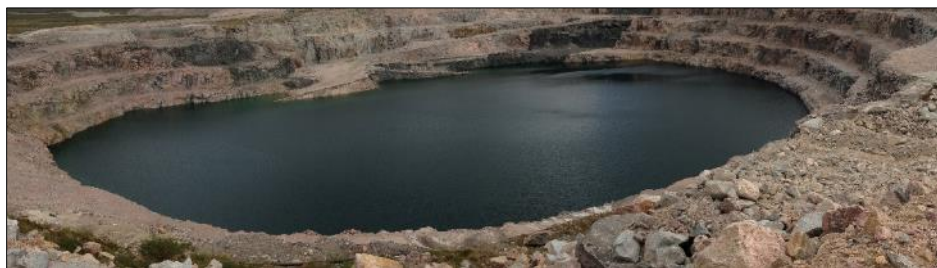
As observed during previous site visits, the water within the open pit continues to rise annually (see [Photo 21](#) through [24](#)). Compared to past site visits, the Monitoring Officer observed that water coloration appeared to be more consistent with nearby natural waterbodies. INAC estimated during the 2016 site visit that at the current rate of infiltration, it would take 40 to 42 years for the open pit to fill and resemble a lake. As part of the stabilization activities approved under NIRB File No. 16UN058, the contractors on-site were actively removing the C1 stream diversion to restore natural water flow back to the pit area which would accelerate the pit infill, estimated at 11 to 15 years. Additionally, approximately 58,000 cubic metres (m³) of water was pumped from Cell B/C into the open pit prior to the site visit. INAC indicated that the discharge was approved by the INAC inspector and that all discharges from Cell B/C met discharge criteria without treatment. For additional discussions related to the open pit see [Section 4.2.8](#). As part of camp operations, the contractors on-site were actively treating greywater using an on-site constructed system which consisted of three (3) separate treatment sumps, pumps, and filters (see [Photo 25](#)).

Photo 21: Water level of the open pit as seen during the 2014 site visit

Photo 22: Water level of the open pit as seen during the 2015 site visit

Photo 23: Water level of the open pit as seen during the 2016 site visit

Photo 24: Water level of the open pit as seen during the 2017 site visit

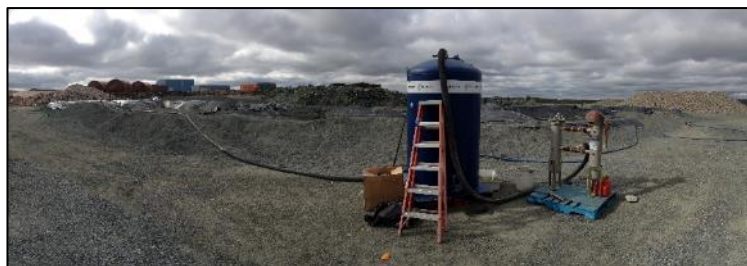
Photo 25: On-site water treatment system for contractor camp greywater

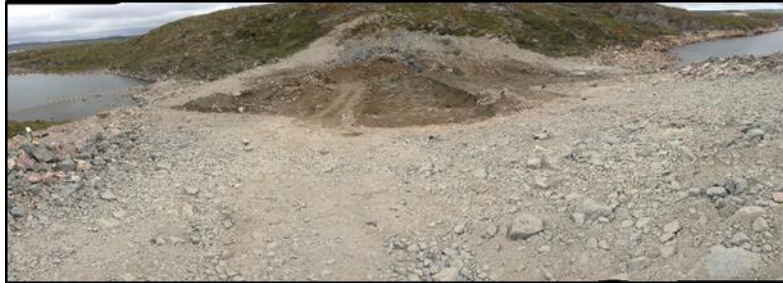
flow. The Monitoring Officer observed that a silt curtain had been deployed on the outflow of the West Dam breach to isolate the nearby environment from the displacement of silt and materials. INAC confirmed that no fish sampling had taken place during the past year.

Photo 26: West Dam breach as observed during the 2017 site visit

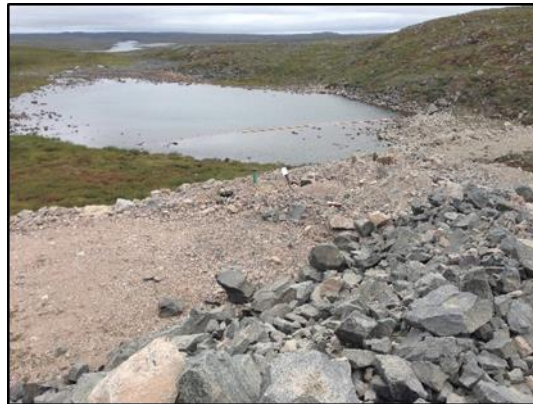
Photo 27: Silt curtain installed near the outflow of the West Dam

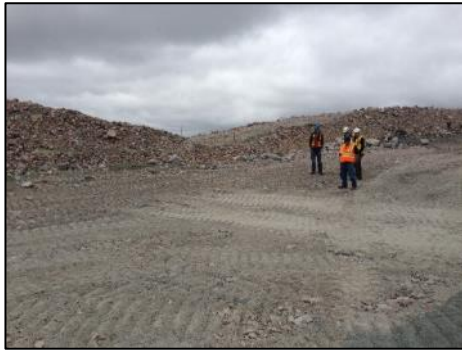
Although Divider Dyke A, separating Cell A and Cell B/C of the PKCA, had been breached as part of the stabilization activities, INAC noted that the dyke would continue to function as a filter dyke. INAC indicated that seasonally, a small pond would likely form at the base of Cell A and eventually flow through the dyke and breach into Cell B/C (see [Photo 28](#) and [Photo 29](#)). As previously noted, as part of the stabilization activities approved under NIRB File No. 16UN058, the contractors on-site were actively removing the C1 stream diversion to restore natural water flow back to the pit area (see [Photo 30](#)). The removal of the C1 diversion was a measure proposed to increase the long-term stability of the water management structure, and to reduce the pit infill timeline, estimated at 11 to 14 years. As part of the works around the open pit, the contractors had also designed an outflow which would flow to Carat Lake when the pit reaches its final elevation.

Photo 28: Divider Dyke A breach

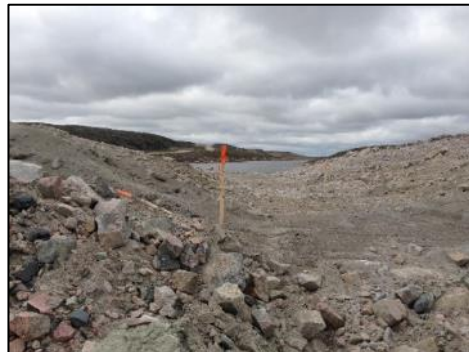
Photo 29: Divider Dyke A breach outflow looking into Cell B/C

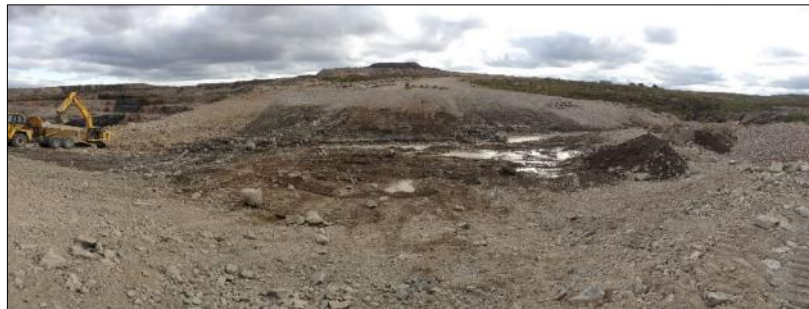
Photo 30: Heavy machinery removing C1 diversion near the open pit

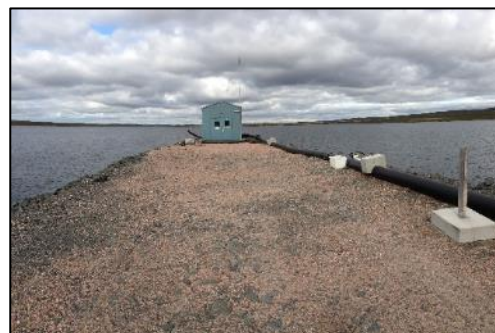
Under the revised scope of activities approved under NIRB File No. 16UN058, INAC intended to remove the water intake jetty in Carat Lake on behalf of DFO to create additional fish habitat in the area. During the 2017 site visit, the jetty had not yet been altered, and DFO representatives noted that remediation of the jetty and associated features may not be undertaken due to unforeseen circumstances. It was clarified that should the activities not be undertaken, DFO would explore alternative options for creating additional fish habitat compensation in the area.

Photo 31: Water intake jetty in Carat Lake

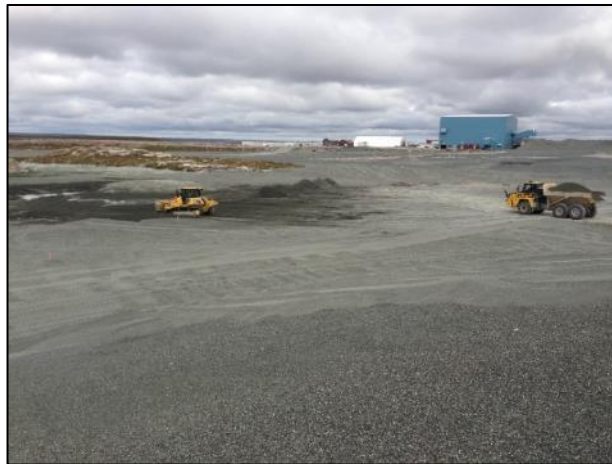
Due to the absence of mining operations and the production of wastewater, the PKCA remains mostly dry which limits the ability to conduct water sampling. As previously noted, during the 2017 site visit the Monitoring Officer observed that windblown dust from the PKCA appeared to be contained as coarse materials were being applied over the fine processed kimberlite, and containment structures previously installed were still in place. The Monitoring Officer noted during the site visit that trace fines within the coarse material cover could result in windblown dust and would require monitoring to confirm its short- and long-term effectiveness. INAC indicated that the tire berm would remain around the PKCA following the completion of the stabilization operations. Ground stability within the PKCA appeared to be improved based on past observations as heavy machinery were able to conduct stabilization works without any apparent difficulties.

Photo 32: Coarse material being applied over the PKCA

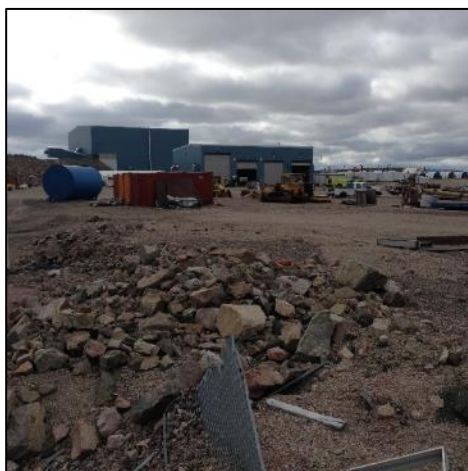
As previously noted, although the Jericho Mine site was occupied by a small contractor camp during the 2017 site visit, the Monitoring Officer observed that waste was generally stored within waste receptacles located on-site or was organized in segregated zones within waste storage areas. During the site visit INAC indicated that all hazardous waste was collected and would be packaged and back-hauled as part of the site remediation and stabilization activities. Inert and non-hazardous materials, including structures, clean tanks, and miscellaneous

Photo 34: Scattered debris adjacent to the truck shop

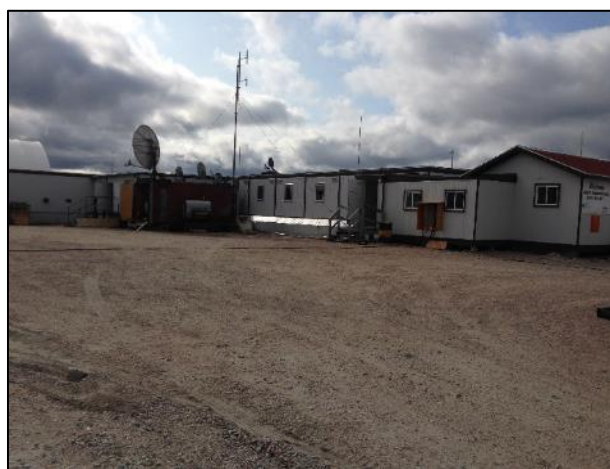
Photo 33: Jericho hard camp and other structures to remain in place

equipment, would remain on-site.

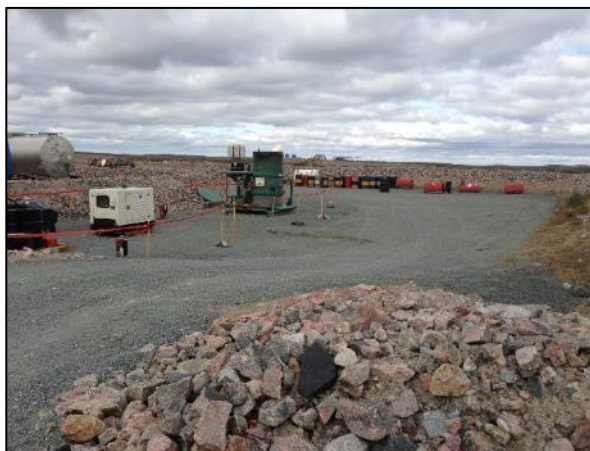
During previous site visits, barrels containing unknown materials were observed in several locations throughout the site, including within the main fuel tank farm. Under the stabilization activities conducted on-site, contractors were actively collecting, cleaning, and storing empty barrels near the hazardous waste storage area. INAC indicated that washwater from the cleaning operations would be treated on-site or shipped off-site for disposal.

Photo 35: Barrel cleaning station near the hazardous waste storage area

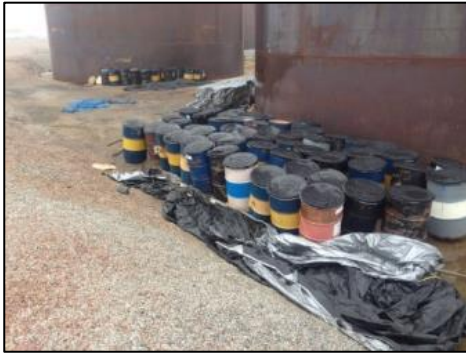
Photo 36: Covered barrels containing waste material as seen during the 2016 site visit

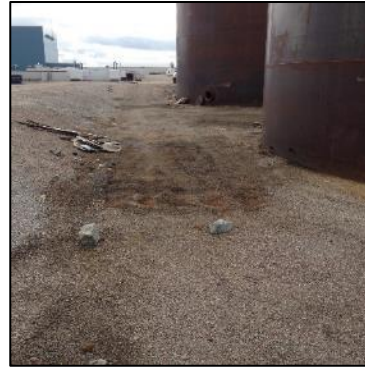
The Monitoring Officer noted that barrels previous stored in the Phase 2 main fuel tank farm had been removed as part of the remediation operations and were being processed as part of the remediation contractor's cleaning operations.

Photo 37: Former barrel storage area in the Phase 2 tank farm as seen during the 2017 site visit
