# 2017-2018 Monitoring Report for the Jericho Diamond Mine Project

**Jericho Diamond Mine Project Certificate No. 002**

**Report Title:** The Nunavut Impact Review Board's 2017 – 2018 Annual Monitoring Report for the Jericho Diamond Mine Project (NIRB File No. 00MN059)

# 2018 Site Visit Report

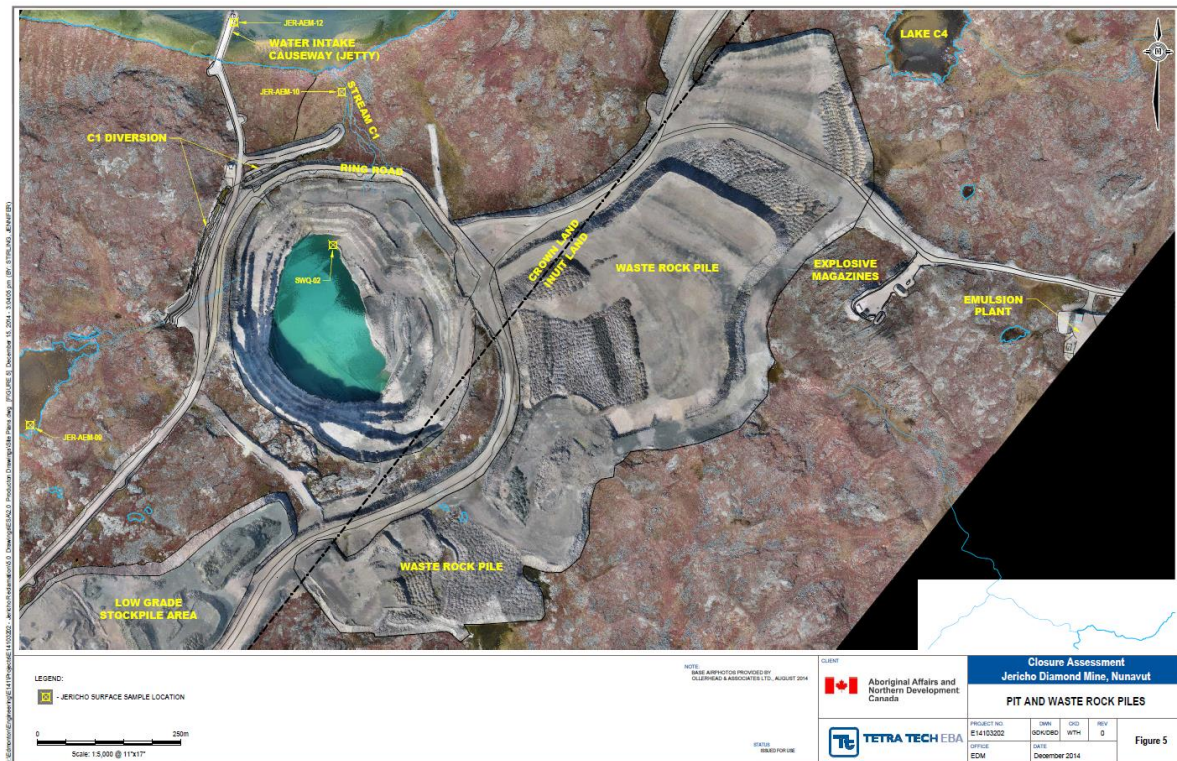
**Figure 2: Water Diversion Channels and Pit<sup>18</sup>**

open pit. This will support the creation of a pit lake. They also breached the open pit side wall to eventually (once the pit lake is formed) allow the original natural flow of surface water into Carat Lake to be restored.

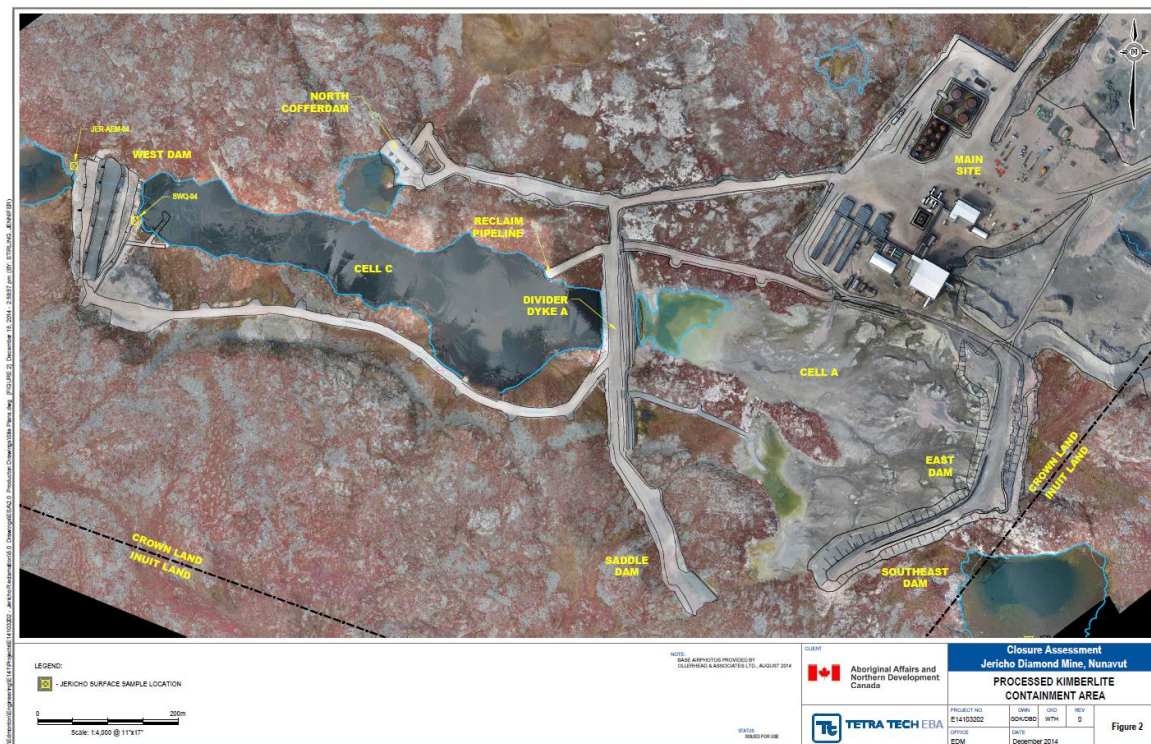
**Figure 3: Processed Kimberlite Containment Area<sup>19</sup>**

Works also included grading the existing tailings in Cell A to allow water to flow in its original direction and have lowered the top and created a breach in Dyke A and have breached the West Dam to restore the original surface water flow. In 2017, 291,500,000 litres of clean water from Cell A and Cell C was tested, pumped and discharged downstream into the receiving environment.

A long-term Operation, Maintenance and Surveillance Plan is in development to for future monitoring of performance of dam breaches.

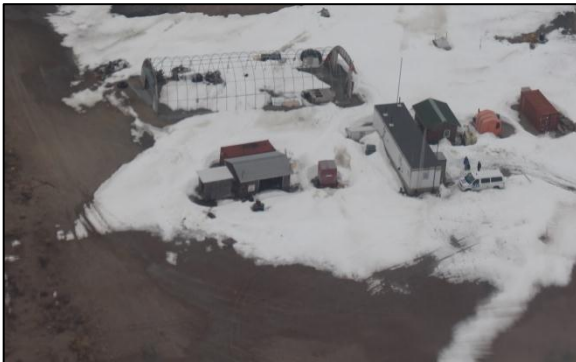
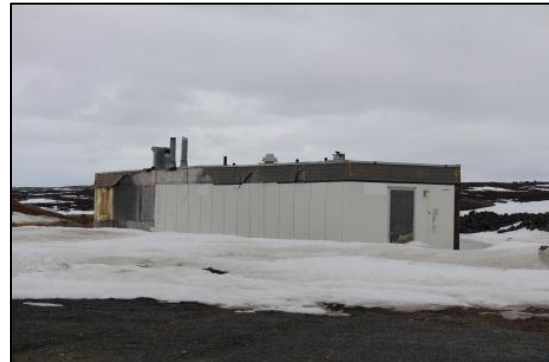
The stabilization and remediation activities at the site are considered complete. Areas of concern identified in the past particularly with regard to fuel and / or chemical contamination have been remediated. Hazardous materials have been transported off site. The Processed Kimberlite Containment Area (PKCA) has been capped with coarse tailings to prevent erosion and the West Dam and Divider Dyke A has been breached to allow free flow of water. The C1 Diversion around the pit has been re-routed into the open pit and an outflow was created for the pit lake that will flow into Carat Lake restoring the original natural flow of surface water. The contractor will return to site in the summer of 2018 to finish a few tasks that were unable to be completed before the snow fell including fixing a “hump of fold” in the hydrocarbon contaminated soil storage cell liner. As noted in previous site visit reports, the Monitoring Officer observed during the site visit that select structures were beginning to show signs of weathering due to seasonal environmental effects and that without intervention, the structures could continue to deteriorate and potentially contribute to contamination in the respective areas.

*Photo 1: Deteriorating structures*

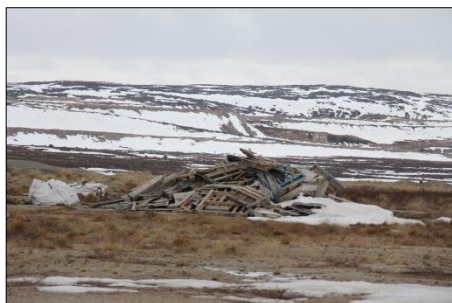
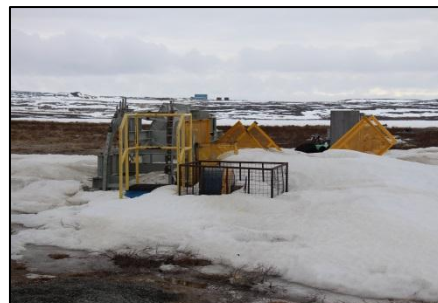
*Photo 2: Scrap wood and metal*

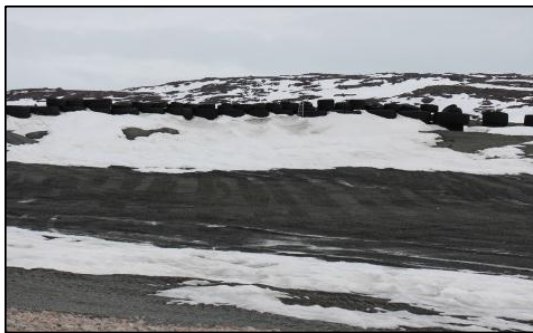
During the 2018 site visit the NIRB Monitoring Officer observed no dustfall monitoring stations and INAC confirmed that no formal dustfall monitoring was conducted on-site during the reporting year only visual observations. They noted that in the past throughout the winter months it was evident from visible dust traces in the snow that fine dust particles from the PKCA do not remain entirely within the containment facility. During the site visit the Monitoring Officer observed very little dust on the snow and it appears stabilization efforts undertaken to cover the PKCA with coarse kimberlite material are performing effectively to reduce the dust compared to other methods in the past including freezing with water. ([Photo 3](#))

Photo 3: Very little dust on snow at PKSA

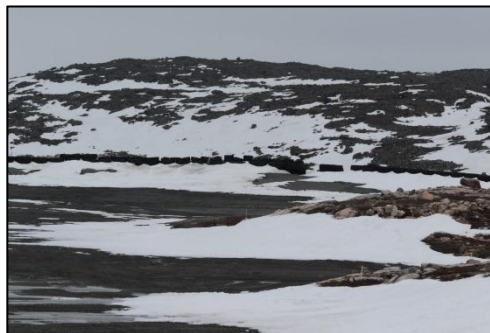
Photo 4: Tire berm used to mitigated dust deposition from PKSA

The Monitoring Officer also confirmed that select containment structures (e.g., tire berm) would remain on-site ([Photo 4](#)). They were originally installed as a mitigation measure to reduce the movement of the fine dust particles, but it was noted that they may not be entirely effective as a large amount of dust has been collecting in the pond behind them. The Monitoring Officer has

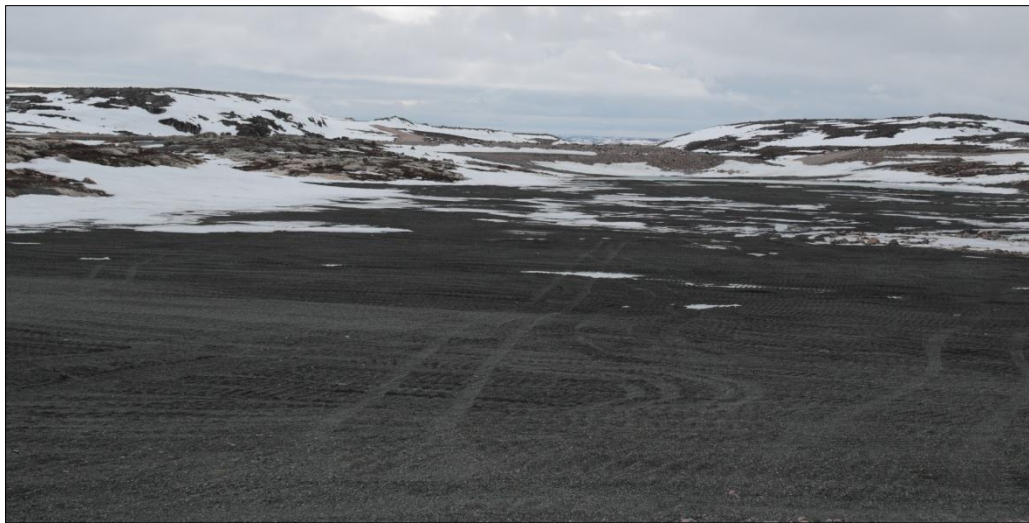
some concerns about future dust dispersion as the coarse kimberlite material will break down with time. Further observations will be required to ensure short- and long-term effectiveness of the coarse kimberlite cover (Photo 5). Discussions were had with INAC with regards to monitoring the PKSA and other techniques for stabilizing the site such as creating artificial boulder fields to encourage the creation of micro environments to support soil and vegetation establishment. The Monitoring Officer noted to INAC that at other mine sites nearby that natural re-vegetation (in particular grasses) establish quickly on processed kimberlite which will help with the stabilization of the PKCA. The Monitoring Officer encouraged INAC to monitor and report on any natural vegetation re-establishment.

*Photo 5: Coarse kimberlite cover on processed kimberlite tailings*

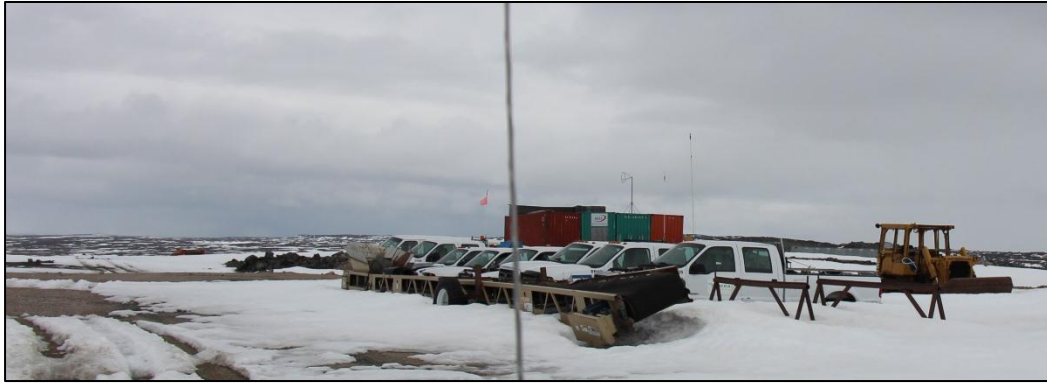
As the site is non-operational, there were no observed noise monitoring or mitigation activities being undertaken related to mining-specific activities. The potential impacts from noise disturbance at the site is low and in the future will be mainly from aircraft travel to the site for monitoring. The majority of heavy equipment has been removed from the site and only a few working vehicles remain.

*Photo 6: Abandoned light duty vehicles*

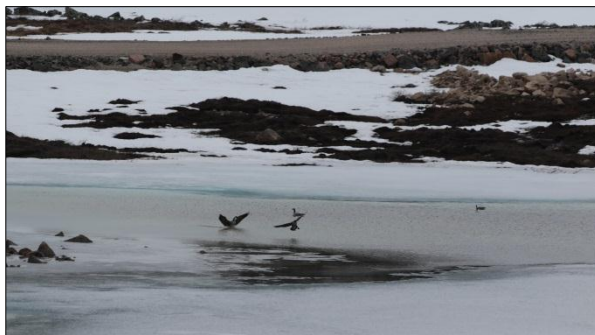
*Photo 7: Geese in Cell B/C pond (left).*

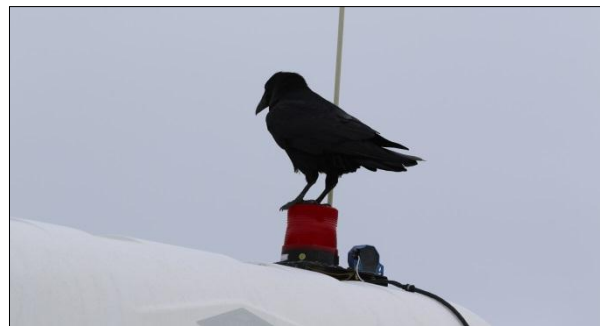
*Raven hanging around vehicle (right)*

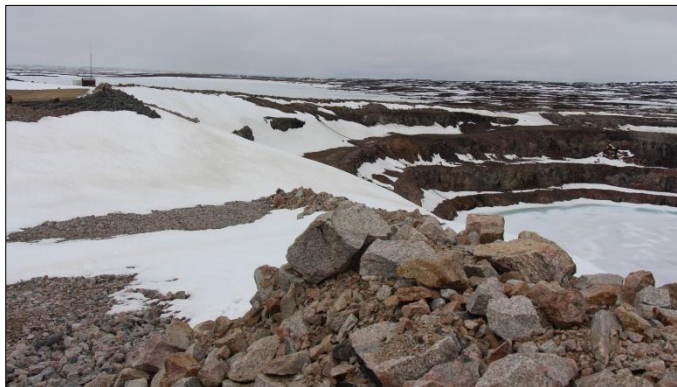
No caribou were observed during the site visit but several caribou had been observed by contractors in June through September along the airstrip as well as adjacent to or on the PKCA. Although the alteration of site features could alter the navigable landscape through the area, the Monitoring Officer did not identify any constraint to movement related to site infrastructure with the exception of the pit. The berm surrounding the pit was intact except for in areas where water management features were being rerouted during stabilization activities (Photo 8). The berm area was not very high or wide and the Monitoring Officer had some concern that there are no caribou deterrent features such as Enokhuk to divert caribou away from the pit area or around the mine site in general.

*Photo 8: View of the break in the berm surrounding the open pit*

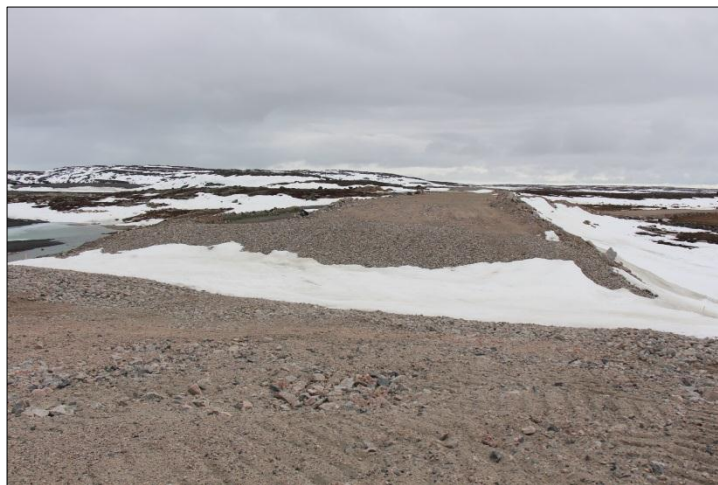
*Photo 9: Breached segment of the Divider Dyke A*

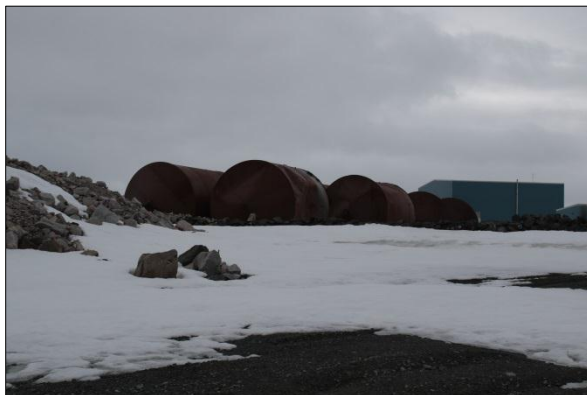
As part of the stabilization activities being undertaken by INAC under NIRB File No. 16UN058, contractors on-site conducted substantial works related to fuel storage areas. Fuel tanks within Phase 1 of the main fuel tank farm have been purged, cleaned, removed, and are being stored on-site ([Photo 10](#)). The contaminated soils, identified through past and ongoing

*Photo 10: Remediated Fuel Tanks*

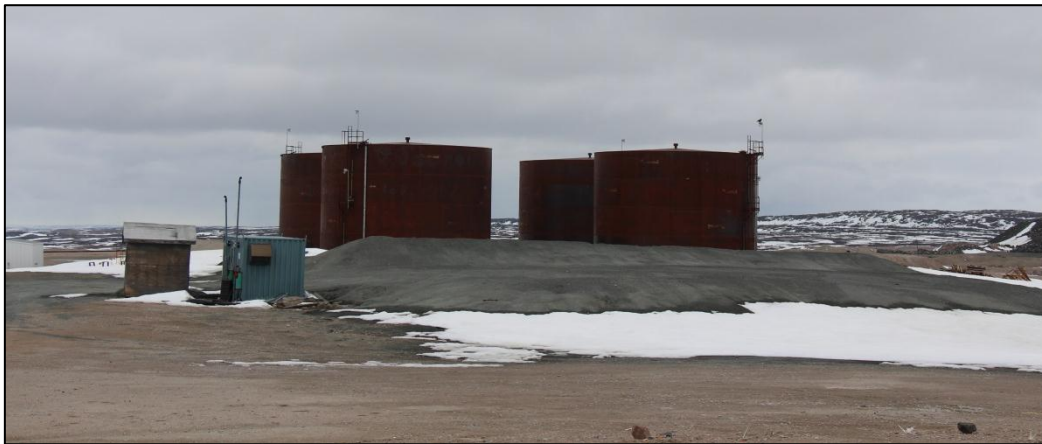
testing at various locations on-site, have been collected, covered with a liner, and capped with coarse processed kimberlite within the Phase 1 berm for long-term storage. The contractor will be returning to site in the summer of 2018 to complete the task by fixing the fold in the top liner ([Photo 11](#)). The bulk fuel tanks within the Phase 2 main fuel tank farm have been purged of their remaining fuel and cleaned, and are to remain in-place within the breached berm area due to their size. The majority of the berms (except for the former Phase 1 tank farm berm) have been breached to avoid seasonal water accumulation ([Photo 12](#)). INAC indicated that all remaining fuel on-site has been purged and burned off using an on-site incinerator, except for a few drums which are being stored in truck shop building. All drums have been emptied, cleaned, and stacked ([Photo 13](#)).

*Photo 11: Phase I berm containing contaminated soil*

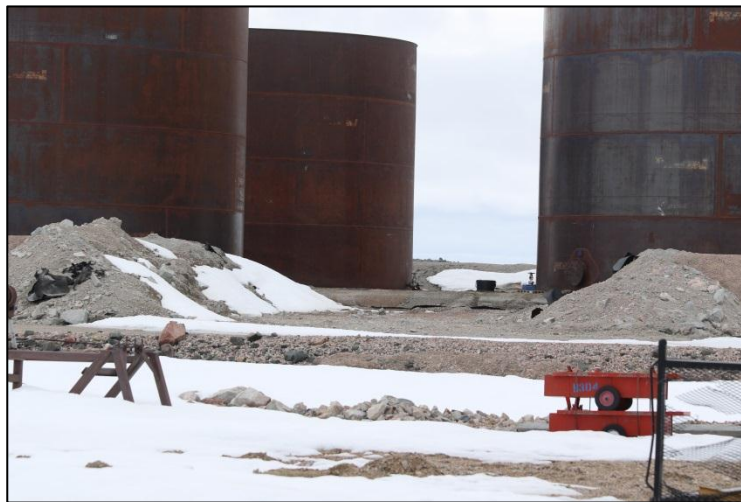
*Photo 12: Phase II fuel tanks with breach in berm*

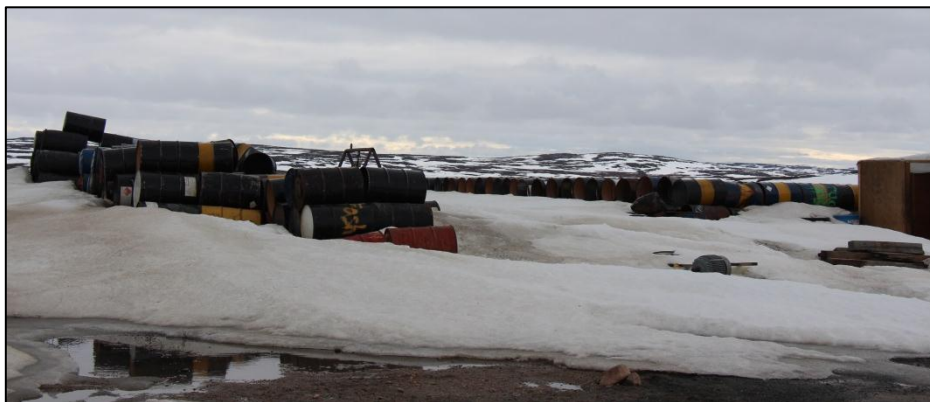
*Photo 13: Cleaned Fuel Drums*

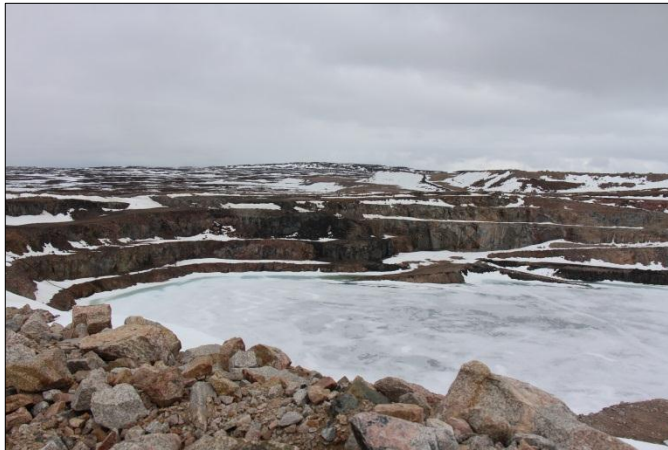
As observed during previous site visits, the water within the open pit continues to rise annually (Photo 14). The pit lake was frozen at the time of the site visit and no free flowing water was observed in any of the streams. INAC estimated during the 2016 site visit that at the current rate of infiltration, it would take 40 to 42 years for the open pit to fill and resemble a lake. As part of the stabilization activities approved under NIRB File No. 16UN058, the C1 stream diversion was removed and plugged, the pit side wall was breached and a channel was restored to allow the original natural water flow back to the pit area which would accelerate the pit infill, estimated at 2 to 3 years (Photo 15 and Photo 16). A breach was also made in the north side of the open pit side wall to restore the natural flow of water back into Carat Lake once the pit reaches its final elevation (Photo 17). For additional discussions related to the open pit see [Section 4.2.8](#).

*Photo 14: Open Pit*

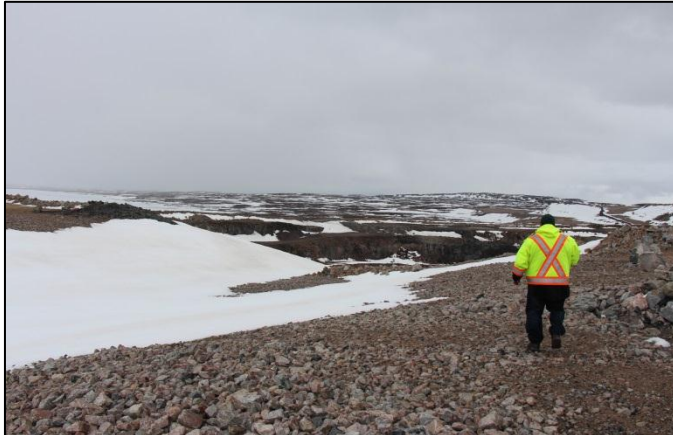
*Photo 15: Removal of C1 Diversion and breach of pit wall to re-route water into open pit*

As part of the stabilization activities approved under NIRB File No. 16UN058, the C1 stream diversion was plugged and removed and the channel was restored to allow the natural water flow back to the pit area (Photo 15). This was not a fish bearing stream. The Monitoring Officer also noted that there were several culverts along the road and was informed that none of these were fish bearing streams.

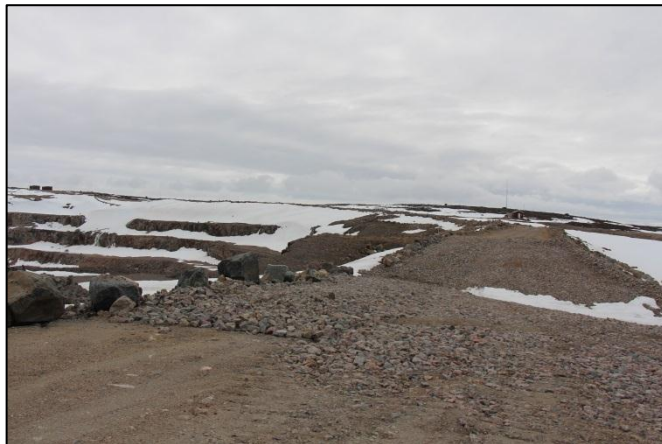
*Photo 16: Outflow from pit lake into Carat Lake*

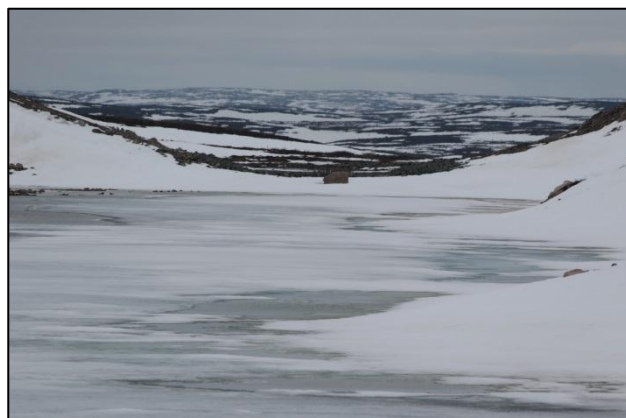
Conditions 4, 7, 19, and 20 through 25 of the Project Certificate No. 002 outline requirements of the Proponent in relation to site water management and recommendations for reducing impacts to fish populations in areas surrounding project activities. During the site visit, INAC noted that in the summer of 2017 water had been transferred from Cell B/C over the West Dam (Photo 17),

*Photo 17: West Dam*

and that no water treatment was required as the water met discharge criteria. Divider Dyke A as well as the West Dam were breached in order to promote water flow through the respective containment structures (Photo 18 and Photo 19). Water was not expected to flow through this season and INAC noted that Divider Dyke A will likely continue to act as a filter dyke into the future as very little ponding was occurring in Cell A and what discharge will likely filter through to Cell B/C. INAC confirmed that no fish sampling had taken place during the past year and is not part of the *future monitoring plan*.

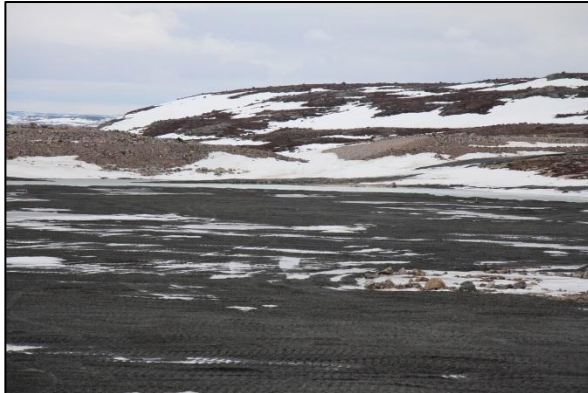
*Photo 18: Breach in Divider Dyke A*

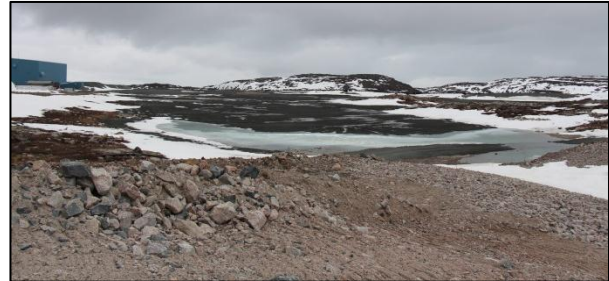
*Photo 19: Ponding in PKSA Cell A behind Divider Dyke A*

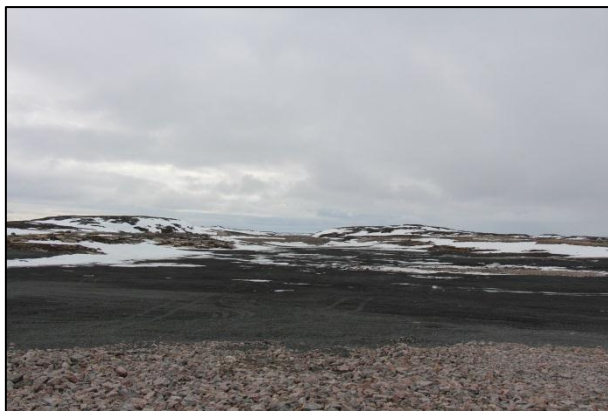
Due to the absence of mining operations and the production of wastewater, the PKCA remains mostly dry. Ground stability within the PKCA is able to support heavy machinery and the coarse rejects cover was able to be applied without any apparent difficulties ([Photo 20](#), [Photo 21](#), [Photo 22](#), [Photo 23](#)). Very little water is expected to flow through the PKCA containment cells into the receiving environment by the West Dam. Previous water quality testing indicated the water quality met discharge criteria and did not need to be treated, therefore no future water quality monitoring will be conducted at the West Dam prior to water being allowed to discharge into the receiving environment.

As previously noted, during the 2018 site visit the Monitoring Officer observed that windblown dust from the PKCA appeared to be contained by the coarse material cover applied over the fine processed kimberlite, and the containment structures (e.g., tire berm) previously installed were still in place. The Monitoring Officer has some concerns about future wind-blown dust as the coarse material will break down with time and will require further observation to ensure short- and long-term effectiveness (See Section 4.2.1).

*Photo 20: PKSA*

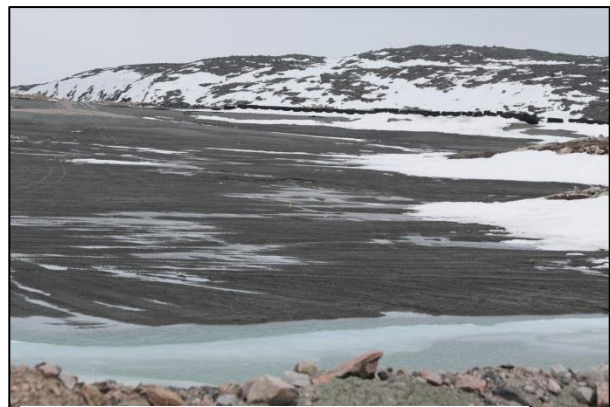
*Photo 21: Cell A PKSA*

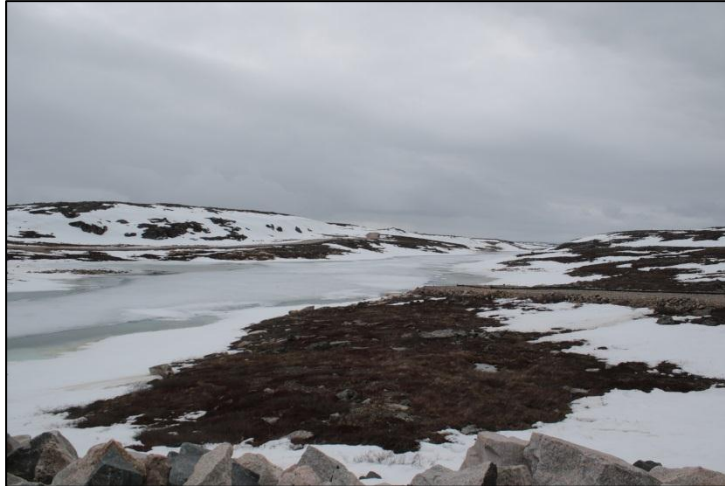
*Photo 22: Cell B/C*

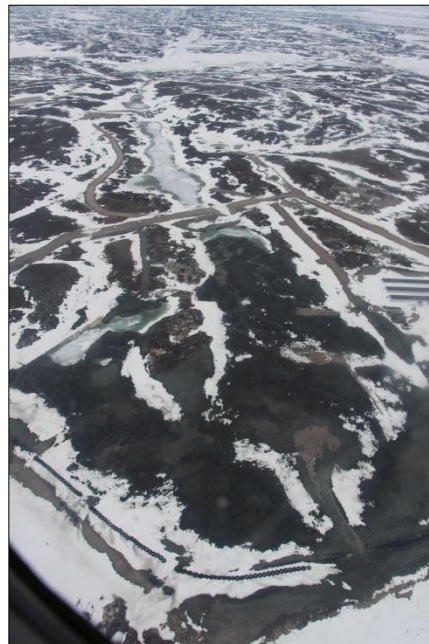
*Photo 23: PKSA as seen from the air (Cell A bottom of photo)*

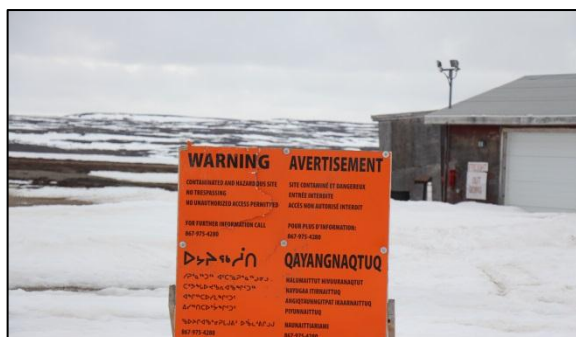
*Photo 24: Contaminated and Hazardous Site Sign*

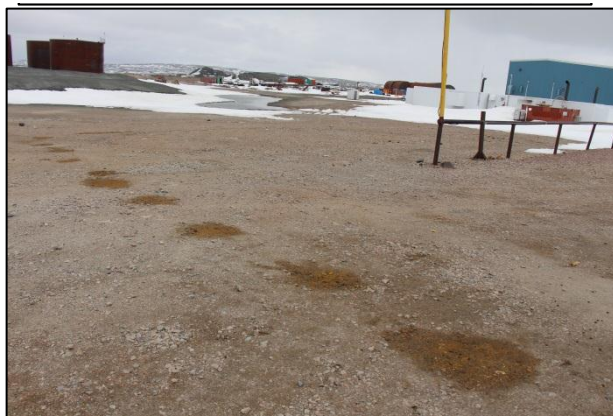
*Photo 25: Spills at location of temporary contractor camp*

At the contractor's temporary camp location, the Monitoring Officer observed a trail of 11 spills of unknown origin, electrical cords, and miscellaneous materials left behind ([Photo 25](#) and [Photo 26](#)). INAC noted that the contractors will be required to clean-up the spills and remove any remaining materials during the summer (2018) when they complete the work on the soil cell liner. The removal of a temporary berm liner in the grey water sump area will also need to be completed ([Photo 27](#)).

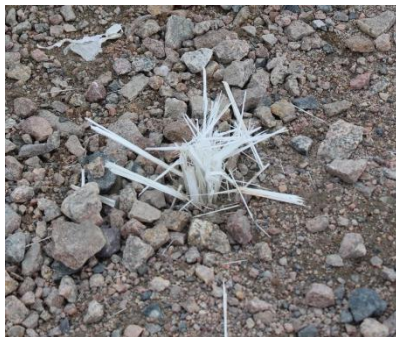
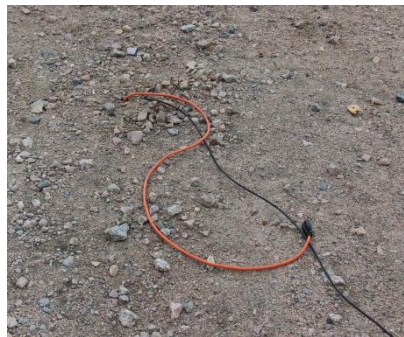
*Photo 26: Material left behind at temporary contractor camp*

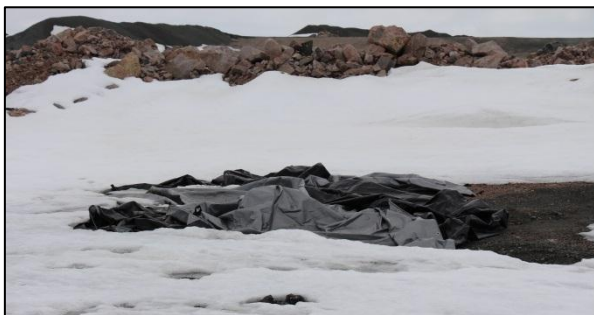
*Photo 27: Temporary Berm Liner*

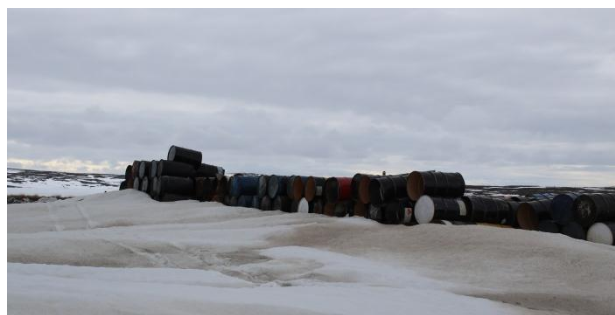
*Photo 28: Empty and Cleaned Fuel Barrels*
