**Re: Renewal Application of Type A Water Licence 2AM-JER0411
Updated Plan – Processed Kimberlite Containment Area Management Plan and
Operations, Maintenance and Surveillance Manual**

PROCESSED KIMBERLITE MANAGEMENT PLAN JERICHO PROJECT, NUNAVUT

AUGUST 2011
ISSUED FOR USE
EBA FILE: E14101140

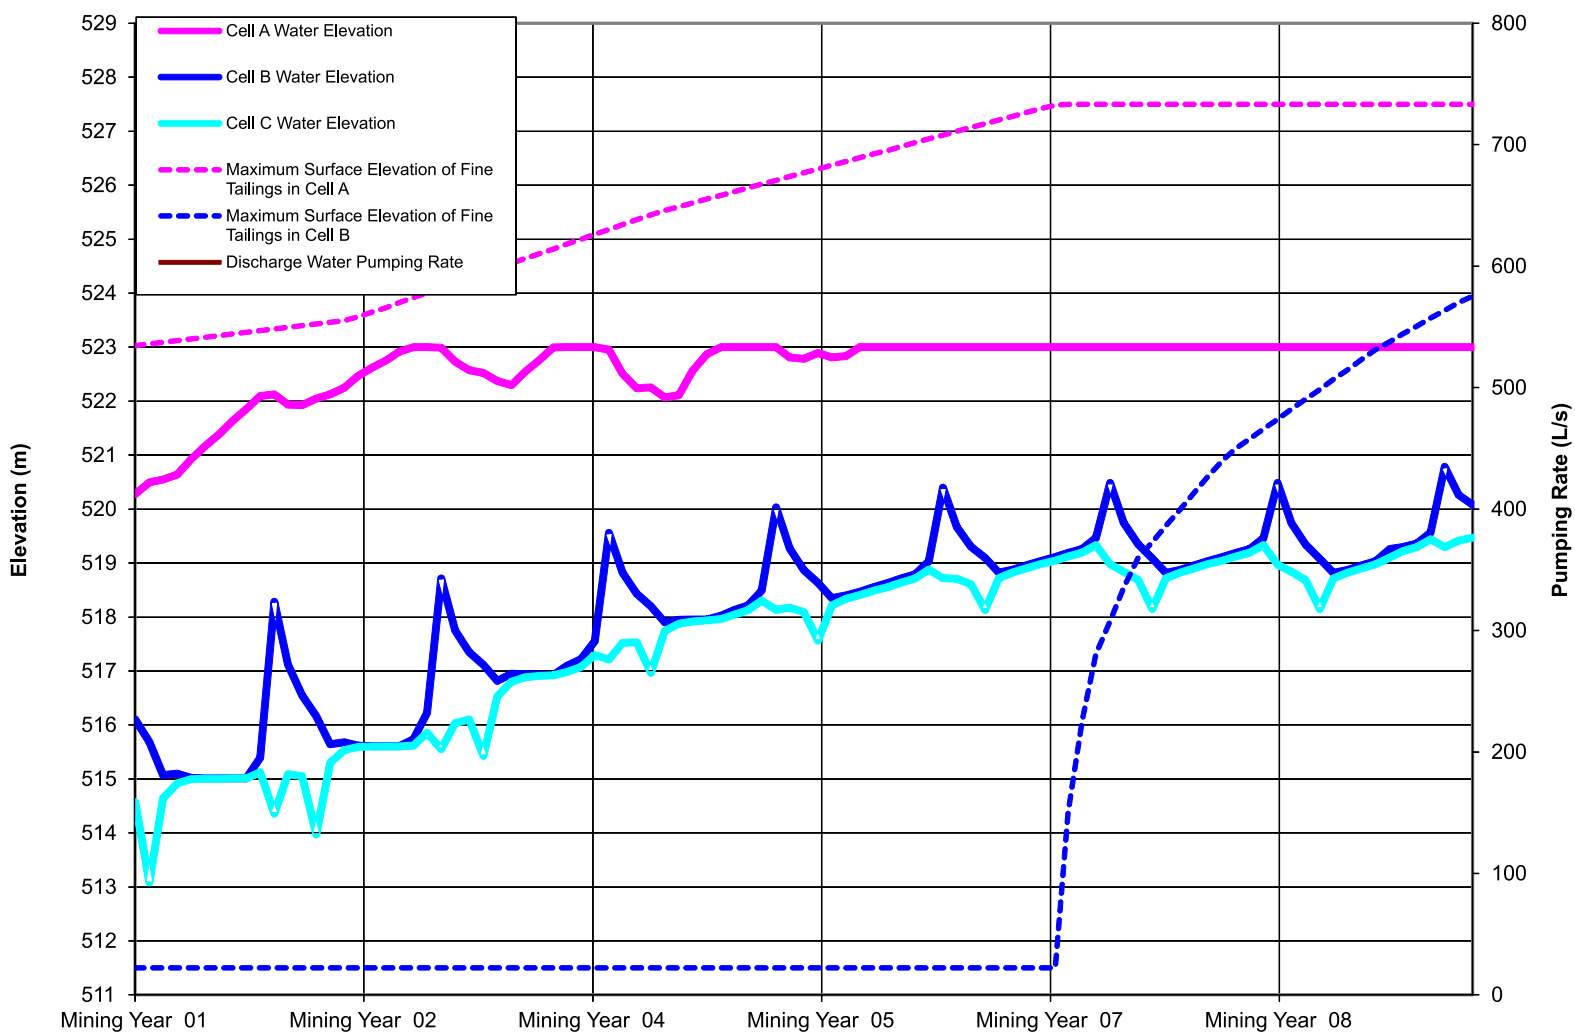
Figure 8

Cell A Water Elevation
Cell B Water Elevation
Cell C Water Elevation

The maximum predicted water elevations in the Cells, A, B and C, for mean conditions and 1:100 wet year conditions are summarized in Table 9. The maximum predicted water elevations in Cell B and C are below the maximum operating water elevation of 523.0 m. As expected the water elevation in Cell A reaches maximum elevation in the third year of production due to blinding off of the filter dyke with fine PK material. Therefore, excess water entering Cell A will be allowed to overflow into Cell B in a controlled manner using a spillway.

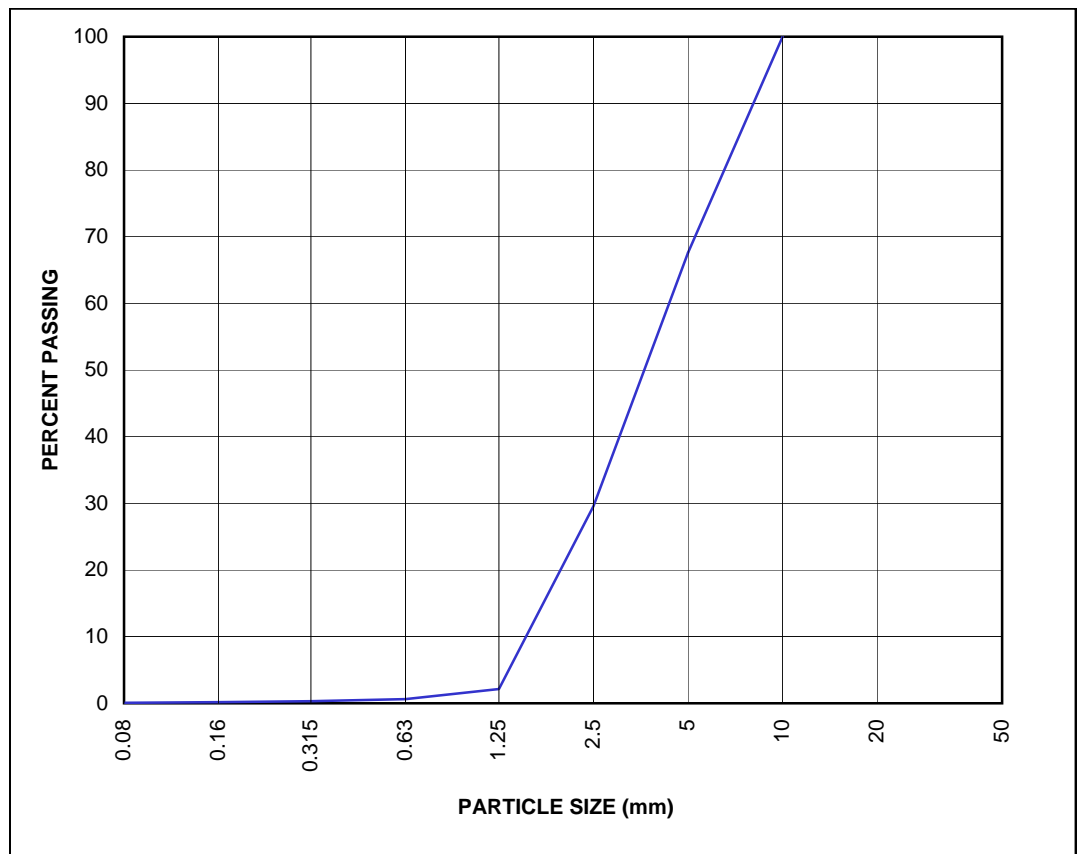
PROJECT:	PKCA Dams	SAMPLE NO:	Tailings_Coarse_005
ADDRESS:	Jericho Diamond Project	SAMPLE DESCRIPTION:	
PROJECT NO:	0101-04-1100060.007		Coarse Tailings from PP without HPGR
DATE TESTED:	Feb 13/06 By: MM		
CLIENT:	Tahera Diamond Corp.	NAT. MOISTURE CONT.:	8.1%
		COLOUR PLATE #:	n/a
		BULK REL DENSITY:	n/a
ATTENTION:	Roland Jones/Harold Gates	BULK REL. DENSITY (ssd):	n/a
		APPARENT REL. DENSITY:	n/a
		ABSORPTION:	n/a

PARTICLE SIZE	PERCENT PASSING
10	100
5	68
2.5	30
1.25	2
0.630	1
0.315	0
0.160	0.2
0.080	0.1

Remarks: Coarse tailings sample without HPGR running was produced by the Process Plant.
